Data-Driven Field Observational Method of a Contiguous Bored Pile Wall System Affected by Accidental Groundwater Drawdown

Elizabeth Eu-Mee Chong ^{1,*} and Dominic Ek-Leong Ong ^{1,2}

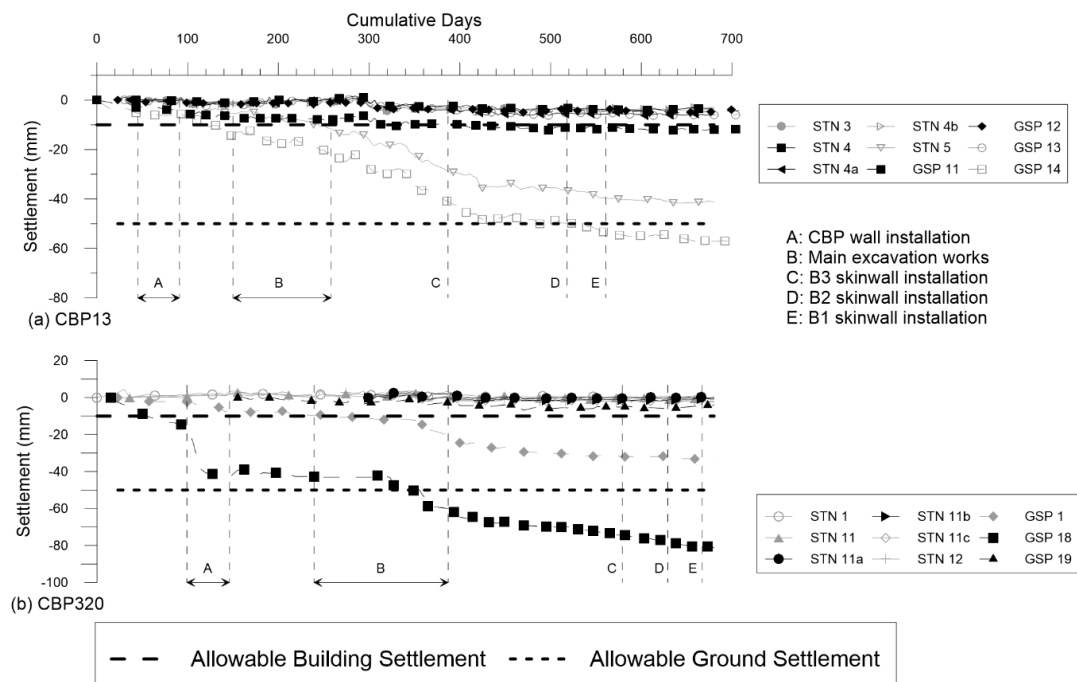
Figure 5. Overall building and ground settlement profiles for (a) CBP13 and (b) CBP320.

As expected, the main excavation works had caused much of the settlement to occur, especially along Walls E and F. The building settlement near CBP393, CBP424, CBP465, and CBP506 recorded settlement from 18.7 mm to 98.3 mm, much greater than the allowable building settlement of 10 mm. For these sections, the ground settlement markers also recorded similar magnitude to the building markers, ranging from 17.9 mm to 93.3 mm. It can be deduced that the buildings (shophouses) which were founded on timber bakau piles settled together with the ground upon removal of the overburden stresses. Essentially, this means the buildings are 'floating' on the timber bakau piles. A separate discussion on these wall sections will be made in the next section. For CBP249, the main excavation works contributed to 16.9 mm ground settlement (77% of the total settlement). The high percentage of settlement was due to the longer construction period as CBP249 was located near the temporary access ramp. Figure 5 shows the overall building and ground settlement profiles for CBP13 and CBP320. There is a remarkable difference between the building and ground settlement. The latter is settling much more than the building settlement. This finding suggested that the buildings near to these two

sections were built on solid foundation that were able to tolerate the soil movement. The ground, however, settles when the horizontal stress increases.

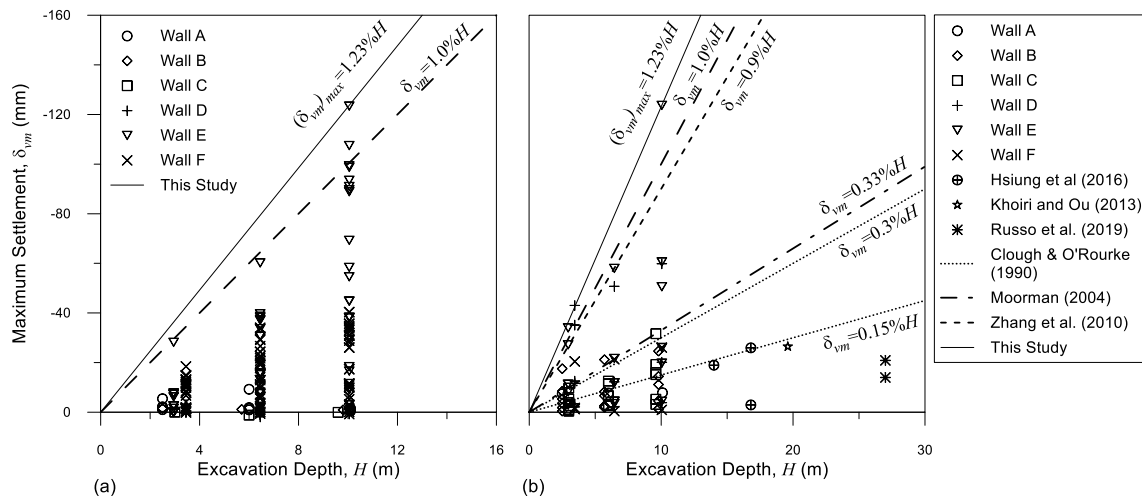
Figure 9. Relationship between maximum settlement and excavation depth for all the excavation stages for (a) building; and (b) ground.

Figure 9 shows the relationship between the measured maximum building and ground surface settlement (δ_{vm}) and the excavation depth (H) for all excavation stages. The δ_{vm} generally increase as H increases, especially for Walls D, E, and F. However, there are also a good spread of data that has registered very small δ_{vm} , allowing the data to fall within the range of 0% to 1.23% H , for both building and ground settlement. Included in Figure 9b are the δ_{vm}/H from databases such as Clough and O'Rourke [3] for excavation in stiff clays, residual soils, and sands; and Moormann [22] for

non-cohesive soils; and some data from excavation in sand [23–25] for comparison. These case histories had relatively small settlement compared to the present study, generally below $0.33\%H$. As previously discussed, the flaw in the CBP wall upon ground anchor installation had caused the groundwater loss and significant settlement had been observed. Due to some settlement markers being located further away from the wall or on buildings that has more solid foundation, a big range of δ_{vm}/H is observed. Zhang et al. [26] reported a quite similar experience to the present study, where δ_{vm}/H was 0.9% and attributed the large ground surface settlements to significant groundwater drawdown.

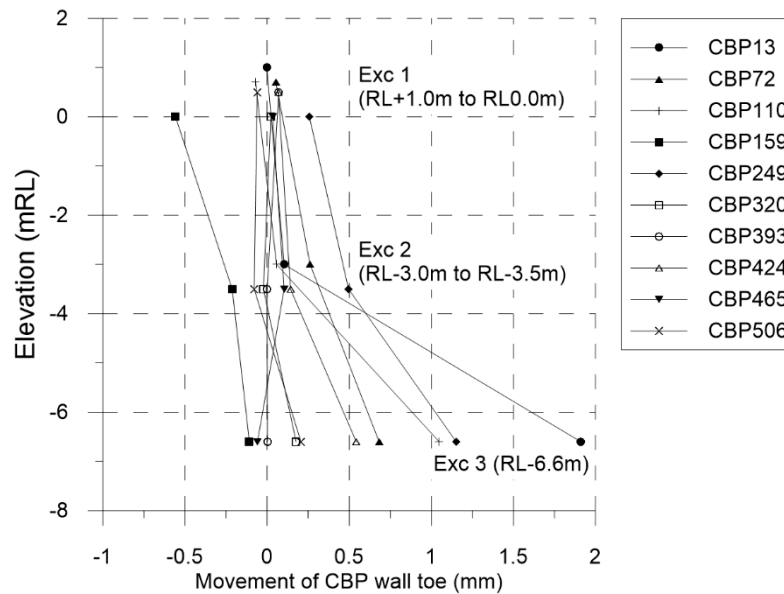
Figure 11. Progressive wall toe movements at all excavation depths.

be moving outward, due to the limit of strut elongation. Figure 11 shows the progression of the wall toe movements at all excavation depths. The first stage of excavation hardly recorded any movement except for CBP159. The second stage of excavation sees a little more movement, but it is within 0.5 mm from the wall. The final stage of excavation caused the wall toe to move inward with the largest movement of 2 mm. With such small measurements, the wall toe movements were considered to be insignificant. This observation further strengthens the fact when the bored piles are socketed into phyllite by about 4 m, the mass block of phyllite layer provided sufficient strength to restrict the wall movement. Furthermore, it is possible to have an outward toe movement in this case, as over-stressing the ground anchor will cause the outward toe movement.

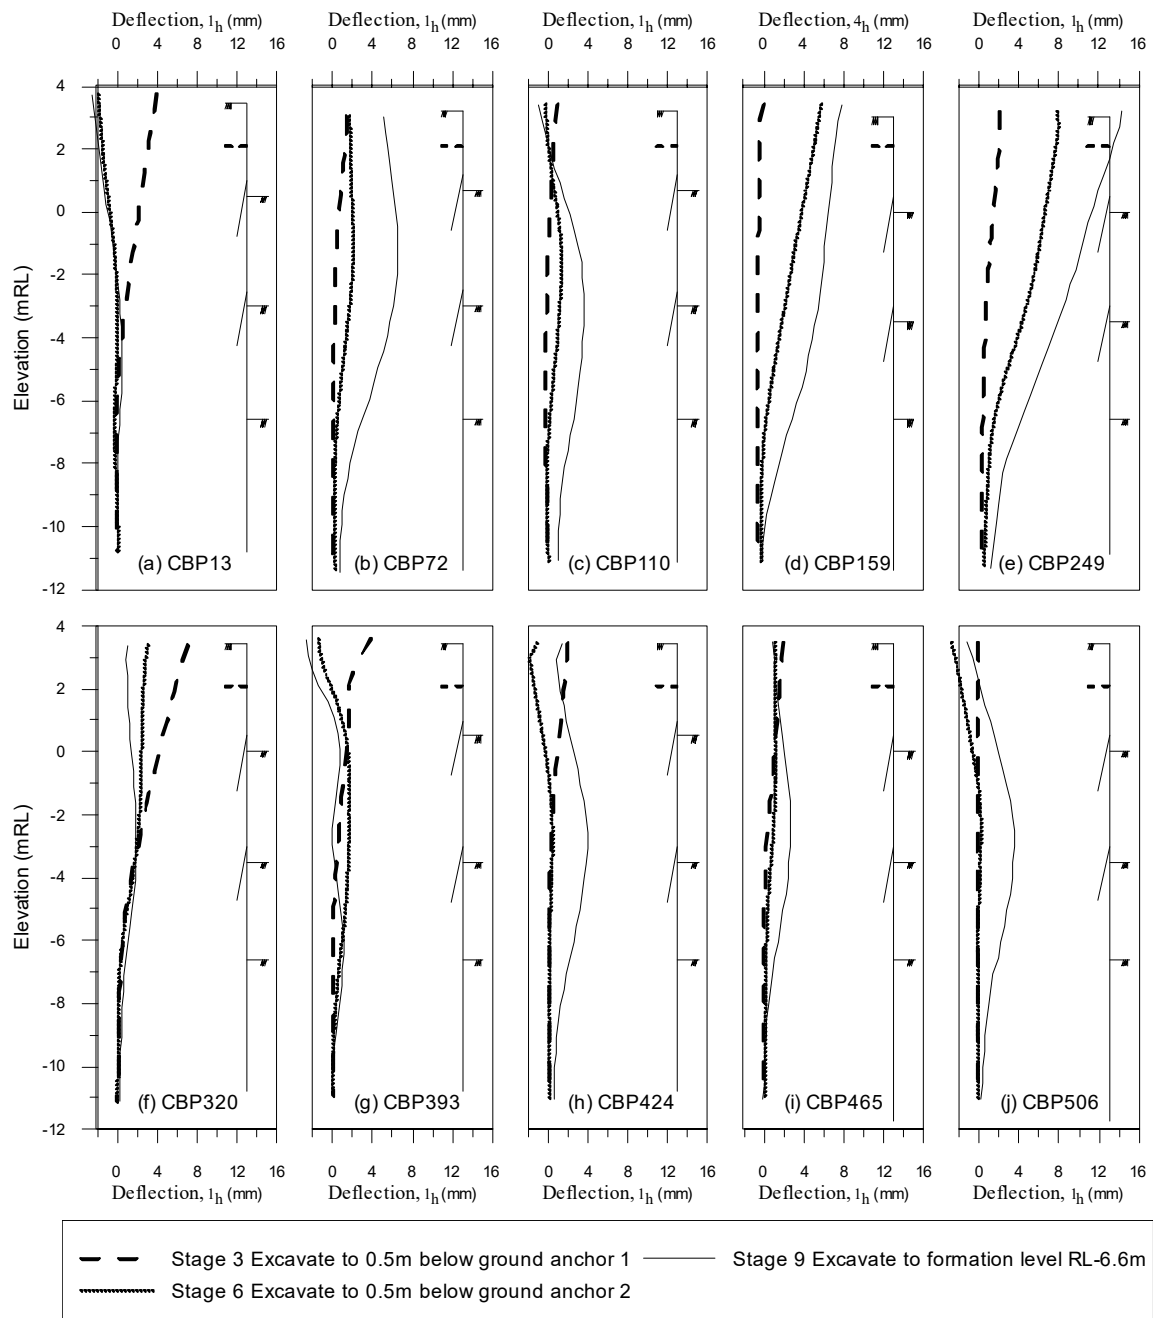
Figure 12. Horizontal wall deflections for excavation Stages 3, 6, and 9.

Figure 12 shows the horizontal wall deflections for excavation Stages 3, 6, and 9. It is observed that the wall behaved in cantilever mode at Stage 3, where the largest movement occurred at the top of the wall. This movement is expected as the soil near the top has been excavated for pile head hacking and subsequently to 0.5 m below GA-1. The maximum horizontal deflection (δ_{hm}) for Stage 3 occurred at CBP13 with 4.04 mm. After the installation of GA-1, the deflection profile changed to prop mode, where the top of the wall moved towards the retained soil. For CBP13, CBP393, and CBP424, the effectiveness of ground anchors were demonstrated when the wall is pulled into the soil by the ground anchor as indicated by the negative deflection value [28]. Although the wall deflection profiles for CBP159 and CBP249 continued the cantilever mode, it was due to CBP159 being situated in a localized pocket of peat which exerts higher pressure onto the wall, while CBP249 was located near the temporary access ramp with heavy machineries passing by. The largest deflection for Stage 6 occurred at CBP249, measuring 7.9 mm. The deep inward movement for all the sections continued to Stage 9, although CBP393 exhibited otherwise. The largest deflection occurred at CBP249, measuring 14.3 mm.

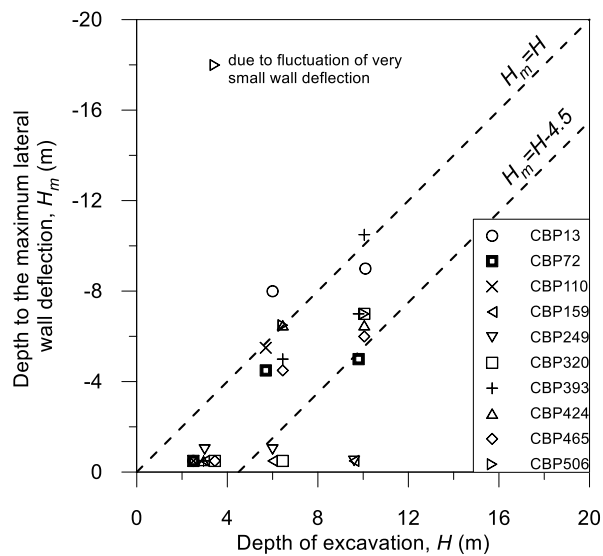
Figure 13. Relationship between location of maximum horizontal wall deflection and excavation depth.

Most of the δ_{hm} occurred near or higher than the excavation surface, similar to observations in clay [29,30]. From Figure 13, the depth to the maximum lateral wall deflection, H_m , is generally close to the excavation depth. Apart from a few exceptions, the data falls within $H_m = H$ to $H_m = H-4.5$, indicating H_m to occur higher than the excavated surface. For CBP506 at Stage 3, the maximum deflection was recorded at 18-m depth, but it was caused by fluctuation of very small wall deflection. At Stage 9, most of the maximum deflections occurred near the depth of the second excavation. Owing to the shallow depth to hard strata, some of the Stage 9 excavation are done at the phyllite layer. Therefore, smaller deflections were observed near to the surface of final excavation.

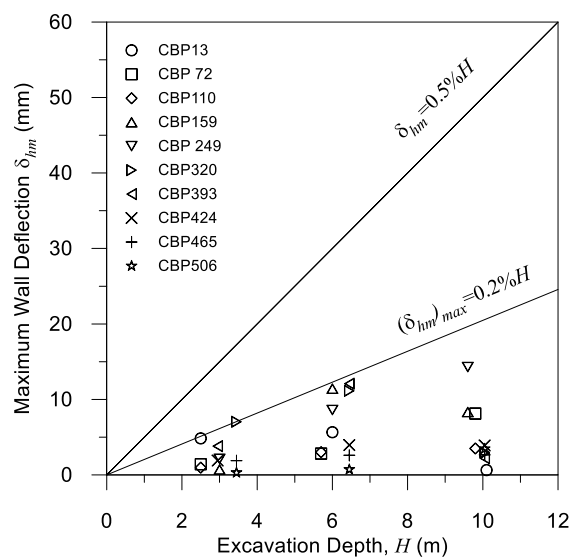
Figure 14. Relationship between maximum wall deflection and excavation depth for all the excavation stages.

Figure 14 presents the relationship between the δ_{hm} and H . The entire δ_{hm} lie below $0.2\%H$. The small deflection experienced in the present study is likely due to the groundwater drawdown caused by the puncturing of walls during ground anchor installation. Relief of pore water pressure in the ground due to the accidental dewatering has resulted in less lateral earth pressure to be exerted on the CBP wall. Other reported δ_{hm}/H for sandy soils tend to be higher, within the range of 0.28 [23,31] to 1.33 [32], which did not observe any groundwater drawdown. Moormann [22] reported $\delta_{hm}/H = 0.5\%$ for excavation in sand. Besides, the shallow depth of phyllite layer have led to smaller deflections as well.

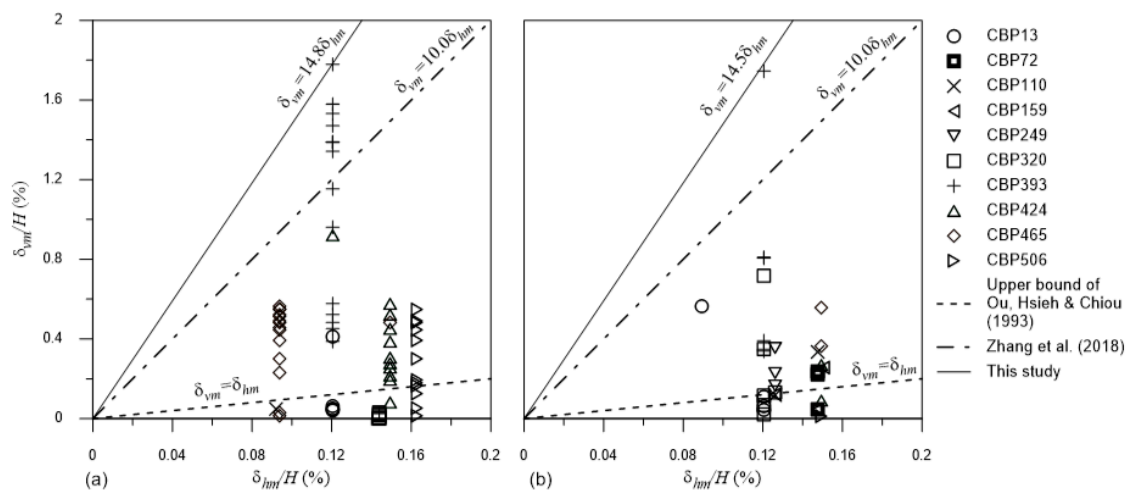
Figure 15. Relationship of maximum (a) building settlement and maximum wall deflection; and (b) ground settlement and maximum wall deflection.

As has been established in the present study, the building settlements were observed to be relatively large with small wall deflection. Figure 15a examines the normalized relationship of maximum building settlement and maximum wall deflection. A typical relationship is $\delta_{vm}/\delta_{hm} = 0.5\text{--}1.0$ [29]. In the present study, the δ_{vm}/δ_{hm} ratio is 14.8. The upper bound of the ratio is contributed by the large

building settlements around CBP393. Ignoring these values, the maximum δ_{vm}/δ_{hm} ratio will be 6, still significantly larger than the typical value of 0.5–1.0. Zhang et al. [26] reported δ_{vm}/δ_{hm} of 10 and attributed the excessive ground surface settlements to significant groundwater drawdown due to under-drainage mechanism. Therefore, drawing upon the data from the water standpipes at the cut-and-cover tunnel, it is deduced that groundwater drawdown, caused by ground anchor installation that punctured the wall, has led to significant settlement. The same observation is also extended to the ground settlement where Figure 15b illustrates the maximum δ_{vm}/δ_{hm} ratio is 14.5. The comparable δ_{vm}/δ_{hm} ratios between normalized building and ground settlement was due to shophouses being built on ‘floating’ timber bakau piles that follows the ground settlement.

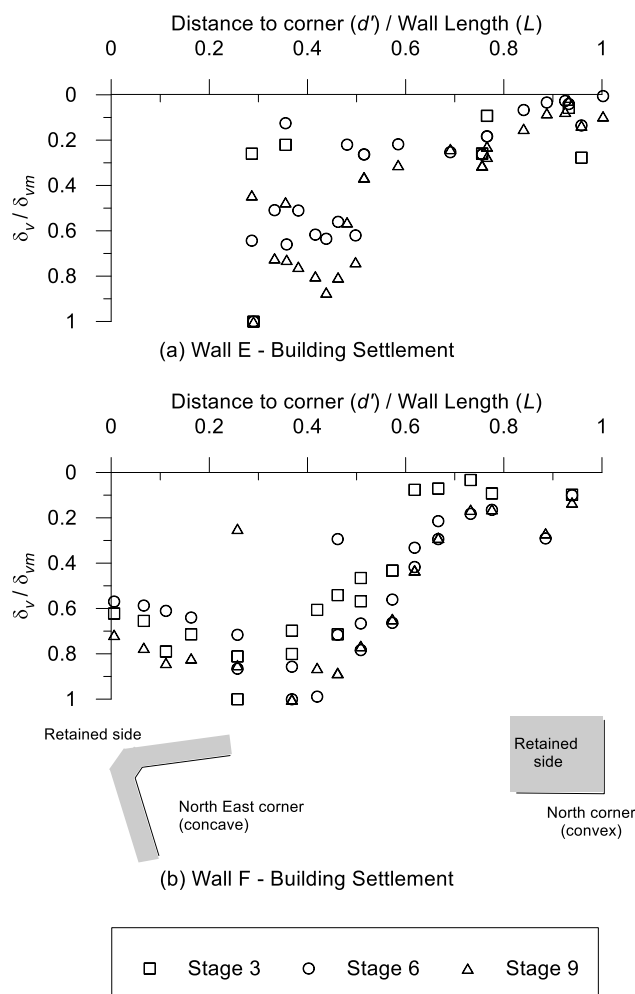
Figure 16. Normalized relationship of maximum settlement and distance to corner for (a) building settlement for Wall E; and (b) building settlement for Wall F.

Higher concentration of settlement markers along Walls E and F will be presented for discussion of corner effect. Figure 16a shows the relationship of building settlement (δ_v) normalized with δ_{vm} and distance to corner (d') normalized with wall length (L) for Wall E. At $d'/L = 0.0$ – 0.3 , no settlement markers were available. For all the three stages of excavation, the settlement data concentrated within $d'/L = 0.3$ – 0.5 (centre of the wall) are larger than those at $d'/L = 1.0$ (corner). This implies the corner effect is present through the corner restraint of the CBP wall.

Along Wall F, the corner effect for all three stages of excavation displayed the corner effect prominently, as observed from Figure 16b. It is to be noted that the larger settlements occurred from $d'/L = 0.0$ to $d'/L = 0.5$ and the left wall corner is located at $d'/L = -0.3$. The slight shift in the d'/L towards the left corner could be explained by the irregular geometry of the excavation where $d'/L = 0$ is 80° concave corner while $d'/L = 1.0$ is a 90° convex corner, which would have lesser earth pressure on the wall, and thus less settlement.

It seems the groundwater lowering due to puncturing of the wall does not seem to diminish the corner effect. Furthermore, the groundwater leakage was observed uniformly for Walls E and F, thus any effect from groundwater lowering on the corner restraint is not significant.
