The 2017, Md = 4.0, Casamicciola Earthquake: ESI Scale Evaluation and Implications for the Source Model.

Table S1. Descriptive sheet of the environmental effects allowed the estimation of the degrees of ESI intensity and the reconstruction of the isoseismal map.

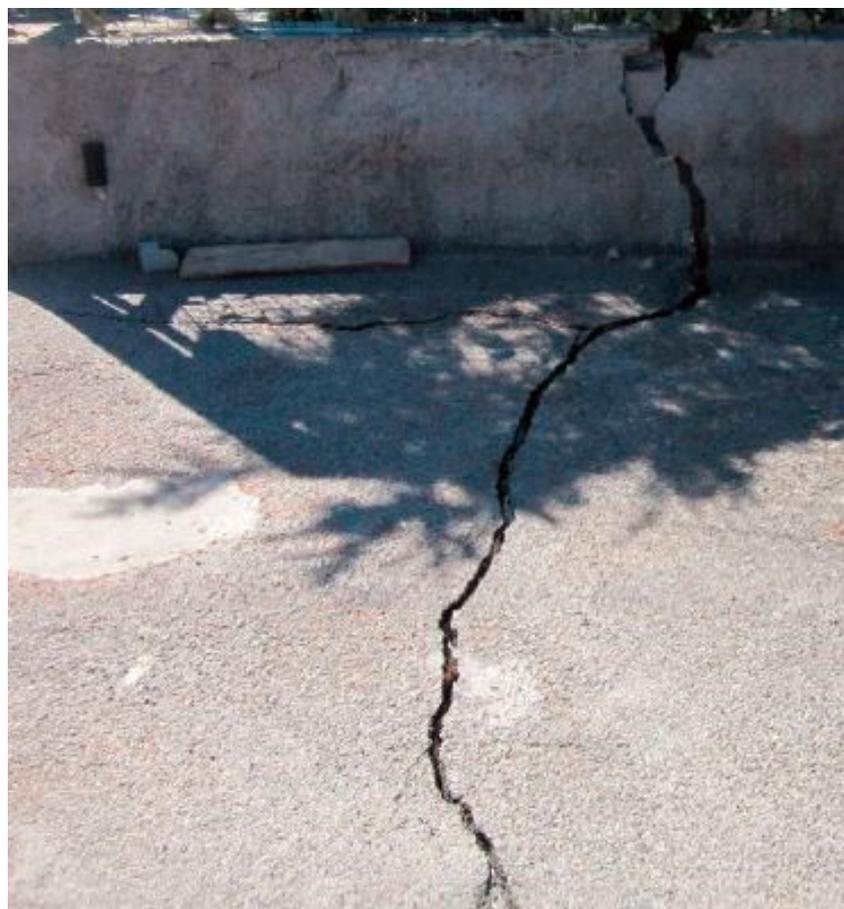
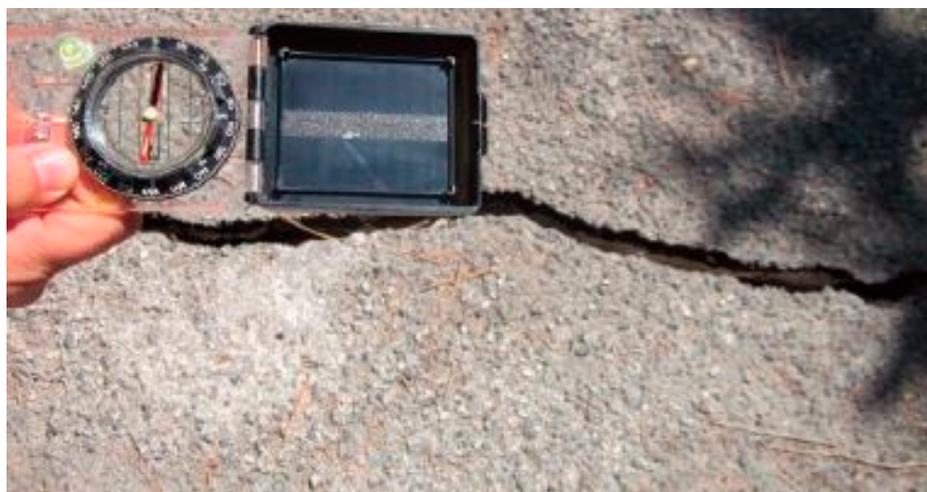
Sources of reference	Emergeo Working Group - 2019.
Site number	9
Latitude	40.742222°
Longitude	13.887901°
Locality	Via dei Carri, Lacco Ameno (NA).
Type of effect	Ground fractures
Description	Fracturing of the road pavement, also affecting the adjacent wall. The fracture extends for about ten meters, with an opening of 1-2cm.
ESI Intensity	VII
Geomorphic setting	Urban area, mostly plain topography

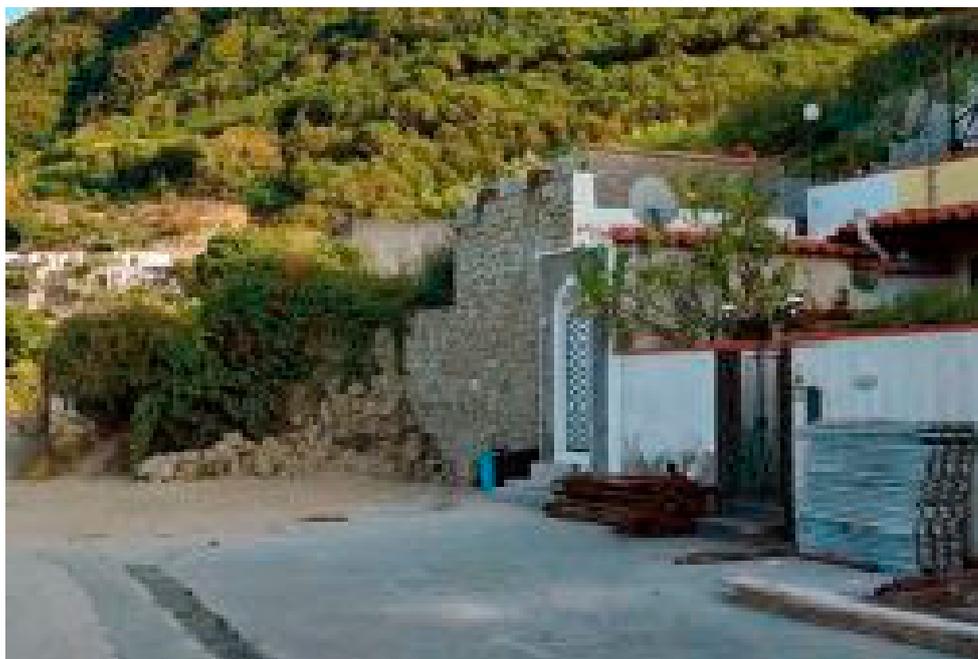
Sources of reference	Emergeo Working Group- 2019.
Site number	11
Latitude	40.741478°
Longitude	13.888903°
Locality	Via dei Carri, Lacco Ameno (NA).
Type of effect	Earth slide
Description	Collapse of a dry stone wall that surrounded a badly damaged house
ESI Intensity	Data reported because located in the immediate vicinity of ground effects
Geomorphic setting	Urban area, hilly topography

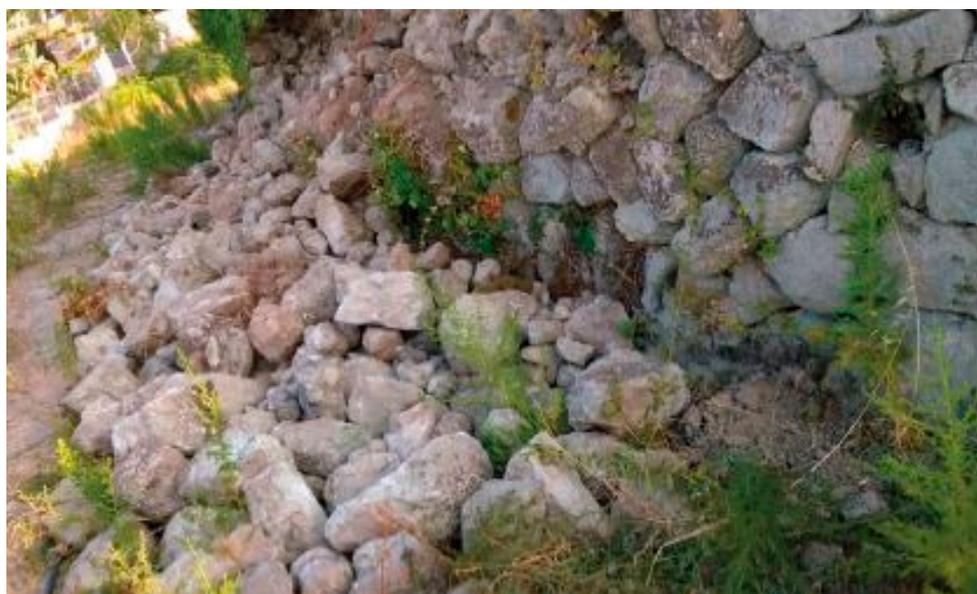
Sources of reference	Emergeo Working Group - 2019.
Site number	12
Latitude	40.740609°
Longitude	13.889906°
Locality	Via dei Carri, Lacco Ameno (NA).
Type of effect	Earth slide
Description	Drywall (parracina) collapse for a length of about 5m.
ESI Intensity	Data reported because located in the immediate vicinity of ground effects
Geomorphic setting	Area scarsamente popolata. Zona collinare.

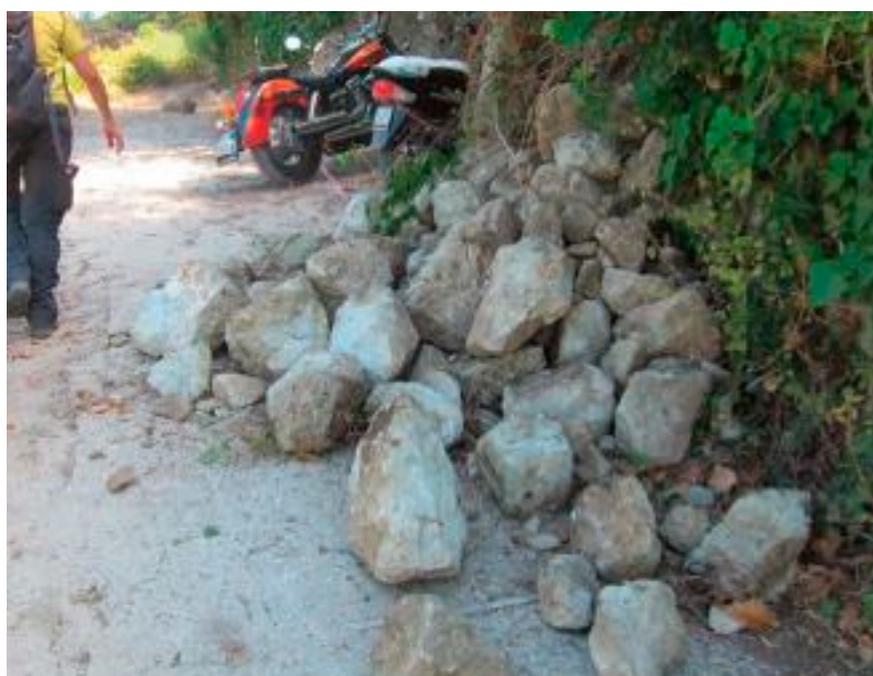
Sources of reference	Emergeo Working Group - 2019.
Site number	13
Latitude	40.739369°
Longitude	13.893487°
Locality	Via dei Carri, Casamicciola Terme (NA).
Type of effect	Earth slide
Description	Drywall (parracina) collapse for a length of 2 m
ESI Intensity	Data reported because located in the immediate vicinity of ground effects
Geomorphic setting	Sparsely inhabited, hilly area, with steep slopes.

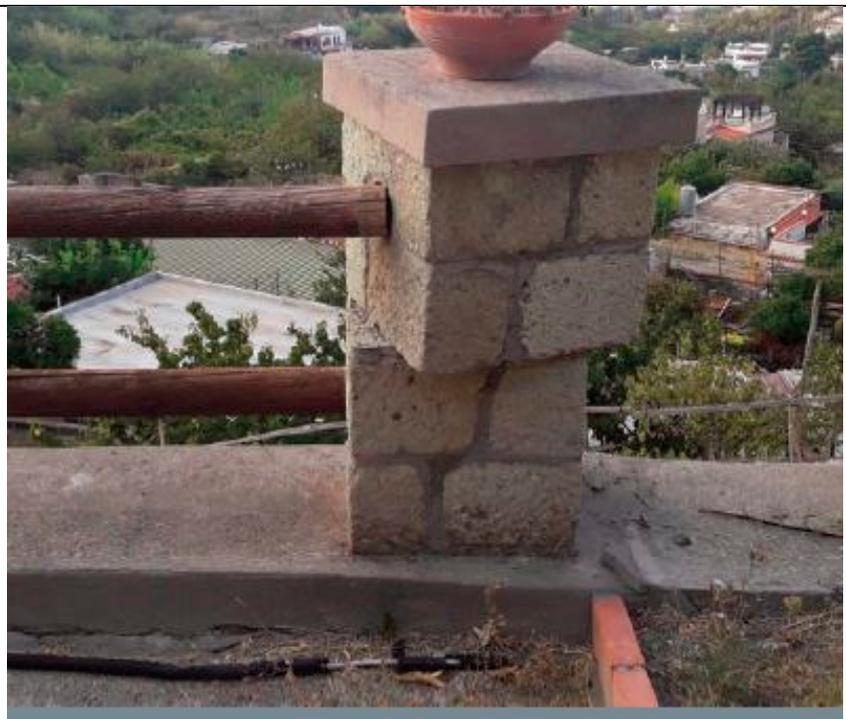
Locality	Via Montecito, Casamicciola Terme (NA).
Type of effect	Fractures
Description	Fracturing, displacement and rotation of a small masonry pillar, which is part of a handrail, on the side of the road.
ESI Intensity	Data reported because located in the immediate vicinity of ground effects
Geomorphic setting	Urban area, hilly topography

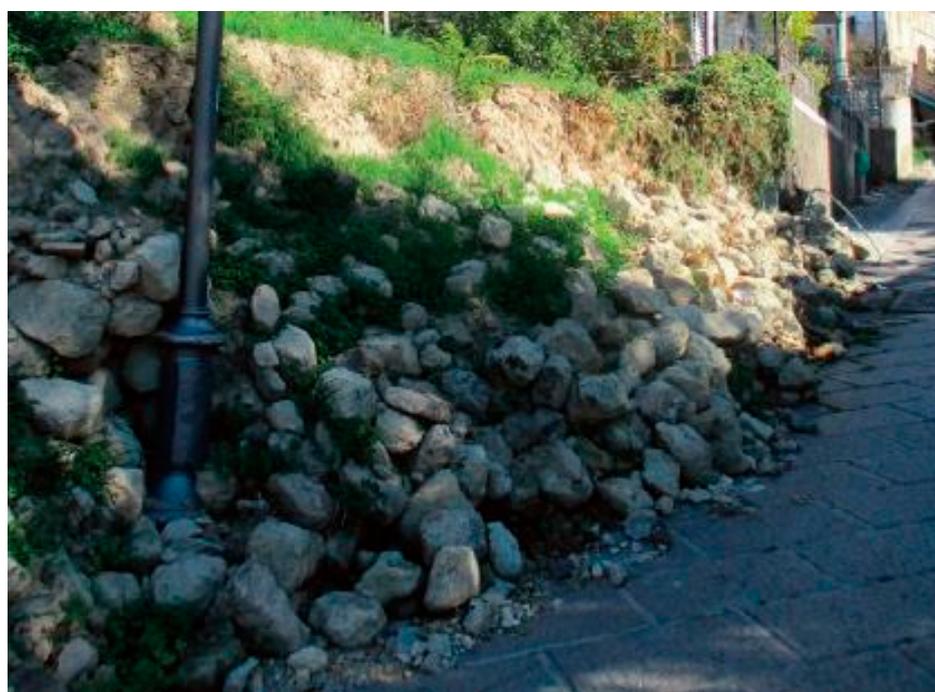
Sources of reference	Emergeo Working Group- 2019.
Site number	25
Latitude	40.743476°
Longitude	13.897395°
Locality	Via D'Aloisio, Casamicciola Terme (NA).
Type of effect	Earth slide
Description	Drywall (parracina) collapse for a length of ca. 5-6 m.
ESI Intensity	Data reported because located in the immediate vicinity of ground effects
Geomorphic setting	Urban area, hilly topography

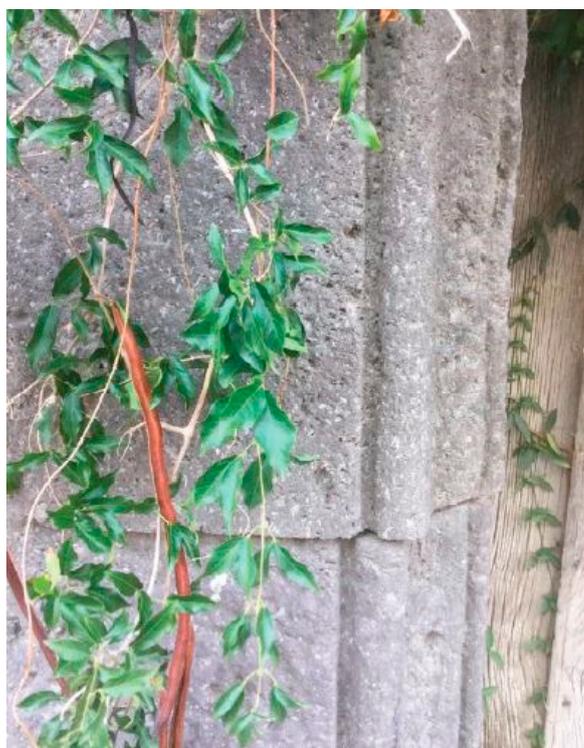
Sources of reference	Emergeo Working Group- 2019.
Site number	29
Latitude	40.742574°
Longitude	13.900215°
Locality	Via D' Aloisio, Casamicciola Terme (NA).
Type of effect	Column rotation
Description	A slight rightward rotation of the upper part of a column is observed.
ESI Intensity	Data reported because located in the immediate vicinity of ground effects

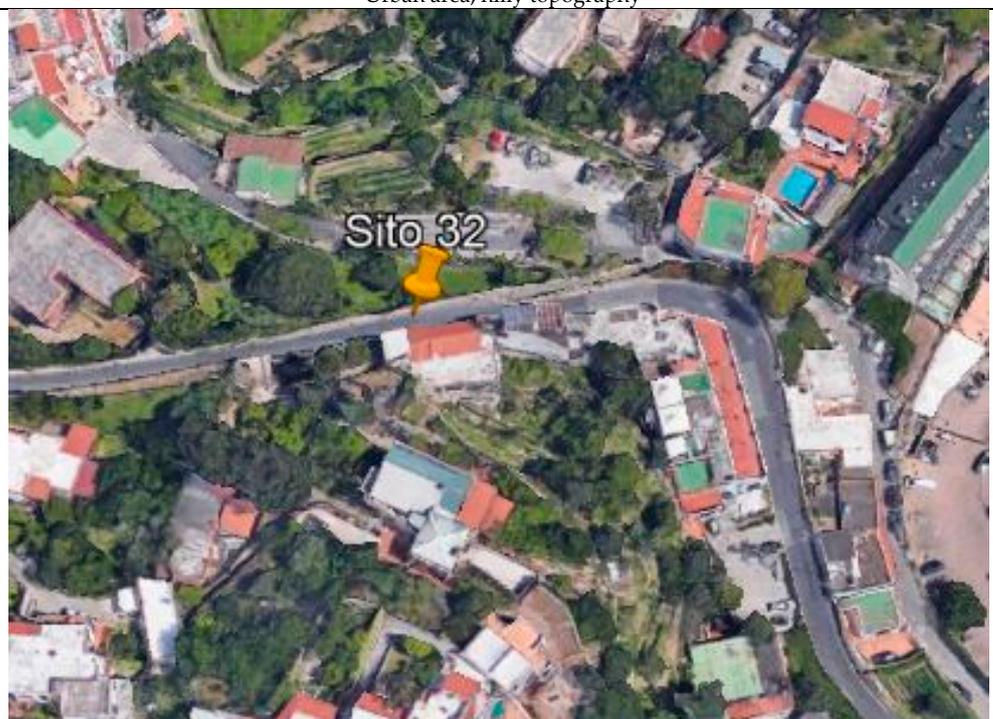
Satellite image

Sources of reference	Emergeo Working Group- 2019.
Site number	32
Latitude	40.745316°
Longitude	13.903518°
Locality	Via Castanito, Casamicciola Terme (NA).
Type of effect	Ground fractures
Description	Fracture of the asphalt road surface, which extends for about 5m and has an opening of no more than 1 cm
ESI Intensity	VI
Geomorphic setting	Urban area, hilly topography

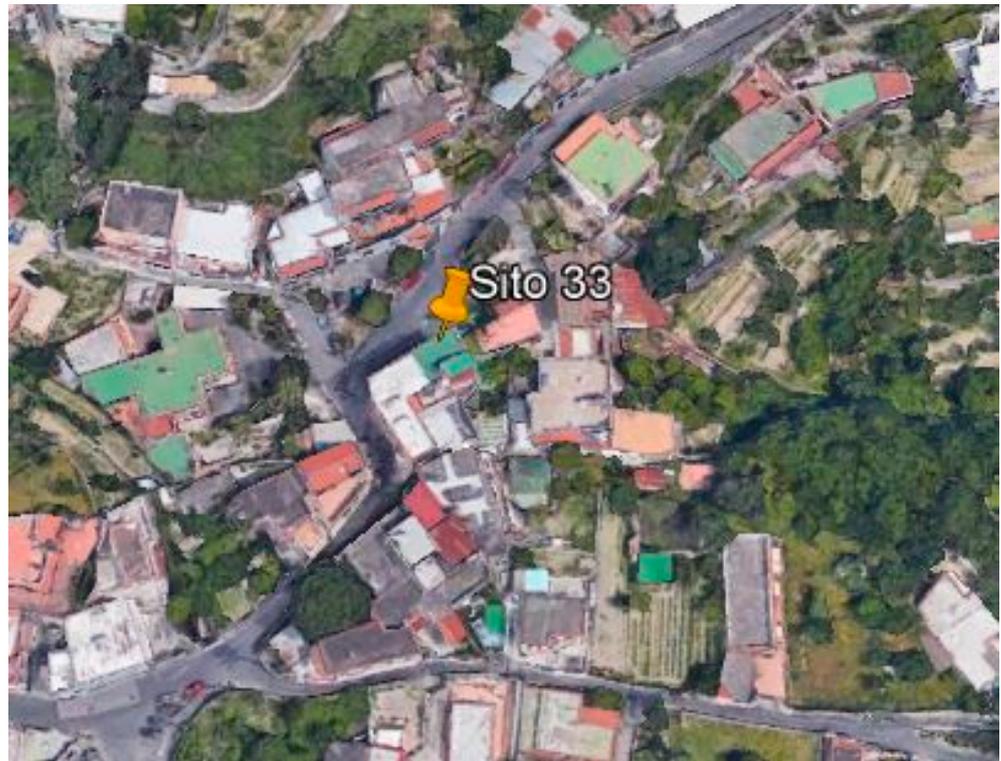
Satellite image

Sources of reference	Emergeo Working Group- 2019.
Site number	33
Latitude	40.743056°
Longitude	13.902477°
Locality	Via Sassolo, Casamicciola Terme (NA).
Type of effect	Ground fractures
Description	Fracturing of the cemented soil in front of a house. The fracture extends for 5m, showing an opening of less than 1 cm and a vertical dislocation of 1 cm, down to the north
ESI Intensity	VI
Geomorphic setting	Urban area, hilly topography

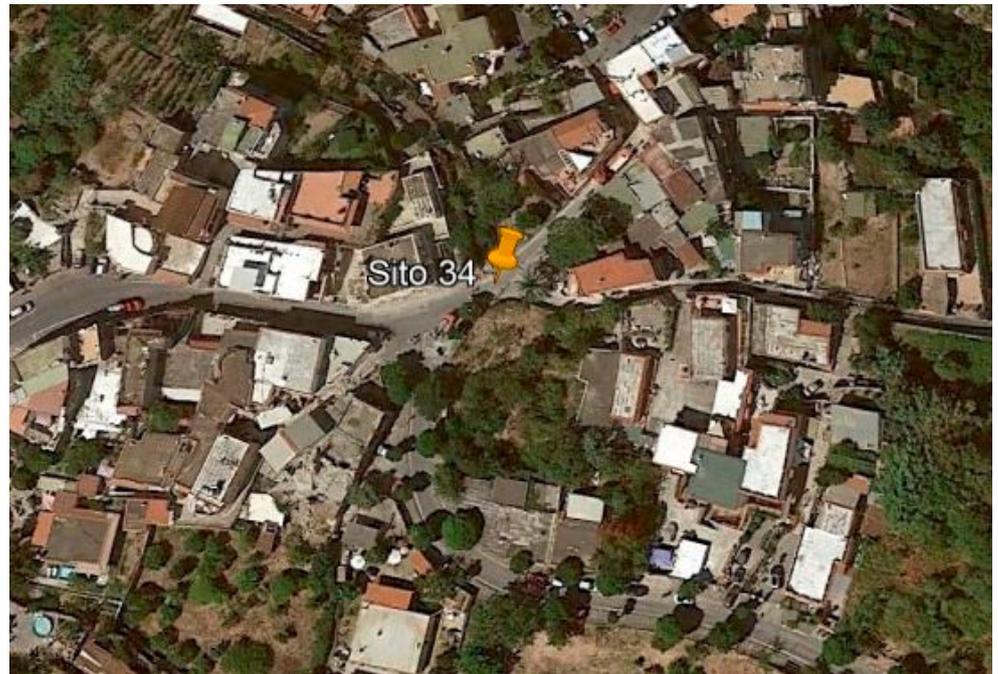
Satellite image

Sources of reference	Emergeo Working Group- 2019.
Site number	34
Latitude	40.742514°
Longitude	13.902068°
Locality	Via Ottringolo, Casamicciola Terme (NA).
Type of effect	Ground fractures
Description	Fracturing of an asphalted road, which extends for about 2 m, with opening and vertical displacement not exceeding 1 cm
ESI Intensity	VI
Geomorphic setting	Urban area, hilly topography

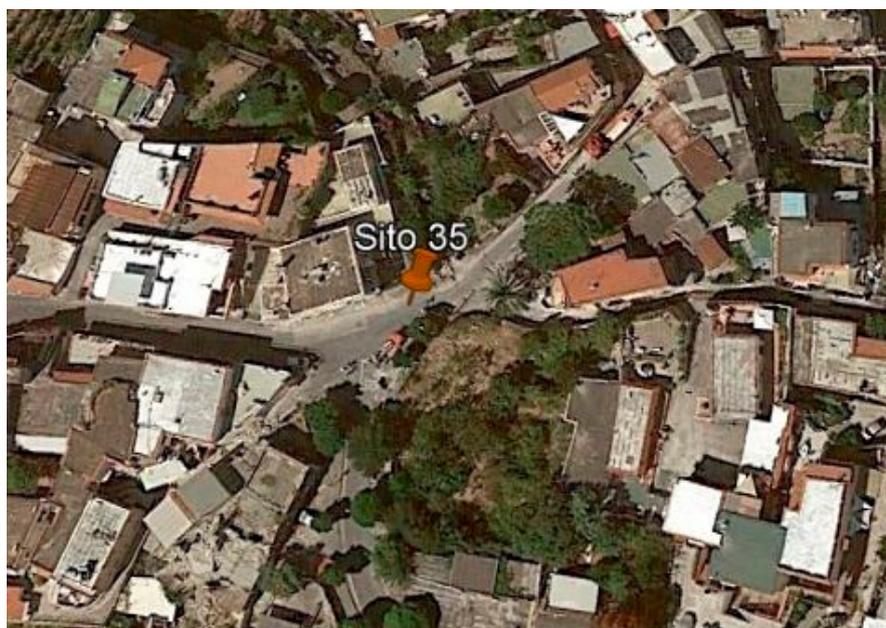
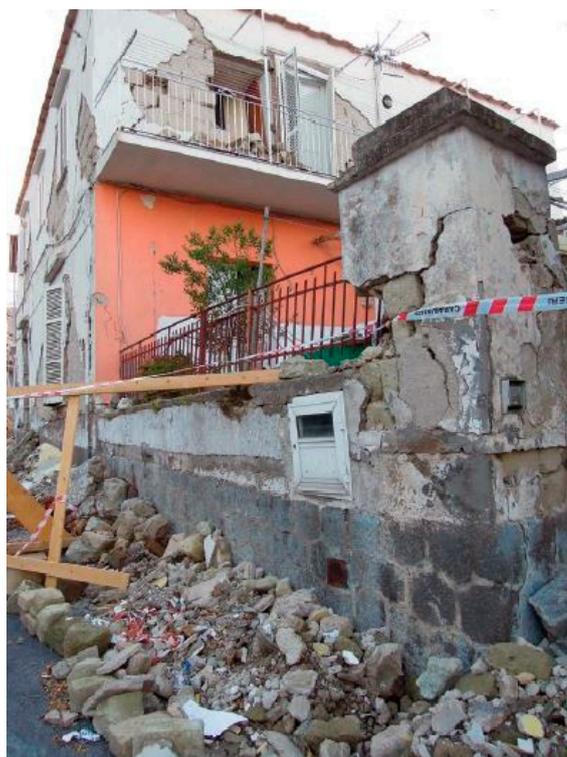
Photographic documentation

Sources of reference	Emergeo Working Group- 2019.
Site number	35
Latitude	40.742491°
Longitude	13.901988°
Locality	Via Ottringolo, Casamicciola Terme (NA).
Type of effect	Earth slide
Description	Collapse of a dry wall several meters long, connected to a badly damaged house
ESI Intensity	Data reported because located in the immediate vicinity of ground effects
Geomorphic setting	Urban area, hilly topography

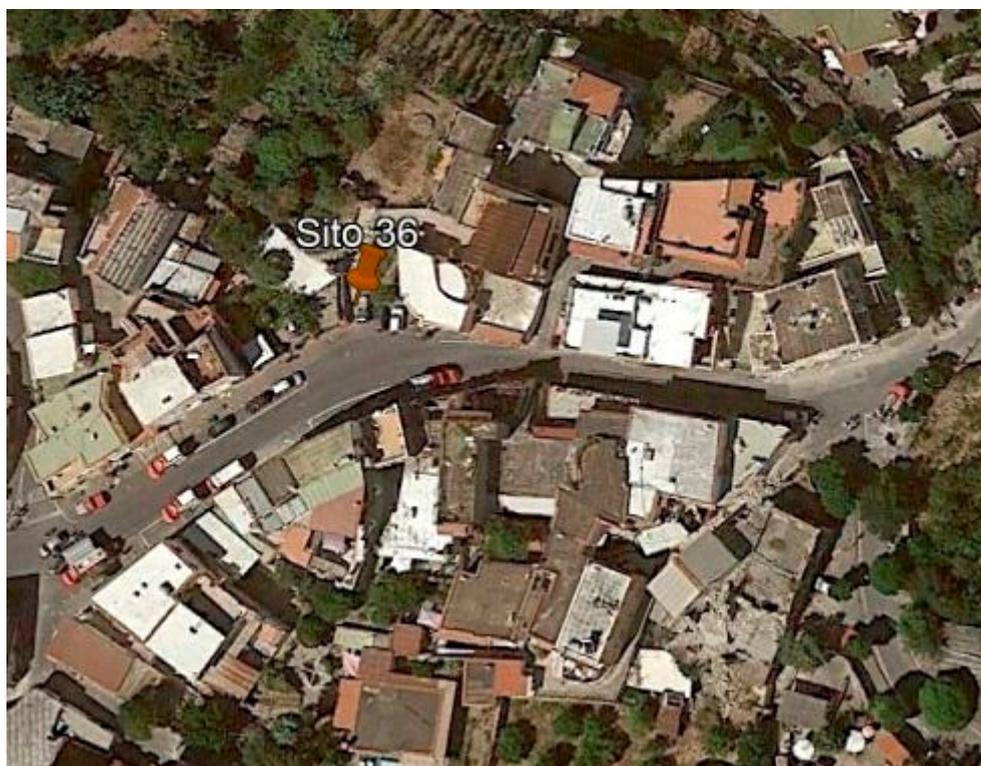
Satellite image

Collapse of several drywalls, which caused the interruption of the road. The walls collapsed for a length of 4-5 m

ESI Intensity	Data reported because located in the immediate vicinity of ground effects
Geomorphic setting	Urban area, hilly topography

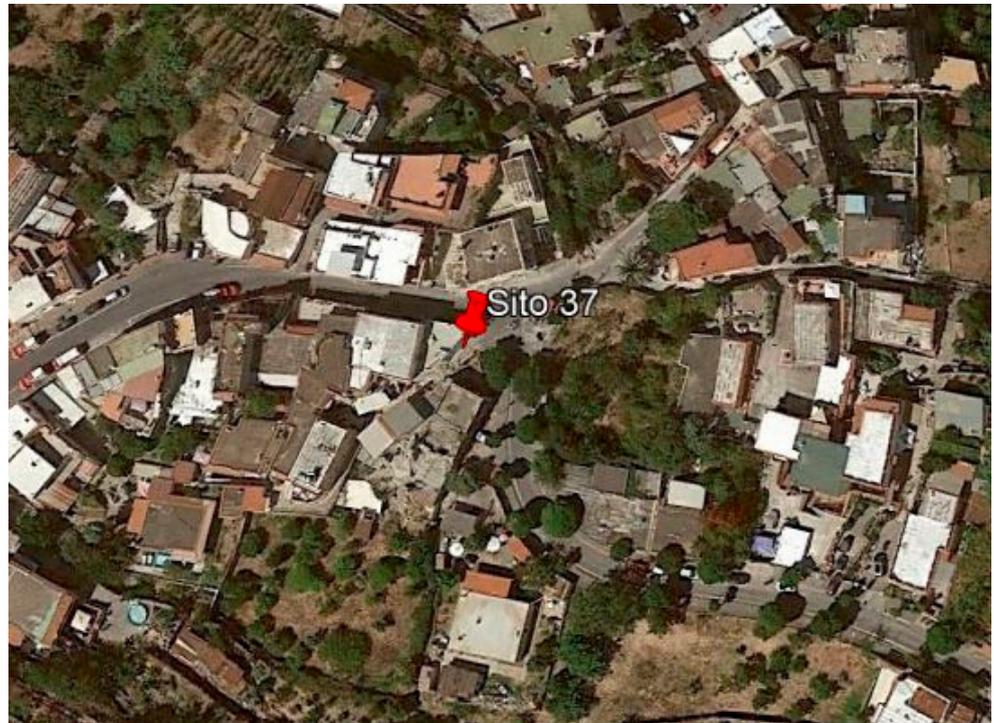
Satellite image

Description	Fracturing of the road at the intersection of the roads Spezieria, Ottringolo and Santa Barbara. The fracture extends for 5-6 m, also affecting the adjacent houses and causing the collapse of the wall of a house. A vertical offset of the fracture of 2-3 cm down to the north is observed.
ESI Intensity	VII
Geomorphic setting	Urban area, hilly topography

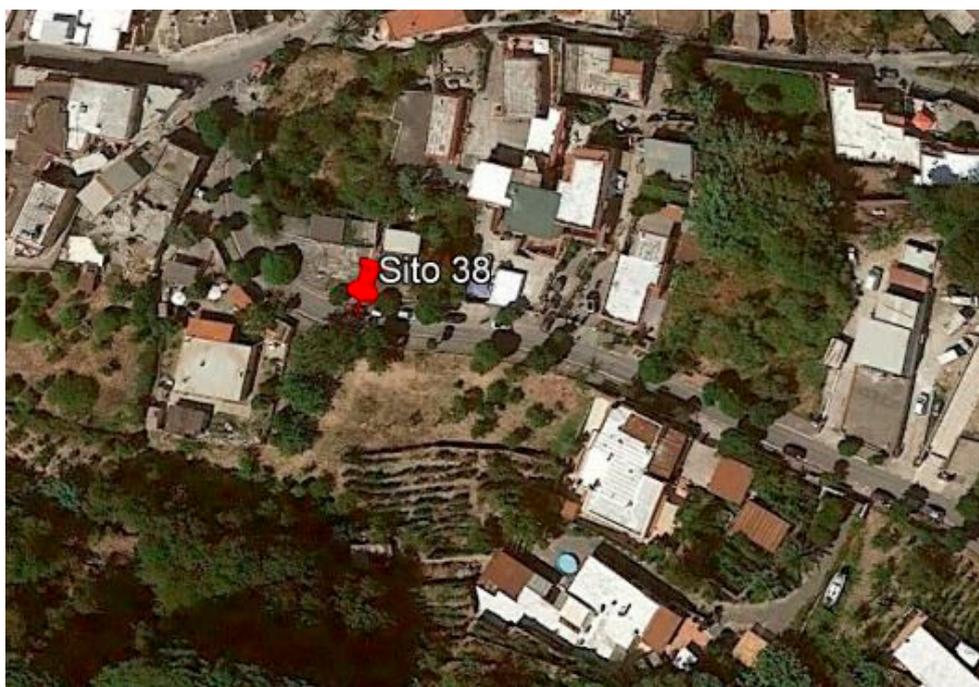
Satellite image

Longitude	13.902195°
Locality	Via Santa Barbara, Casamicciola Terme (NA).
Type of effect	Ground fractures
Description	Fracturing of the asphalt road; the fracture extends for 5 m, crossing sidewalks, streets and buildings. It has an opening of 1 cm
ESI Intensity	VII
Geomorphic setting	Urban area, hilly topography

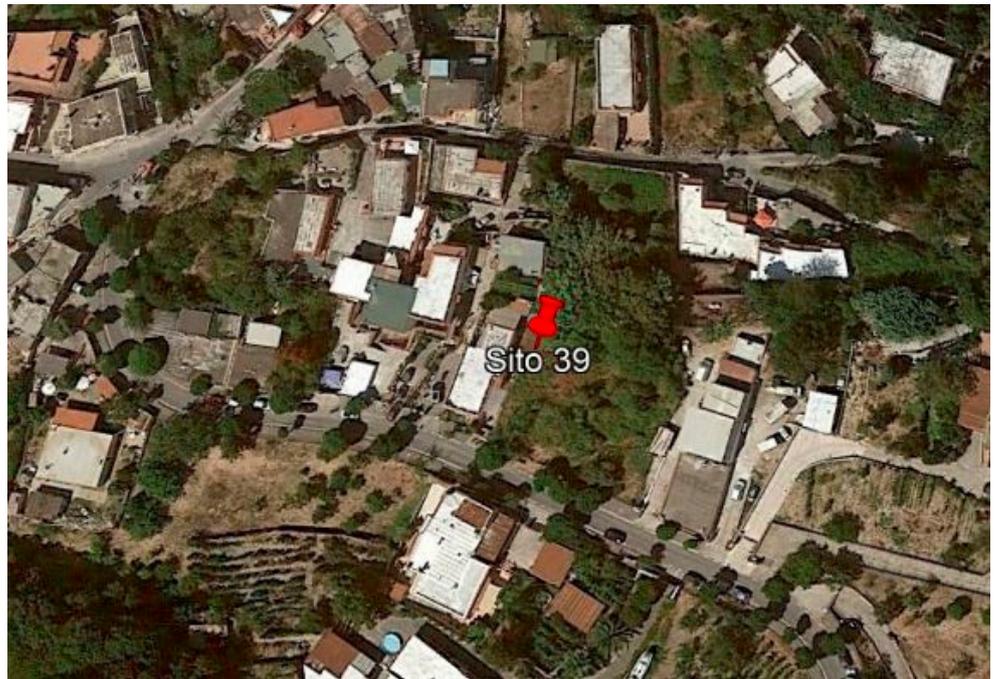
Satellite image

Sources of reference	Emergeo Working Group- 2019.
Site number	39
Latitude	40.742104°
Longitude	13.902934°
Locality	Via Santa Barbara, Casamicciola Terme (NA).
Type of effect	Ground fractures
Description	Fracturing of incoherent soil that extends for 20 m in the garden of a house. The fracture has an opening of 2-3 cm. A subsidence of the soil is observed north of the fracture
ESI Intensity	VII
Geomorphic setting	Courtyard of a house, urban area, hilly topography

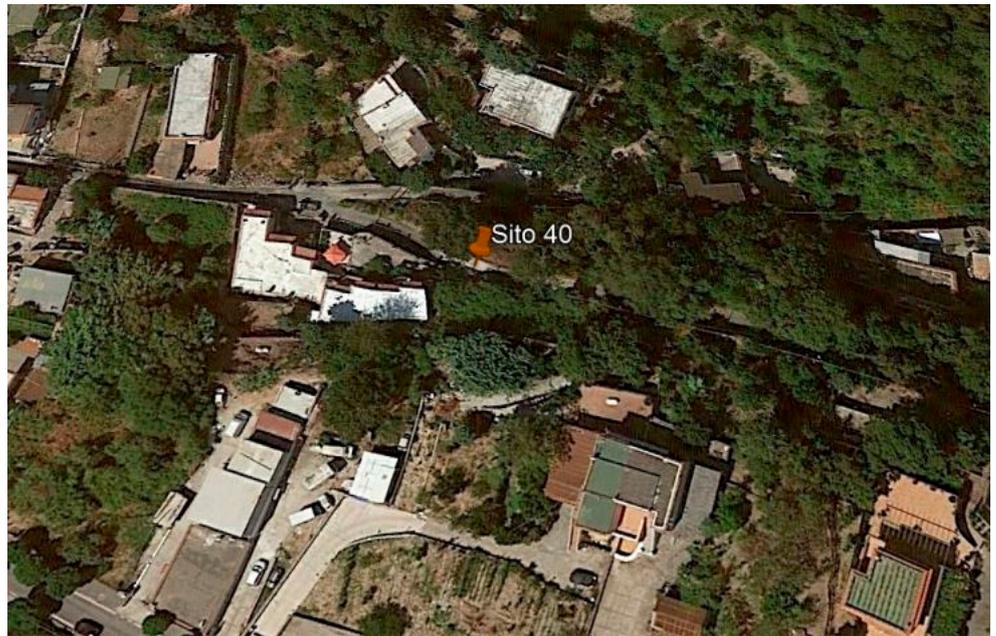
Satellite image

Sources of reference	Emergeo Working Group- 2019.
Site number	40
Latitude	40.742345°
Longitude	13.903753°
Locality	Via Nizzola, Casamicciola Terme (NA).
Type of effect	Earth slide
Description	Collapse of a drywall (parracina) for a length of 5 m
ESI Intensity	Data reported because located in the immediate vicinity of ground effects
Geomorphic setting	Urban area, hilly topography

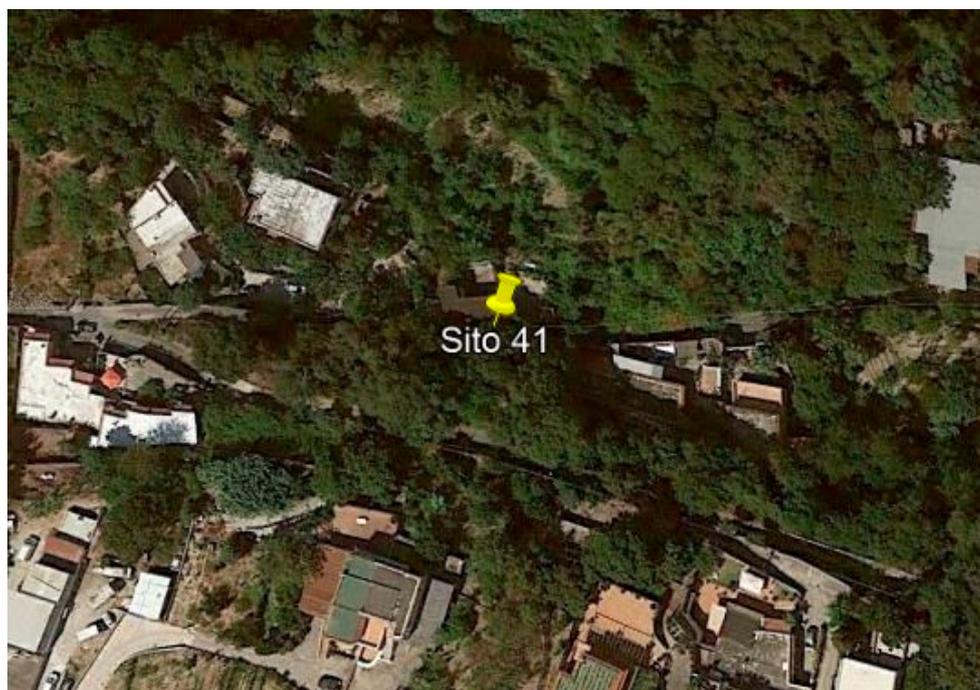
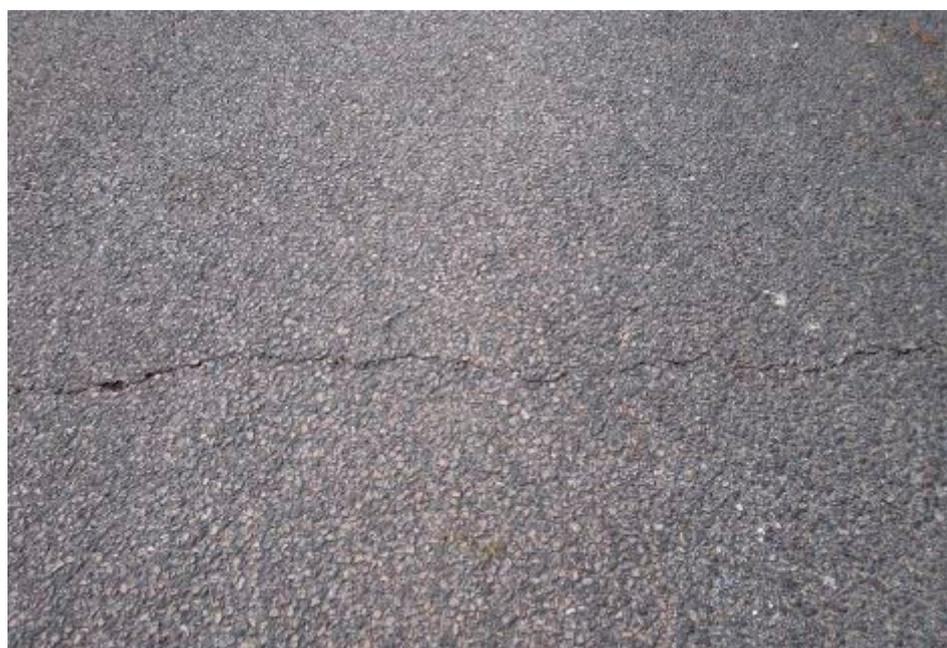
Photographic documentation

Sources of reference	Emergeo Working Group- 2019.
Site number	41
Latitude	40.742459°
Longitude	13.904303°
Locality	Via Nizzola, Casamicciola Terme (NA).
Type of effect	Ground fractyres
Description	Fracture of the asphalt road, which extends for about 2 m, with an opening of less than 1 cm
ESI Intensity	V
Geomorphic setting	Urban area, hilly topography

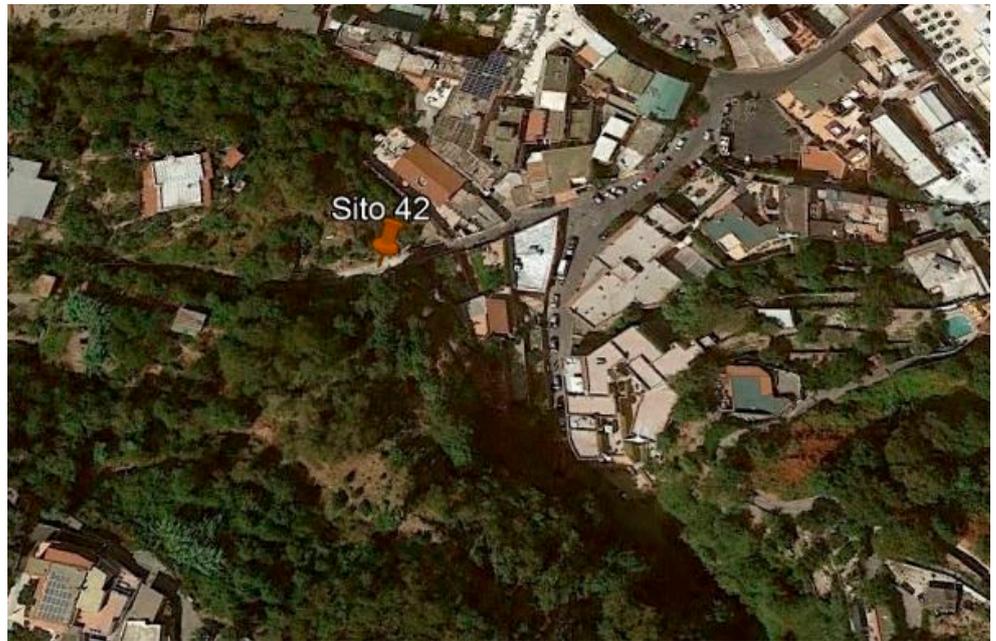
Satellite image

Sources of reference	Emergeo Working Group- 2019.
Site number	42
Latitude	40.742511°
Longitude	13.906498°
Locality	Via Nizzola, Casamicciola Terme (NA).
Type of effect	Earth slide
Description	Collapse of a dry stone wall (parracina) for a section about 3 m long
ESI Intensity	Data reported because located in the immediate vicinity of ground effects
Geomorphic setting	Urban area, hilly topography

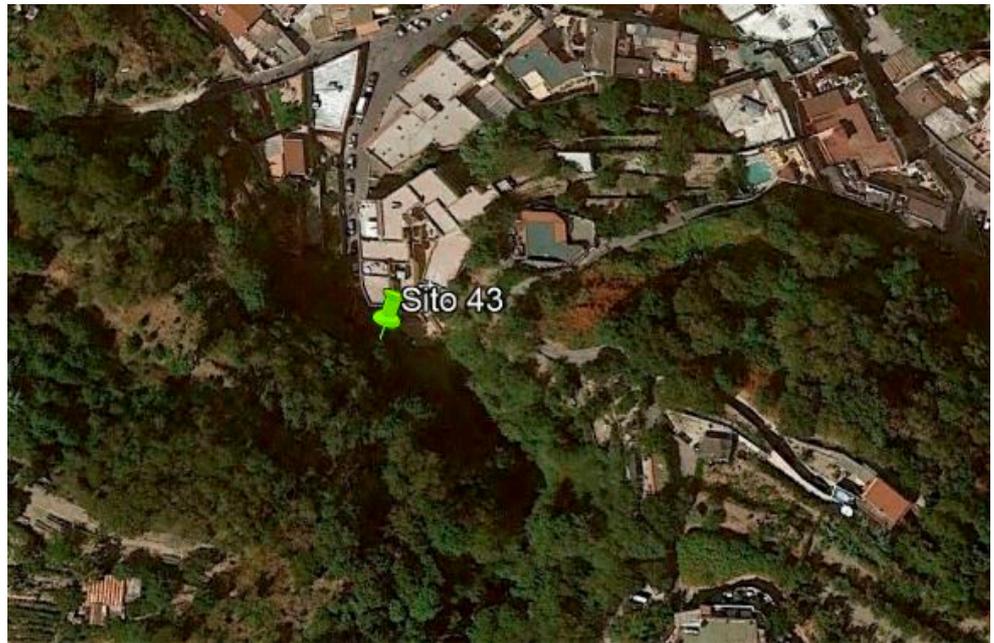
Satellite image

Sources of reference	Emergeo Working Group- 2019.
Site number	43
Latitude	40.741983°
Longitude	13.907134°
Locality	Via Nizzola, Casamicciola Terme (NA).
Type of effect	Landslide
Description	Landslide of modest size in volcanoclastic deposits
ESI Intensity	IV
Geomorphic setting	Rural area, sparsely populated, hilly topography with steep slopes

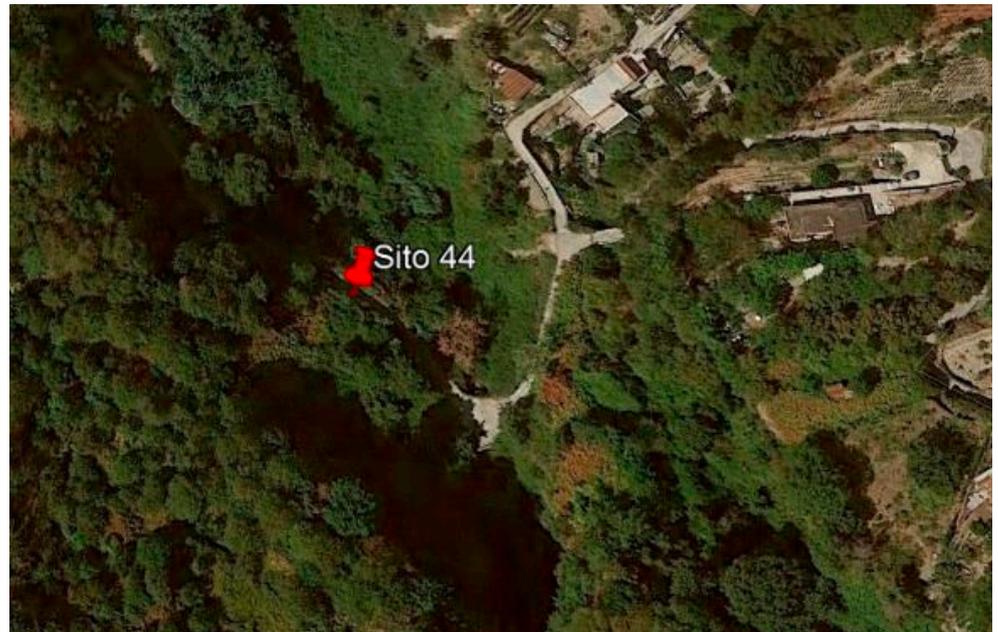
Satellite image

Sources of reference	Emergeo Working Group- 2019.
Site number	44
Latitude	40.739411°
Longitude	13.906299°
Locality	Via Campomanno, Casamicciola Terme (NA).
Type of effect	Ground fractures
Description	Fracturing of the asphalt road; the fracture extends for 100 m, with an opening of 1 cm
ESI Intensity	VII
Geomorphic setting	Rural area, sparsely populated, hilly topography with steep slopes

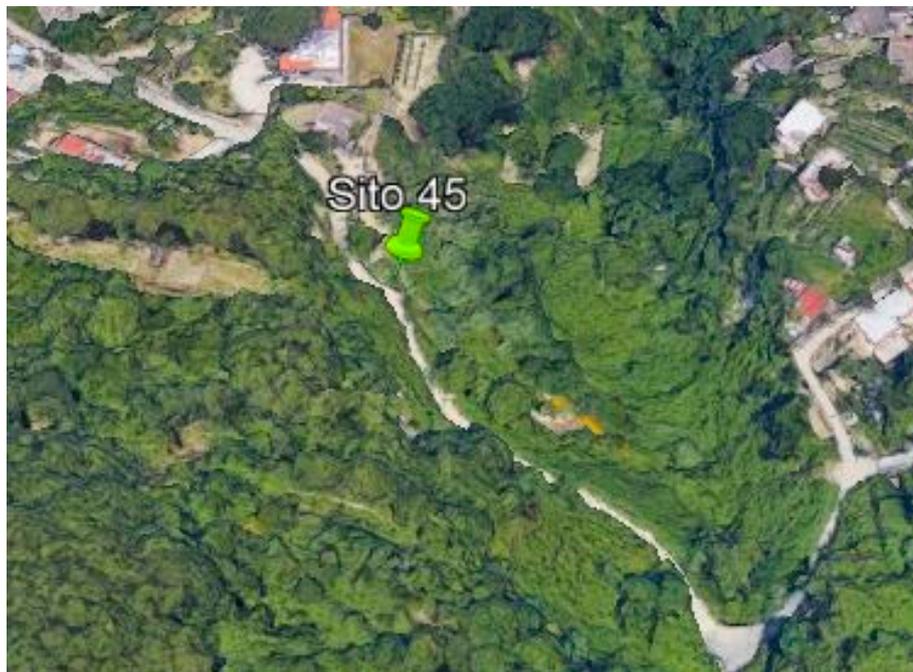
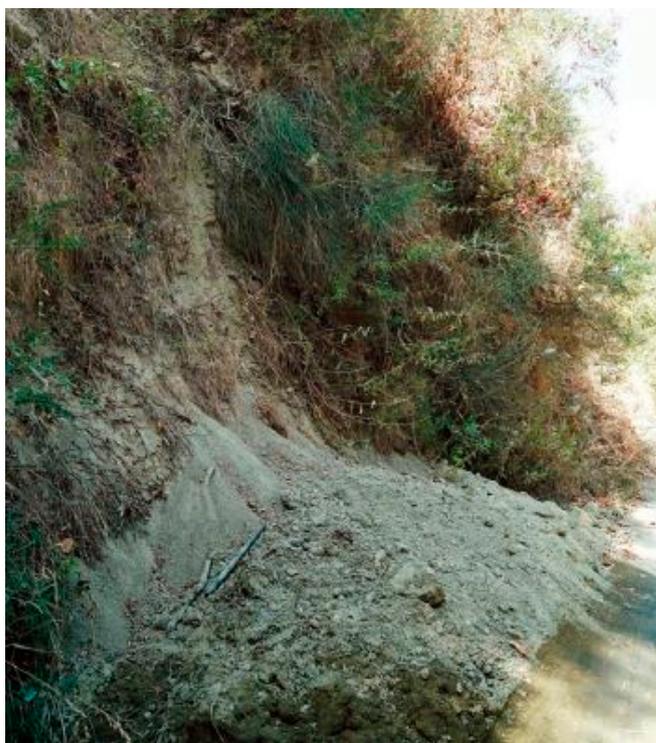
Photographic documentation

Sources of reference	Emergeo Working Group- 2019.
Site number	45
Latitude	40.739919°
Longitude	13.905659°
Locality	Via Campomanno, Casamicciola Terme (NA).
Type of effect	Landslide
Description	Landslide of modest size in volcanoclastic deposits
ESI Intensity	IV
Geomorphic setting	Rural area, sparsely populated, hilly topography with steep slopes

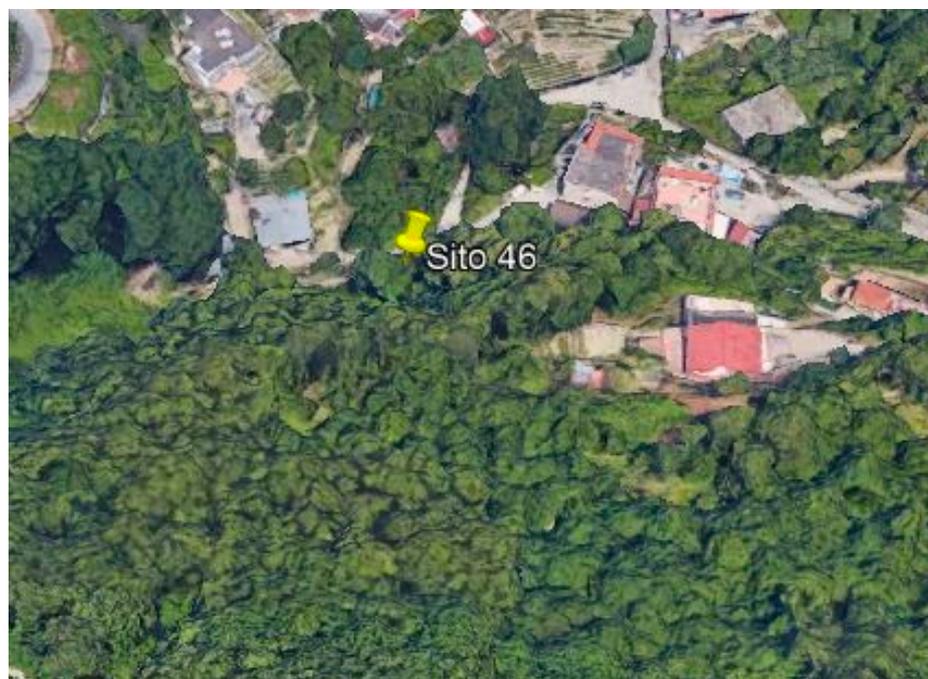
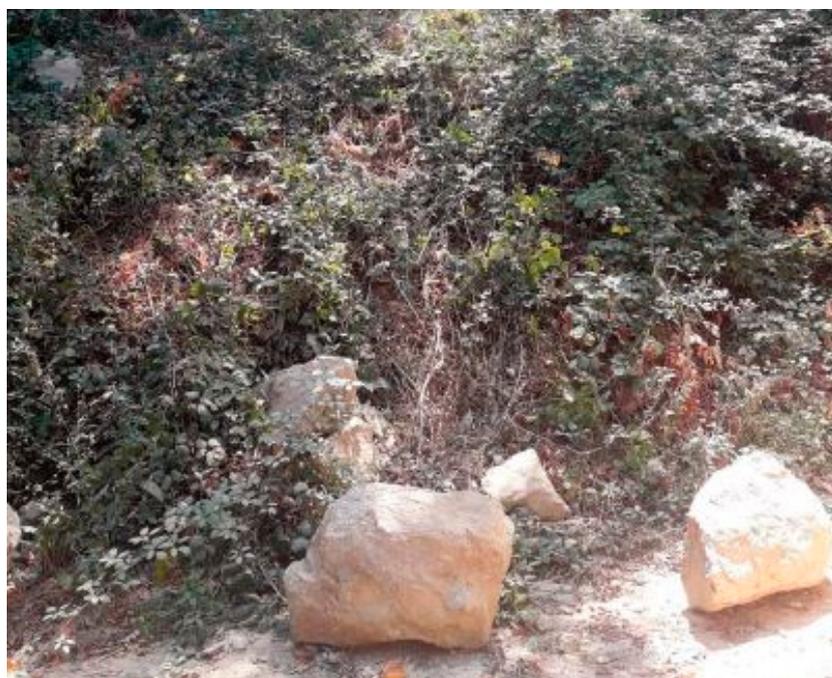
Photographic documentation

Sources of reference	Emergeo Working Group- 2019.
Site number	46
Latitude	40.740213°
Longitude	13.903796°
Locality	Via Campomanno, Casamicciola Terme (NA).
Type of effect	Rockfalls
Description	Fall of rocks from the Mount Epomeo slope; boulders have modest dimensions, which do not exceed 50 cm in diameter

ESI Intensity	V
Geomorphic setting	Rural area, sparsely populated, hilly topography with steep slopes

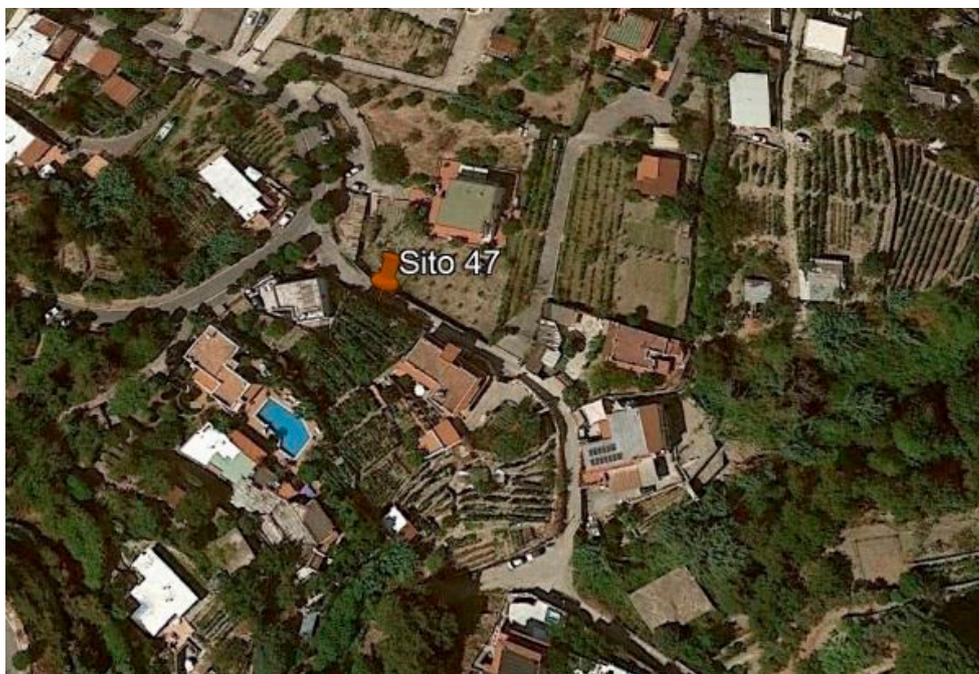
Satellite image

Site number	47
Latitude	40.741168°
Longitude	13.903835°
Locality	Via Campomanno, Casamicciola Terme (NA).
Type of effect	Earth slide

Description	Collapse of a dry stone wall (parracina), for a length of about 10 m
ESI Intensity	Data reported because located in the immediate vicinity of ground effects
Geomorphic setting	Urban area, hilly topography

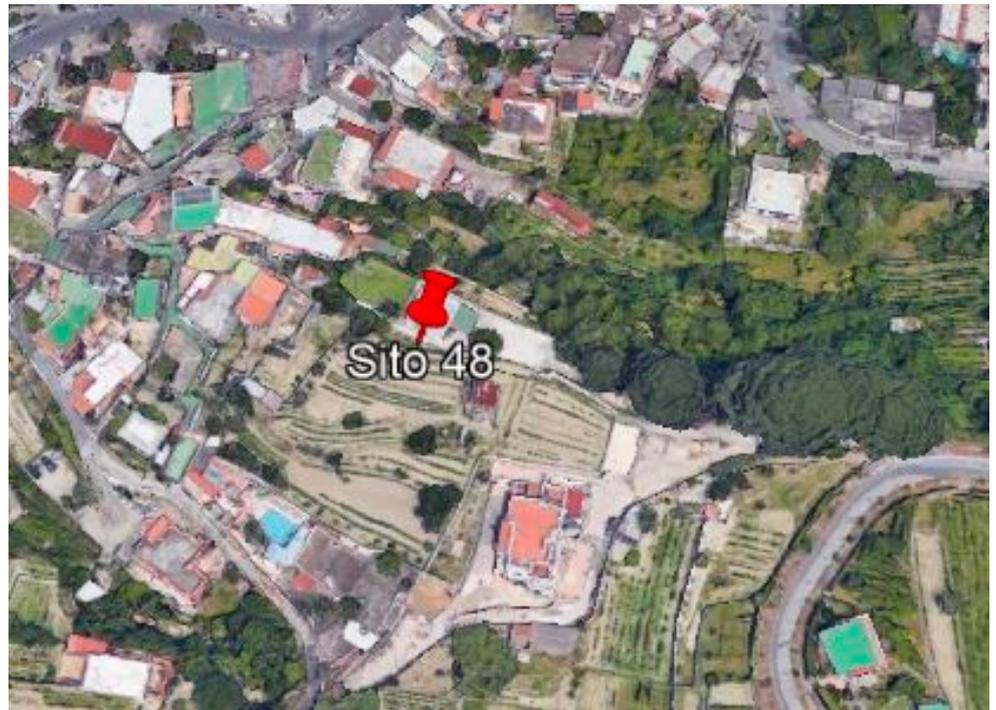
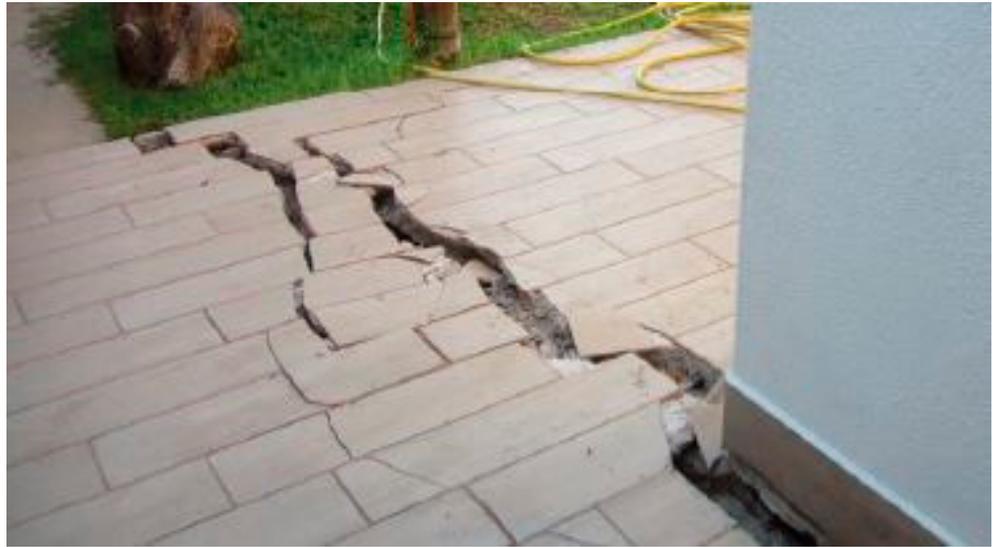
Satellite image

Sources of reference	Emergeo Working Group- 2019.
Site number	48
Latitude	40.741468°
Longitude	13.900964°
Locality	Via Santa Barbara, Casamicciola Terme (NA).
Type of effect	Ground fractures
Description	Fracturing of the soil involving the road surface, the garden and the paved terrace of the adjacent house. The fracture extends for a hundred meters, with a maximum opening of 4 cm. In some points a vertical displacement of a couple of centimeters is observed, down to the north
ESI Intensity	VII
Geomorphic setting	Urban area, hilly topography
