Damage to Churches after the 2016 Central Italy Seismic Sequence

Abstract: The present study focuses on seismic damage to 36 masonry churches observed after the 2016 Central Italy earthquake. In the sample, recurrent architectural and structural features were identified and accurately described. In order to classify the churches in the sample based on their safety level, their seismic vulnerability was assessed by adopting the simplified procedure proposed in the current Italian standards for cultural heritage. The observed damage, directly detected by the authors during the post-earthquake surveys, is presented and carefully described, highlighting the evolution of the damage. An analysis of the damage suffered by the inspected churches highlighted the most frequent causal mechanisms and the most vulnerable macroelements. Particular attention was devoted to computation of a damage index based on the observed damage as well as on the macroelements present in the surveyed churches. Moreover, a judgment of usability, i.e., whether a church could be occupied after a seismic event, was made using the official survey form and related to both the seismic intensity experienced and the ob

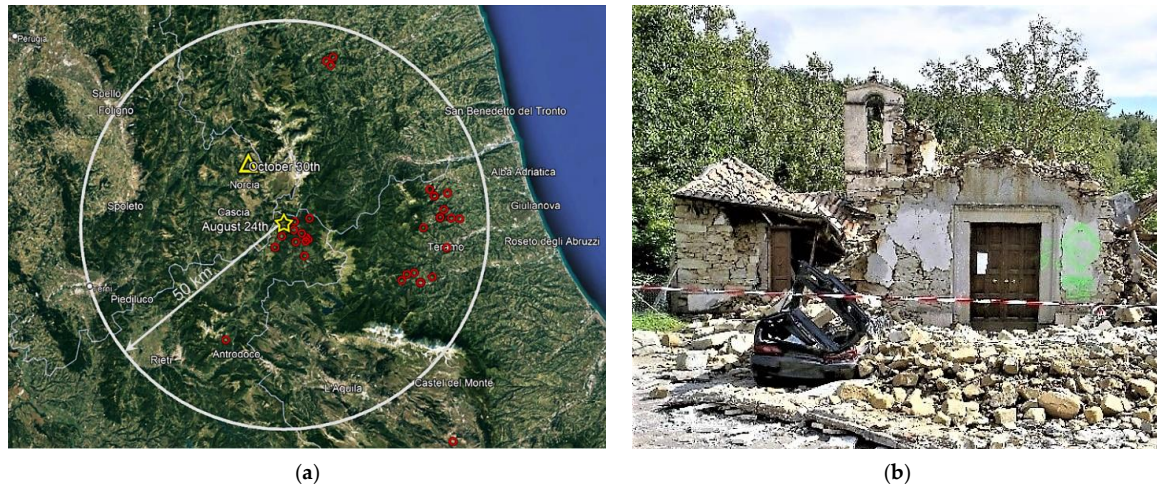
Figure 1. (a) Geographical localization (adapted from Google Earth) of the inspected churches (red circles), with the position of epicenters of 24 August (yellow star) and 30 October 2016 (yellow triangle); (b) a disrupted church in Amatrice, 5 km away from the epicenter of 24 August.

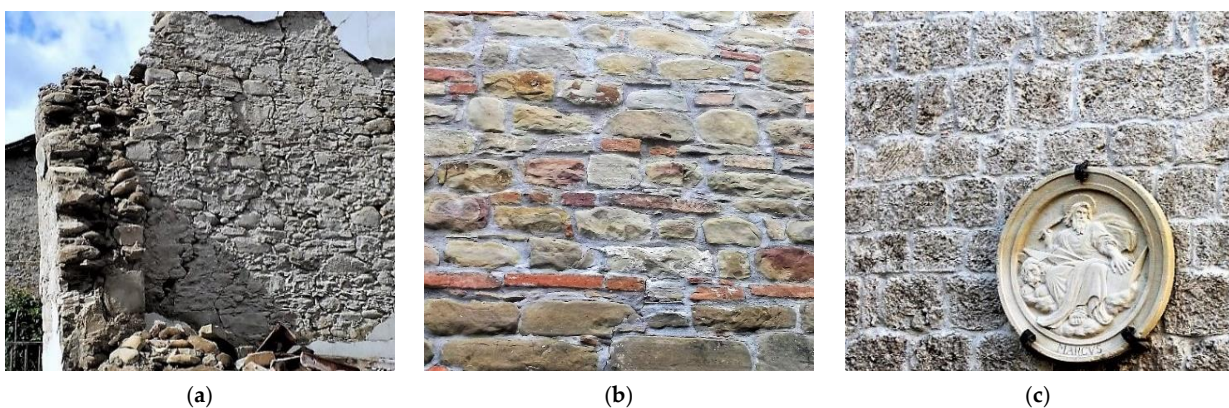
Figure 6. Different masonry typologies surveyed: (a) typical double-layer wall without headers (St. Francis, Amatrice); (b) irregular rubble masonry with partially staggered vertical joints (St. Savino in Gualdo, Macerata); (c) calcareous squared stones masonry (Abbey of Holy Mary in Montesanto, Civitella del Tronto).

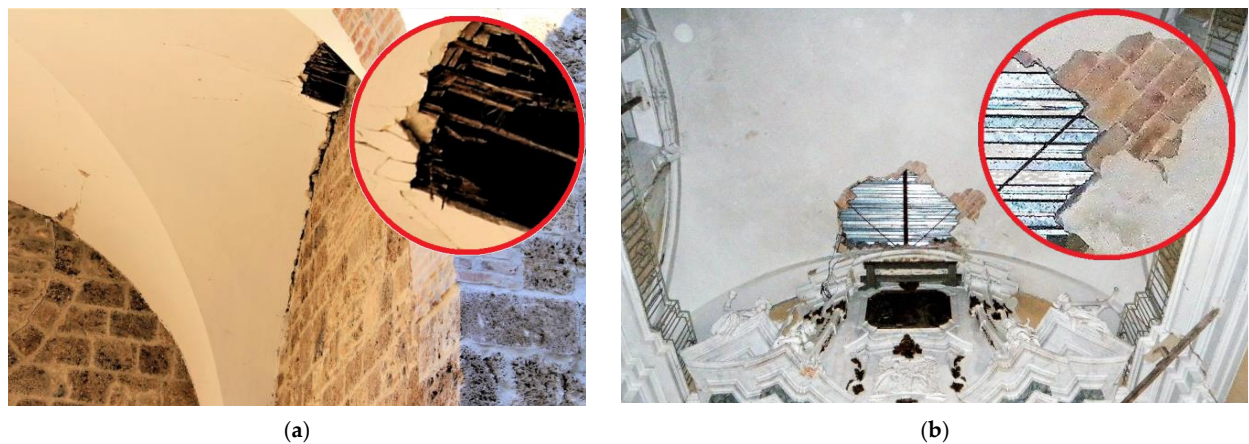
Figure 8. Surveyed vaults: (a) the false camorcanna vaults of Abbey of Holy Mary in Montesanto, Civitella del Tronto; (b) the in folio vaults of St. Anthony Abbot in Teramo.

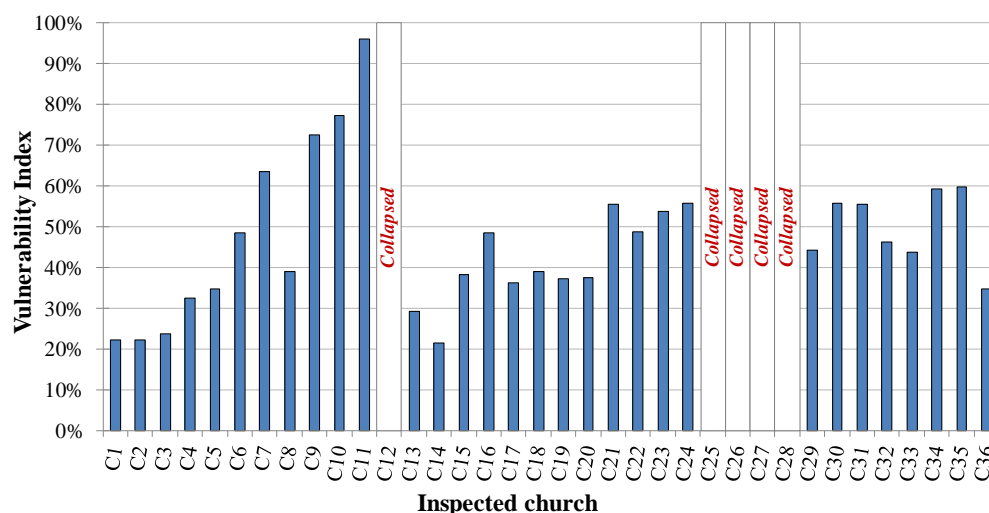
For all the analyzed churches, the obtained vulnerability indexes are listed in Table 2 and reported in Figure 9. It is worth underlining that the vulnerability index cannot be evaluated for the collapsed churches (C12, C26–C29), since the inspections were realized only after the earthquake when the collapses had occurred. The results of the LV1 procedure (Table 2, Figure 9) show a predominant low–medium vulnerability of the inspected churches: 39% of the sample is characterized by a low vulnerability index (lower or equal

Figure 9. Vulnerability index evaluated for the inspected churches according to the LV1 approach.

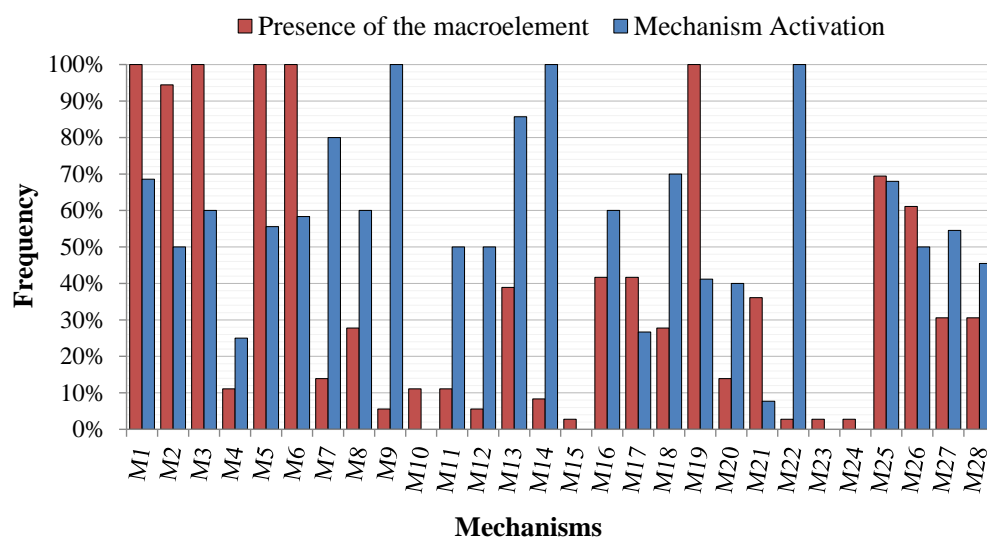
Figure 21 shows the relative presence and occurrence of the mechanism activation for each macroelement—recalled following the nomenclature used in Table 1. Observing the red bars, in more than 90% of the surveyed churches the façade, (M1, M3), the gable (M2), the nave (M5–M6), and its roof (M19) were present, as expected. In more than 60% of the cases, plano-altimetric irregularities (M25) and the standing-out elements (M26) were observed. The vaults were present in different positions inside the church, such as in the nave,

the transept, etc., for about 42% of the cases; however, if consideration is limited to the more relevant elements, characterized by weight $\rho_k = 1$ (i.e., M8 and M9 according to Table 1), this proportion reduces to 31% of the cases. The other macroelements—the belltower (25%), transept (11%), dome (8%), and chapel (3%)—were registered with significantly lower frequency.

Figure 21. Presence and activation of the 28 mechanisms in the inspected churches.

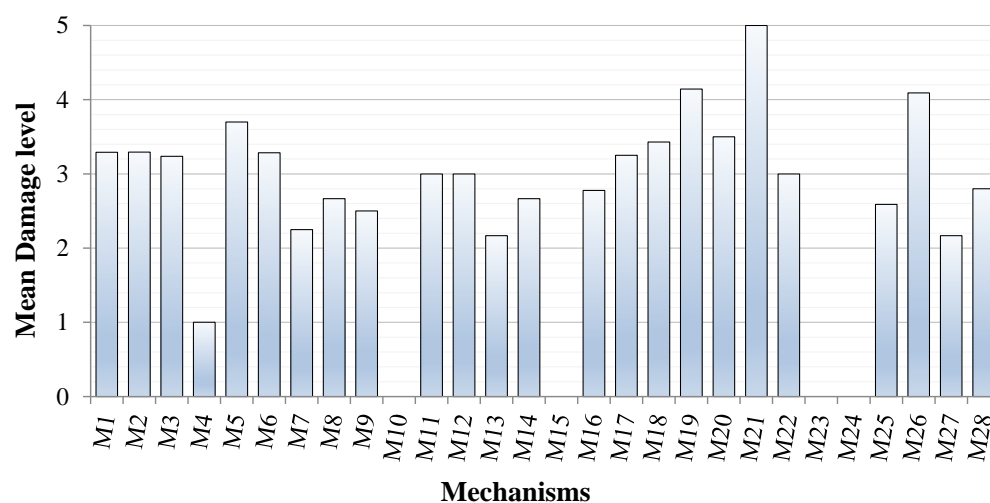
Figure 22. Mean damage levels of the mechanisms activated in the inspected churches.

It can be observed that the mechanisms M19 (nave roof), M21 (roof of apse and presbytery), and M26 (standing-out elements) are characterized by a higher mean damage level. However, damage of nave rooves, and the standing-out elements can be considered particularly serious because of their frequency of occurrence and, above all, because of their relevance in the churches' seismic performances. On the contrary, the apse was rarely present in the sample; therefore, the damage in its roof could not be considered meaningful. Among the mechanisms with an observed mean damage level higher than 3, the risk seems significant only for the façade (M1, M2, M3), the nave (M5 and M6), and the walls of the presbytery and the apse (M17). In fact, the vaults of the presbytery and the apse (M18), as well as the roof of the transept (M20), were infrequent in the sample, as previously indicated.

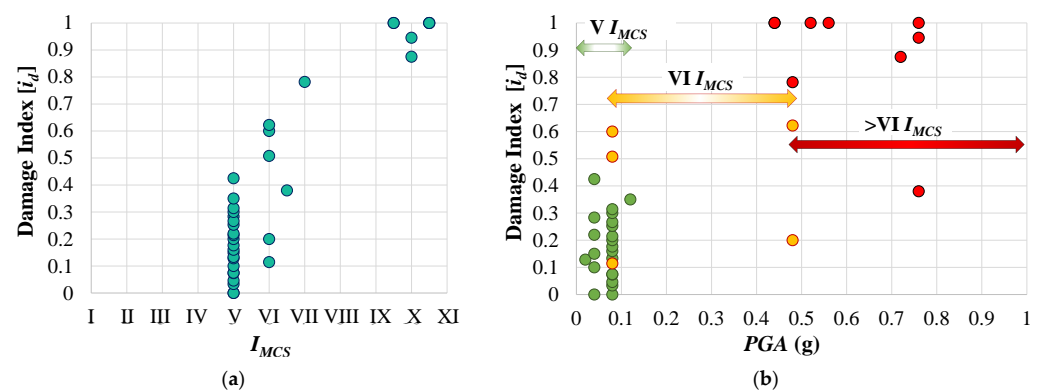
Analyzing the relationship between i_d and the macroseismic intensity (Figure 23a), it can be observed that, for lower intensities ($I_{MCS} = V$), the distribution of the observed damage index spreads between 0 and 0.43; meanwhile, higher values ($I_{MCS} > VII$), cataloged as ruinous–destructive for ordinary buildings, according to the I_{MCS} scale, were suffered by churches whose damage index is above 0.8, except for one case, with i_d equal to 0.78. Concerning I_{MCS} values equal to VI, the damage index is very scattered. Since there is not a direct correlation between the observed I_{MCS} and the PGA , some overlapping can be observed in Figure 23b. Noteworthy aspects related to the inspected churches and seismic intensity measures are the following:

- The locations of most of the inspected churches are characterized by the V degree of the I_{MCS} scale, corresponding to PGA values between 0.02 g and 0.08 g (except for one struck by a PGA of 0.12 g).
- Even if the VI degree of the I_{MCS} corresponds to a wide range of PGA (from 0.08 g to 0.48 g), only 5 churches of the inspected sample are in such an area.
- The degrees of I_{MCS} greater than VI are associated with high PGA values, ranging between 0.44 g and 0.76 g.

Figure 23. Damages directly observed by the authors in the churches sample compared to: (a) PGA (g); (b) macroseismic intensity, I_{MCS} .

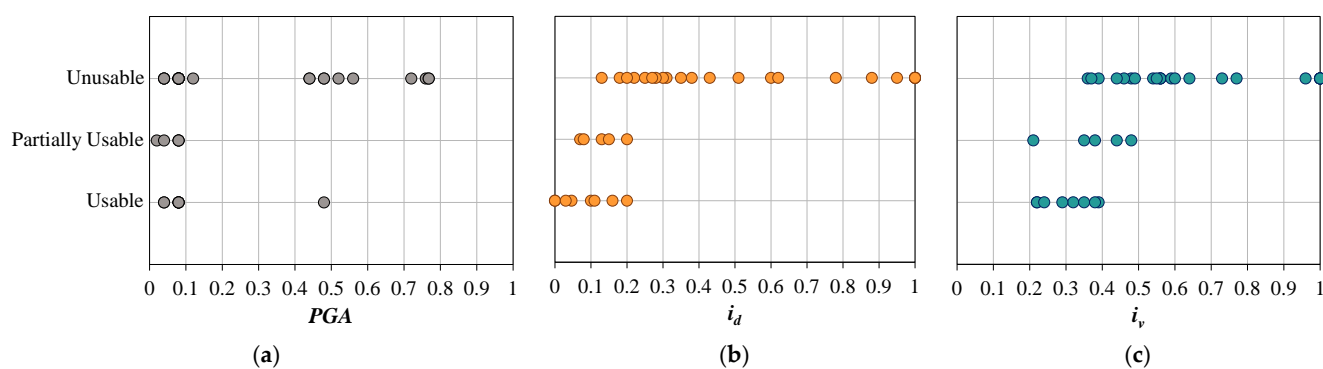
- Unusable churches suffered a PGA ranging from 0.04 to 0.77 g; in detail, 10 churches were characterized by $PGA > 0.40$ g, whilst 13 churches were struck by PGA ranging between 0.04 and 0.12 g.

- Overall, all churches with a $PGA > 0.08$ g were unusable and seriously damaged, with the only exception of 1 usable building.
- It is difficult to identify a proper correlation between the intensity measure and the usability judgment for low values of PGA . In fact, church vulnerability plays a key role in the judgment of damages and usability.

Figure 24. Correlation between usability assessment, PGA (a), global damage index evaluated according to Equation (2) (b), and vulnerability index defined according to LV1 approach (c).

According to the obtained results (Figure 24b), the usability judgment shows a low correlation with the mean damage index. Conversely, it has become well established that i_d does not frequently depict the actual scale of the suffered damages and the usability assessment of ancient masonry churches [77,84], the seismic behavior of which is not characterized by the activation (progressive or simultaneous) of all local mechanisms. When only one macroelement collapses, or a very limited number of kinematic mechanisms are triggered, one finds that the church is declared unusable, and the observed damage index, i_d , results are exceptionally low. This is, for example, the case of C23 (Holy Mary Abbey in Montesanto) (Figure 25), where the roof was completely collapsed: the church was clearly unusable, but the observed damage index is equal to 0.35. Similarly, the churches characterized by a preexisting crack pattern as a consequence of the 2009 L'Aquila Earthquake—in the case of the structures located in the Abruzzo region—or due to the consecutive earthquakes of the 2016/2017 seismic sequence, show worsening conditions affecting the already damaged macroelements. In this situation, the church is declared unusable due to the overall observed damage pattern—the result of several shakes occurring over a long time—even when the mean damage index, i_d , is low, and when the seismic accelerations of the main earthquake occurring before the inspection were small.
