Deterioration of Sandstone in the Historical and Contemporary Sea Walls upon the Impact of the Natural and Man-Made Hazards

Rina (Irena) Wasserman

Department of Conservation of Sites and Monuments, Western Galilee Academic College,
POB 2125, Acre 24121, Israel; rinaw@edu.wgalil.ac.il

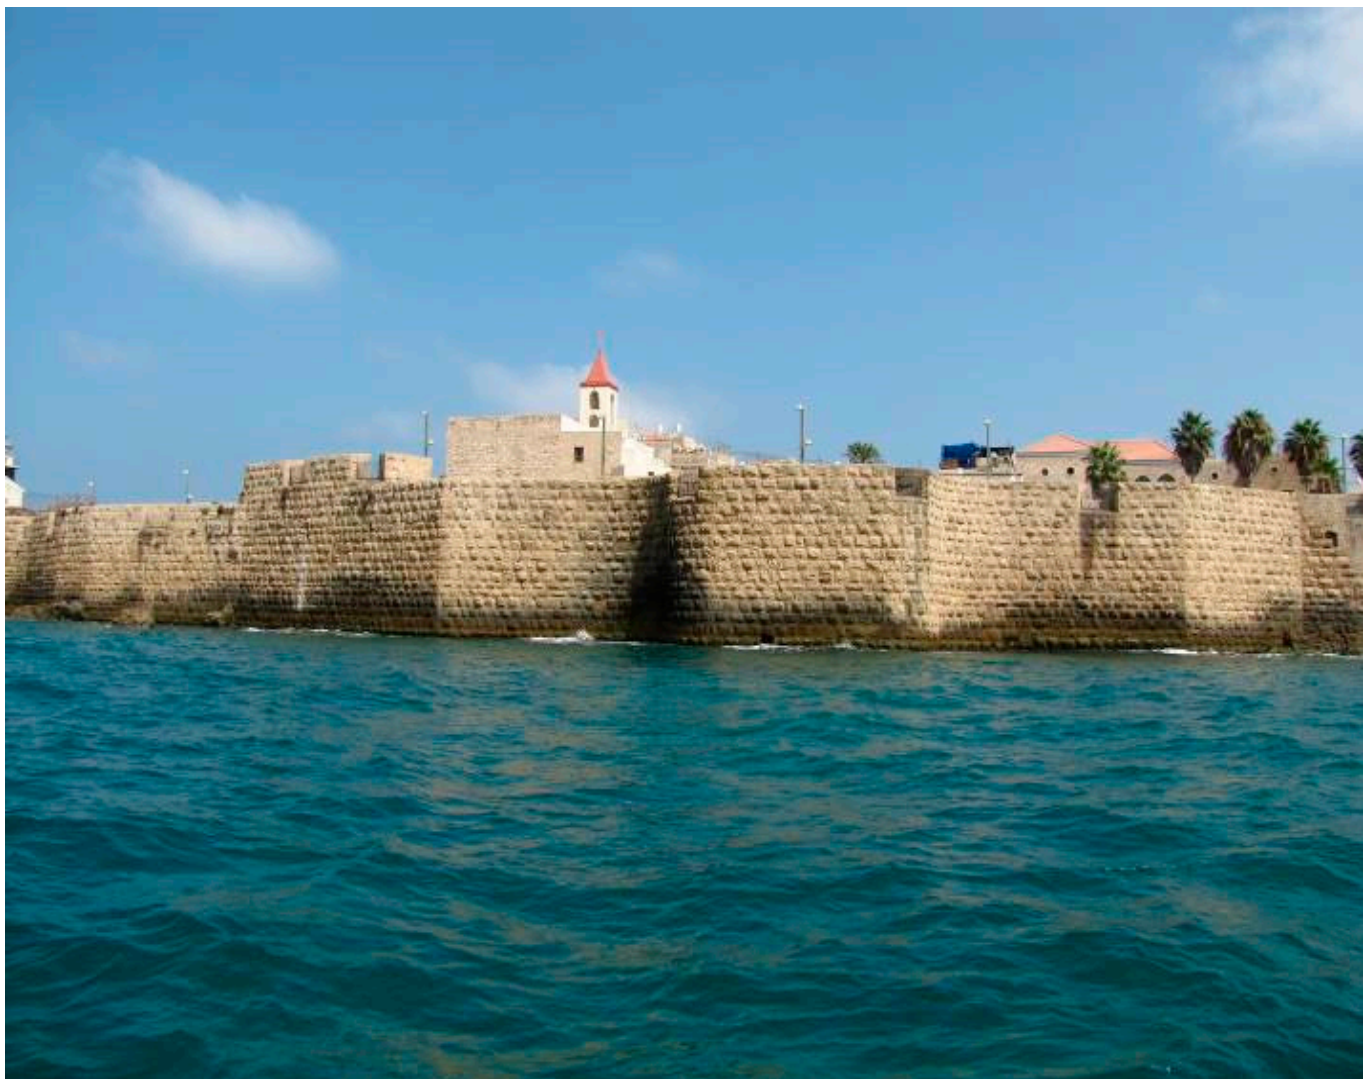
Figure 2. Historic sea wall in Acre. Captured by author on 27 November 2018.

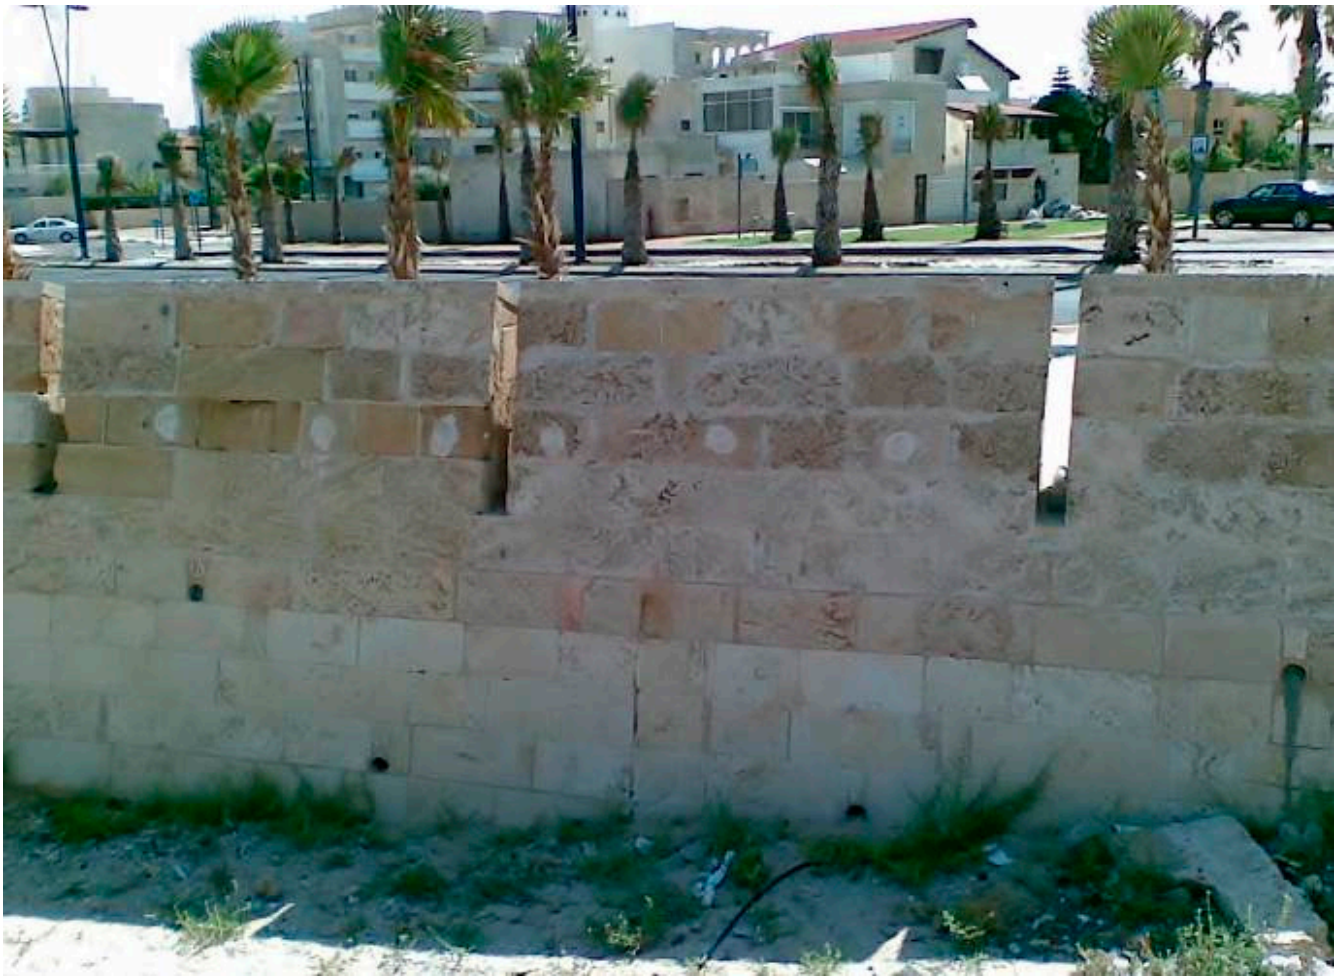
Figure 3. Panorama Sea Wall in Acre. Captured by the author on 27 November 2018.

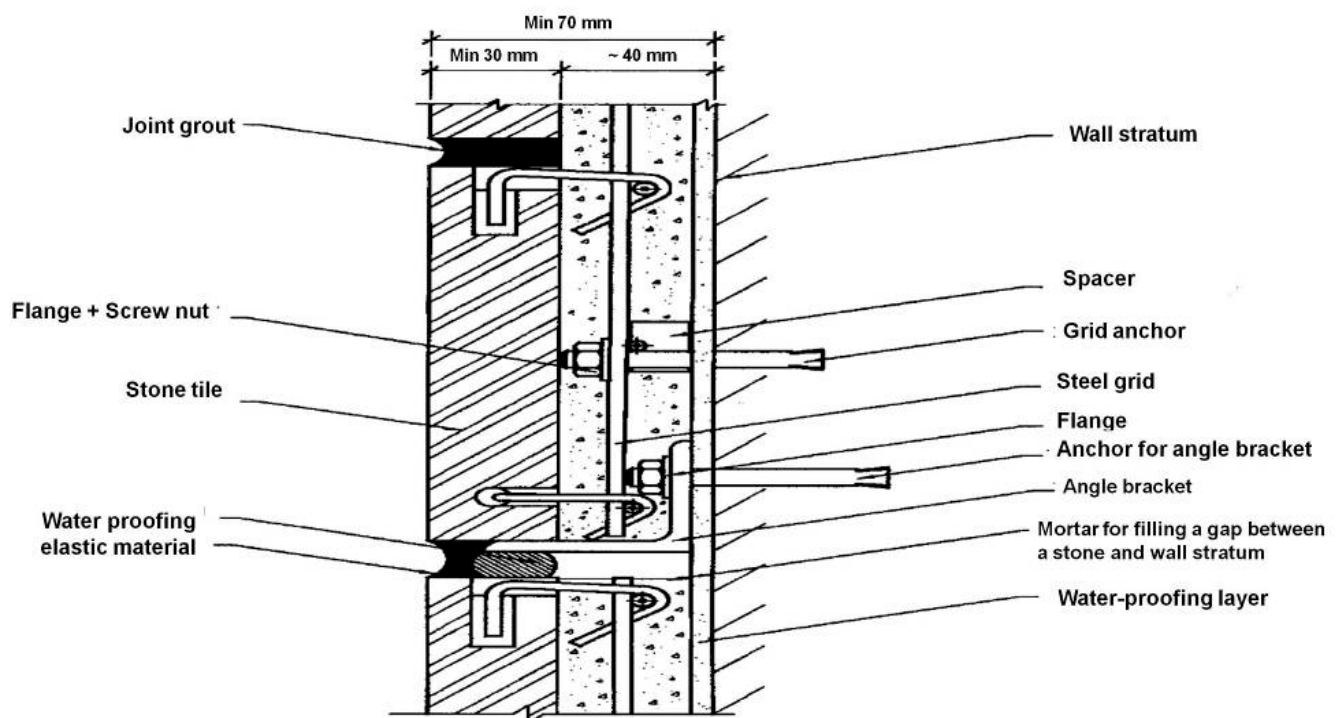
Figure 4. Design of stone veneer, according to [11].

The modern Panorama Sea Walls are constituted of the reinforced concrete wall cast against the porous sandstone veneer. This stone veneer has been made of kurkar plates ca. 0.3–0.5 m long and wide and up to 0.15 m thick by size, see Figure 4. The joints between the stones in the veneer and the veneer's background consist of Portland cement mortar and concrete, respectively. Portland cement matrix covered ca. 70% of the total surface of the kurkar plate, and only 30% of the surface is useful for the evaporation of moisture from the wall. However, Portland cement mortar is always much denser than air lime mortar, whether its evaporation ability is far less than that of the last one. This fact is the core reason why cement-based mortars are not breathable enough. Thus, the deterioration reactions involving the hazardous environmental agents and moisture absorbed by kurkar stone have spread much quicker and intensively in the modern Panorama Sea Walls than the historic sea walls in Acre. Here, the hazardous environmental agents are the high humidity and salinity common in the Mediterranean offshore zone and the local air pollution. In combination with high water absorption of kurkar sandstone and its unstable mineralogical composition, Portland cement mortars and concrete have quickly caused a severe worsening of the physical and mechanical properties of kurkar sandstone siding in the Panorama Sea Wall (see Table 2) and to the apparent defects, as shown in Figures 5–10.

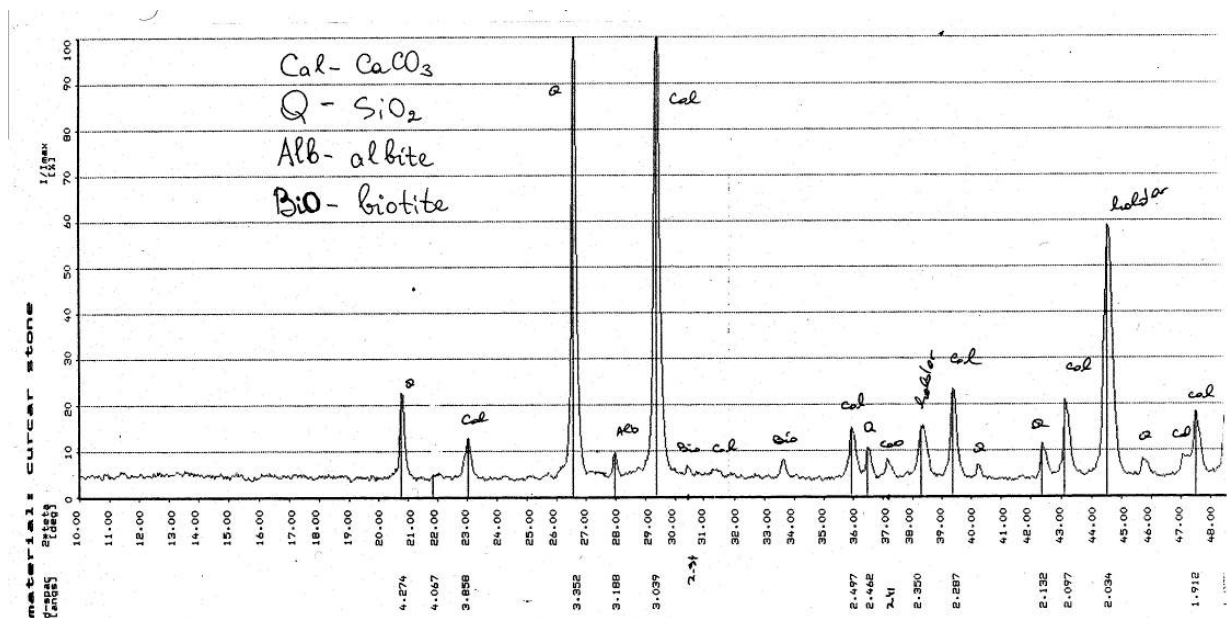
Figure 11. XRD diffraction of kurkar sandstone.

The main minerals determined were calcite, CaCO_3 , and quartz, SiO_2 . The secondary minerals found in the kurkar sandstone were albite, $\text{NaAlSi}_3\text{O}_8$, and biotite $\text{K}(\text{Fe}, \text{Mg})_3\text{AlSi}_3\text{O}_{10}$.

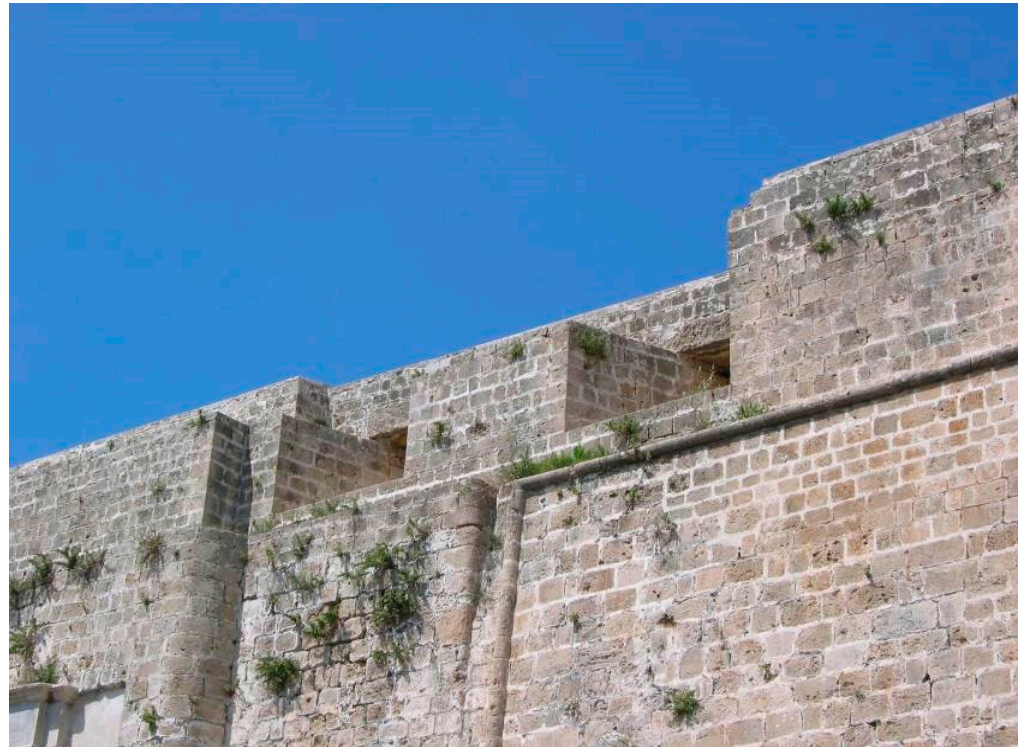
- The ashlar kurkar blocks, ca. 0.3–0.6 m long, thick, and wide by size, were used in the Historic Walls' stonework in Acre. In these Walls, the bed joints were made of air lime mortar, [41], see Figure 15. Air lime mortar covered ca. 15% of each kurkar block's total surface, and the rest of the body has been left breathable and useful for the evaporation of moisture from the historic sea walls.

Figure 15. Acre historic wall with the lime-mortar bed joints (source: https://commons.wikimedia.org/wiki/File:Acre_-_wall.JPG. Accessed on 11 November 2020).
