Colour Ageing in Acrylic Resin Plates and Natural Minerals on the Façade after 10 Years of Sun Exposure in the Marine Environment

Department of Architectural Constructions, University of Alicante, 03690 Alicante, Spain; victor.echarri@ua.es (V.E.-I.); antonio.galiano@ua.es (A.G.-G.); carlosrm@ua.es (C.R.-M.); isabel.perez@ua.es (M.I.P.-M.)

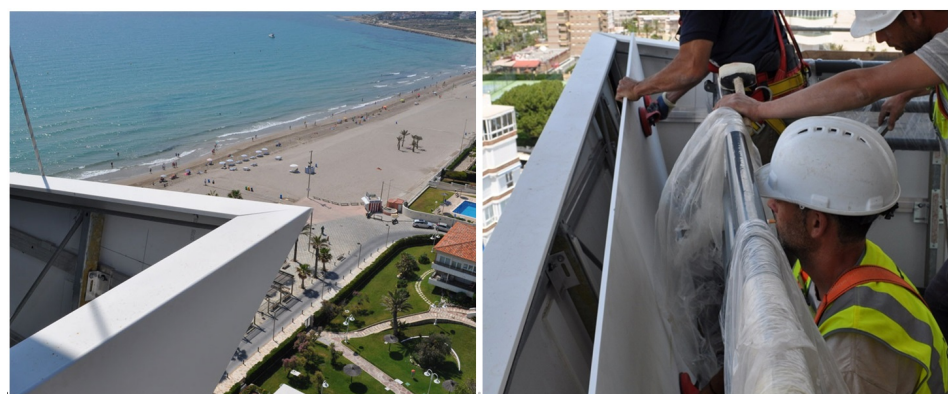
Figure 6. Images of interior and exterior finishing plate placement.

- Placement of the acrylic and natural mineral plates. Once the sub-structure of the parapet was in place, the plates were placed on the inside and outside (Figure 6).
