Article The Intersection of Architectural Conservation and Energy Efficiency: A Case Study of Romanian Heritage Buildings

3. Case Study: Câmpulung Town Hall Building

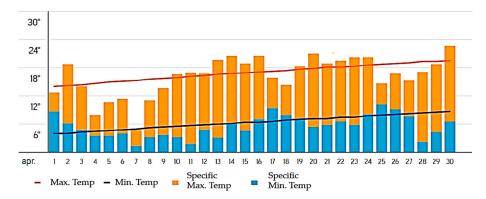
As can be observed in Figure 6, the temperatures throughout March and April of this year, during both night and day, were different, with almost daily temperature drops.

Figure 6. Exterior temperatures between March and April 2023, the period when the in situ measurements took place.
