Article

Operational Modal Analysis and Safety Assessment of a Historical Masonry Bell Tower

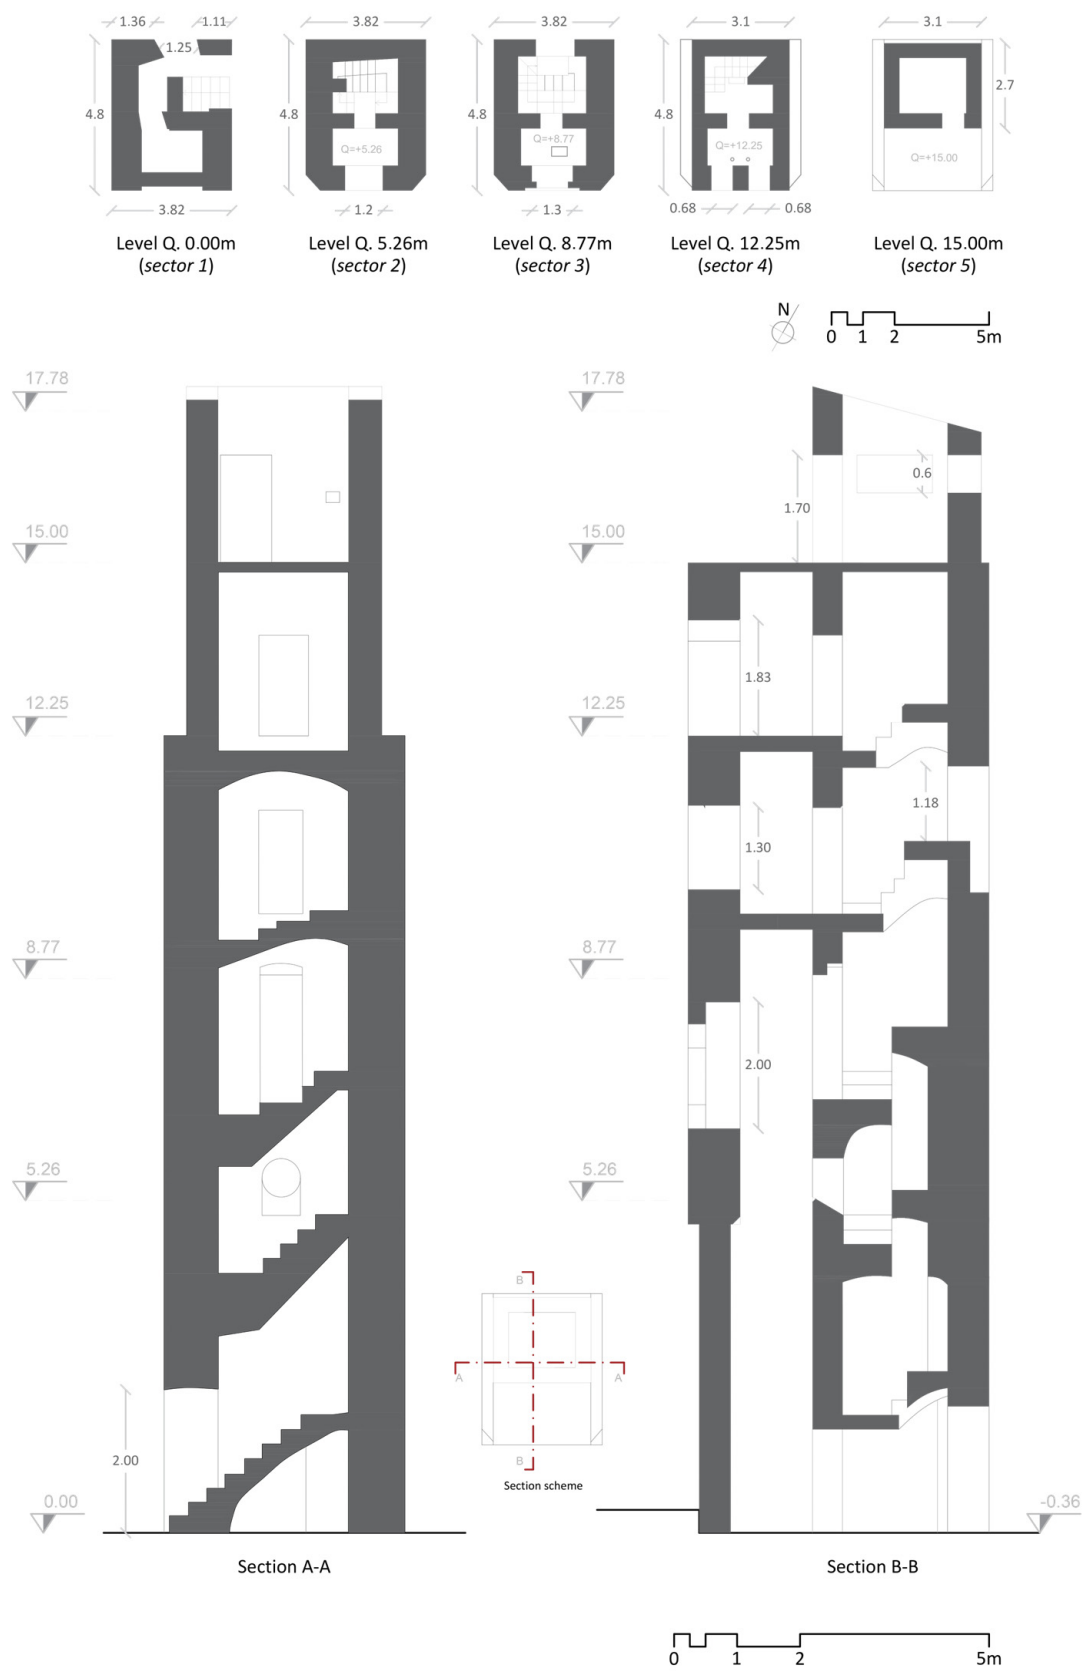
The complete geometrical survey of the tower, including the plan views at the different sectors and two sections, is provided in Figure 3.

Figure 3. Geometrical survey of the tower of St. Lucia Church in Cellole (CE).

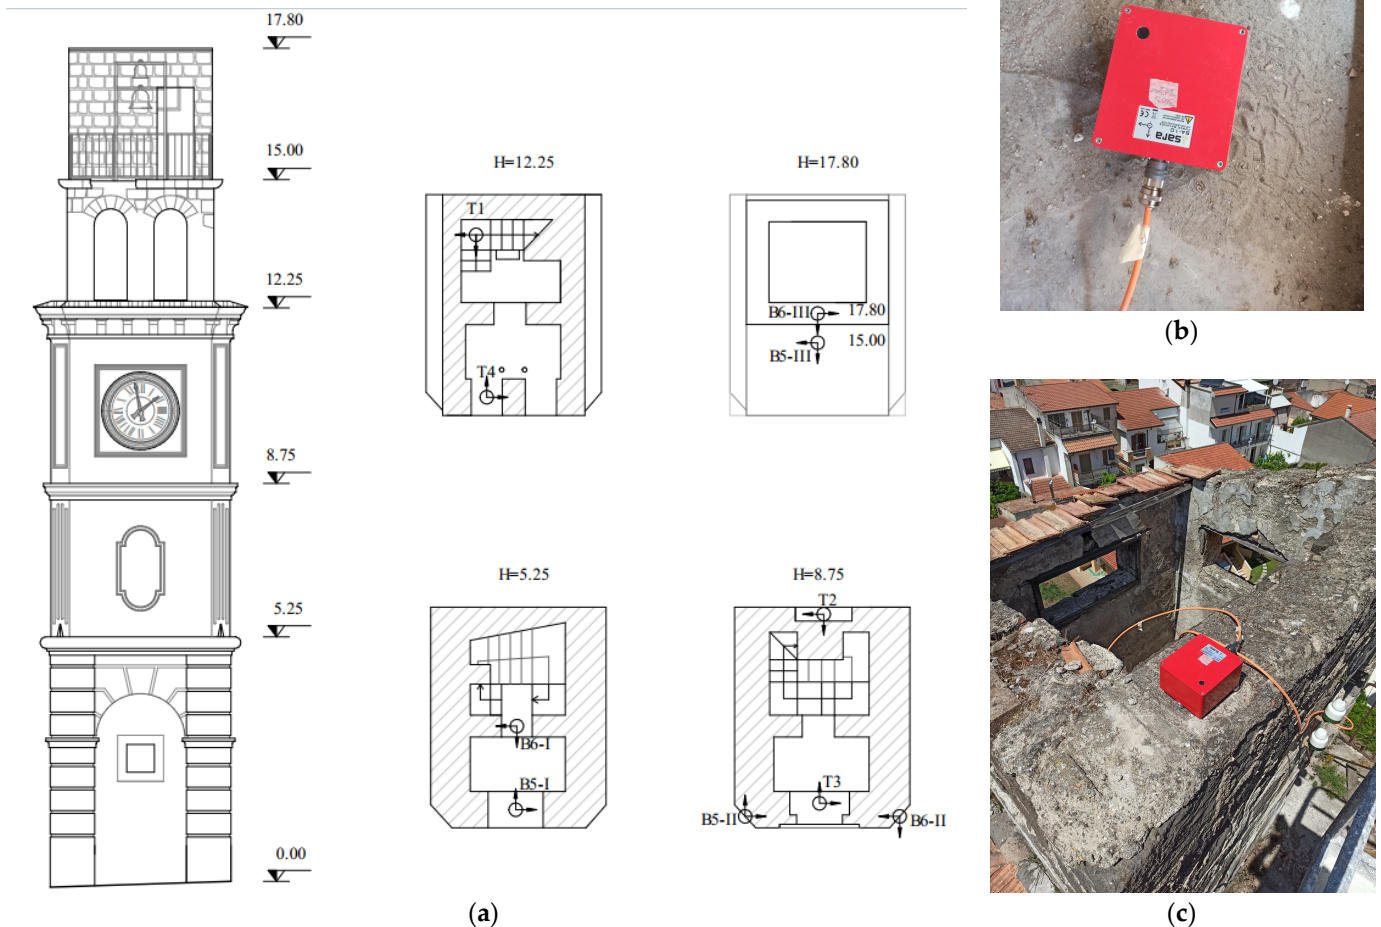
Figure 6. AVT setups: (a) position of the accelerometers, labelled as T (triaxial) or B (biaxial), with the Roman letter indicating the setup number; (b) view of T1 and (c) B6-III.

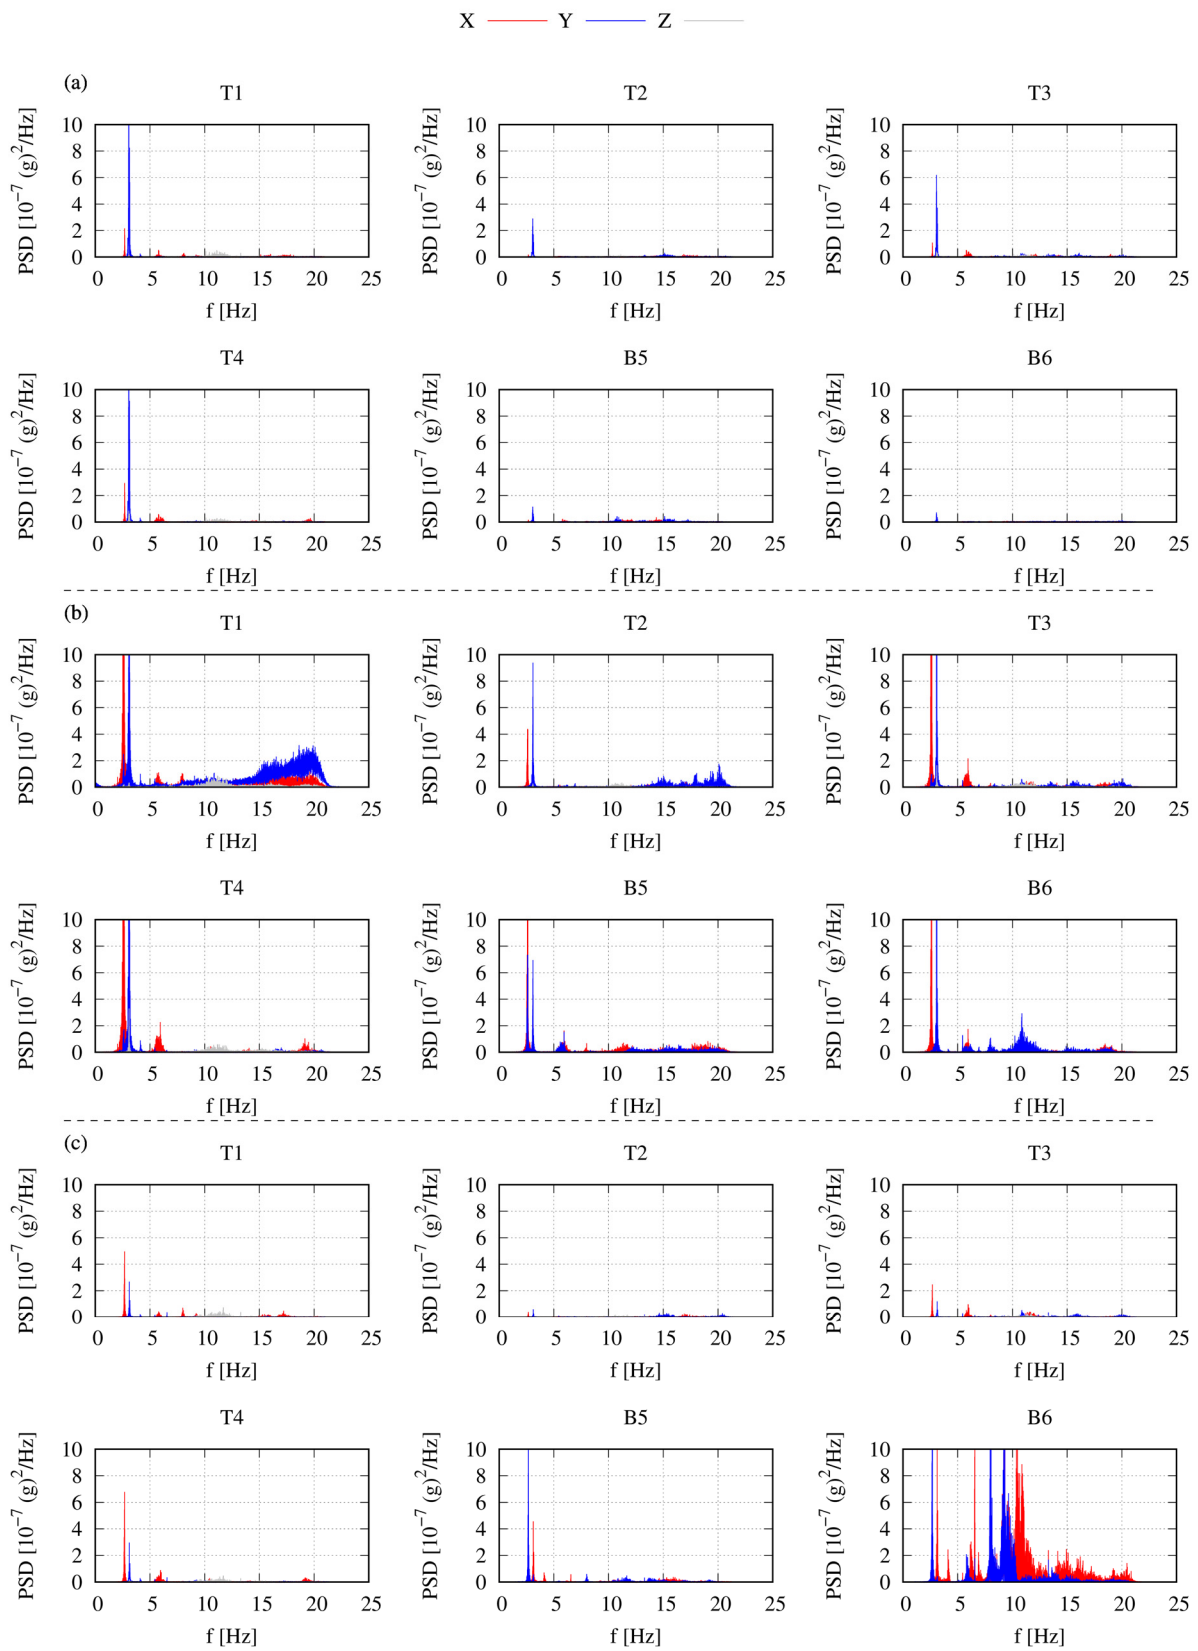
The Fast Fourier Transforms (FFTs) of the signals (Figure 7) consistently show two peaks in two orthogonal directions at about 2.6 Hz and 3.1 Hz. Another lower peak is also recognized for some signals at about 5.9 Hz, while strong power density is also observed for accelerometer B6 in setup III for many frequencies between 6 and 12 Hz. Since this sensor was placed on the top of a wall not significantly constrained out of its plane (Figure 6), it seems clear that these frequencies are related to local modes of the top floor walls.

Figure 7. Fast Fourier Transform of the signals in the three directions: (a) setup I, (b) setup II and (c) setup III.

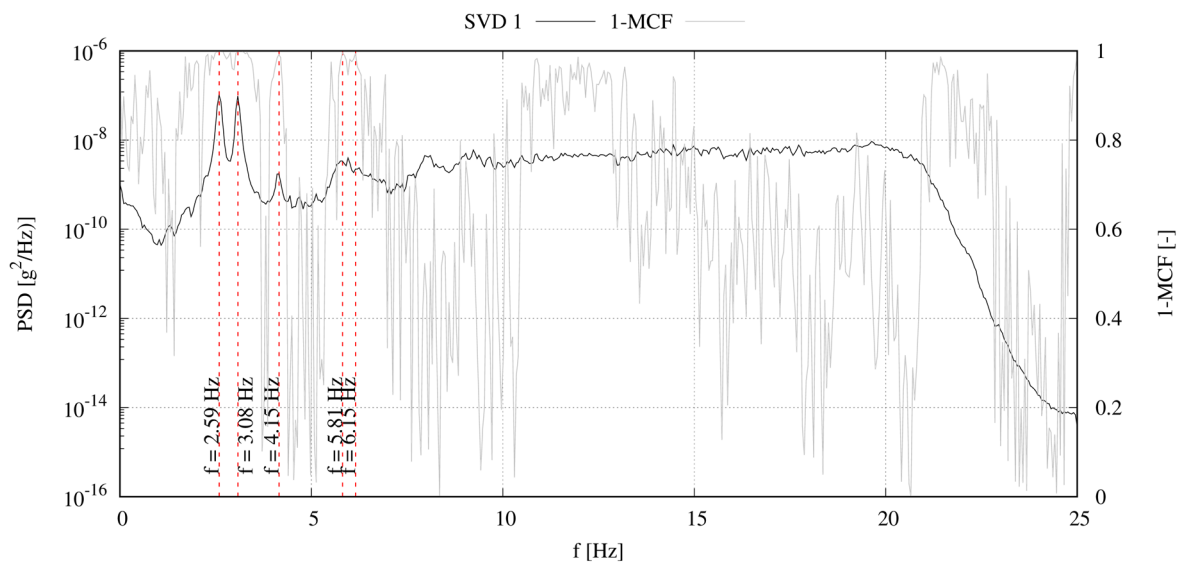
Frequencies and mode shapes were obtained by means of Frequency Domain Decomposition (FDD) [21], applying the procedure proposed by Amador and Brincker [22] to merge multiple setups having reference and roving sensors. In Figure 8, the first singular value (SVD 1) of the merged signals is plotted against frequencies. Three clear peaks are recognizable at 2.59 Hz, 3.08 Hz and 4.15 Hz. Some help in recognizing real modes when using FDD is offered by the analysis of the Modal Complexity Factor (MCF) for a given mode shape ψ_r , defined as in [23]

Figure 8. First Singular Value plot and identification of the first five frequencies.

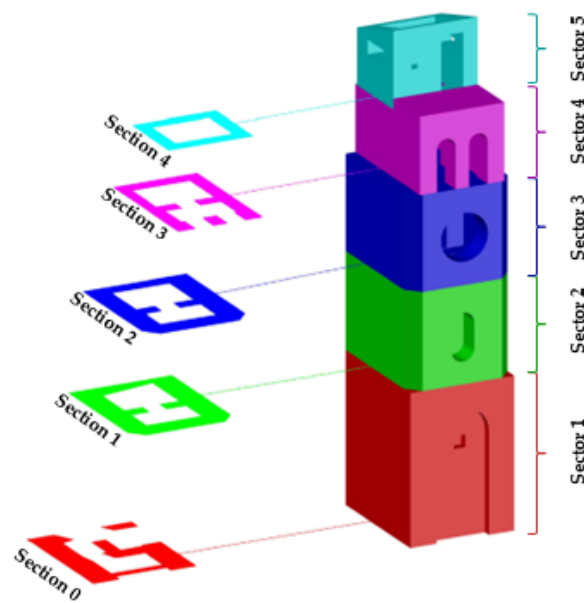
Figure 13. Subdivision of the tower in sectors and sections adopted for the EL1 checks.

According to EL1 methodology, which allows for performing a simplified structural check neglecting out-of-plane and shear failures, the bell tower under investigation presents a safety factor of less than unity for design seismic loads at the ULS, and thus cannot be considered safe. In particular, by assuming a linear displacement and 2nd mode proportional load distributions (along x-direction), the base section returned a safety index in terms of acceleration equal to 0.94 and 0.84, respectively. On the other hand, when a 1st mode proportional load pattern was considered, the section at the base of the 3rd sector was the sole returning a negative outcome of the structural checks. This can be related to

the significant openings the tower presents at this level. In the other cases, the analyzed sections were verified with a safety index in terms of acceleration ranging from 1.05 (section 1, 1st mode proportional) and 4.09 (section 4, linear distribution).

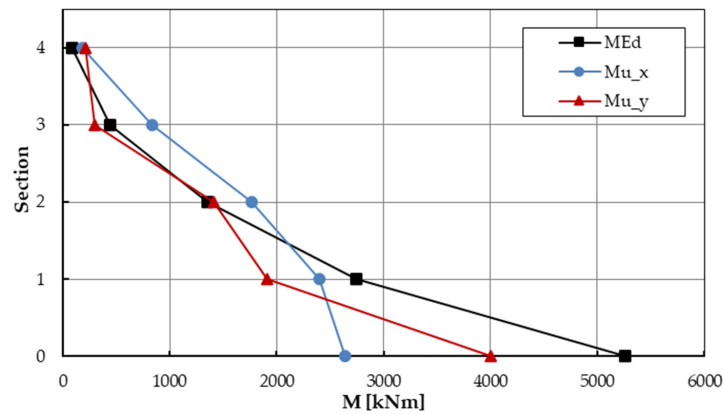
Figure 16. Comparison between design and resisting bending moment at each relevant section, with $q = 1.5$ (linear acceleration profile).

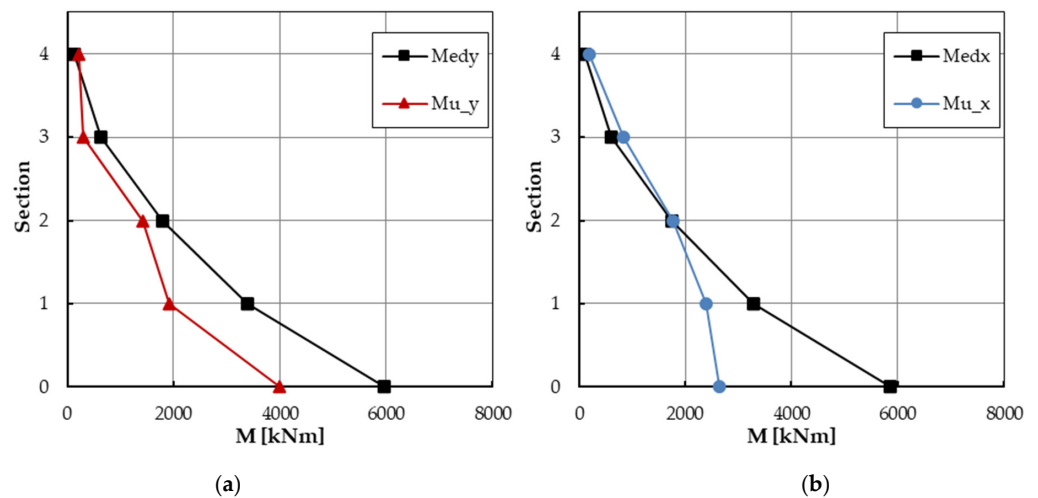
Figure 17. Comparison between design and resisting bending moment at each relevant section with $q = 1.5$: (a) 1st mode-proportional and (b) 2nd mode-proportional acceleration profiles.
