# Effect of Vehicle Vibration on Interior Noise of Railway Vehicles Passing Through Rail Corrugation Sections

**Abstract:** This study involved experimental research to analyze the effect of rail corrugation on interior noise levels inside railway vehicles. Measurements taken on the Incheon Line 2 light rail indicated that the vehicle's age and maintenance condition have minimal effects on interior noise. Although wheel wear slightly reduces interior noise, it is insufficient to address the issue of abnormal noise. The analysis of the relationship between vehicle vibrations and interior noise revealed that at 80 km/h and with a 24 mm rail corrugation wavelength, vibrations at 920 Hz in the axle box and car body increase, coinciding with the dominant interior noise frequency of 926.6 Hz. Furthermore, an analysis using a car body sweep confirmed a relative increase in noise in the 920 Hz range. Therefore, abnormal noise in rail corrugation sections is caused by vibrations at 920 Hz due to the corrugation wavelength and train speed, which align with the car body resonance frequency, leading to increased car body vibrations and interior noise.

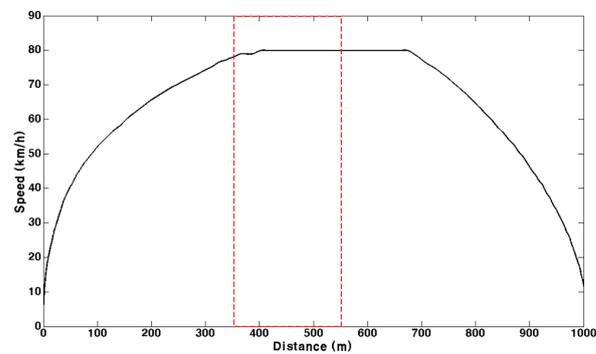
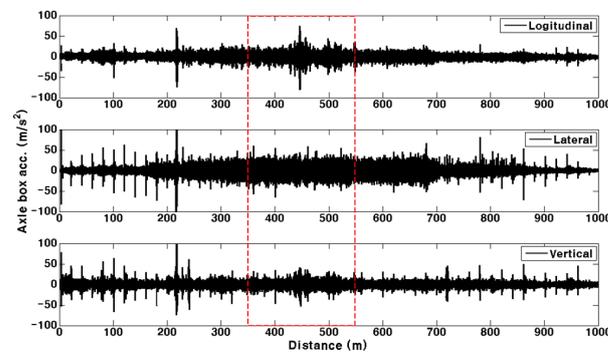
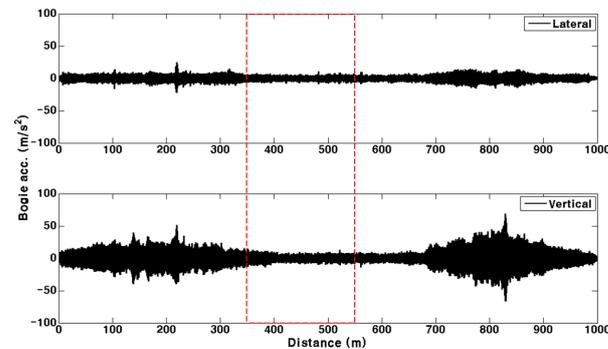
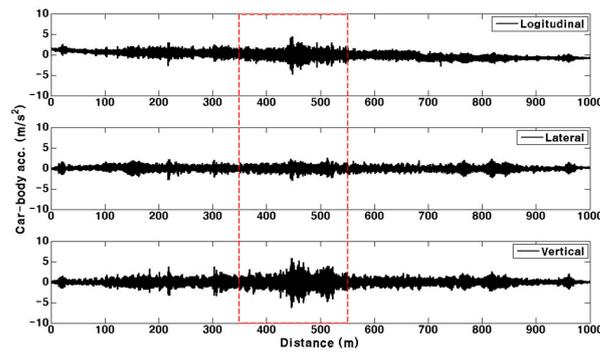
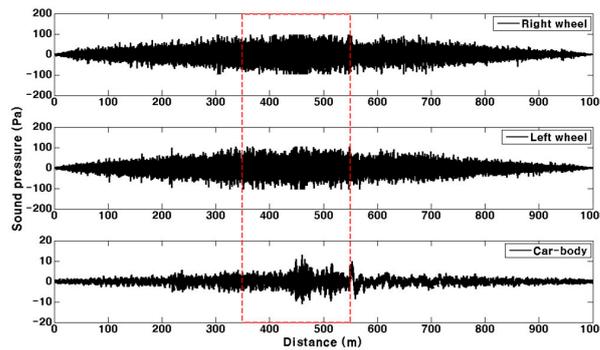
Figure 9. Acceleration and noise data measured in the rail corrugation section (□).

The test section was selected as the S10 upline section, where the highest noise levels were observed among the corrugated sections, as shown in Figure 3. Corrugation was observed in the 350–550 m section, and the vehicle speed was maintained at the same level as the commercial operation speed. Figure 9 presents the vehicle speed, axle box, bogie frame, car body accelerations, and wheel and car body noise data measured in the S10 section.

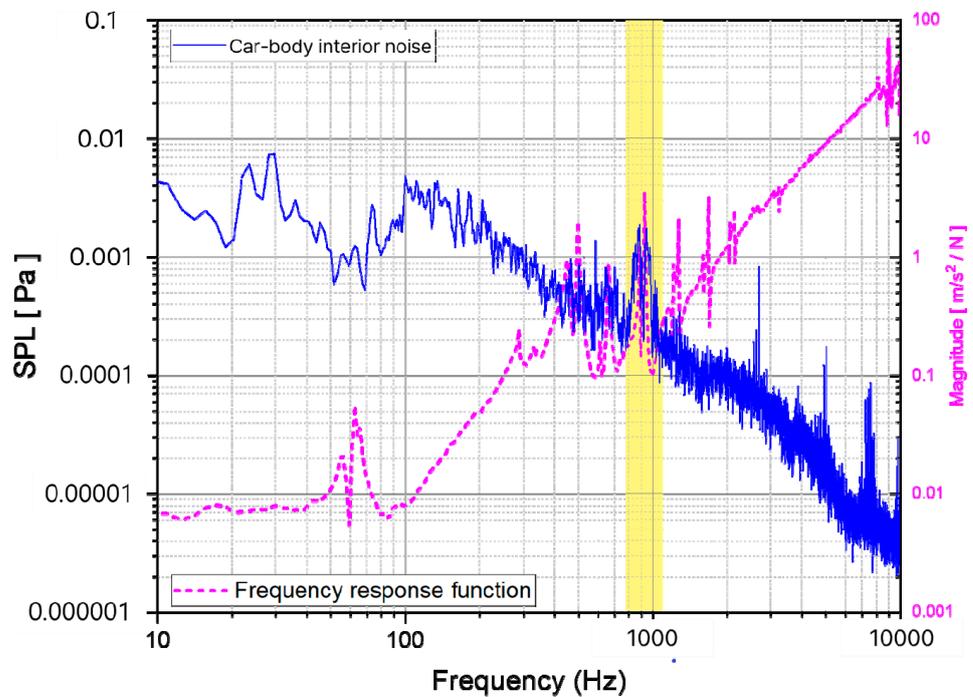
Figure 17. Interior noise characteristics.

Figure 16 shows the results of testing the natural frequency of the car body according to the under-body excitation. Frequencies related to the 920 Hz abnormal noise frequency observed during the rail corrugation section operation, such as 884.4 Hz and 926.6 Hz, were detected. These frequency bands have very low damping ratios, indicating a high possibility of car body resonance. To confirm this, the interior noise was measured by sweeping the frequency band at approximately 900 Hz, which is the car body resonance frequency. Figure 17 shows the results of the car body noise characteristic test, confirming that the noise around (yellow section) the car body resonance frequency of 920 Hz increased.

Therefore, it is concluded that the abnormal noise observed during rail corrugation section operation is caused by 920 Hz vibrations induced when the vehicle operates at 80 km/h through a rail corrugation section with a wavelength of 24 mm, transmitted vertically through the axle box and car body. The 920 Hz band vibration of the car body matches the car body's resonance frequency of 926.6 Hz, resulting in increased interior noise.
