Failure Analysis of the Crack and Leakage of a Crude Oil Pipeline under CO₂-Steam Flooding

¹ State Key Laboratory for Performance and Structure Safety of Petroleum Tubular Goods and Equipment Materials & CNPC Tubular Goods Research Institute, Xi'an 710077, China

Citation: Song, C.; Li, Y.; Wu, F.; Luo, J.; Li, L.; Li, G. Failure Analysis of the Crack and Leakage of a Crude Oil Pipeline under CO₂-Steam Flooding. *Processes* **2023**, *11*, 1567. <https://doi.org/10.3390/pr11051567>

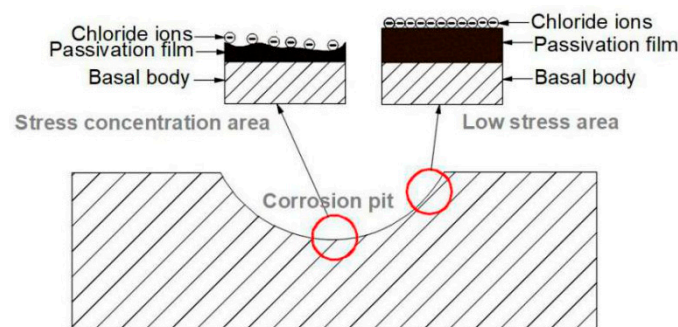
Corrosion pits have formed after significant localised corrosion has occurred on the external wall of this pipeline. Under operating pressure, soil pressure and other residual stress, there is a large stress concentration at the bottom of the corrosion pits. Residual stresses account for the largest proportion of several stresses because the pipeline is subjected to various processes, such as cooling, thermal processing, welding, etc., which can cause residual stresses. Besides, 316L austenitic stainless steel also has process hardening characteristics. The presence of stress makes the passivation film surface in the stress concentration area enriched with more chloride ions, which reduces the thickness, integrity of the passivation film, and pitting resistance [33,34]. This results in faster anodic dissolution in the stress concentration zone. In the low-stress area, the concentration of chloride ions is relatively low, and the passivation film thickness is greater and more complete, resulting in greater resistance to pitting corrosion. Figure 14 shows the model for stress corrosion of stainless steel.

The stress concentration area is prone to cracking [35,36], and the cracks in this pipeline all start at the bottom of the corrosion pits. As a result, once a crack has developed, the passivation film formed at the crack's tip differs from that away from the crack [37]. It is much looser and less stable, leading to cracking of the passivation film. The corrosion rate at the tip of the crack will be higher than at other locations [37], thus allowing the crack to expand in a direction perpendicular to the stress. Once the formation of micro cracks, its expansion rate is much faster than other types of localized corrosion, so SCC is the most destructive and damaging type of corrosion among all types of corrosion.

Figure 14. Mechanism model of chloride SCC.
