A Brief Report of Hotel Collapse Causing Casualties in Suzhou, China

This paper presents the preliminary investigation into the cause of a recent hotel collapse in Wujiang, Suzhou, which resulted in 17 deaths and serious injuries to 5 people. The objective of this study is to contribute to the understanding of old building collapses accidents and supply effective recommendations. The background of this accidental event is first introduced, and then rescue operations are presented. Subsequently, a discussion on direct causes of collapse, management problems, as well as some measures to avoid similar accidents are proposed.

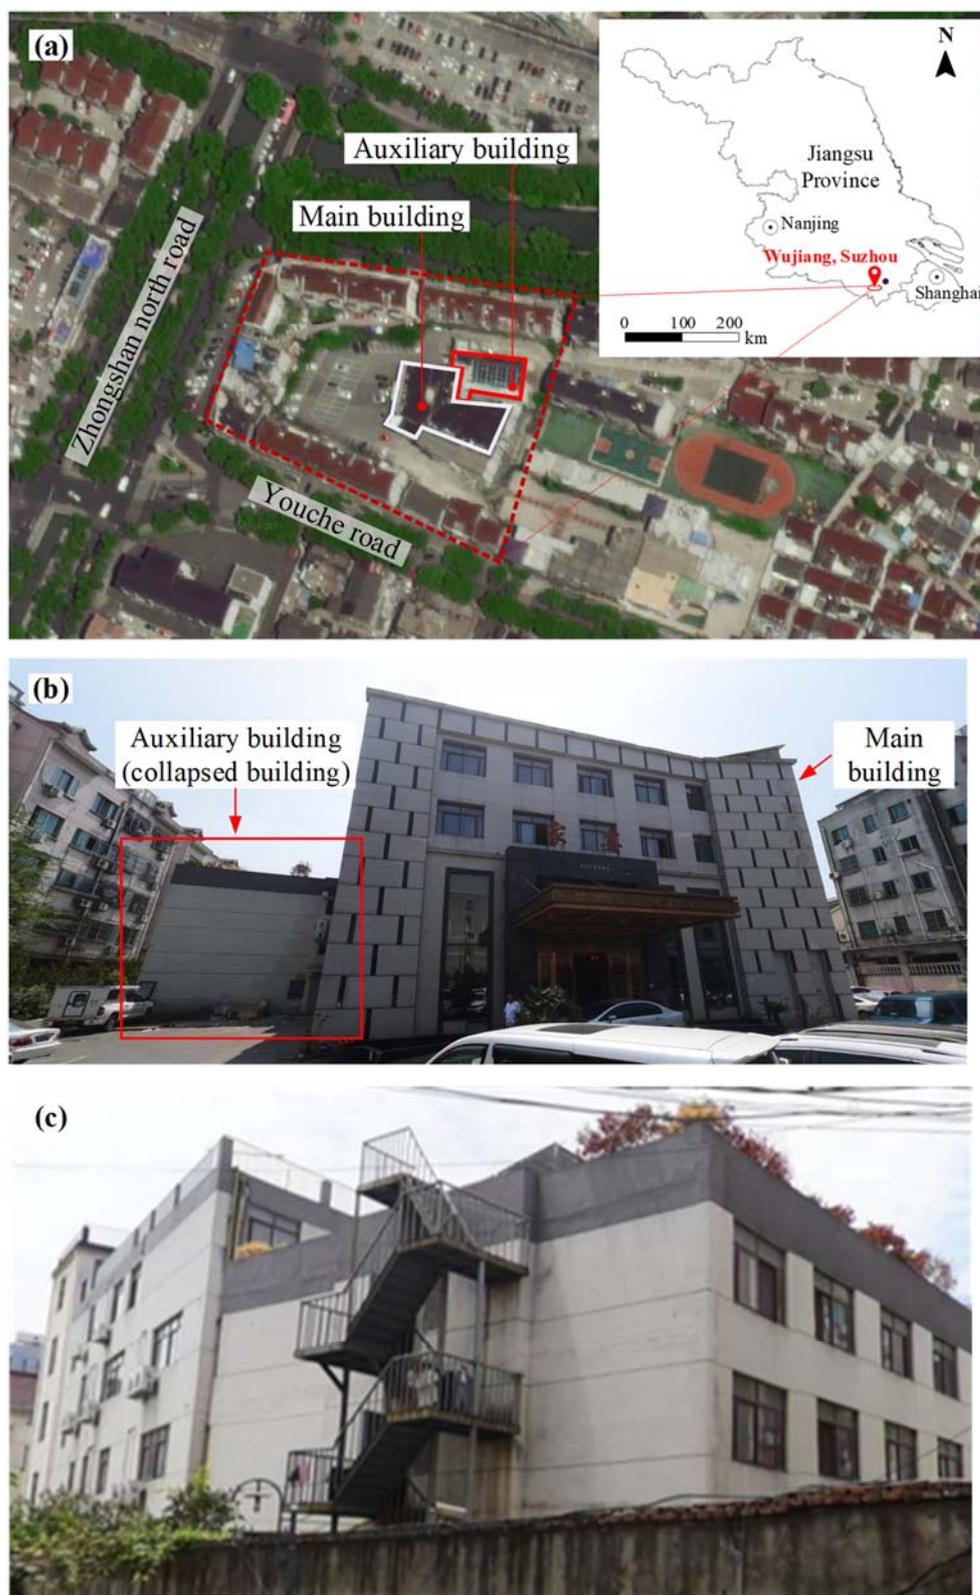
Figure 1 shows the location of the collapsed hotel as well as its appearance before the accident. This accidental event took place in the Wujiang district of Suzhou, Jiangsu Province and involved the “Four seasons Kaiyuan Hotel”. The hotel consisted of two buildings relatively close to each other: a main building and an auxiliary building (Figure 1b). The main building (four-story) was intended to provide accommodation, catering, and other hotel services, while the auxiliary building (four-story) was mainly designed to host entertainment facilities such as guest rooms or chess and card rooms. In terms of structural design, the hotel used to adopt a reinforced mixed brick wall structure with a steel roof.

In 2018, the “Four seasons Kaiyuan Hotel” was renovated to adapt to the owner’s business strategies. According to media reports, when the owner acquired the hotel in 2018, the main and auxiliary buildings were structurally connected by a wall that already revealed some cracks. In addition, several guests who stayed at the hotel few days before the collapse said that they could hear distinctive cracking noises in their rooms. Unfortunately, these noises were warning signs that ultimately evolved into its breakdown. It should be noted, however, that the collapse did not affect the main building of the four-story hotel, but its auxiliary building.

Figure 1. (a) Location of the building collapse site; (b) a view of hotel facade; (c) a view of the auxiliary building before the accident (Source: <https://map.baidu.com/@13431247.69,3632620.17,19z>, accessed on 13 July 2021).
