# Lessons Learned from the Module Production for the First CMS Silicon Tracker

Alan Honma

**Abstract:** A personal view of some of the more important lessons learned from the module production for the CMS silicon tracker. This work took place from about 2002–2005. The focus is on areas where I had strong personal involvement; therefore, the tasks of hybrid production, hybrid assembly, and the wire bonding of modules and hybrids are emphasized. This article will first give a general description of the silicon tracker project and how the module production was organized. Then, there will be description of several of the key issues or problems during the production and how they were resolved. Some recommendations for future similar large-scale productions will be given.

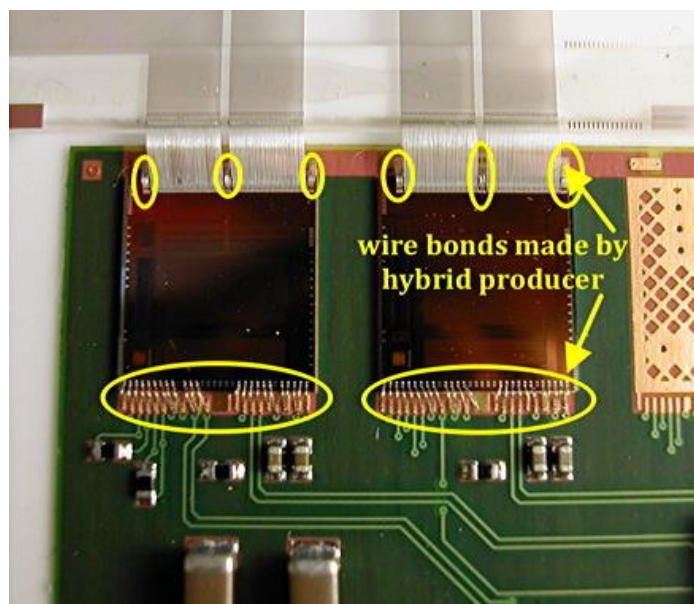
The first problem occurred in the front-end hybrids, where the assembly company performed the wire bonding from the readout ASICs to the PCB bond pads (see Figure 10). We had (fortunately) decided to ask the company to make “dummy” hybrids (electrically bad but mechanically good) with dummy chips so the soldering, gluing, and bonding steps could be tested without wasting good parts. One out of twenty hybrids assembled was a dummy. Both the company and CMS conducted wire-bond pull tests on the bond wires they placed on the dummies. A pull test is when you take a dynamometer with a very tiny wire hook and pull up on a bond wire to measure how much force it can take before it either breaks or the wires detach from one of the end weld points (called the bond foot). The problem that occurred was that CMS started to get very poor results on the pull tests of some of the hybrids that the company had also tested but with good results. The difference

was very substantial in some cases: the company got nominal results (which was a pull test strength of about 10 g) whereas CMS would get values of 2–3 g (the required value was a mean of 8 g for a set of 10 wires).

**Figure 10.** Location of wire bonds on a hybrid assembly made by the hybrid producer.

After several heated discussions about whether the company or CMS was conducting the test correctly, it was found that the result depended very strongly on precisely where the wire hook was placed when conducting the test. The company had chosen to pull very near the apex of the wire loop whereas CMS was pulling closer to the central point mid-way between the ends of the wire (a difference in distance of perhaps 0.3 mm out of the typical 3 mm length of a wire). However, this very small difference in pull location could lead to very large differences in the result. There were good reasons for choosing either position; the company's choice would result in the least change in position of the wire during the pull test (moving the wire will generally weaken it) whereas the CMS choice would result in the force applied to the two ends of the wire to be nearly equal, thus testing both ends fairly.

There were more heated discussions as to which was the correct method to use in order to apply the pull test criteria and decide if the wire bonding passed or failed those criteria. As CMS was the client and because we wanted the wires to be able to survive the handling and thermal changes over the long lifetime of the detector, we insisted that if a wire is slightly moved during this test, it should not lose 90% of its strength. In fact, a more careful analysis of why this weakness occurred after such a small flexing of the wire showed that because of the design of the ASIC, the wire was developing a crack at the point where the wire rose upward from the ASIC bond pad. This crack developed because there was a "passivation" (protection) layer of polyimide, which was about 7  $\mu\text{m}$  thick and surrounded the ASICs' wire bond pads. Because the bond pads were very small (95  $\mu\text{m}$   $\times$  95  $\mu\text{m}$ ), the bond weld foot (which was about 75  $\mu\text{m}$  long) often would run into the edge of the polyimide, which could create a dent in the soft aluminium wire and the local stresses and further movements of the wire during the bonding process caused a crack to form near this point (see Figure 11). If the wire was not much stressed further (as for the company's method of pull testing), the strength of the wire was close to normal. If the wire was moved physically (as was the case for the CMS method of pull testing), the crack would quickly propagate through much of the rest of the intact wire material and cause a failure with very little (or even no) pull force.
