Combined ND Techniques for Structural Assessment: The Case of Historic Nepali Constructions after the 2015 Gorkha Earthquake [†]

Abstract: Combined non-destructive in situ techniques—namely sonic tests and ambient vibration measurements—are applied on two Nepali Pagoda temples damaged by the 2015 Gorkha earthquake, providing the dynamic elastic modulus of masonry and the buildings’ frequencies.

This study presents an experimental investigation on two Nepali Pagoda temples damaged by the 2015 Gorkha Earthquake, namely Jagannath Temple in Kathmandu Durbar Square and Krishna Temple in Bhaktapur Durbar Square.

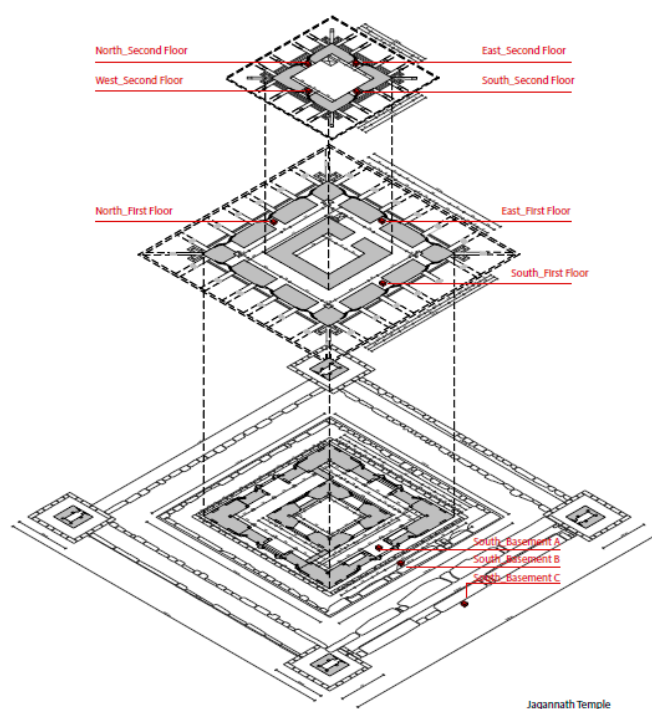
Figure 2. Locations of the velocimeter, Jagannath Temple.

AVMs were accomplished on 23 October 2016. The measurements on the south basement were accomplished on 29 October 2016. The locations of the velocimeter are shown in Figure 2. The record duration was 16 min for the south basement, 6 min at the north side of first floor and 10 min for the remaining records. The sampling frequency was 128 Hz. The Fourier amplitude spectra of velocity are shown in Figure 3.

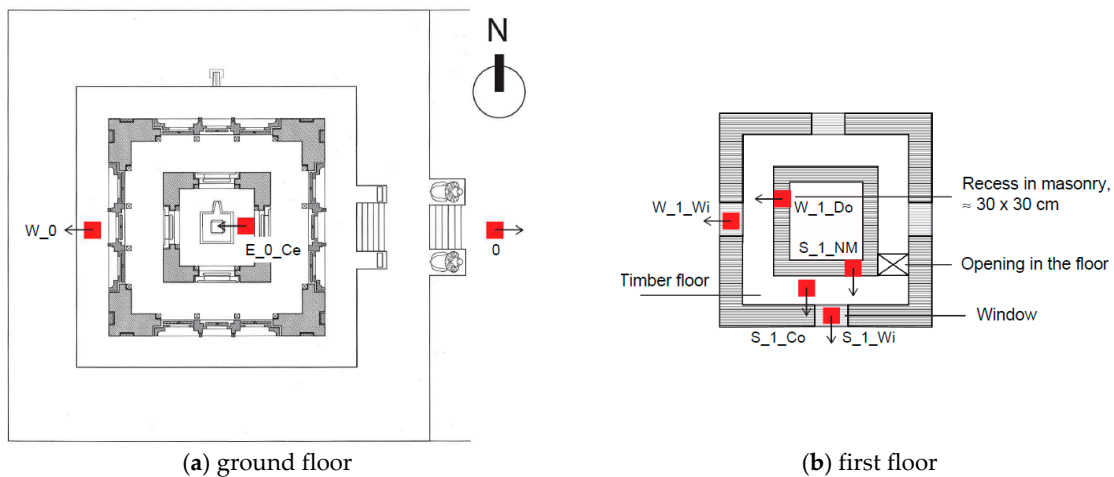
Figure 5. Locations and orientations of the velocimeter, Krishna Temple.

AVMs were accomplished on 24 October 2016. The locations of the velocimeter are shown in Figure 5. The arrows show the instrumental N direction. The duration of each record was 16 min and the sampling frequency 128 Hz. The Fourier amplitude spectra of velocity are shown in Figure 6.

The first two frequencies ($f_1 = 2.3$ Hz, $f_2 = 2.4$ Hz) have mixed components, along the NS and EW directions, possibly with torsion. The third frequency ($f_3 = 3.3$ Hz) corresponds to the first torsional mode around the vertical axis (the S wall moves along the EW direction and the W wall along the NS direction). The fourth frequency ($f_4 = 5.6$ Hz) has mixed components along the NS and EW directions. The fifth frequency ($f_5 = 6.1$ Hz) corresponds to the free-field and the basement, showing local amplification effects. Finally, the last three frequencies ($f_6 = 6.5$ Hz, $f_7 = 9.4$ Hz, $f_8 = 9.8$ Hz) have again mixed components along the NS and EW directions. Coupling between the horizontal and the vertical components can be found at the first floor.
