New Frontiers of Composites Applications in Heritage Buildings: Repair of Exposed Masonry of St. Nicola Church in Pisa

Pietro Croce

Citation: Croce, P. New Frontiers of Composites Applications in Heritage Buildings: Repair of Exposed Masonry of St. Nicola Church in Pisa. *J. Compos. Sci.* **2021**, *5*, 218. <https://doi.org/10.3390/jcs5080218>

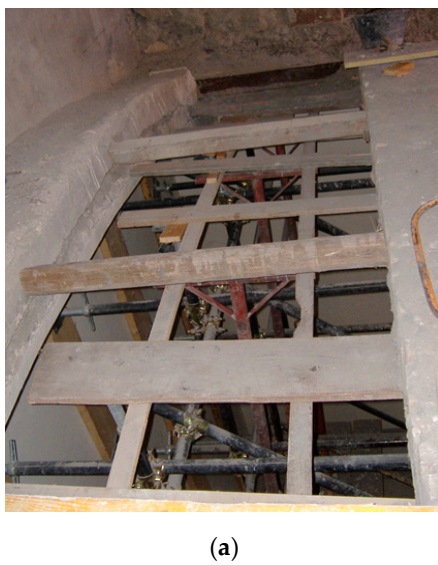
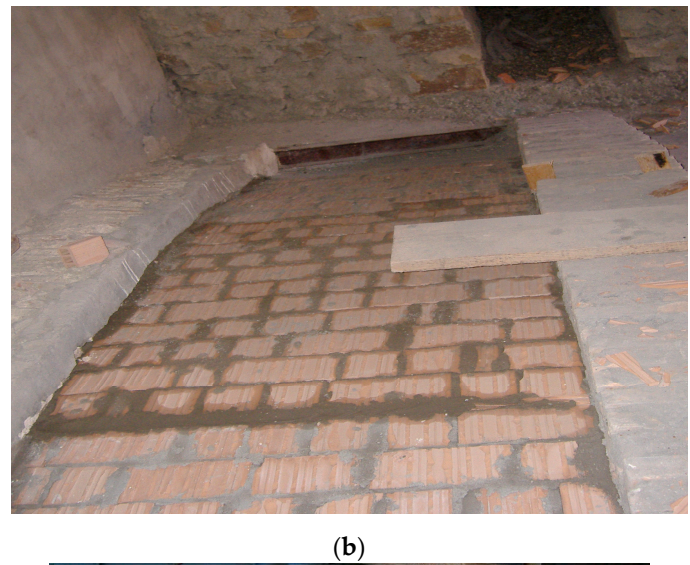
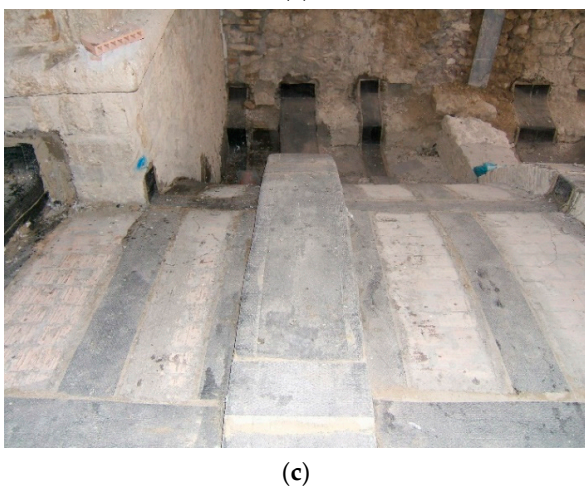
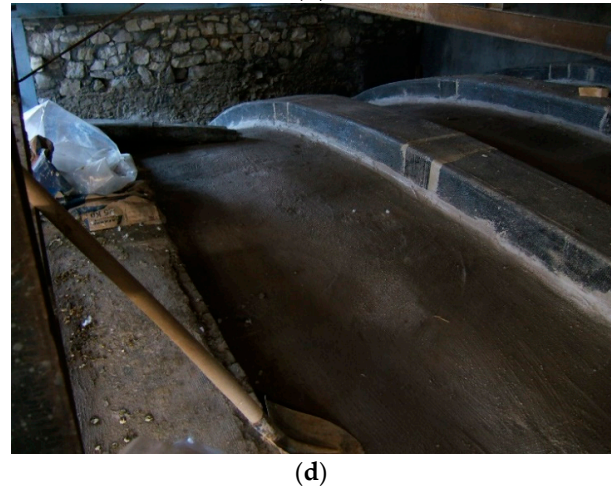
Figure 5. Composite strengthening of a partly collapsed ribbed barrel vault: (a) detail of the collapsed part; (b) reconstruction of the collapsed part; (c) detail of composite reinforcement; (d) detail of the completed intervention.

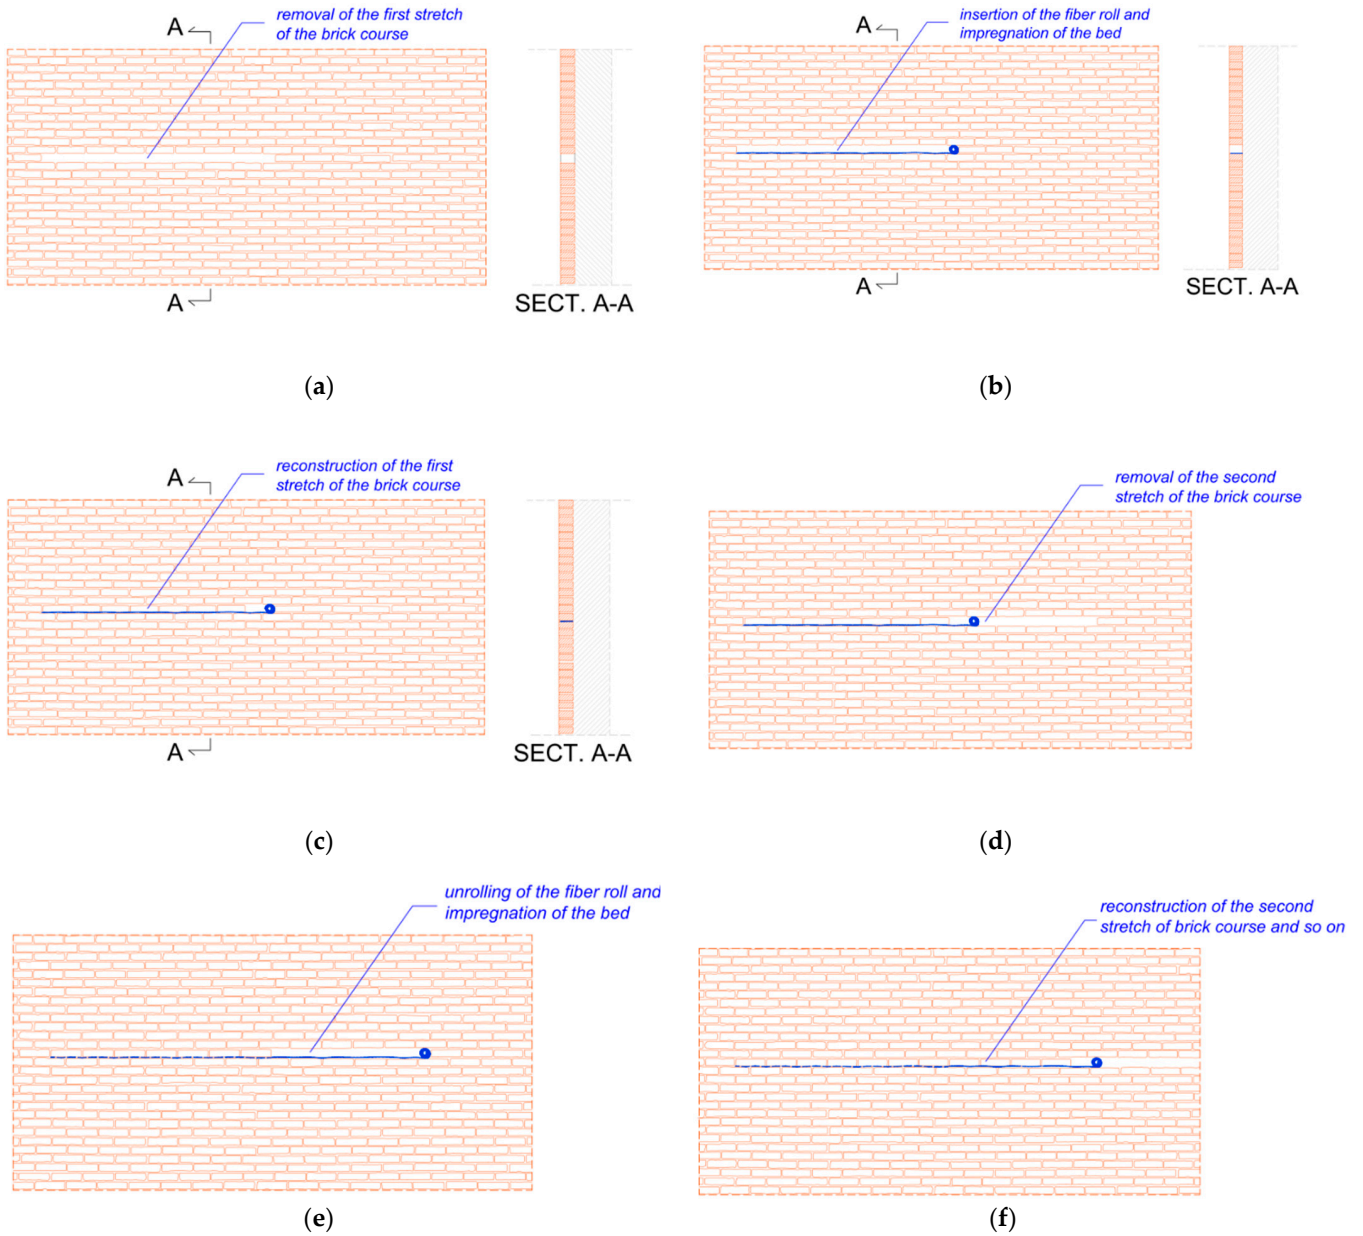
Figure 9. Phases of the proposed intervention: (a) removal of the first stretch of brick course; (b) unrolling and impregnation of the fiber roll; (c) reconstruction of the first stretch of the brick course; (d) removal of the second stretch of brick course; (e) unrolling and impregnation of the fiber roll; (f) reconstruction of the second stretch of brick course and so on.

3. rolling up of the fiber strip,
4. starting of the indent: careful removal of the first stretch of the brick course (Figure 9a), and cleaning of the so obtained recess,

5. application, using a spatula or a paintbrush, of low viscosity polymeric resin, for example, epoxy resin, insertion and partial unrolling of the fiber roll and its impregnation with the resin (Figure 9b),

6. waiting until the resin is suitably cured, typically 24 h;
7. reconstruction of the stretch of the brick course: reinsertion of the bricks and renovation of mortar joints (Figure 9c), using a mortar having a composition similar to the historical one, for example, a lime mortar,

8. removal of the second stretch of the brick course (Figure 9d),
9. unrolling and impregnation of the fiber roll, as in step 5 (Figure 9e),
10. reconstruction of the stretch and renovation of mortar joints, as in step 6, and so on until the total extension of the course is completed (Figure 9f).

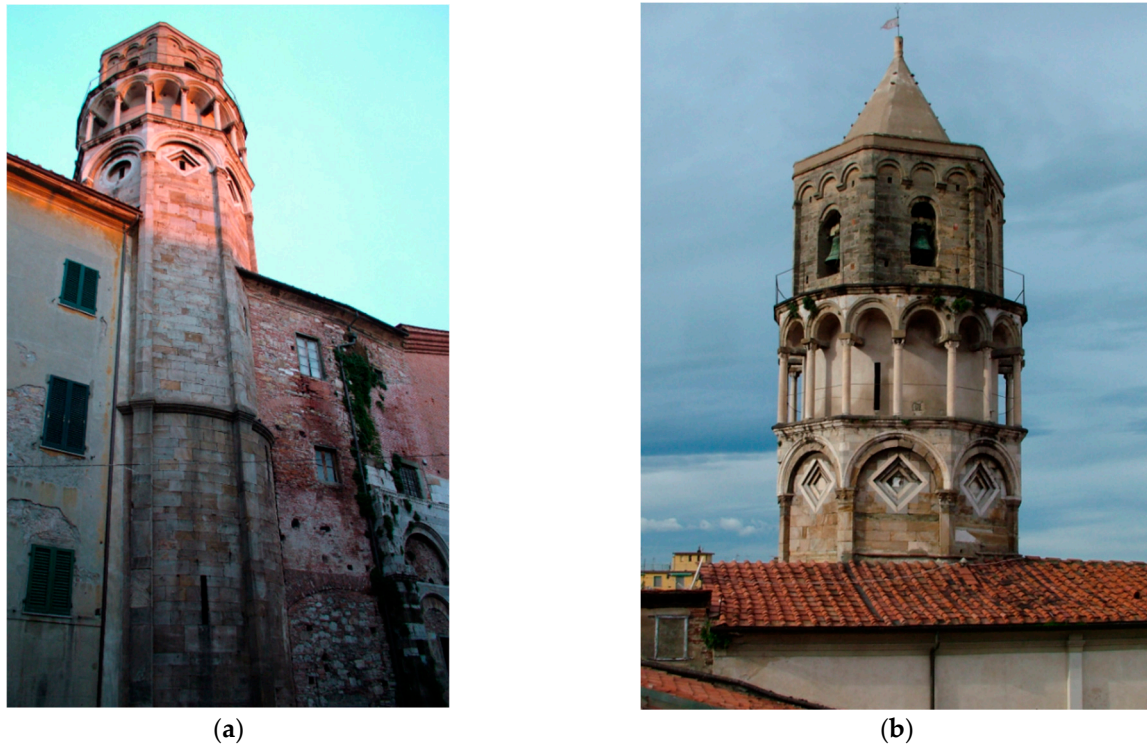
Figure 12. The bell tower of the St. Nicola Church in Pisa: (a) the bell tower from St. Maria Street; (b) the belfry.

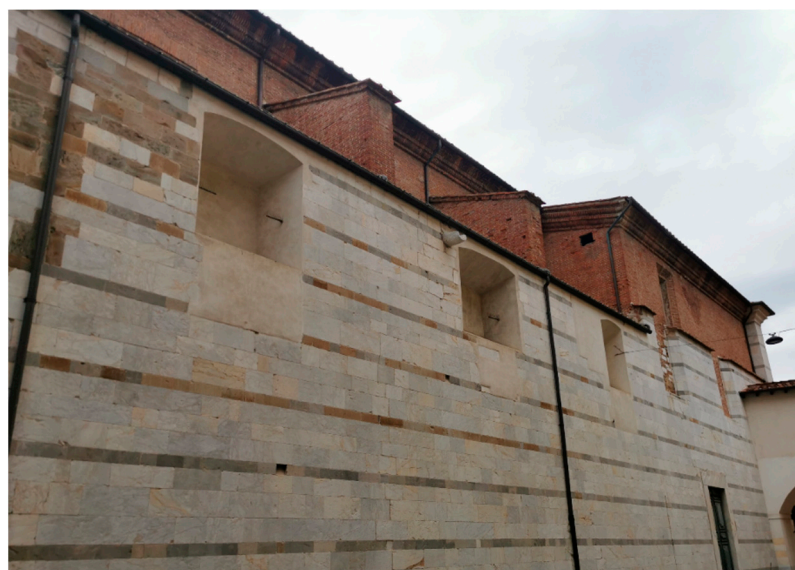
Figure 13. The south wall of St. Nicola Church.

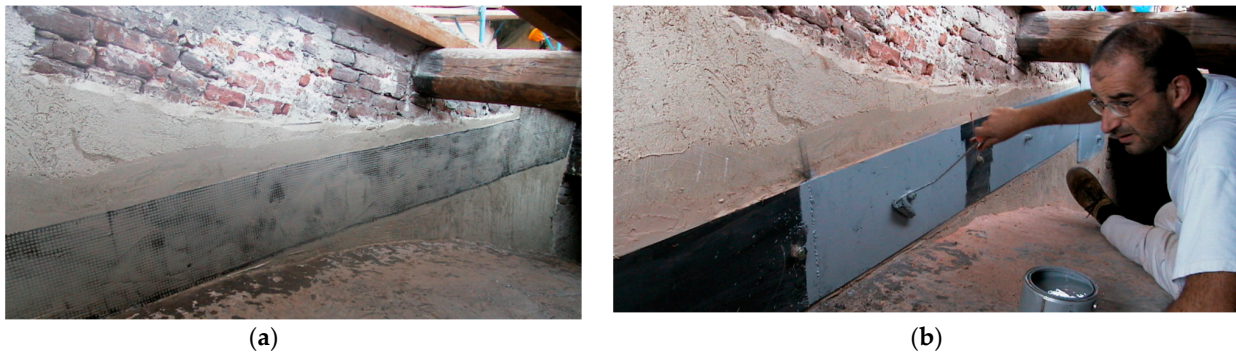
Figure 22. Composite steel-FRP tie: (a) carbon-fiber reinforcement; (b) steel plate.

The composite FRP-steel tie, composed of a composite strip, about 335 mm wide, and a S355J2 steel plate 300 mm wide and 3 mm thick, was obtained and connected similarly to the top composite strip (Figure 22), but the carbon fiber strip was obtained by folding the fabric to one third and two thirds of its width.
