Surface Mechanical Effects of Wildfires on Rocks in Climbing Areas

Pablo Yeste-Lizán ^{1,*}

Abstract: Wildfires are widely recognized as a cause of mechanical damage to rocks. Nevertheless, previous research has neglected how wildfires might impact sport climbing areas. In Spain, two large wildfires affected two climbing areas between 2020 and 2021. This paper addresses the rock mechanical effects of wildfires that could lead to safety issues, such as rock falls, climbing hold deterioration, and climbing anchor damage. In this study, the Non-Destructive Techniques (NDTs) of Ultrasonic Pulse Velocity (UPV) and Schmidt Hammer (SH) were used, and two types of measurements were carried out: randomized grid measurements and measurements along the climbing routes. Two phenomena were recognized: (a) thermal breakdown and (b) mineralogical changes. The results of using the SH show a relationship between the decrease in the rebound value and the observed mechanical damage. Field observations showed mechanical weathering, such as cracking, spalling, granular disaggregation, and thermochemical weathering with different temperature thresholds. Observed thermochemical reactions included redde

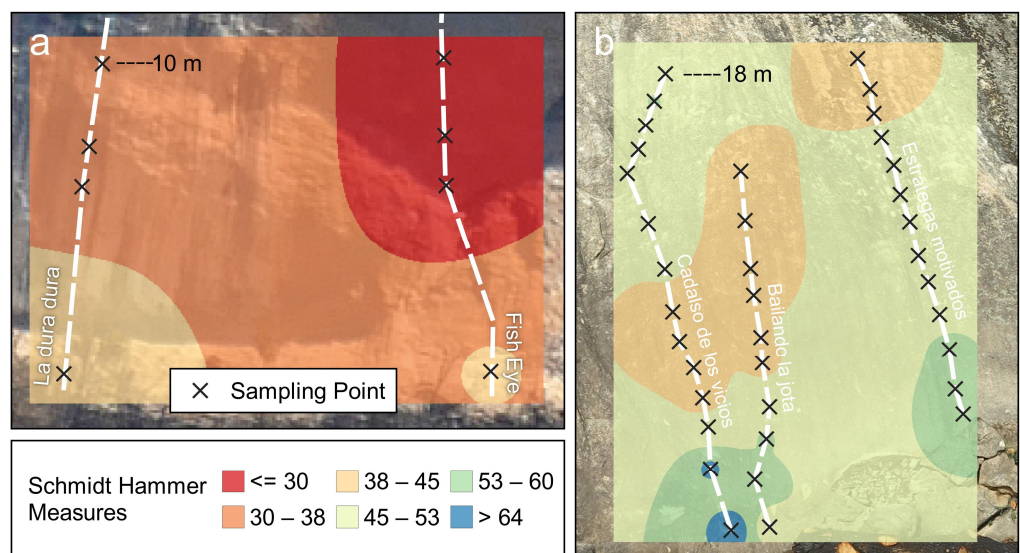
Figure 12. Spatial distribution of the SH measurements in: (a) “La Dura Dura” (Olina) and (b) three routes in Site 6 of Cadalso de los Vidrios.

As referenced in the methodology, the iconic route of “La Dura Dura” in Oliana was selected for a detailed SH and UPV survey (Figures 12a and 13a). As this route was only partially affected by the fire, the results do not show the same large gradation as Cadalso. Figures 12b and 13b show SH and UPV maps from the three studied routes in Cadalso de los Vidrios and show a gradation of values: lower SH and UPV at the bottom, and lower SH and UPV to the top right. This gradation is coherent with the results obtained from the random grid measurements (Figure 11), in which the areas with detached spalling show higher SH and UPV values than those areas showing reddening. This is because reddened areas with non-detached spalling have more microcracks than those in which the surface affected by fire has detached and, therefore, a “new” surface not affected by the fire is exposed. The SH values differ slightly more than those of UPV and show less significant trends. This is because UPV values are influenced by a larger volume of rock than the SH rebound number, and are, therefore, less sensitive to minor and localized mineralogical heterogeneities of the rock.

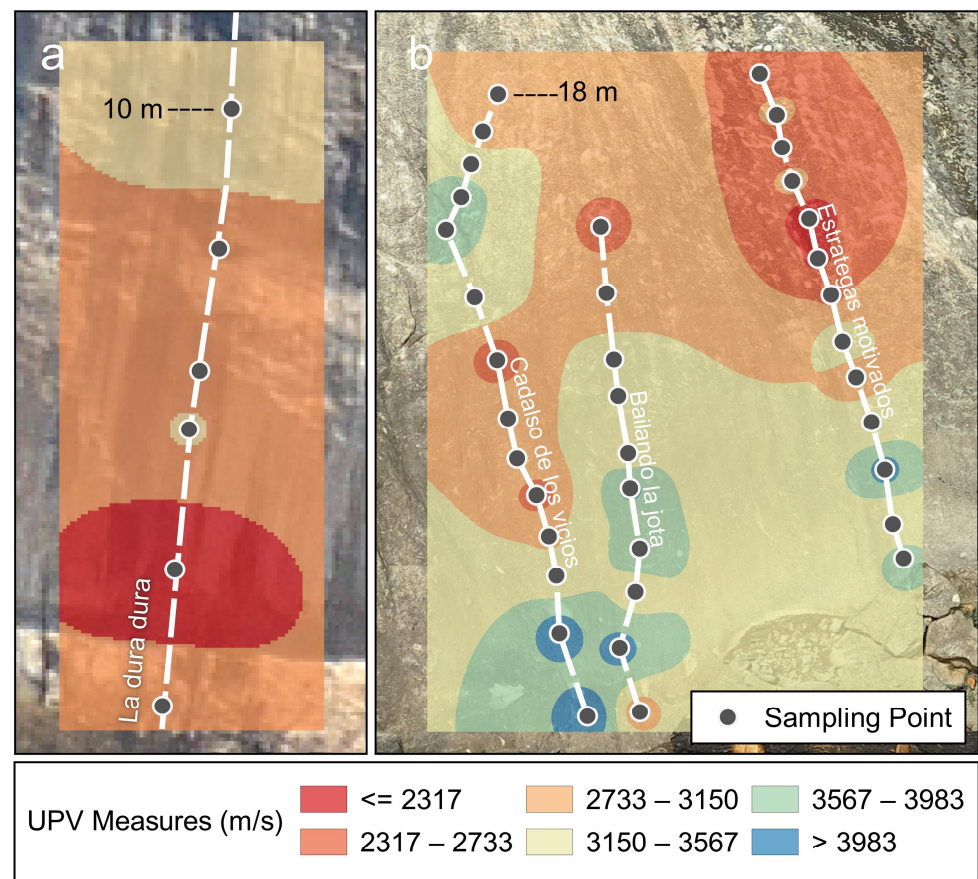
Figure 13. Spatial distribution of UPV measurements in: (a) “La Dura Dura” (Oliana) and (b) three routes in Site 6 of Cadalso de los Vidrios.

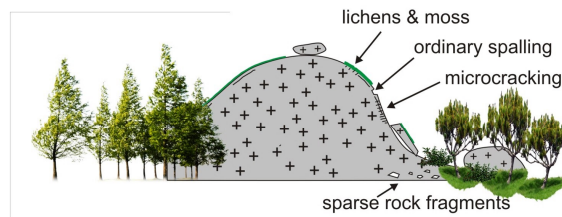
a: regularly weathering

Figure 15. Surface mechanical effects of wildfires on rocks in the climbing areas: (a) ordinary situation with current weathering; (b) changes in bedrock by weak wildfire partially affecting an area; (c) strong effects of a wildfire on a bedrock wall.

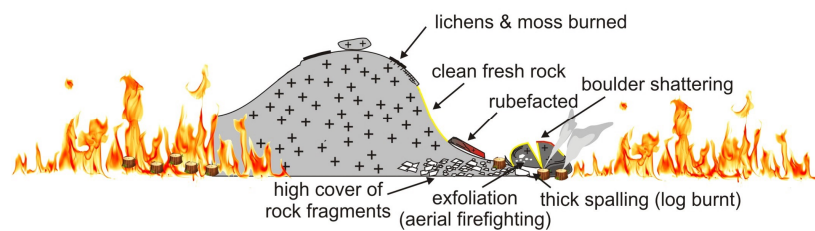
c: wildfire weathering (strong effects)

Wildfire weathering (Figure 15) has been noted as an important erosive agent, with changes in soil stoniness of up to 90% in the most damaged areas of Oliana. In Mediterranean areas, this effect has been demonstrated [46] by means of intense spalling. Both in Oliana and Cadalso, we noted the degree of spalling as a result of an increase in fire intensity and resulting sudden thermal shock. This effect is one of the most critical for sport climbing.
