Explosion Shock Dynamics and Hazards in Complex Civil Buildings: A Case Study of a Severe Fuel Explosion Accident in Yinchuan, China

Abstract: Gas explosion accidents can easily lead to large-scale casualties and economic losses, significantly impeding the urban development. The purpose of this study was to comprehensively review and investigate a significant gas fuel explosion accident in Yinchuan City, China, and to conduct an in-depth discussion on process traceability, failure risk, hazard prevention, and urban development related to the accident. The research found that the accidental failure of double-valve liquefied petroleum gas cylinders and human error were identified as the direct causes of gas leakage. The numerical results indicated that the progression of the accident disaster was chaotic and highly destructive. The maximum explosion overpressure of 92 kPa resulted in severe shock-wave damage to personnel, leading to the complete destruction and collapse of the 0.2 m thick solid brick wall and obstructing the stairway for escape. The rapid change in temperature and oxygen levels caused by the explosion led to the risk of burns and asphyxiation for personnel at the sc

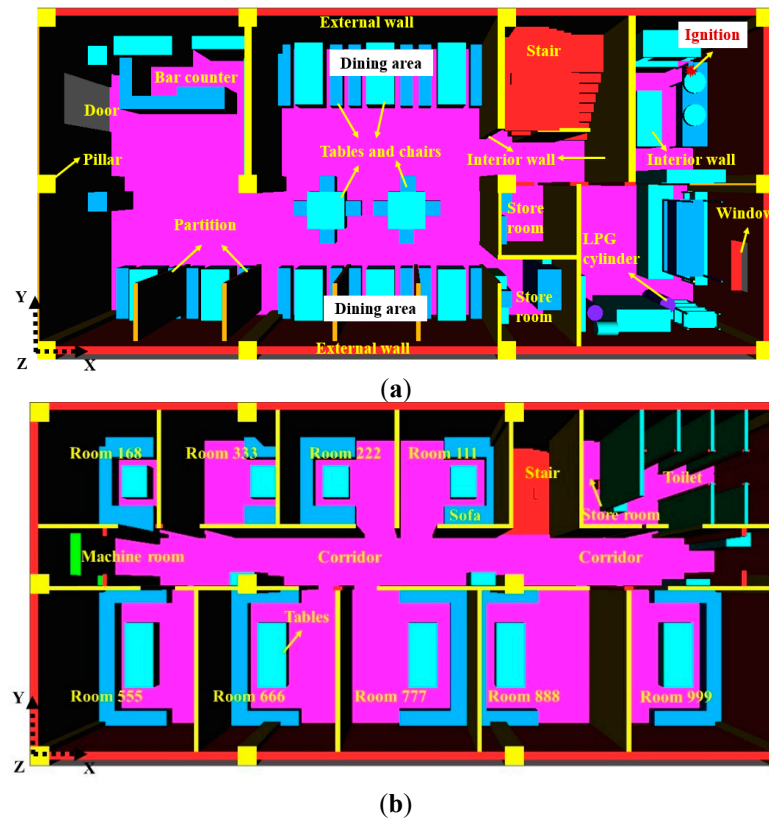
In the context of the accident building's original structure, a detailed 1:1 full-size proportional explosion physical model was constructed, as shown in Figure 10. This physical model encompassed various components of the building, including glass elements like doors and windows, rigid structures such as internal and external walls, load-bearing pillars, and stairs. The first-floor dining hall featured items like a bar, tables and chairs, a refrigerator, and hollow decorative partitions, among others. The kitchen barbecue area retained essentials like a disinfection cabinet, freezer, locker, operational table, oven, and two gas cylinders. The cooking area included a locker, operational table, and primary stove. On the 2nd floor, there were nine rooms, a machine room, a storage room, and a toilet. Each room retained elements like partition walls, sofas, and dining tables. To streamline the modeling and simulation process, minor components such as lamps, wires, pipelines, and simple decorations that had a minimal impact on the explosion effect were omitted.

Figure 10. Physical model of the accident building (horizontal direction): (a) the 1st floor of the building; (b) the 2nd floor of the building.

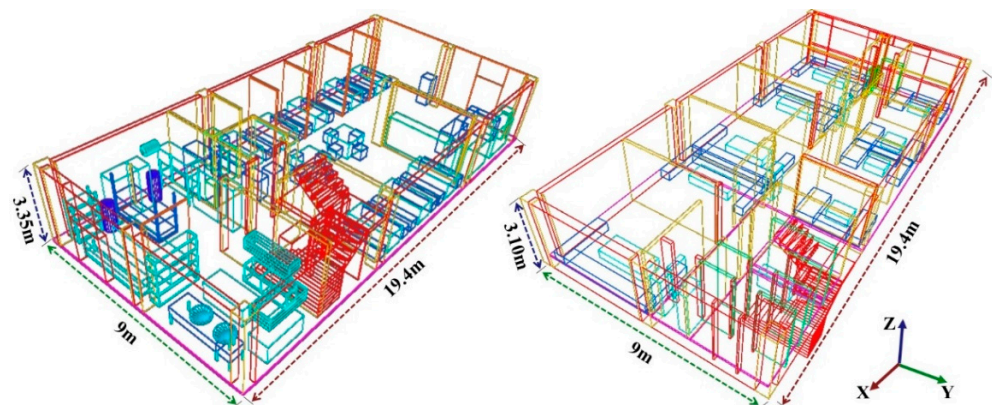
The physical model dimensions and the three-dimensional positioning of internal building components are shown in Figure 11. The overall size of the two-story building model was 19.4 m (X) × 9 m (Y) × 6.45 m (Z). The dimensions of the 1st floor and the 2nd floor were 19.4 m (X) × 9 m (Y) × 3.35 m (Z) and 19.4 m (X) × 9 m (Y) × 3.10 m (Z), respectively. For the numerical calculations, the ignition was placed near the gas stove in the northeast corner of the kitchen cooking area, with a height of approximately 0.8 m from the ground. The initial pressure in the model corresponds to the local atmospheric pressure of 9.93×10^4 Pa at the time of the incident, while the initial ambient temperature was set to 305 K. The surface roughness was 0.01, the atmospheric stability was categorized as F, and the average altitude was 1100 m. To capture critical data, multiple measuring points were positioned at key damage locations and areas where personnel were affected to gather parameters such as explosion overpressure, temperature, and oxygen content.

Figure 11. The boundary wireframe of the physical model.

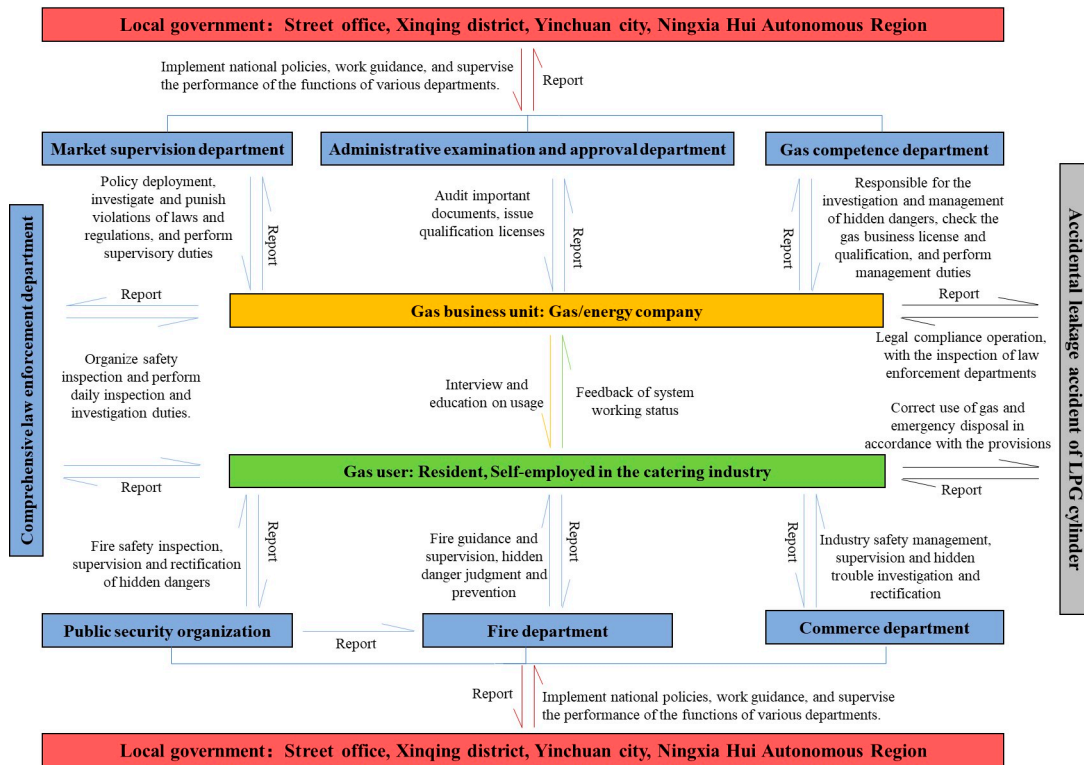
As the first control level, the local government was responsible for implementing the national energy policy, guiding the work, and supervising the gas management department to strictly perform its functions. The second control level consisted of seven departments, including the market supervision department, approval department, and law enforcement department. This level was responsible for conducting hidden danger investigations, providing education and training, overseeing rectification and investigations for gas companies and gas users, and playing a crucial role in regulating gas production and use safety. The third level, represented by the gas company, offered gas sources, operational training, and

daily maintenance services for gas users. Gas users, at the fourth level, were required to promptly report any abnormal gas cylinder work conditions to the gas company and use the gas cylinder correctly. All lower levels were obligated to report to the higher level.

Figure 15. Layered safety control structure for preventing the leakage of LPG cylinders.
