Analyzing Traditional Building Materials: A Case Study on Repair Practices in Konuralp, Düzce-Türkiye

Özlem Sallı Bideci ^{1,*}

and Büşra Sabuncu ²¹ Faculty of Art, Design and Architecture, Düzce University, 81600 Düzce, Türkiye² Graduate School of Natural and Applied Sciences, Düzce University, 81600 Düzce, Türkiye; busrasemercioglu@duzce.edu.tr

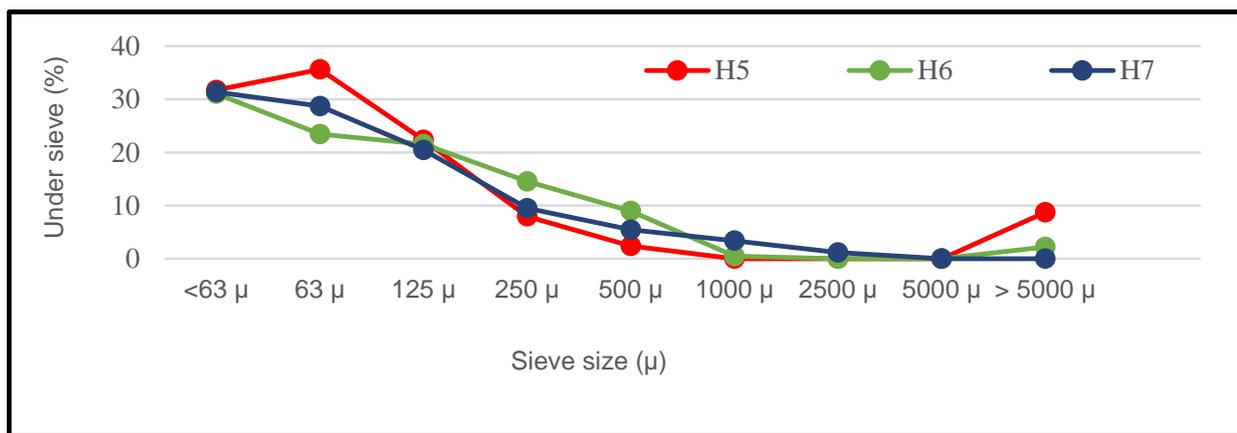
Figure 6. Sieve analysis of the bulk size distributions of the parts that do not undergo acid changes.

When the acid loss and sieve analysis results were analyzed, the binder–aggregate ratios of samples H5 and H7 (belonging to the building numbered 1766) were determined to be 1:6–7; the ratio of sample H6 was 1:5. Uygun [17] determined that the binder-to-aggregate ratio of the mortars and plasters sampled from Halhallı Mosque is 1:4, while the binder-to-aggregate ratio of the plaster sampled from Kaya Bey Mosque is 1:3. Based on the results of this study, it is observed that the binder-to-aggregate ratios of the mortar and plaster samples taken from the structure are consistent with the findings reported in the literature.

Based on the findings of the study and the recommendations in the KUDEB report [24], the H5 repair plaster mortar recommended for use in the areas represented by the samples could consist of one part of slaked lime putty and six parts of locally sourced clay-rich soil, sieved under 1 mm. In the preparation of the mortar, approximately 8 kg of crushed straw fiber should be added per cubic meter (m^3) of material. Furthermore, the straw fiber aggregate should be mixed in while dry, without adding lime, and then slaked lime should be added, continuing the mixing process.
