Identifying Defects in Aerospace Composite Sandwich Panels Using High-Definition Distributed Optical Fibre Sensors

Abstract: Automated methods for detecting defects within composite materials are highly desirable in the drive to increase throughput, optimise repair program effectiveness and reduce component replacement. Tap-testing has traditionally been used for detecting defects but does not provide quantitative measurements, requiring secondary techniques such as ultrasound to certify components. This paper reports on an evaluation of the use of a distributed temperature measurement system—high-definition fibre optic sensing (HD-FOS)—to identify and characterise crushed core and disbond defects in carbon fibre reinforced polymer (CFRP)-skin, aluminium-core, sandwich panels. The objective is to identify these defects in a sandwich panel by measuring the heat transfer through the panel thickness. A heater mat is used to rapidly increase the temperature of the panel with the HD-FOS sensor positioned on the top surface, measuring temperature. HD-FOS measurements are made using the Luna optical distributed sensor interrogator (ODISI) 9100 system comprising a sensor fabricated using

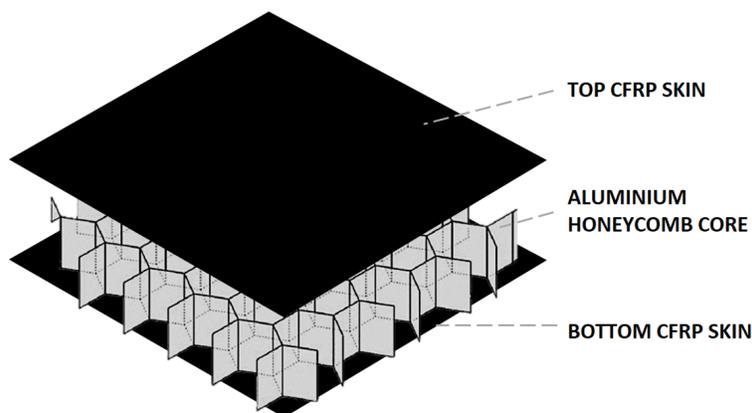
Figure 1. Structure of composite sandwich panel with two outer skins of carbon fibre reinforced polymer (CFRP) and inner core of aluminium honeycomb.

Currently, composite components represent 50% of the weight of commercial air frames with sandwich panels most often used for nacelles, rudders, elevators and wing-lets [3]. Aerospace sandwich panels typically consist of two outer layers (or skins) over a lightweight core, a combination proven to offer an excellent strength-to-weight ratio; although foam cores are used, aluminium honeycomb cores are preferred. Figure 1 depicts a carbon fibre reinforced polymer (CFRP) sandwich panel with an aluminium honeycomb core. The top and bottom skins are typically bonded to the core using an adhesive film [4].

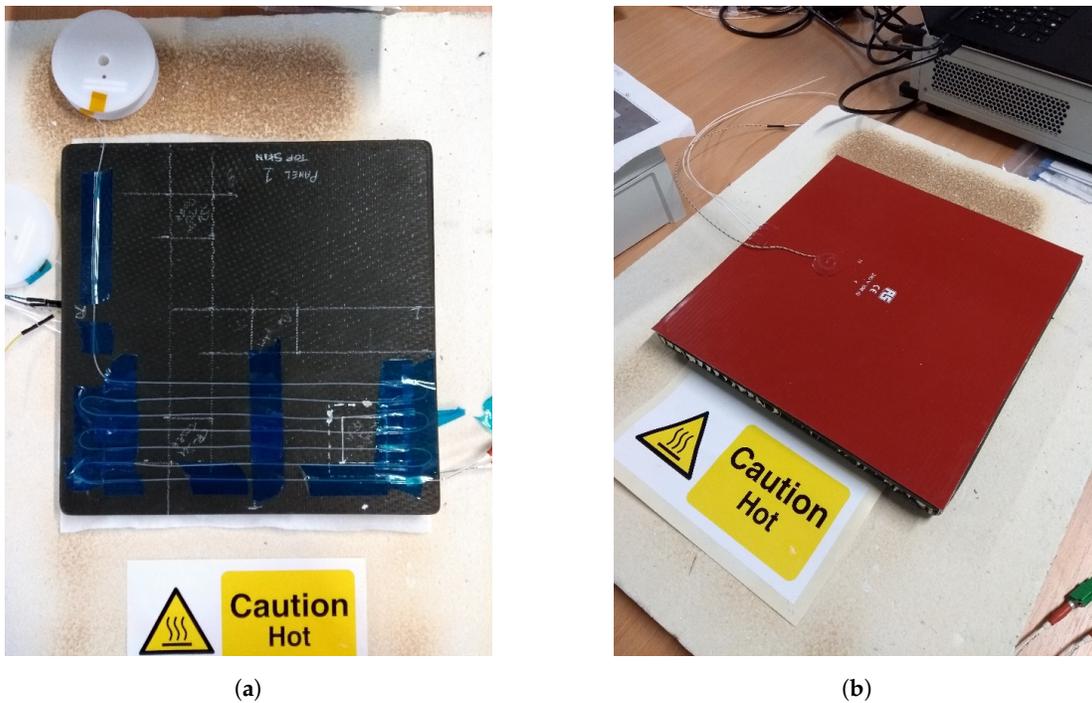
Figure 4. Experimental set-up. (a) Top-skin of the sandwich panel with the high-definition fibre optic sensing (HD-FOS) sensor located on the CFRP surface. (b) Heater mat located on the bottom-skin of the sandwich panel, with integrated type J thermocouple.

The panel was heated evenly and rapidly on one side by an RS PRO 396 W, 240 V ac Silicone Heater Mat to 80°C . The heater mat had an inbuilt type J thermocouple, which provided temperature measurements and control capabilities to ensure an even and consistent heat delivery, see Figure 4b. The temperature uniformity of the heater mat was tested using a thermal imaging camera to ensure a homogeneous application of heat. The OFDR-based fibre-optic distributed temperature sensor was configured to provide measurements at a spatial resolution of 2.6 mm, giving 648 data points across the six lines at a frequency of 25/s. 73,018 sets of data providing spatially distributed temperature measurements over the test panel were acquired over a near 49 min period. The HD-FOS unit was controlled through the optical distributed sensor interrogator (ODISI) graphical user interface, which provided live readings and collected the data from the optical fibre. The sets of data were stored on a.csv file for analysis.

Given that the HD-FOS sensor measures changes in both temperature and strain, the experimental methodology for collecting the relevant data ensured only temperature changes were recorded. The fibre was held in position with aerospace-grade flash tape to set its position on the flat panel (see Figure 4a), and any insulation effect created by the tape was considered negligible. This process prevented the fibre from moving and ensured that no external strain could influence the collected data. Once fixed,

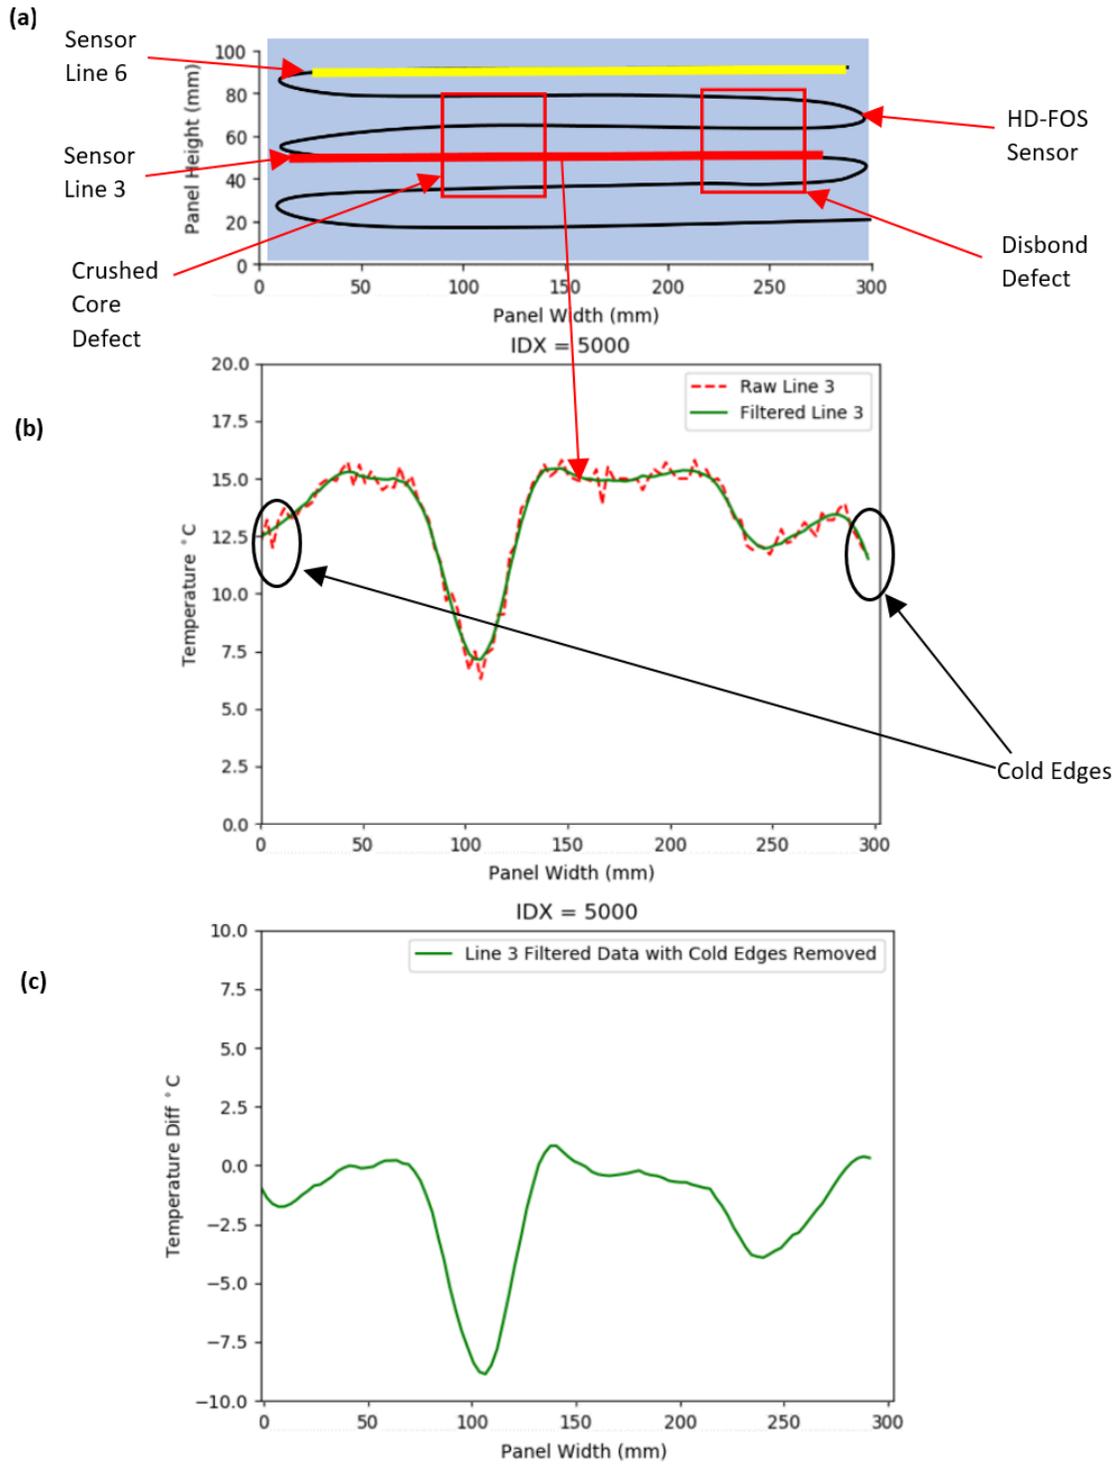
Figure 5. (a) Annotated segment of the composite sandwich panel top surface with defects and HD-FOS sensor shown. (b) Sensor Line 3 raw data and Savitzky–Golay filtered data comparison with cold edges highlighted. (c) Sensor Line 3 Savitzky–Golay filtered data with cold edges removed.

Figure 5b shows the raw measurement data from Sensor Line 3, shown in Figure 5a. The data was filtered using a Savitzky–Golay Filter, with a window length of 15 and a degree-3 polynomial, to smooth noise, selected as it provides excellent performance without loss of key data features, e.g., peaks and troughs, when compared with moving average filtering [41]. An example of the output of the filtering is shown in Figure 5b. The IDX (index) value represents the data set number, out of the total 73,018 data sets collected. A value of 5000 equates to 3 min and 20 s after the heater mat was turned on.

As a result of convection, the “cold” edges of the panel were more prominent than expected, potentially masking defects on the colour-mapping of the component. Thus, the uppermost sensor output (unaffected by defects), shown as “Sensor Line 6”, was used as a datum from which the temperature differences of the other five sensors were recorded. As shown in Figure 5c, the methodology successfully removed the cold edges from the data.

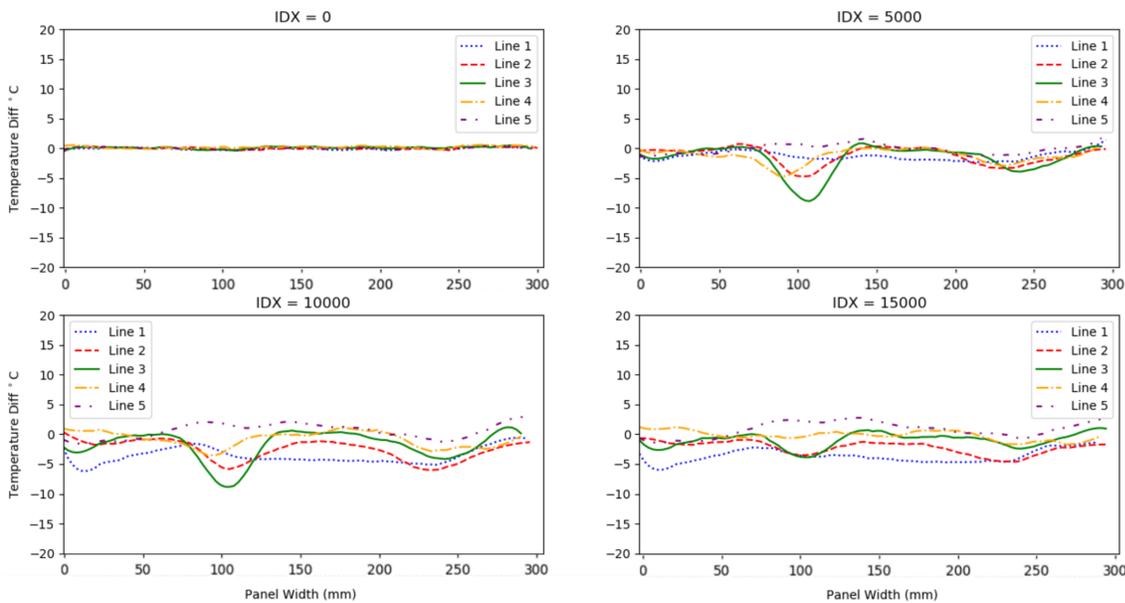
Figure 6. Graph series showing the temperature differences of Sensor Lines 1–5 from Sensor Line 6 (datum) at four points in the experiment. IDX (index) values indicate which data set is displayed.

In Figure 6, the temperature differences of the remaining five sensor outputs are displayed over a 10 min period. The sensor length is displayed on the x-axis, and temperature difference from a datum value of 0 °C on the y-axis. A region of significantly lower surface temperature—a reduction of approximately 13 °C from the datum—is visible in alignment with the position of the crushed core. The position is identified at 364 mm along the fibre, which corresponds to 86 mm along Sensor Line 2 (from the left). The second trough in temperature, which begins at 474 mm along the optical fibre corresponding to 195 mm along Sensor Line 2 (from the left), is less pronounced, nevertheless identifying the position of the disbond defect; the disbond induces a temperature difference of 6 °C.

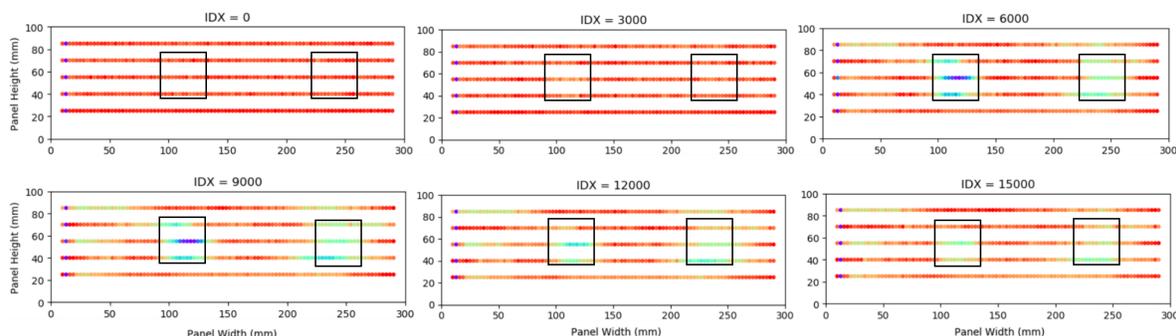
Figure 7. Colourmap graph series showing the temperature differences of Sensor Lines 1–5 from Sensor Line 6 (datum) indicating defect locations. Defect locations have been superimposed onto the graphs.

Figure 7 depicts the data on a colour map, highlighting the locations of the defects. The lengths and approximate widths of the crushed core and disbond defects were estimated from the data. The crushed core has a length of 39 mm and width of approximately 26 mm; the disbond has a length of 54 mm and an approximate width of 39 mm. The PTFE inserts used for the disbond were 38.1×38.1 mm and the crushed core area was approximately 38.1×38.1 mm. The derived area of the crushed core is accurate;

however the disbond defect area is larger than expected, attributed to slippage between the PTFE inserts resulting in a larger thermographic silhouette.
