Article

SBAS-InSAR Based Deformation Monitoring of Tailings Dam: The Case Study of the Dexing Copper Mine No.4 Tailings Dam

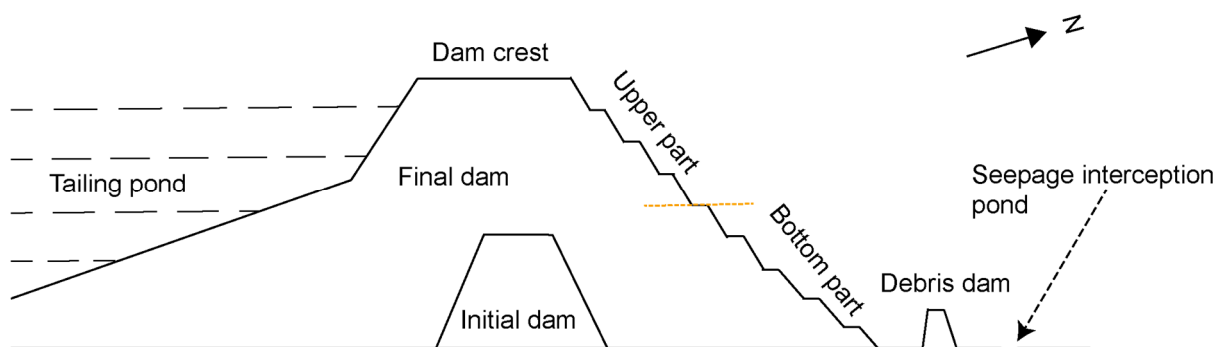
Figure 2. Schematic diagram of the dam profile of the No.4 tailings pond. The profile from left to right corresponds to the orientation from south-southeast to north-northeast. The orange dashed line indicates the dividing line between the upper and bottom parts.

The construction of the tailings dam at Tailings Storage Facility No.4 was divided into two phases: an initial dam and an accumulation dam (Figure 2). The dam body, constructed between 1988 and 1990, is composed of medium-weathered fresh phyllite. It is important to note that the tailings dam, the first of its kind in China to be built using the centerline method, was erected vertically along the initial dam. Designed to be built in eleven phases from 1991 to 2008, it served as a significant achievement [66]. The upper part of the site's geological structure consists of water and artificial fill. The lower part is composed of the Pre-Cambrian Double Bridge Mountain Group bedrock. Based on its lithology and engineering characteristics, the division from top to bottom is as follows: Water, Unaltered fill soil, Colluvial fill soil, Strongly weathered tuffaceous sandstone, and Moderately weathered tuffaceous sandstone. The tailing ore is pale yellow-pink granules. The copper content in the tailings ore is 0.139%; it also contains other valuable gold groups such as Fe, Pb, Zn, etc. The size of the tailings is fine, and the tailings with a diameter of $-38\ \mu\text{m}$ account for 65%. The pH of the supernatant of the tailing pulp is in the range of 11.5 to 12.5, the pH value is high, and the content of organic matter is less. After settling, the contents of Fe, Ca, Al, and Mg in the tailings are higher, while the contents of Pb and Cd are less than $5\ \mu\text{g/g}$. The pH of acidic wastewater of mine mountain is in the range of 2.0 to 2.3, the pH value is low, and the waste water contains a lot of heavy metal elements [67].

Depending on the time and material of dam construction, tailings dams can be divided into two portions (Figure 2): the internal initial dams and the later stockpile dams. Due to the fact that only stockpile dams can be observed at the surface, we only analyze the deformation trajectory of stockpile dams and predict their deformation over the next two years. According to our deformation monitoring data, the bottom of the dam is deforming in the opposite direction from the upper part of the dam. The upper part of the dam deforms away from the satellite direction, while the bottom of the dam deforms close to it, and the deformation trends are also quite different. Since the deformation of the dam body formed in two distinct directions, we selected all points within a radius of 50 m around the representative locations at the bottom and the top of the dam body, and averaged the deformation information of these points to obtain more representative deformation information. These data were utilized to analyze the time-series deformation trends of the dam body and to make reasonable predictions regarding future deformation.

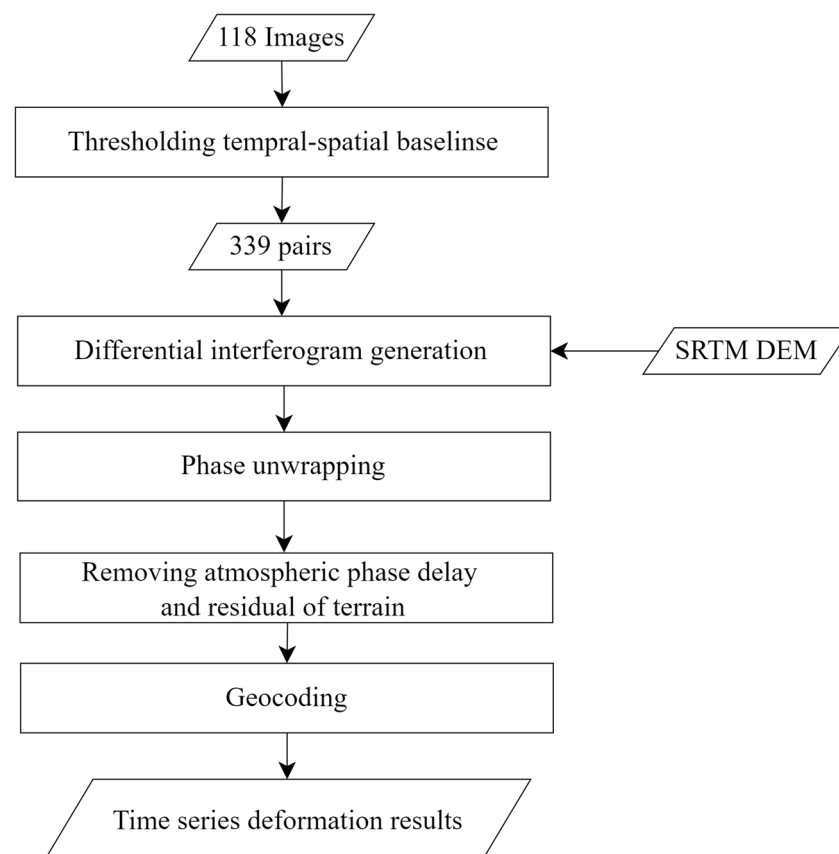
Figure 3. Flowchart of the SBAS-InSAR data processing.

We then utilize Singular Value Decomposition (SVD) to solve the least-squares solution [54] and derive the azimuthal phase averaging rate. Multiple SAR images of the same region acquired at different time intervals and with minor geometric differences are analyzed to produce differential interferograms, which enable the detection of temporal variations of ground displacement in the LOS direction. The data processing flowchart of SBAS-InSAR is shown in Figure 3.

As shown in Figure 3, data processing mainly includes five steps:

Step 1: firstly, in order to reduce image noise and reduce data volume, we need to perform 4:1 (range: azimuth) multi-look processing on 118 images; then we obtained 118 new images with a spatial resolution of about 20 m. Secondly, due to the rugged terrain and dense vegetation distribution in the study area, the decoherence effect is obvious; we established a temporal baseline threshold of 48 days and a spatial baseline threshold of

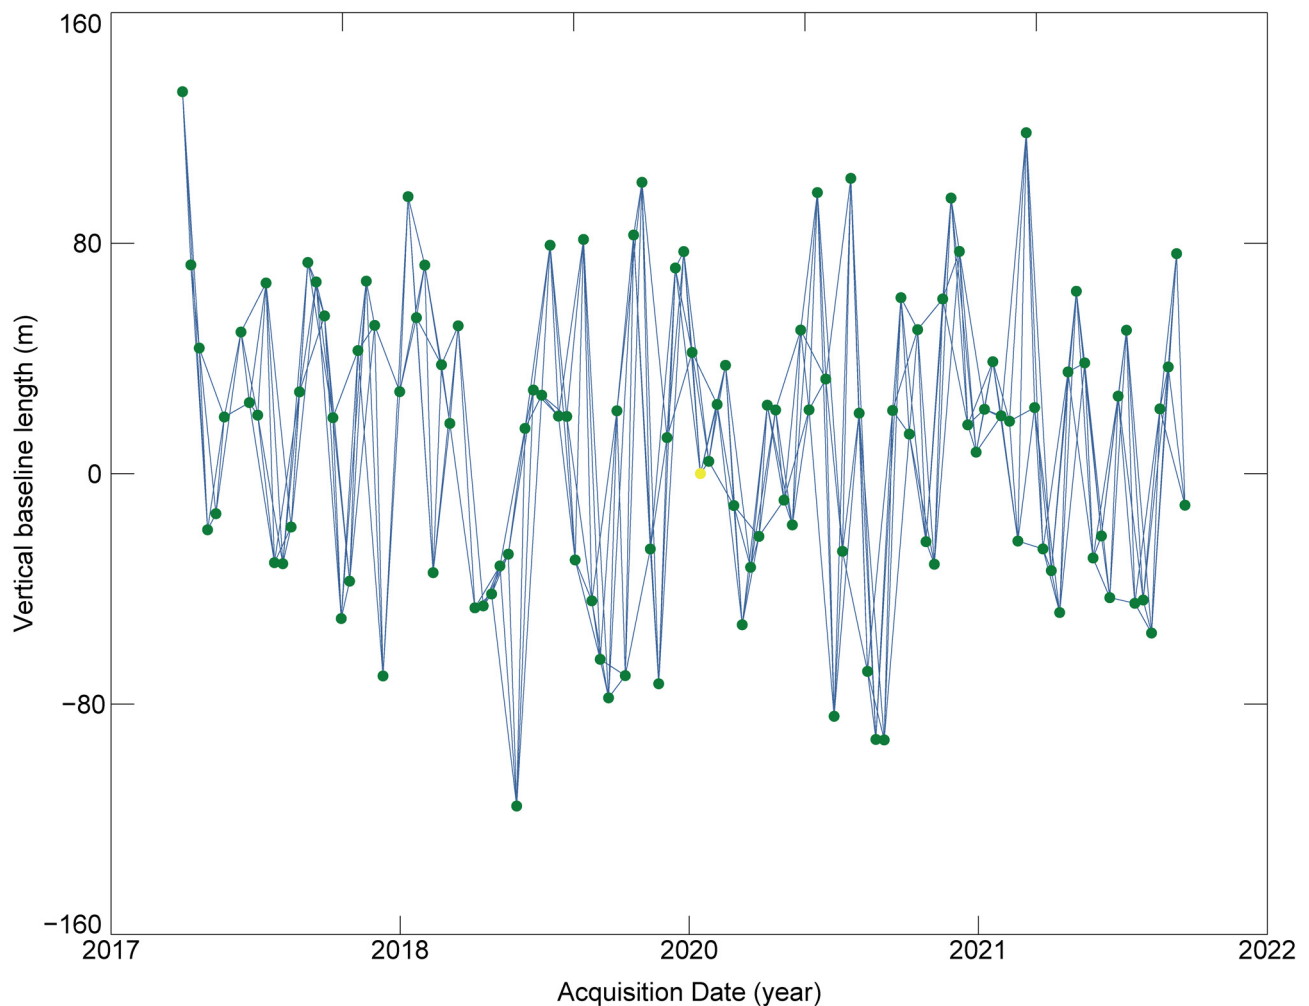
Figure 4. Spatio-temporal baseline network. The green dot shows the obtained image, and each blue line between two distinct locations represents an interferogram pair. The yellow dot corresponds to the co-registration reference image.

200 m. Finally, we generated a total of 339 pairs of interferometric baselines; the baseline network is shown in Figure 4.

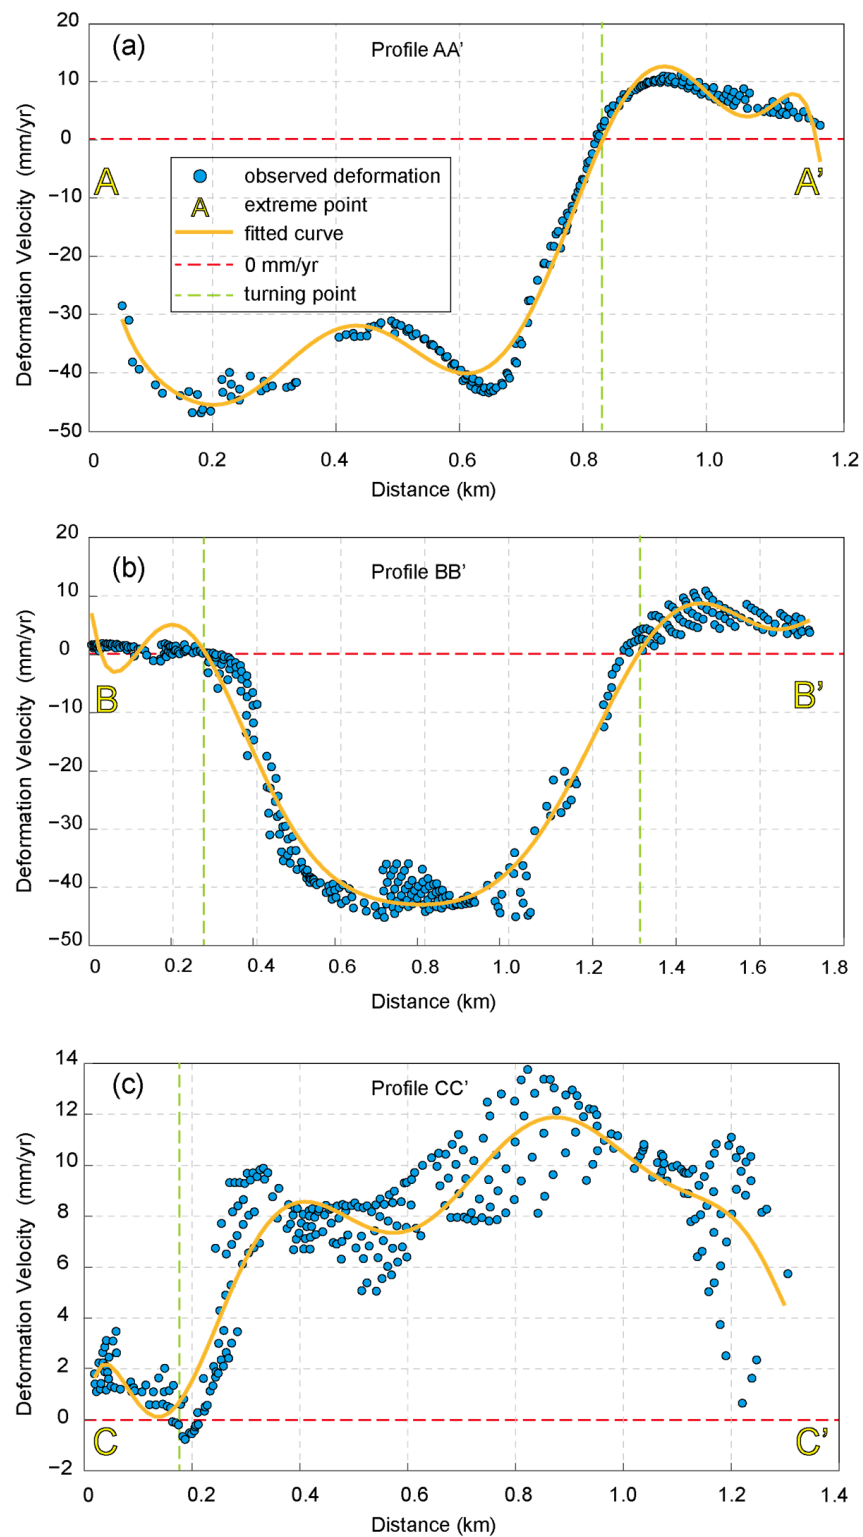
Figure 6. Deformation rate profiles. Deformation rate profiles for (a) line AA', (b) BB', and (c) CC'. The blue dot represents the average deformation rate at all sites within 30 m of the buffer zone of the line segment. The orange line represents the deformation rate fitting curve, the red dashed line represents a deformation rate of 0 mm/yr, and the green dashed line represents the location where the deformation rate is 0 mm/yr.

As shown in Figure 6a, the deformation rate profile of AA' indicates that the lowest values of deformation rate are observed at the center of the top of the dam and 600 m north of the center. The deformation rate tends to be zero at the top and bottom of the dam. After the boundary line, the deformation rate at the bottom of the dam ranges from 5 to 10 mm/yr. The A-LOS area stretches northward towards the northern section of the seepage interceptor pool and southeast towards the natural hillside on the eastern side of the dam. According to the deformation rate profile at BB' (Figure 6b), the dam body exhibits the lowest deformation rate of -43 mm/yr in its upper center. The hillslopes on the west side of the BB' line experience more stable deformation, with rates ranging from -1 mm/yr to 2 mm/yr, whereas the east side of the hillslopes demonstrates deformation rates between 5 and 13 mm/yr, resulting in a A-LOS area on the eastern side of the dam. With a deformation rate ranging from 5 to 13 mm/yr, the east slope forms an A-LOS zone that extends from the dam crest towards the upstream region of the dam body. This A-LOS zone encircles the downstream tailings dam, stretching from east to north and spanning around 1300 m in length and 240 m in width. The CC' line (Figure 6c) traverses the bottom of the dam body in a west-to-east direction, and the deformation rate within this pathway area exhibits considerable variation, initially increasing and then decreasing from west to east. The highest deformation rate, reaching 13 mm/yr, is found in the ridge that extends from the eastern base of the dam, coinciding with the aforementioned A-LOS zone.

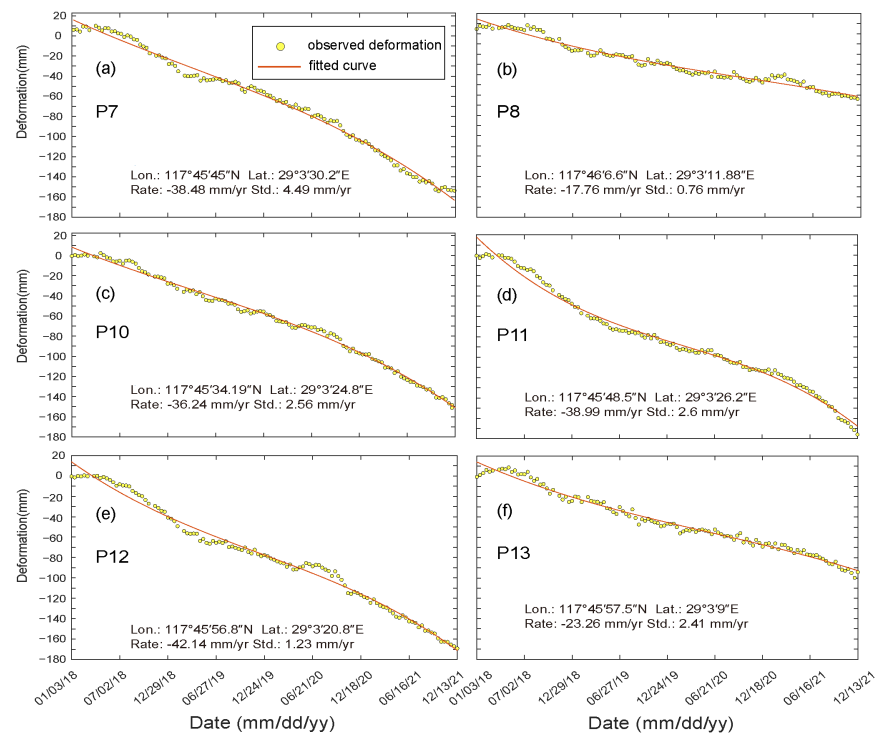
Figure 8. Cumulative deformation of P7 (a), P8 (b), and P10–P13 (c–f), their distribution positions are shown in Figure 5. The yellow point indicates the average deformation rate at all points within a 30 m radius centered on the point.

On the basis of the deformation monitoring data from January 2018 to December 2021, we plotted the time-series deformation cumulative maps (Figures 7 and 8) for representative observation points (P1–14 in Figure 5). These points, along with the positive extreme, negative extreme and the stabilization points mentioned earlier (triangular points in Figure 5), form a network covering the dam body and surrounding areas, covering all types of deformation.

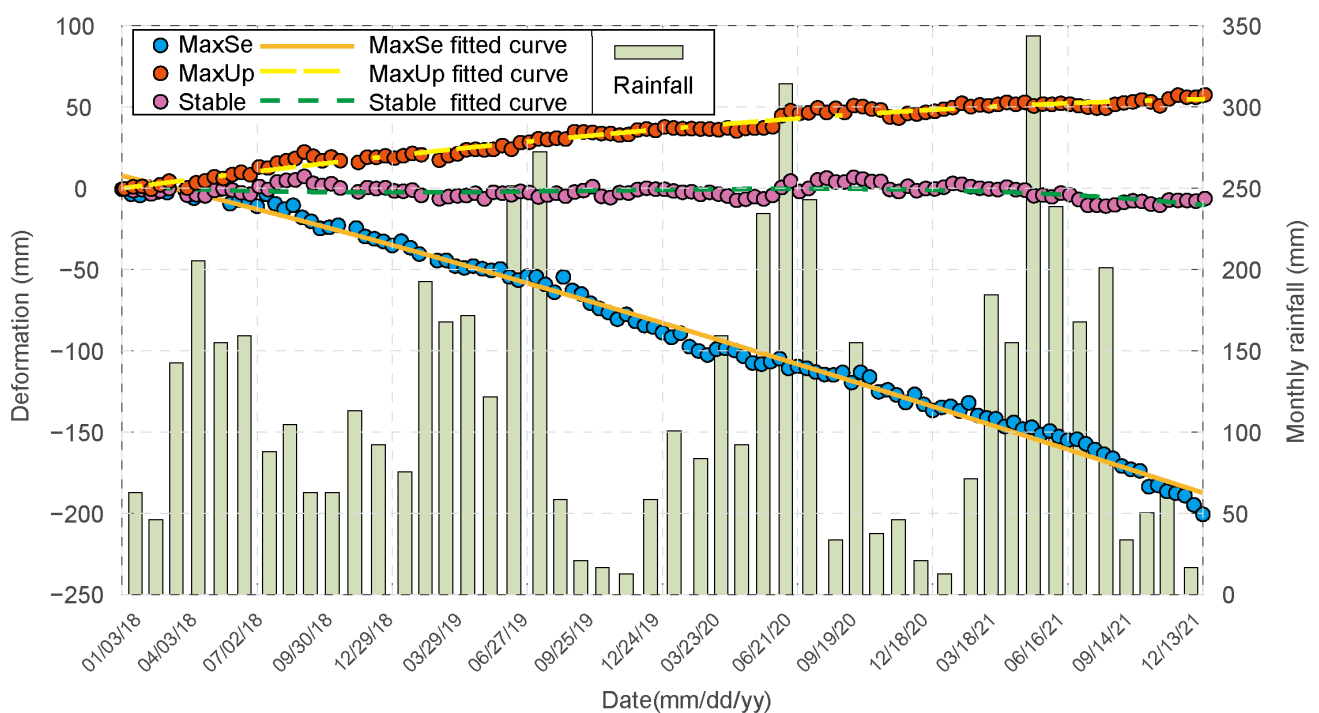
Figure 11. A scatterplot of dam deformation accumulation versus precipitation. The red, blue, and pink points depict the deformation accumulation at the point of maximum A-LOS, maximum M-LOS, and stabilization, respectively, while the aqua-green bar represents the current month's precipitation. The duration is between January 2018 and December 2021.

Figure 11 illustrates the cumulative quantity of deformation versus time for the LOS deformation extreme and stabilization points in Figure 5. The highest value of M-LOS point is found at the midpoint between the top of dam and the junction of the dry beach. Based on analysis of satellite imagery, the maximum M-LOS value corresponds to the pipeline situated on the south side of the dam top (high-coherence point), which exhibits a uniform rate of M-LOS, with a cumulative value of 210 mm. We conclude that the material of the dam body and its own weight are the main causes of this area's deformation. The dam body is primarily composed of the accumulation of coarse tailing sand, which has a large pore space, and the tailing sand has already completed the final stage of accumulation at the time of monitoring. Due to rain erosion, weathering, and other factors, the pore space and volume of the tailing sand decrease over time, causing the surface to subside. Not only that, but the hefty self-weight of the tailing sand caused the M-LOS to become bigger.

At the eastern end of the dam base, on top of the hill ridge, is where the maximum A-LOS point is found, with the summer of 2020 as the turning point, and the A-LOS speed is first fast and then slow, with a total A-LOS of about 60 mm. The elevation of the top of this hill ridge is about 164 m, that of the foot of the southern slope is 114 m, and that of the foot of the northern slope is 92 m, which forms a squeezing trend from south to north. We infer that the deformation in this region is primarily attributable to the mountain structure and accumulation of sediments. The small mountain range resembles an east-west wall, and the sediment accumulation on the south side is increasing, leading to the deformation of the mountain range on the north side and the deformation close to the LOS. Stabilization occurs at the junction of the dam's top and base (shown as an orange dashed line in Figure 2), where deformation is more stable. Positively deformed regions are located far from the dam's upper portion and are biased toward the dam's base. We infer that the construction duration and materials of the tailings dam are primarily responsible for the stability of this region. The initial dam was built between 1988 and 1990 and was filled

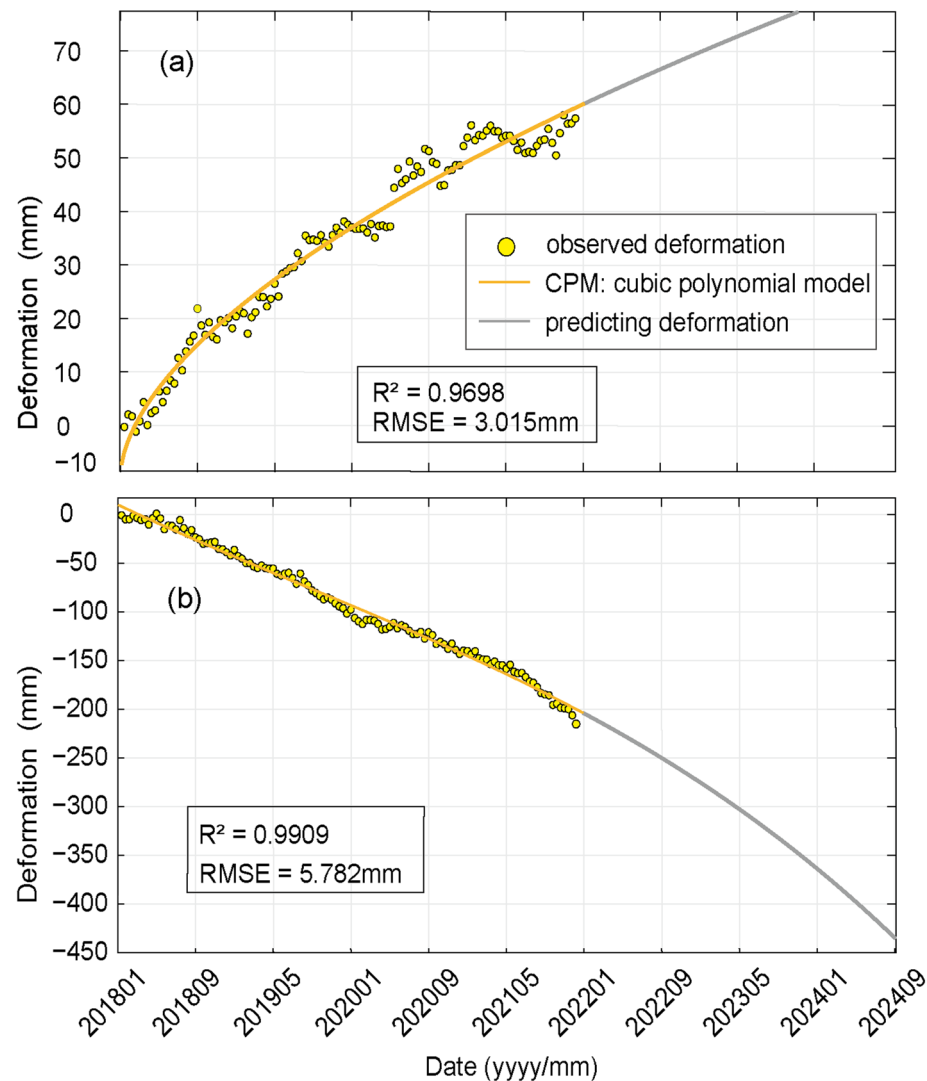
Figure 12. Power function model fitting curves for the bottom and upper deformation of the dam body. (a) power function fitting curves of deformation at the bottom of the dam body, (b) power function fitting curves of deformation at the upper part of the dam body. The yellow line is the three fitting curves, and the gray line represents the predicted deformation.

In general, these models are suitable for the regions with a flat surface and variations in deformation rate over the observation period, such as regions where the deformation velocity is first fast and then slow, with a tendency of 0 mm/yr. In contrast, the topography of our study area is more diverse, and the deformation speed remains single, and there is no sign of slowing down in the near future. Due to the quasi-linear deformation in these two places, the general consolidation model could not accurately fit the deformation time distribution characteristics. It is ultimately determined that the power function can maximally fit the deformation accumulation versus time; therefore, the deformation characteristics of the typical areas at the bottom and the top of the dam body were fitted and predicted based on the power function model (Figure 12). The R^2 of the power function fitted curves was 0.9698 for the deformation of the lower portion of the dam and 0.9909 for the deformation of the upper portion of the dam. It is difficult to predict the end time of the deformation because the deformation rate of two parts of the dam body is relatively uniform during the observation time and there is no obvious variable speed. The power function fitting curve shows that the A-LOS rate of the bottom portion of the dam body is fast and then slow during the observation period, but it keeps a strong upward trend, and the annual A-LOS is about 10 mm. The M-LOS trend of the upper part of the dam body in

the next two years is similar to the usual, with a quasi-linear trend M-LOS value of about 40 mm per year. In conclusion, although the change in the deformation rate of the two is not large, the change in the trend indicates that the deformation of the tailings dam may be developing in a more serious direction, and the tailings dam management personnel should formulate countermeasures.
