Chlorine Dioxide Degradation Issues on Metal and Plastic Water Pipes Tested in Parallel in a Semi-Closed System

Abstract: Chlorine dioxide (ClO₂) has been widely used as a disinfectant in drinking water in the past but its effects on water pipes have not been investigated deeply, mainly due to the difficult experimental set-up required to simulate real-life water pipe conditions. In the present paper, four different kinds of water pipes, two based on plastics, namely random polypropylene (PPR) and polyethylene of raised temperature (PERT/aluminum multilayer), and two made of metals, i.e., copper and galvanized steel, were put in a semi-closed system where ClO₂ was dosed continuously. The semi-closed system allowed for the simulation of real ClO₂ concentrations in common water distribution systems and to simulate the presence of pipes made with different materials from the source of water to the tap. Results show that ClO₂ has a deep effect on all the materials tested (plastics and metals) and that severe damage occurs due to its strong oxidizing power in terms of surface chemical modification of metals and progressive cracking of plastics. These phenomena could in turn become an i

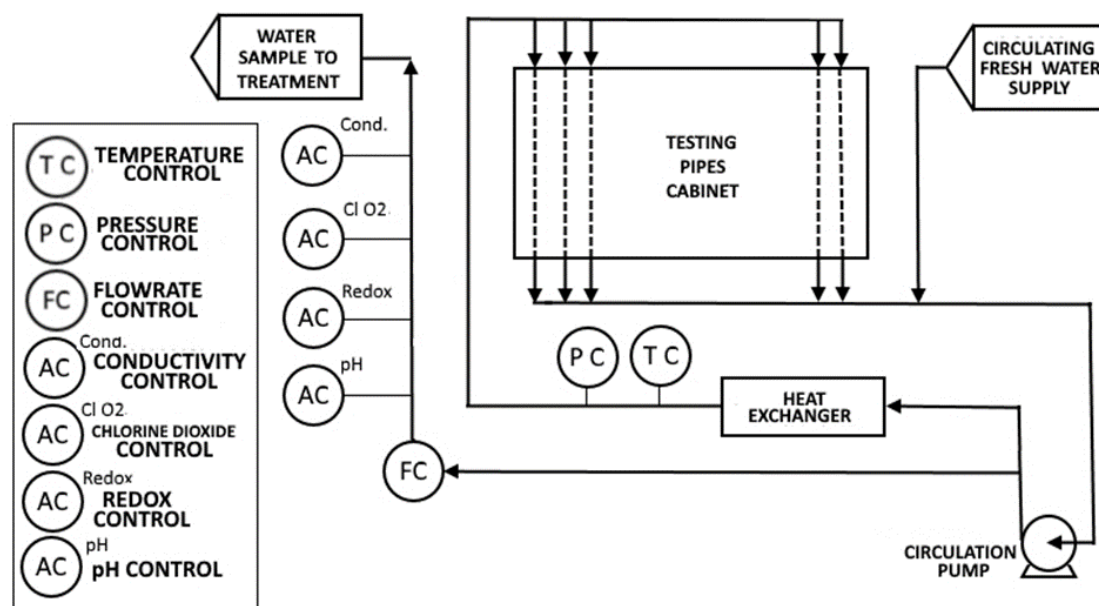
Figure 1. Schematic representation of the testing apparatus.

The apparatus was developed to perform the accelerated aging test of the whole system (pipes and joints) and to resemble a real-world scenario where, from the potabilization plant to the tap, the drinking water interacts with several kinds of materials. Tuning the purge flow rate, for example, the accumulation of disinfection and corrosion by-products can be minimized or maximized. The concentration of ClO₂ (1 mg/L ClO₂) is a compromise between the need of an accelerating process (high concentrations), the necessity to have a model fluid with a concentration of sanitizer not too far from a real-world application and checking the experimental set-up already adopted by other research groups [20,23,28].

A scheme of the experimental set-up used is presented in Figure 1.

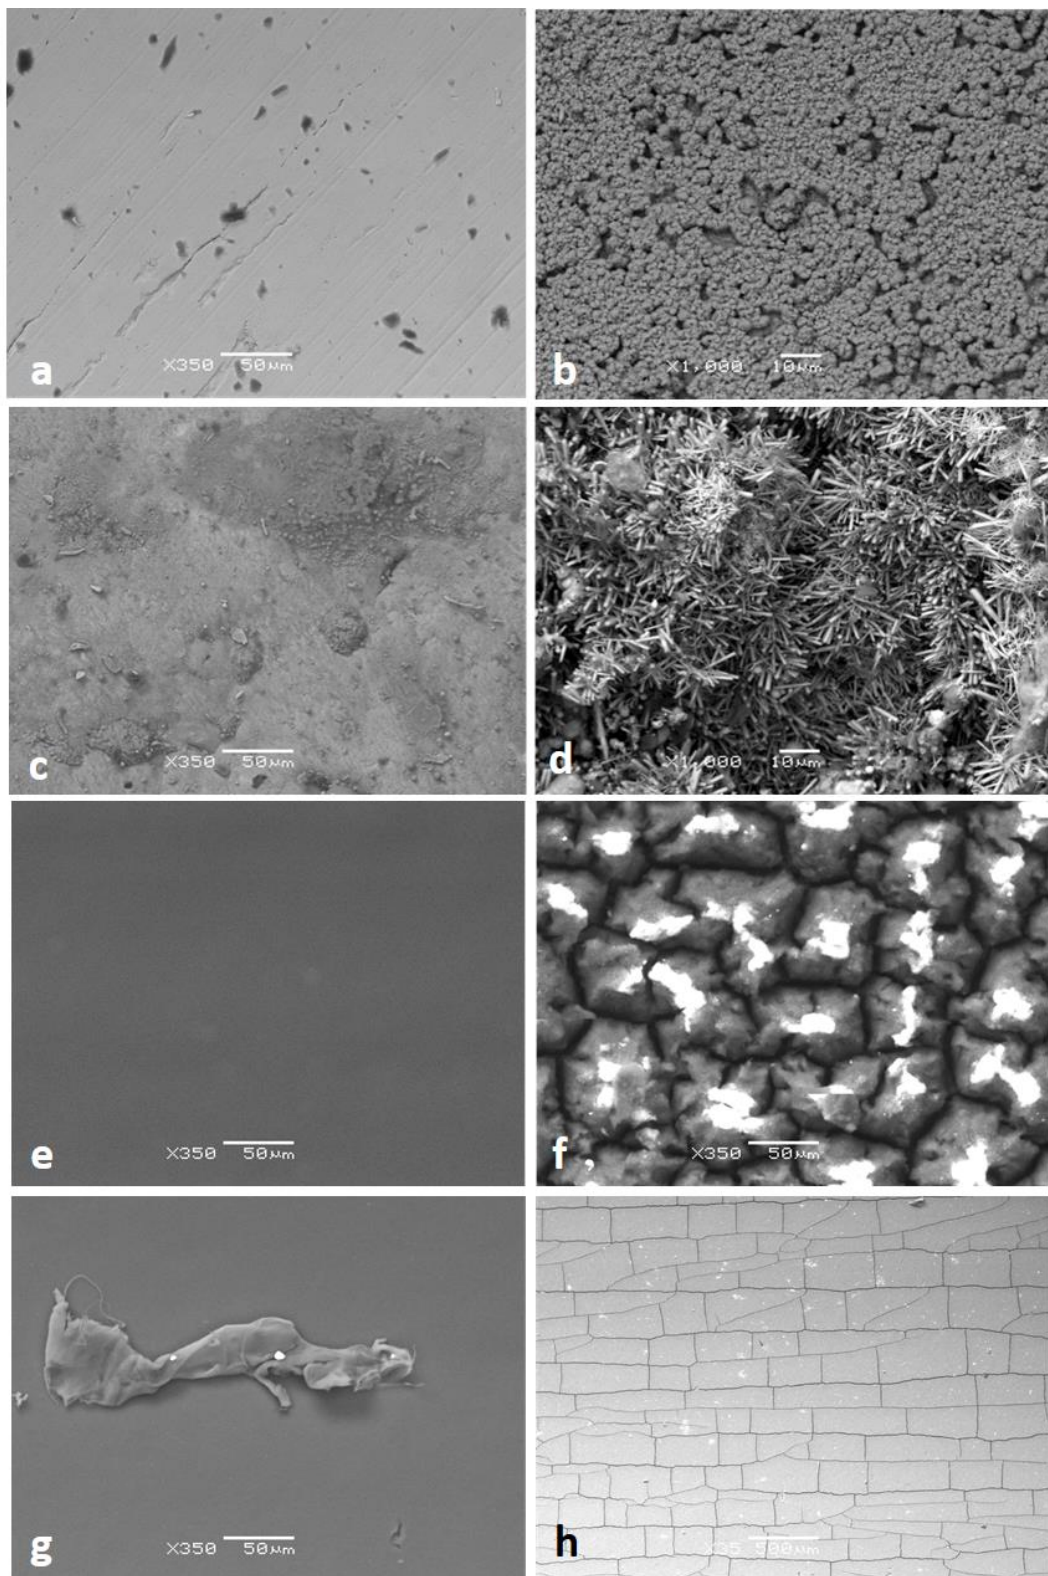
Figure 3. Cu pipe—new (350X) (a), Cu pipe—8 weeks (1000X) (b), galvanized steel—new (350X) (c), galvanized steel—8 weeks (1000X) (d), random polypropylene (PPR)—new (350X) (e), PPR—8 weeks (350X) (f), polyethylene of raised temperature (PERT)—new (350X) (g), and PERT—8 weeks (350X) (h).

SEM analyses were performed on both plastic and metal pipes, as shown in Figure 3.

In all cases, SEM images demonstrate severe degradation of the inner surface of the pipes even if, as expected, the behavior changes significantly according to the material, as illustrated after.

Even if the EDS results must be considered as semi-quantitative, they clearly indicate that all pipes have undergone severe degradation: Copper has turned to copper oxide, which, according to Figure 3b, is very porous. Galvanized steel has undergone partial dezincification, with the surface showing the typical appearance of degraded galvanized steel.

Plastic-based pipes have different degradation profiles, with the formation of cracks that, in the case of PE-RT, follow the extrusion direction of the pipe with perpendicular cracks between them, in a brick wall-like pattern. In the case of PPR, cracks are different, i.e., more random. In both cases, materials are highly oxidized on the surface, as confirmed by EDS.

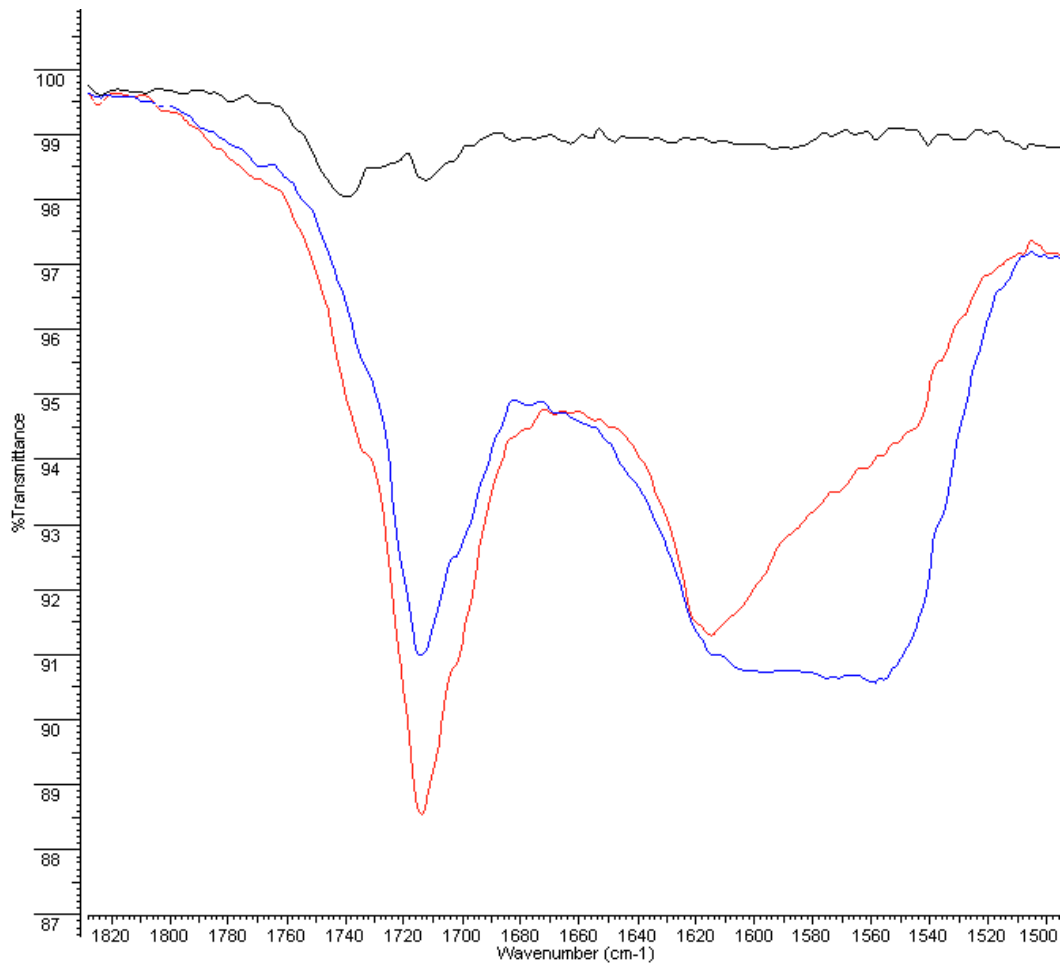
Figure 5. FT-IR spectra of PERT inner surface: new (**black**), 4 weeks (**red**), and 8 weeks (**blue**)—magnification of $1830\text{--}1500\text{ cm}^{-1}$ region.

Furthermore, these bands are accompanied by the appearance of a broad absorption band between $1550\text{--}1620\text{--}1640\text{ cm}^{-1}$ that becomes dominant after 8 weeks and could be assigned to both H-bonded carboxyl and to carboxylate anion groups, the latter of which is derived from salification. All these data are consistent with the reported literature [15] and indicate a consistent degradation of the pipe inner surface caused by ClO_2 .

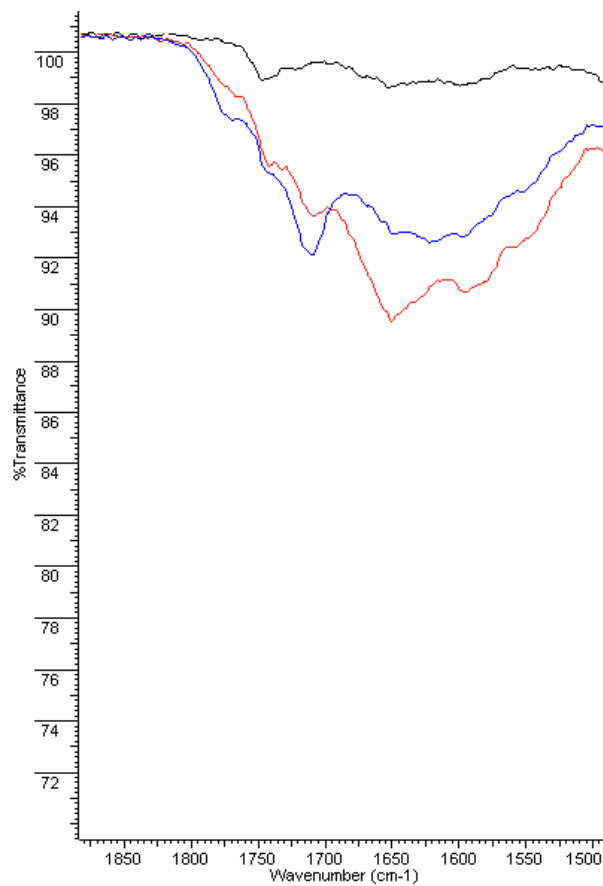
Figure 7. FT-IR spectra of PPR inner surface: new (black), 4 weeks (red), and 8 weeks (blue)—magnification of 1900–1500 cm^{-1} region.

except for a greater persistence of the antioxidants before the appearance of carbonyl and carboxylic functional groups in the IR spectra (Figures S6–S8—Supplementary file).

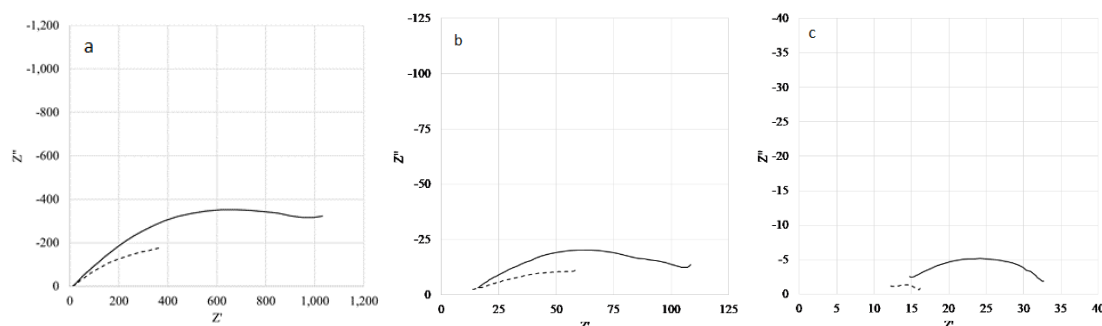
Figure 9. Cu new pipe (continuous curve) and after 8 weeks aging (dotted curve) at 0.0 V (a), 0.05 V (b), and 0.1 V (c) vs. the saturated calomel electrode (SCE).

Figure 9a,b shows the Nyquist diagram for new (continuous curve) and aged (dotted curve) samples at different polarization potentials for the frequency range selected to highlight the behavior of electron transfer resistance, R_{ct} , and double layer capacitance, C_{dl} . Fitting was carried out using an R_1 in series to a parallel R_{ct} CPE. The use of a constant phase element (CPE) is necessary due to the presence of rough metallic surfaces and pores, and in the case of the aged sample, due to the corrosion product film on the metallic surface, thus evidencing a diffusion step in the same frequency domain.

The reduction in the R_{ct} values (from the semicircle amplitude) is evident, increasing the polarization potential from 0 to 0.05 V versus SCE (Figure 9a vs. Figure 9b), due to the increase of the Cu corrosion process rate. At 0.1 V, the Nyquist plot presents two almost overlapped semicircles, as at this higher potential, the $t = 0$ sample is prone to the anodic degradation process. At a lower potential, this phenomenon is much more evident for the aged Cu (see R_{ct} in Table 4), as its surface is already modified and damaged by ClO_2 action, and at 0.05 V vs. SCE, the anodic polarization accelerates the corrosion process.

The higher R_{ct} value for Cu at $t = 8$ weeks compared to $t = 0$, when polarized at 0.05V, is probably connected with the CPE exponent value, which is about 0.6 for Cu at $t = 0$ at all potentials and about 0.5 for Cu at 8 weeks of aging at 0 and 0.1 V, while it becomes 0.23 at 0.05 V (see 4th column Table 4). This is most likely due to the modification of pore sizes and the shape present in the corrosion film on the Cu surface; a phenomena that can deeply affect the diffusion of ions back and forth towards the underlying metallic surface, thus reducing the electron transfer rate evidenced by the increase of R_{ct} . In any case, this behavior is strictly connected with the film layer on the Cu surface produced during the aging process in the presence of ClO_2 . No such behavior has been detected for the pristine Cu. Lastly, the C_{dl} values for the pristine sample are smaller, of about one order of magnitude, than the aged values (Table 4), thus indicating a more corrugated metallic surface due to the damaging action of ClO_2 .
