# A New Fault Location Approach for Acoustic Emission Techniques in Wind Turbines

Carlos Quiterio Gómez Muñoz \* and Fausto Pedro García Márquez

**Abstract:** The renewable energy industry is undergoing continuous improvement and development worldwide, wind energy being one of the most relevant renewable energies. This industry requires high levels of reliability, availability, maintainability and safety (RAMS) for wind turbines. The blades are critical components in wind turbines. The objective of this research work is focused on the fault detection and diagnosis (FDD) of the wind turbine blades. The FDD approach is composed of a robust condition monitoring system (CMS) and a novel signal processing method. CMS collects and analyses the data from different non-destructive tests based on acoustic emission. The acoustic emission signals are collected applying macro-fiber composite (MFC) sensors to detect and locate cracks on the surface of the blades. Three MFC sensors are set in a section of a wind turbine blade. The acoustic emission signals are generated by breaking a pencil lead in the blade surface. This method is used to simulate the acoustic emission due to a breakdown of t

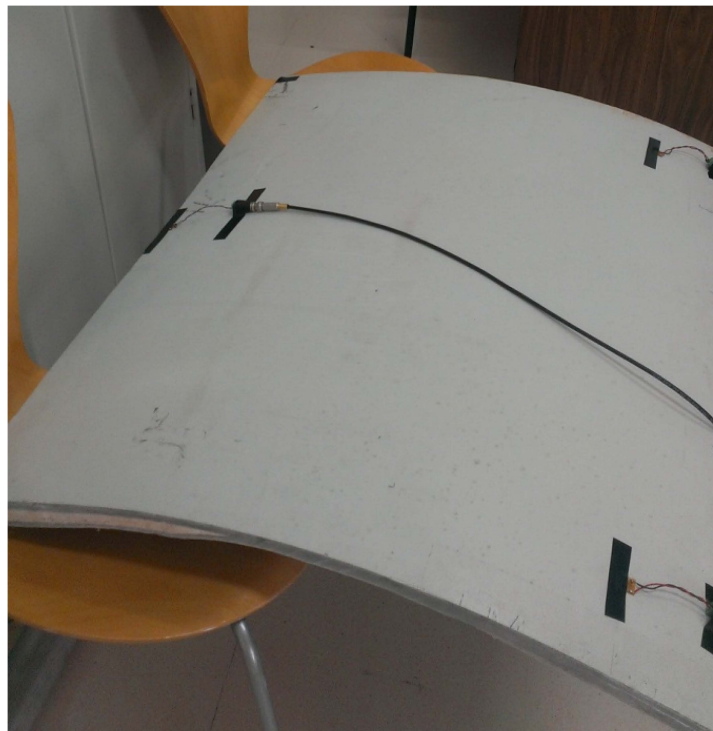
The experiments are done in a section of the wind turbine blade. The fragment, shown in Figure 1, is made of glass fiber-reinforced polymer (GFRP), with dimensions of  $100 \times 79.5$  cm. The section is composed of a honeycomb central layer embedded between two fiberglass layers made of polyester resin. This type of material has good structural properties, resistance to fatigue and other advantages. The attenuation of the acoustic emission in the blade is high, and it depends on the material, wave frequency and travelling distance between the failure source and the sensor location [23].

**Figure 1.** Wind turbine section with sensors for acoustic emission location.

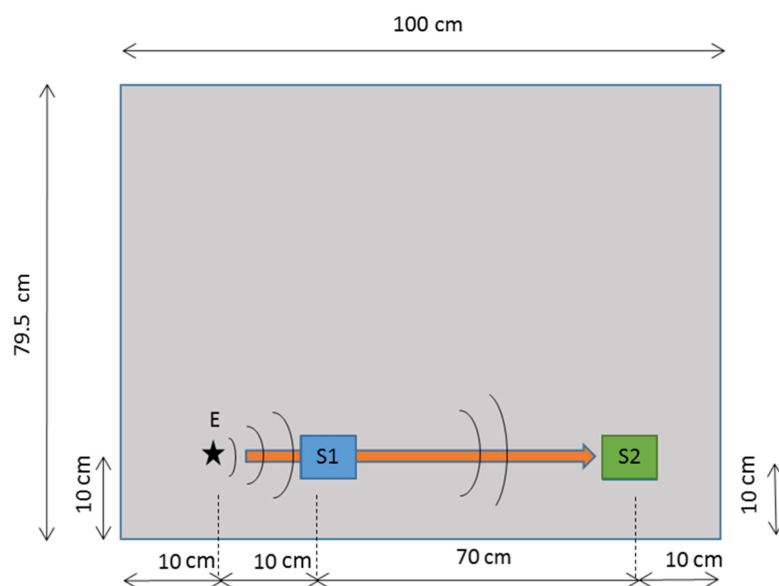
The propagation velocity of the acoustic emission (see Figure 2) has been experimentally calculated by breaking a pencil lead and measuring the delays in the excitement of the sensors S1 and S2 (Figure 3).

**Figure 2.** Measuring the experimental propagation velocity in the composite material.

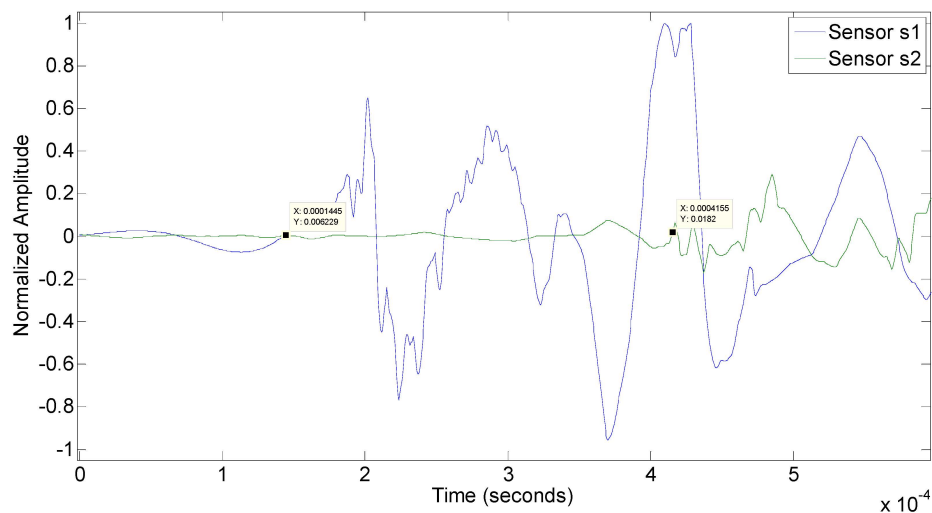
**Figure 3.** Peak detection of the acoustical emission collected by Sensor 1 (blue) and Sensor 2 (green) to obtain the experimental propagation velocity in the composite material.

The delay between Signals 1 and 2 is 271  $\mu\text{s}$  (542 samples), and the propagation velocity for the composite material is 2583 m/s.

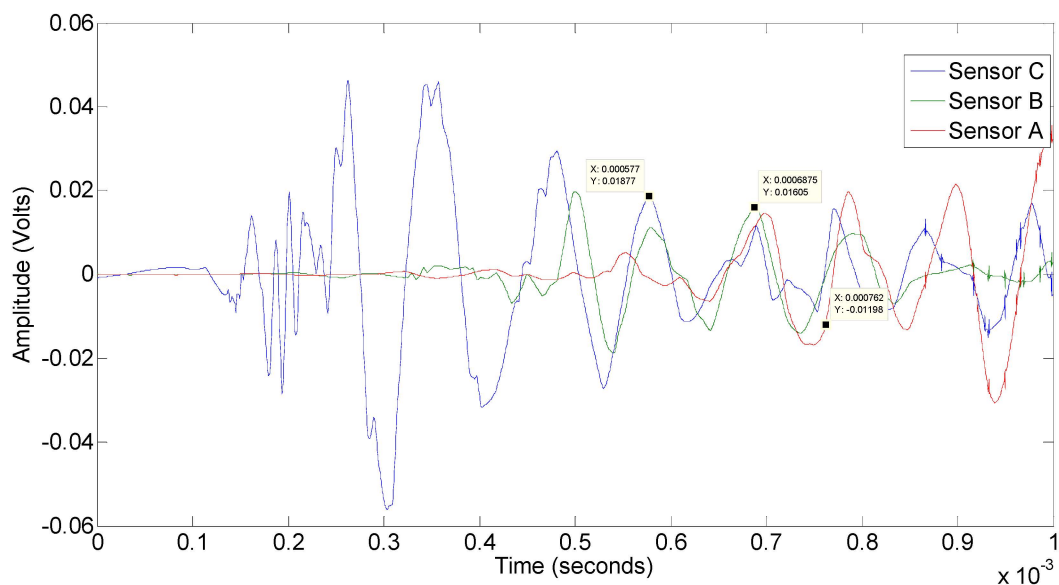
The signal processing consists of a pass band filter that eliminates low and high frequencies and carries out a comparison of the peaks of the wave front in the same frequency range of Signals A, B and C, generated by the above-mentioned MFC sensors, A, B and C (Figure 4).

**Figure 4.** Pre-processing of the signal. Wave front collected by Sensors C (blue), B (green) and A (red).

The seven nonlinear equations to solve this problem are given by Equations (3) to (9), considering the scheme shown in Figure 4, where the MFC sensors are located at Points A, B and C, and the defect is at Point D. The coordinates and radius are:

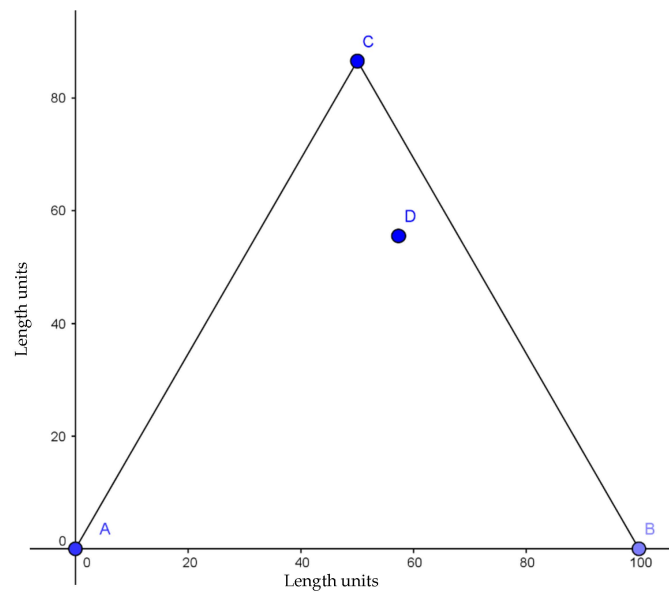
The MFC Sensors A, B and C are placed as an equilateral triangle (see Figure 5). D is the location of the emission source by the breaking, D (D is known in this experiment).

**Figure 5.** Location of Vertices A, B and C and the, defect D.

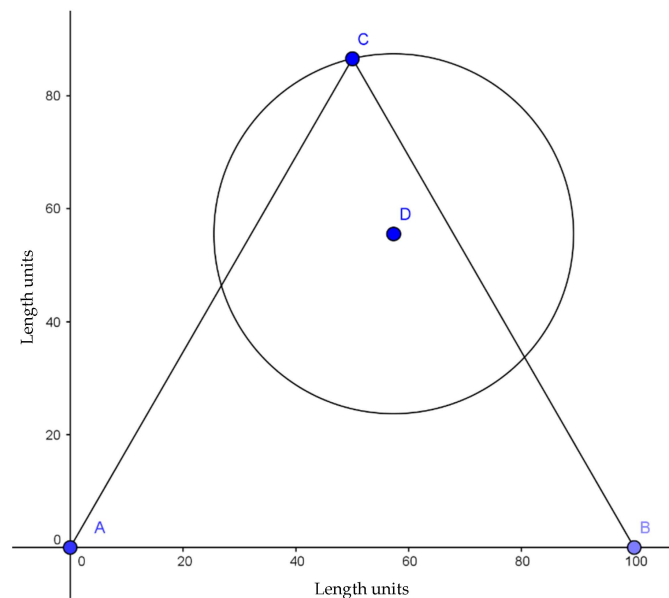
The nearest Sensor C is the first to be excited due to the wave front coming from the acoustic emission (Figure 6).

**Figure 6.** Wave front of the acoustic emission collected by the nearest Sensor C.

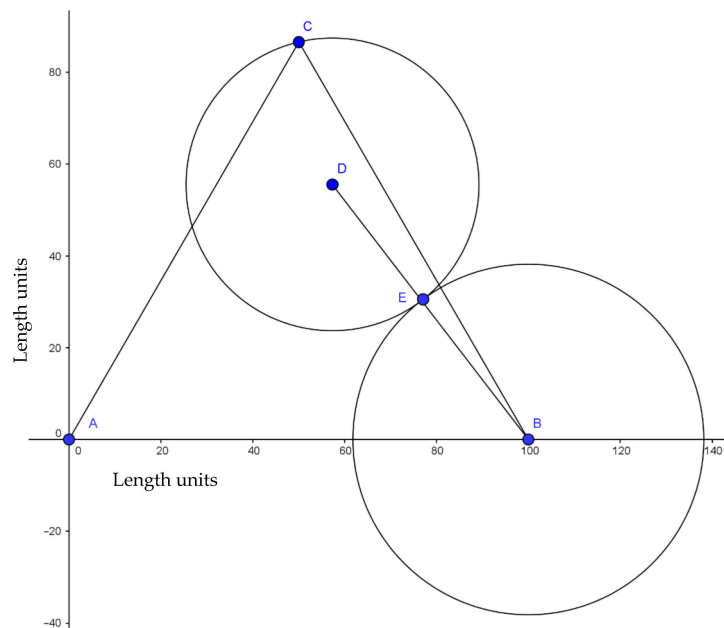
The delay between the excitation of the first Sensor C and the second closest Sensor B to the defect, D, is given by the distance from E to B (Figure 7). The delay time and the speed of the wave propagation on the blade is calculated by Equation (1):

$$D_{EB} = v \times t_{CB} \tag{1}$$

where  $D_{EB}$  is the distance between E and B,  $v$  is the propagation velocity of the wave (obtained experimentally) and  $t_{CB}$  is the time delay between the excitation of Sensors C and B.

**Figure 7.** Location of Point E, set by the delay between the excitation time in Sensors C and B.

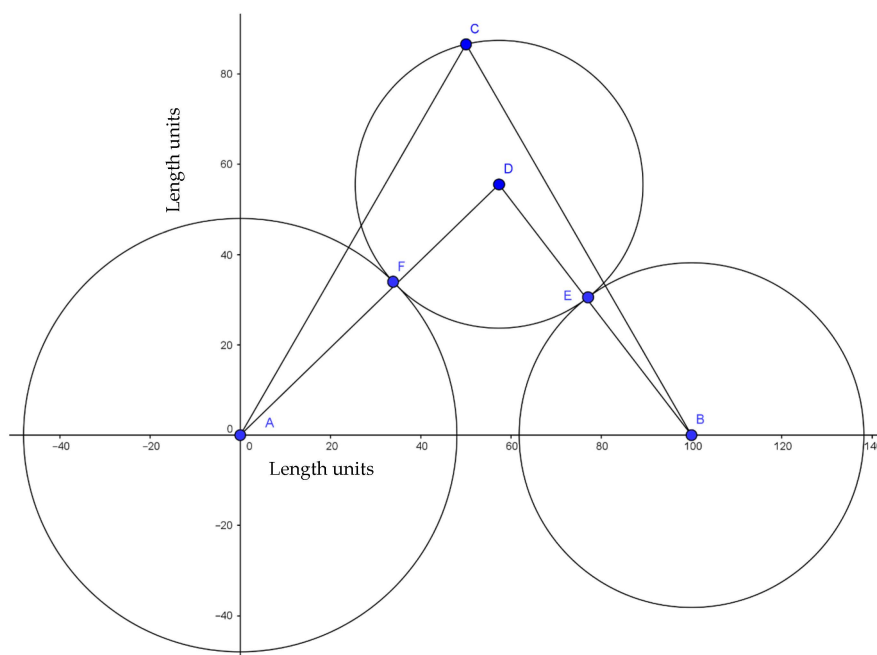
where  $t_{CA}$  is the time delay between the excitation of Sensor C and Sensor A. Figure 8 shows the scheme of the triangulation approach, the delay being represented by a circle.

**Figure 8.** Scheme of the acoustic emission delays for locating the source.

The objective is to find the source of the acoustic emission D mentioned above. This point is the center of a circle that is tangential to two given circles and passes through Point C (see Figure 8). The solution is obtained in this paper employing a graphical method and an analytical method using a system of seven nonlinear equations.

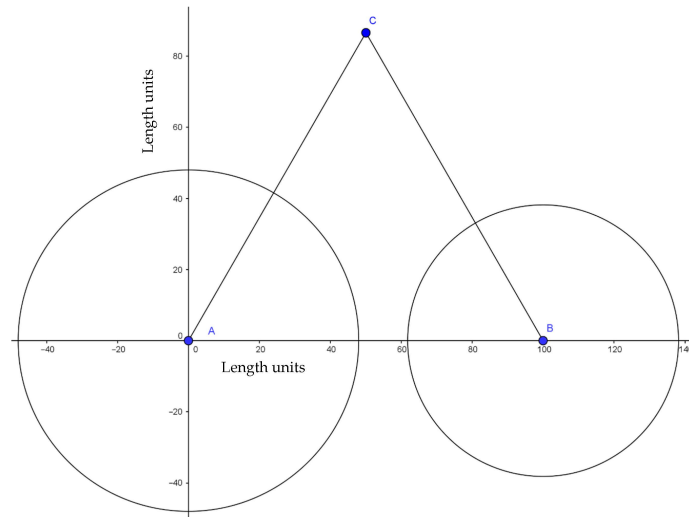
In a real case study, Point D is unknown regarding the time and location, and the delays between the different sensors can be calculated. This condition is shown in Figure 9, where the circumferences represent the delays of the signal that comes to each sensor with respect to the first sensor (C).

**Figure 9.** Initial conditions to locate the source of the acoustic emission.

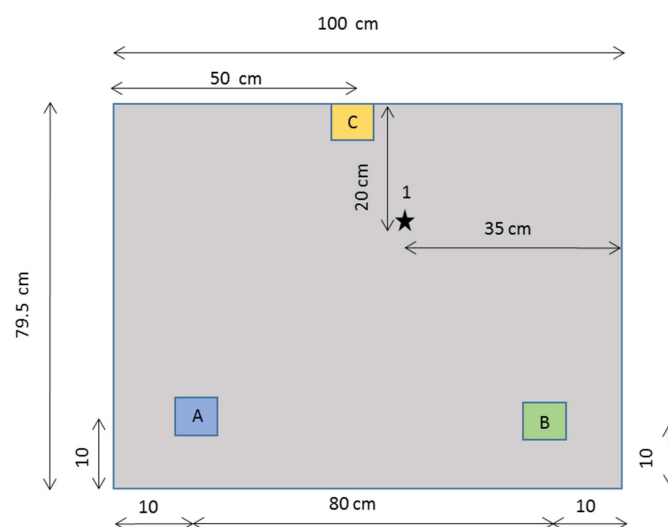
The time of flight and distances are set in this section for Sensors B and A regarding C, C being the first sensor to receive the acoustic signal of the breakage. The experiments are repeated four times to take into account the deviations of the results. The algorithm gives the exact location of the defect, as well as a graphic outline, knowing the radius of the circles with centers at B and C. The dimensions of the blade section, the distribution of the sensors and the emission source (star) in the wind turbine blade are shown in Figure 10. The mathematical results obtained with the algorithm are given in Tables 1–8.

Figure 10. First experiment. Case Study 1.

The breaking of the lead is made in the following coordinates from Sensor A at Point 1 (star); see Figure 10. Sensor A is the coordinate origin.

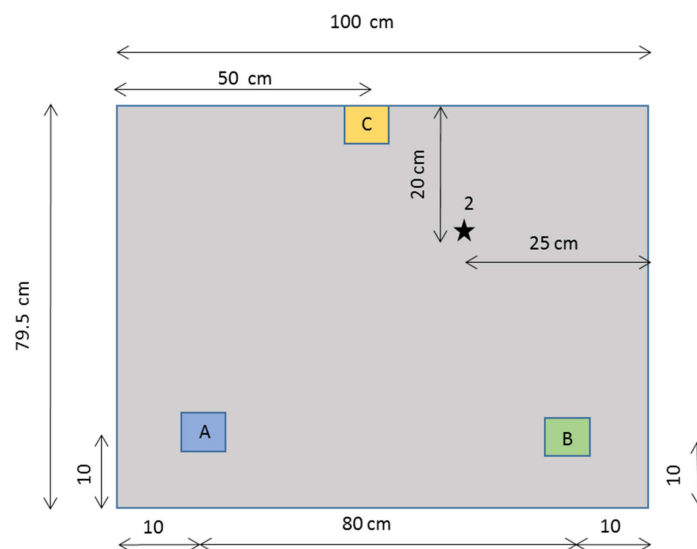
In this case, the emission source was generated at Point 2 (star), shown in Figure 11:

- Coordinate x: 0.65.
- Coordinate y: 0.495.

**Figure 11.** Scheme for Case Study 2.

The location of the source employing the algorithm is: Point 2: (x: 0.6502, y: 0.4950). The errors in the location are: coordinate x: 0.2 mm; coordinate y: 0.00 mm.

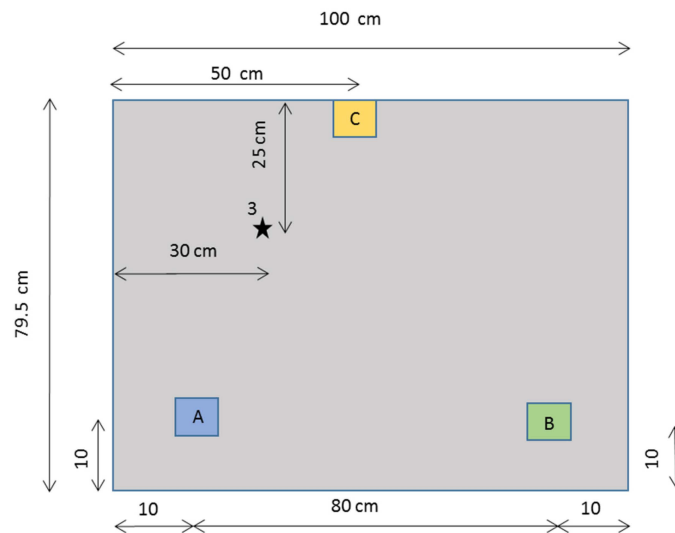
In this case, the emission source was generated at Point 3 (star); see Figure 12:

- Coordinate x: 0.20.
- Coordinate y: 0.445.

Figure 12. Scheme for Case Study 3.

The location of the source employing the algorithm is: Point 3 (x: 0.1914, y: 0.4434). The errors in the location are: coordinate x: 8.6 mm; coordinate y: 1.6 mm.

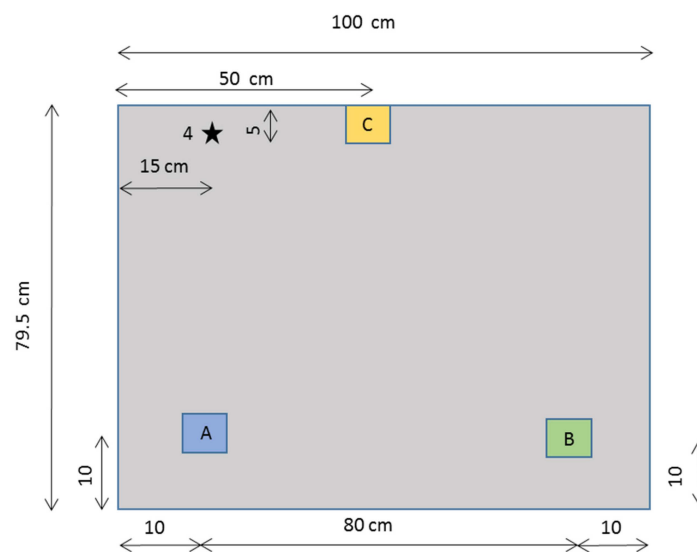
In this case, the emission source was generated at Point 4 (star), and it is shown in Figure 13:

- Coordinate x: 0.05.
- Coordinate y: 0.645.

Figure 13. Scheme for Case Study 4.

The location of the source employing the algorithm is: Point 4: (x: 0.050, y: 0.6495). The errors in the location are: coordinate x: 0 mm; coordinate y: 4.5 mm.

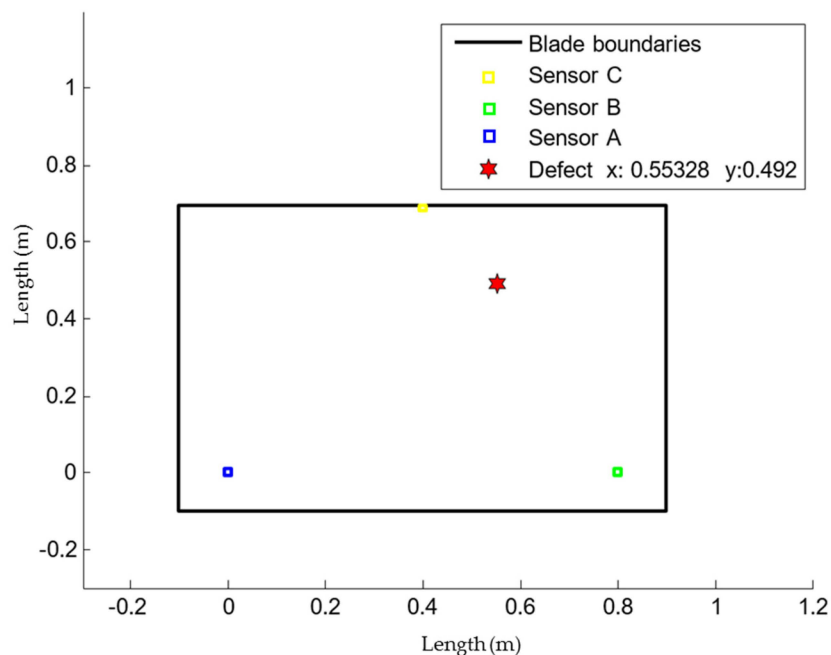
Finally, the algorithm shows the position of the acoustic emission point with the real dimensions of the blade. Figure 14 shows the location of the acoustic emission for the first case study.

**Figure 14.** Scheme of the location of the acoustic emission for the first case study.
