Article

Impact of Wetting–Drying Cycles on the Mechanical Properties and Microstructure of Wood Waste–Gypsum Composites

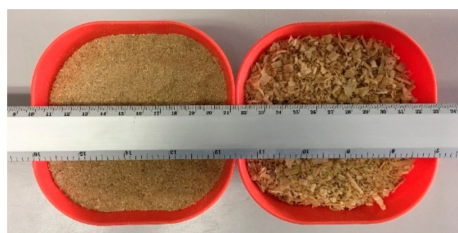
Figure 1. Sawdust and wood shavings used as raw material in the development of the new gypsum plasters.

Wood shavings (WS) and sawdust (S) were used as raw materials in the plasters (Figure 1). The wood waste used for this work came from old *Pinus* wooden slabs (timber beams and joists), that were replaced or demolished in rehabilitation works.

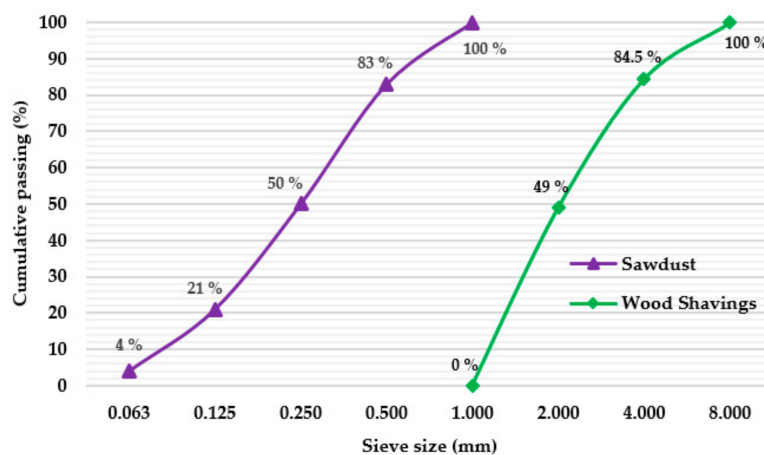
Figure 2. Particle size distribution of wood waste used as raw material.

When the material was received, the wood waste was submitted to a surface cleaning process, using wire brushes, to eliminate any possible sand/dirt adhered to the material. After that, the wooden pieces were crushed using a TELEMECANIQUE crusher. To obtain the sawdust (0.063–1.000 mm) and wood shavings (1.000–8.000 mm), different PROETI sieves were used, as shown in Figure 2.

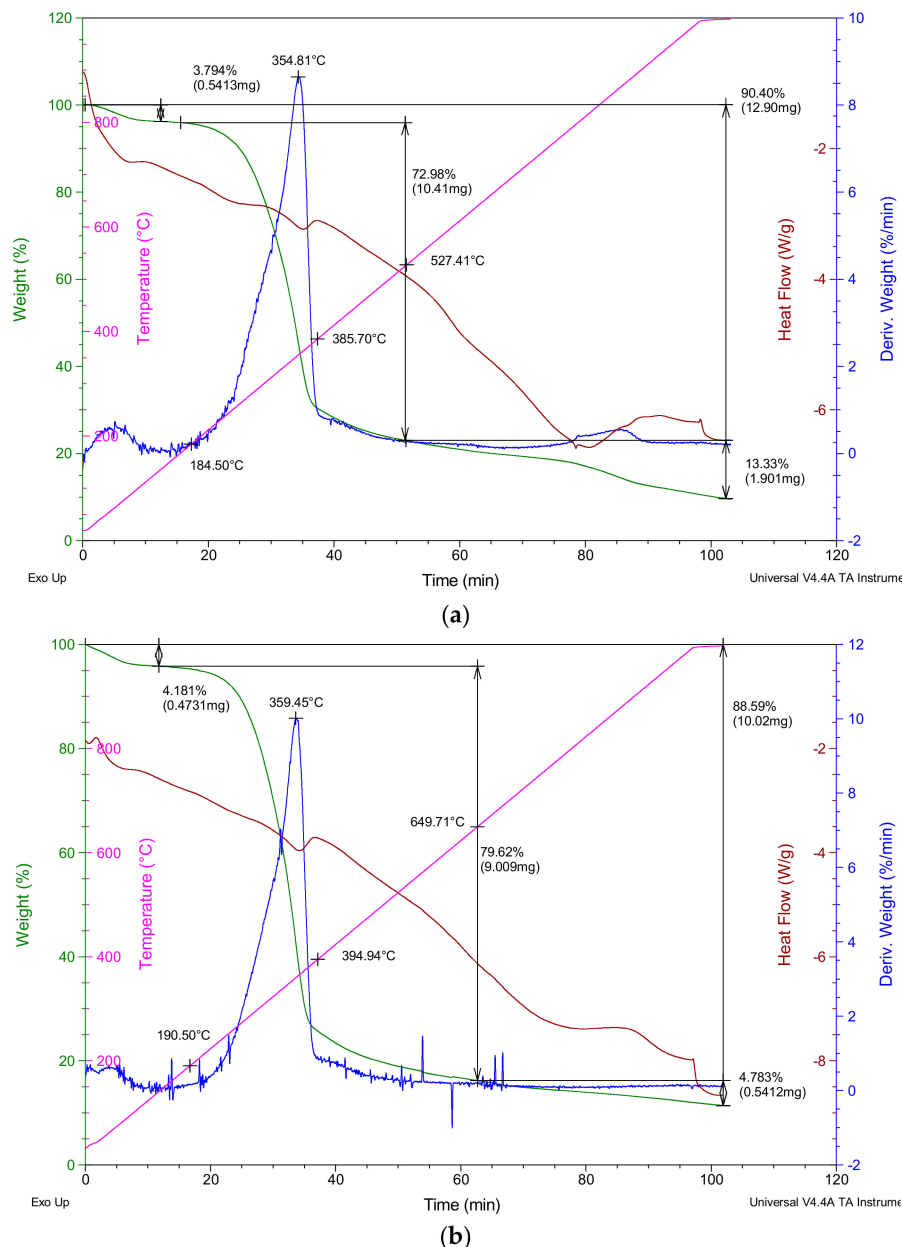
Figure 3. Thermogravimetric analysis (TGA) results. (a) Sawdust; (b) wood shavings.

Once the wood residue was classified into chips and sawdust, an exhaustive characterization of both was carried out. First, to obtain the moisture content of the material, the wastes were placed in an oven until constant mass (18 h at 50 °C). A relative humidity of 5.8% for sawdust and 6.3% for wood shavings was obtained. Subsequently, the true density of both materials was obtained by helium pycnometry, using a QUANTA CHROME stereopycnometer (Boynton Beach, FL, USA). The results showed that sawdust had a true density of 1.2 g/cm³ and wood shavings had one of 1.5 g/cm³. Finally, a thermogravimetric analysis (TGA) was carried out using a TA SDT Q600 equipment (New Castle, DE, USA), and the results are shown in Figure 3.

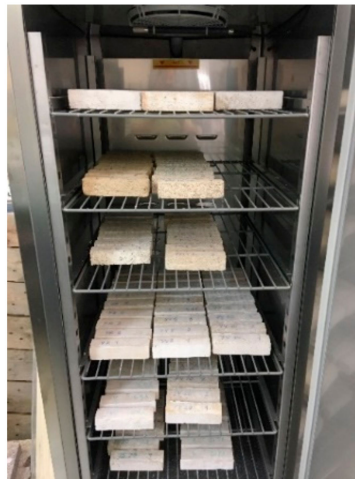
Figure 4. Samples during the wetting–drying cycles in the curing chamber.

Samples were exposed to 5, 10, and 15 wetting–drying cycles in order to amplify the aggressive treatment. The wetting–drying cycles were conducted in a CCI CLIMATICA STD curing chamber (Universidad de Sevilla, Sevilla, Spain) (Figure 4). For each cycle, the samples were weighed before and after drying in order to monitor water content.

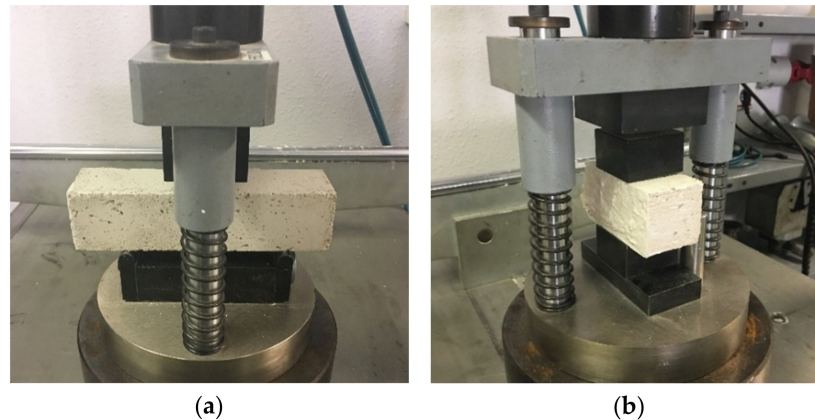
Figure 5. Samples during the mechanical tests. (a) Flexural strength; (b) compressive strength.

- *Flexural strength:* The three points bending test (Figure 5a) was used to determine the flexural strength of the new composites, according to standard UNE-EN 13279-2 [27]. To obtain the bending strength of the plasters, three measurements were conducted for each mixture, obtaining the flexural strength of the materials as the mean value of those three samples.

- *Compressive strength:* The 6 half-pieces obtained from the flexural strength test were used to obtain the compressive strength of the new plasters, according to standard UNE-EN 13279-2 [27]. During these test, a central progressive load was applied to the specimen, obtaining the compressive breaking load value of each sample (Figure 5b). The mean value of the six tested samples was obtained to determine the compressive strength of each mixture. A statistical analysis of the resistance tests results was also carried out. Both mechanical tests were performed using the SUZPECAR multi-test machine (Universidad de Sevilla, Sevilla, Spain), a press with a 20-ton load capacity and a precision that varies according to the control type. In the control per round, the precision is 0.01 mm/min, whereas in load control the precision is 0.1 kg/s.

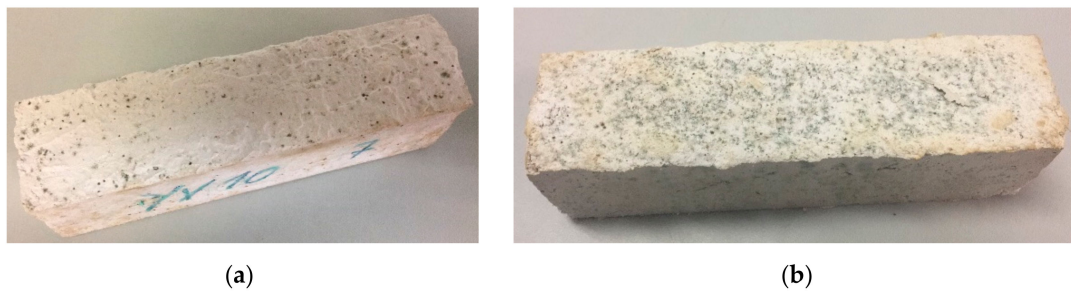
Figure 6. Small spots of mildew in wood shavings plasters after 15 wetting–drying cycles. (a) WS10; (b) WS20.

After the inspection executed at the end of the first 5 and 10 cycles, no damage was detected in the samples. However, after completion of the whole process (15 cycles), damage was seen in the samples with wood shavings with a higher percentage of waste. Specifically, WS10 and WS20 showed small spots of mildew in the surface of the sample as shown in Figure 6. This proliferation was far more significant in the mixture with 20% waste (WS20). Furthermore, small cracks and surface degradation appeared in the surface of the WS20 samples after 15 wetting–drying cycles (Figure 7). Finally, it is important to note that no surface damage was observed in any of the mixtures that used sawdust as raw material throughout the test plan.

Due to its high hygroscopicity and the abrupt humidity changes during the tests, the wood was susceptible to the proliferation of fungi (mildew). These, together with the expansion and retraction of the sample due to the presence of humidity, are the cause of the damage seen in the visual examination of the mixtures.

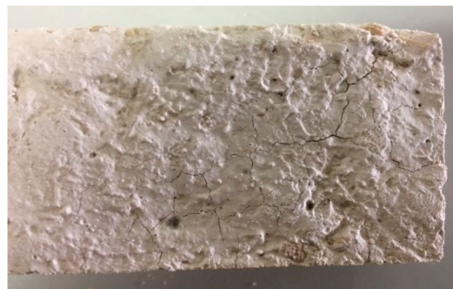
Figure 7. Small cracks in WS20 samples after 15 wetting–drying cycles.

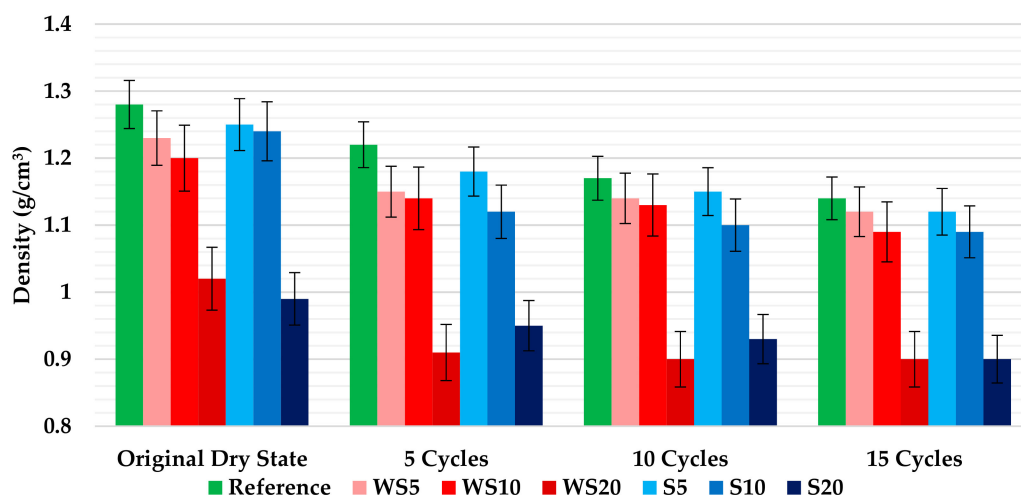
Figure 8. Density of the plasters after 0, 5, 10, and 15 wetting–drying cycles.

Figure 8 shows the density values of the mixtures at the end of each batch of cycle repetitions. It was observed that, for all the mixtures, the increase in the percentage of wood waste added to the plaster led to a decrease in the density in relation to the reference material. That drop in density was most pronounced in mixtures with wood waste aggregate at 20%, an important drop in relation to the value achieved for composites with 10% of waste. The reduction obtained was in accordance with the results obtained previously by Morales-Conde et al. [9] and by Dai and Fan [30], who also used wood waste for the development of gypsum plasters. On the other hand, it could be observed that, for all the plasters, the increase in the number of wetting–drying cycles was linked to a decrease in density in relation to those that had not been submitted to the aging process (0 cycles). The biggest drop was achieved for the WS20 samples, reducing the density of the plaster by 11.8% after 15 wetting–drying cycles. This reduction was due to loss of mass, caused mainly by the small disintegration process, that was suffered by the composites with the highest percentage of waste, when they were subjected to the wetting–drying cycles. Finally, it must be said that other studies from the literature also achieved an important reduction in the density of the materials when they were submitted to wetting–drying cycles [13,17,24].

The ultrasonic velocity depends on the density and elastic properties of a material. So, as can be appreciated in Figure 8, the addition of more wood waste (sawdust and wood shavings), and increased wetting–drying cycles, reduces the density of the plasters. The effects of the wetting–drying cycles in the materials were tested by ultrasonic measurements and the results are shown in Figure 12. The results obtained agreed with the density results, decreasing the ultrasonic velocity as the amount of wood waste in the composites and the number of cycles increased.

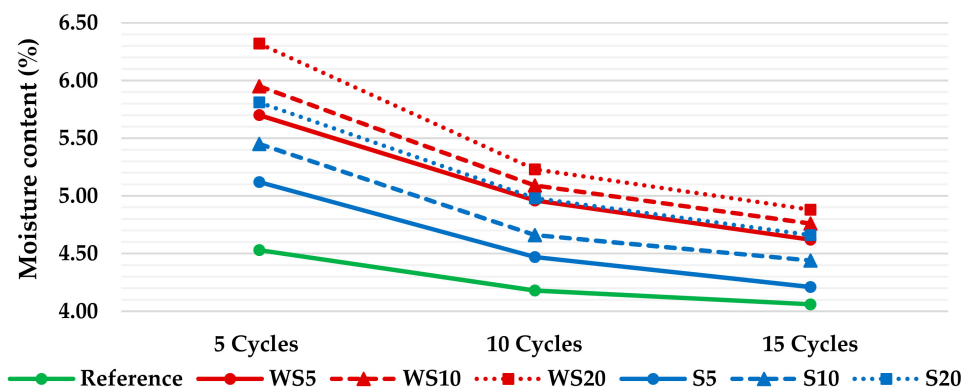
Figure 9. Moisture content evolution of the plasters during the cycles.

Once the specimens were submitted to each batch of cycle’s repetitions, they were weighted and dried to the absolute dry state. Following that procedure, the moisture content of the mixtures after 5, 10, and 15 cycles was obtained as shown in Figure 9. As can be seen, the moisture content of the samples was reduced when the number of wetting–drying cycles increased. This fall was more significant for samples with a higher wood waste content (mainly WS20). In addition, the most important decrease occurred during the first cycle, and was almost stabilized when the 15th cycle was finished. Those results are in accordance with those obtained for the density of the plasters.

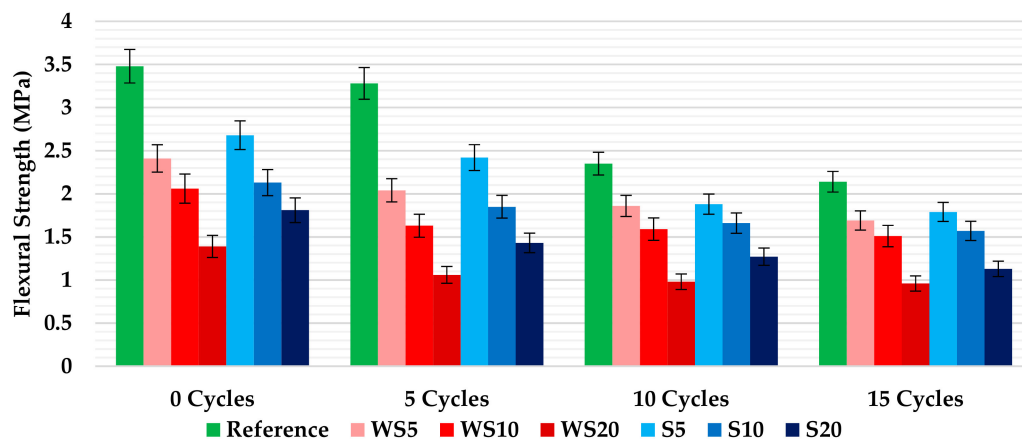
Figure 10. Flexural strength of the plasters after 0, 5, 10, and 15 wetting–drying cycles.

The results obtained for the flexural strength test of the mixtures (and their variability), at the end of each batch of cycle repetitions, are presented in Figure 10. Similar to the density, the increase of the percentage of wood waste added to the plasters meant a decrease in the flexural strength. For all the mixtures, and for the same percentage of waste, mixtures with sawdust showed better mechanical behavior than those with wood shavings. On the other hand, in all cases, the increase in the number of wetting–drying cycles was linked to a significant decrease in the flexural strength of the materials. The fall was more relevant in those composites that contained a lower percentage of wood waste, with the reference material being the one with the biggest drop after 15 cycles (38.9%). It must be considered that, in most of the mixtures, the bending values achieved were higher than the minimum standard requirement (1 MPa) for gypsum plaster, suggesting that is viable to use any of the composites

analyzed in construction works [26]. However, the WS20 samples after 10 and 15 wetting–drying cycles (0.98 and 0.96 MPa, respectively) touched the standard requirement without reaching it.

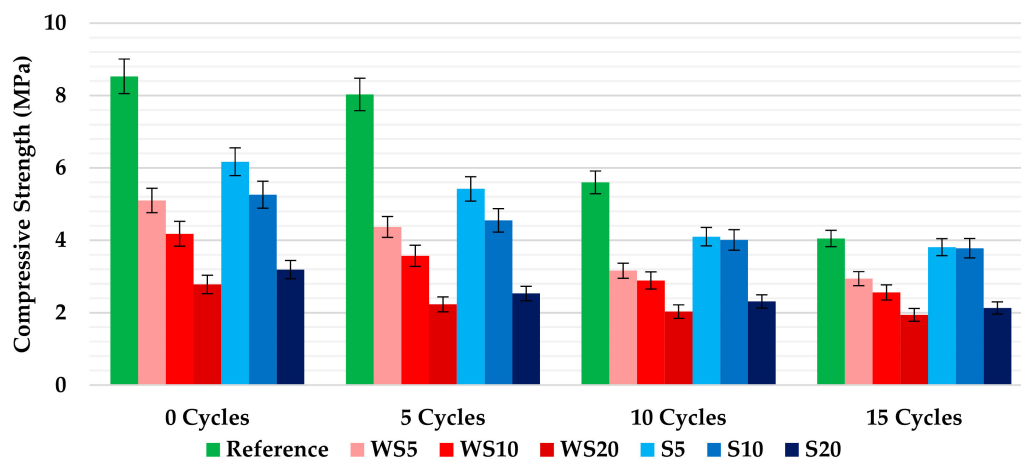
Figure 11. Compressive strength of the plasters after 0, 5, 10, and 15 wetting–drying cycles.

The way in which the new composites behaved when subjected to compression tests is analyzed in Figure 11, which shows the mean strength values, measured in MPa, at the end of each batch of cycle repetitions. As in the other properties analyzed, the increase in the percentage of wood waste added to the mixtures led to a reduction in the materials’ resistance capacities. The specimens with sawdust showed a better compressive strength behavior than those with wood shavings with the same aggregate percentage. On the other hand, in all cases, the increase in the number of wetting–drying cycles was linked to a significant decrease in the compressive strength of the materials. The fall was more relevant in those composites that contained a lower percentage of wood waste, with the reference material being the one with the biggest drop after 15 cycles (52.5%). Most of the results obtained were above the minimum value required for the compressive strength of gypsum plasters (2 MPa), according to the standard [26]. However, the resistance achieved for the WS20 mixture (1.94 MPa), after 15 wetting–drying cycles, was not enough to overcome the standard requirement. The small surface disintegration process that was suffered by the composites with the highest percentage of waste, when they were subjected to the wetting–drying cycles, could be one of the reasons that caused the loss of resistance of the plasters after the aging process.

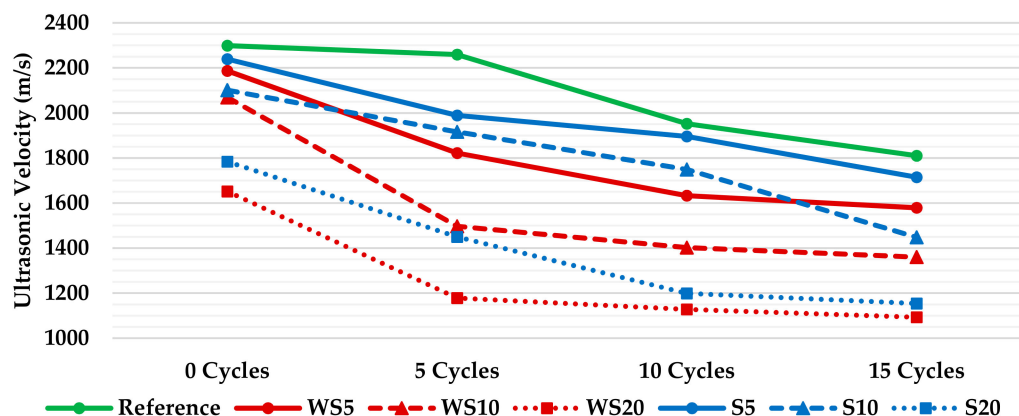
Figure 12. Ultrasonic velocity of the plasters after 0, 5, 10, and 15 wetting–drying cycles.

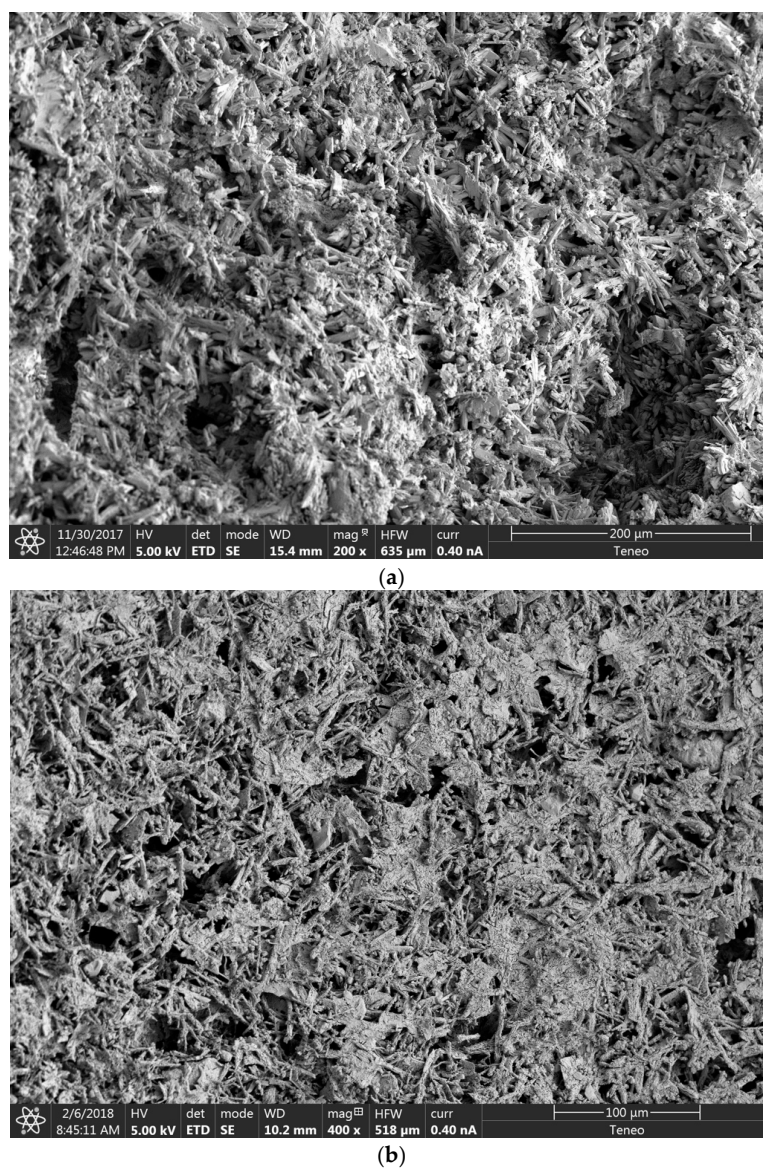
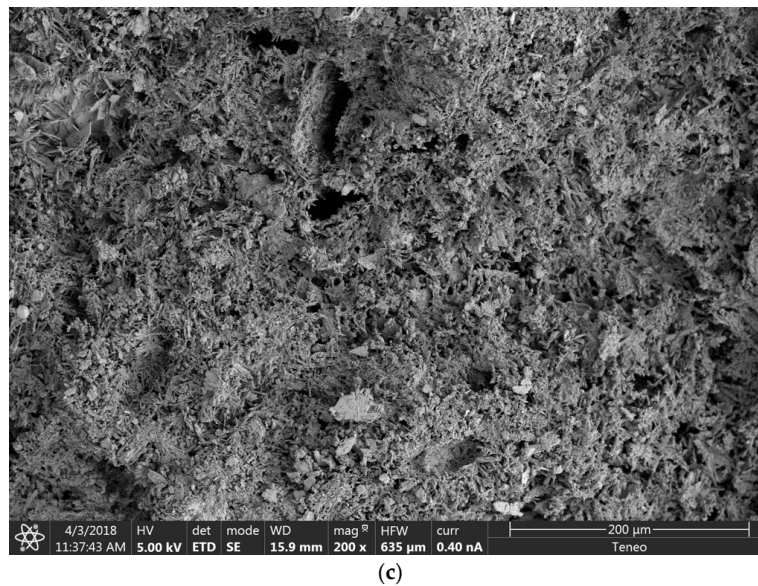
Figure 13. Reference SEM Analysis. (a) Five cycles; (b) 10 cycles; (c) 15 cycles.

The SEM images obtained for the reference plaster (no wood waste addition) are shown in Figure 13. In the images, a progressive modification of the crystalline structure of the material can be observed. After the aging process, an important morphological transformation of the usual crystalline structure of the gypsum plasters was observed. The crystals decreased in size, causing a loss of compactness and strength in the composite.

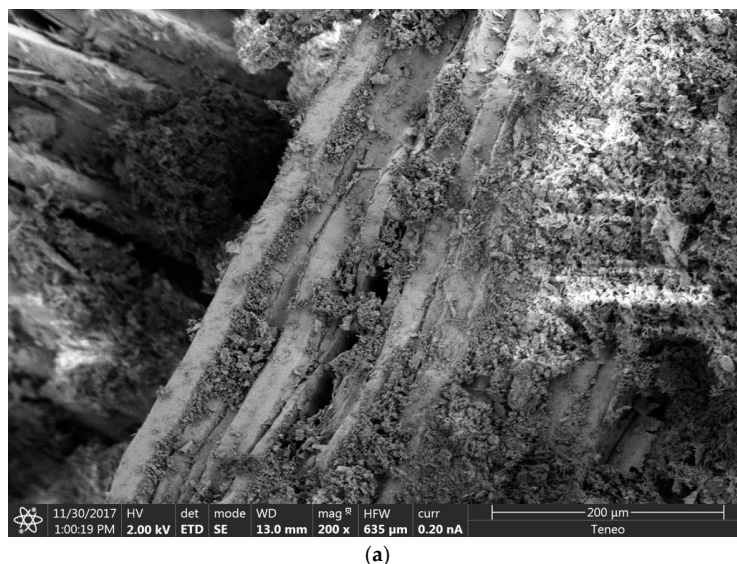
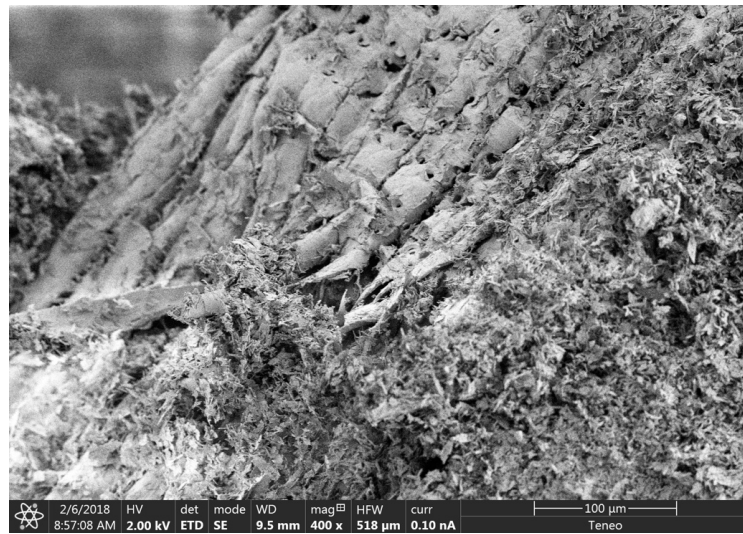
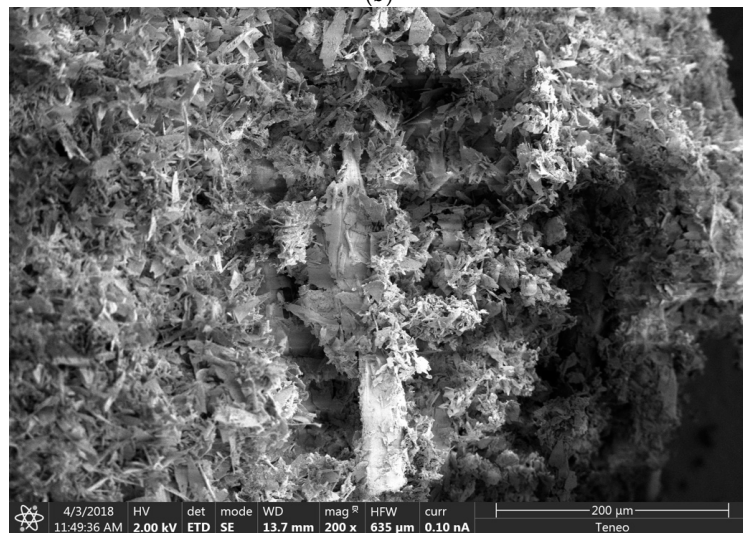
Figure 14. WS20 SEM Analysis. (a) Five cycles; (b) 10 cycles; (c) 15 cycles.

SEM images of gypsum plasters with 20% of wood waste after 5, 10, and 15 wetting–drying cycles are presented in Figure 14 (WS20) and Figure 15 (S20). Apart from the transformation in the crystalline structure of the gypsum matrix, the images showed a progressive surface deterioration of the wood waste. Furthermore, the adherence, between the matrix and the wood waste surface, worsened when the composites were subjected to wetting–drying cycles.

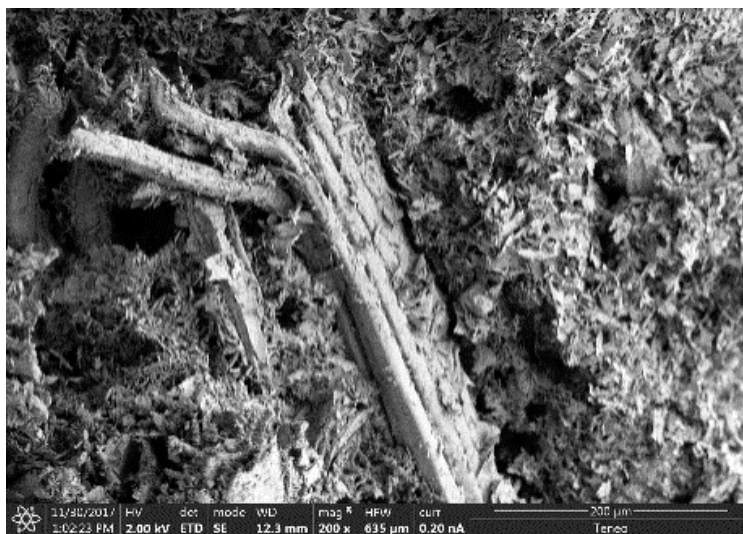
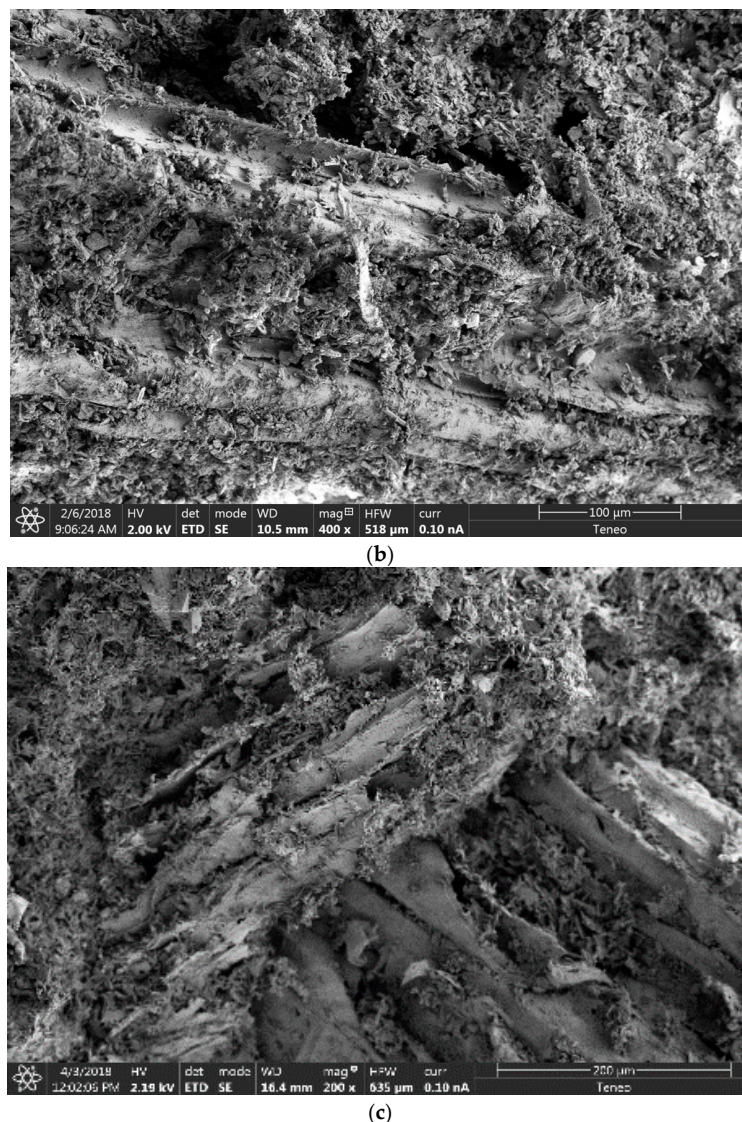
Figure 15. S20 SEM Analysis. (a) Five cycles; (b) 10 cycles; (c) 15 cycles.
