Crack Healing and Mechanical Properties Recovery in SA 508–3 Steel

Abstract: Internal cracks could be healed under the process of hot plastic deformation. In this study, mechanical properties recovery after crack healing in SA 508–3 steel were investigated. Microstructures of the crack healing zones were observed using an optical microscope (OM) and electron back scattered diffraction (EBSD) technology, and the recovery degrees of mechanical properties in the crack healing zones with the healing temperature and a reduction ratio were tested systematically. The results showed that the internal cracks in SA 508–3 steel disappeared and were replaced by newly formed grains, achieved by recrystallization and abnormal grain growth. The tensile properties of crack healing zones could be fully restored, while their impact and low cycle fatigue properties could only be partially achieved. The recovery degrees of mechanical properties in crack healing zones increased with increasing the healing temperature and reduction ratio in the temperature range of 950–1050 °C. When the temperature was above 1150 °C, the impact properties began to deteriorate because of grain coarsening and larger MA (

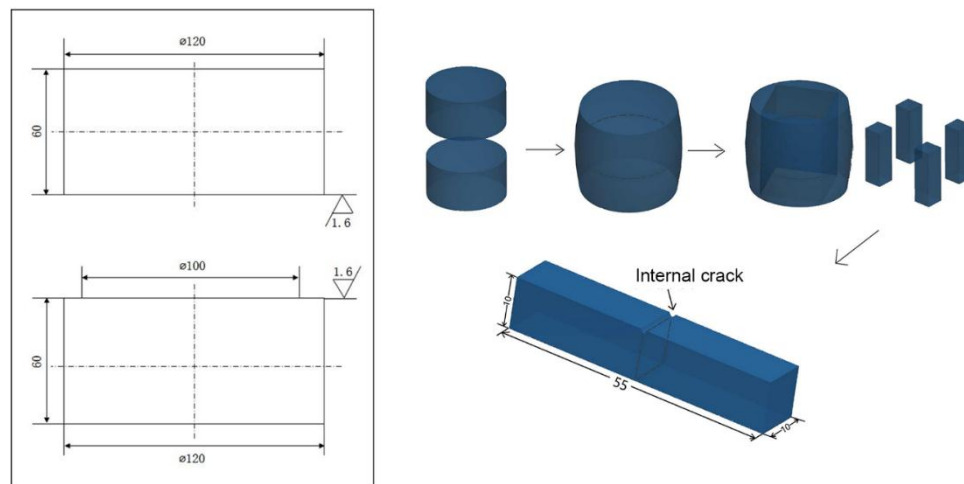
The material used in the research was SA 508–3 steel, having a composition (in wt %) of 0.19 C, 0.22 Si, 1.4 Mn, 0.006 P, 0.006 S, 0.12 Cr, 0.53 Mo, and 0.65 Ni. SA 508–3 steel is often used in nuclear power equipment. The samples with internal pre-cracks were prepared via a butt-joint method. The detailed process of crack presetting is shown in Figure 1.

Firstly, SA 508–3 steel was machined into cylindrical samples with a 120 mm diameter and a 60 mm height. Then, to facilitate the subsequent welding, the contact surfaces of the samples were polished into a mirror plane with the roughness of 1.6 µm using a buffing machine, and the edge was chamfered. After cleaning the contact surface, two samples were welded. The plate-shape pre-crack was obtained in the middle part.

Figure 1. A schematic illustration of the butt-joint method.

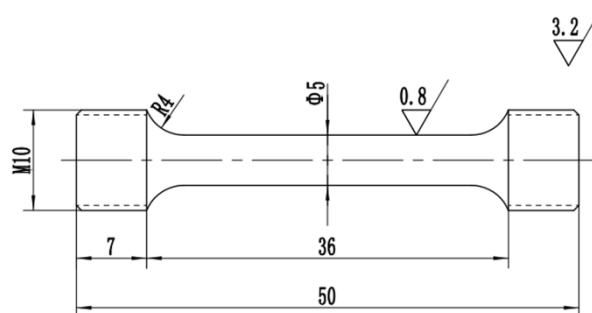
Room-temperature tensile tests were conducted to examine the tensile properties recovery of SA 508-3 specimens with crack healing zones by an electronic universal testing machine (model WDW-100). The dimensions of tensile specimens were illustrated in Figure 2. The crack healing zones were confirmed to lie in the middlemost part of the parallel section in the tensile specimens.

Figure 2. A schematic illustration of the tensile specimens.

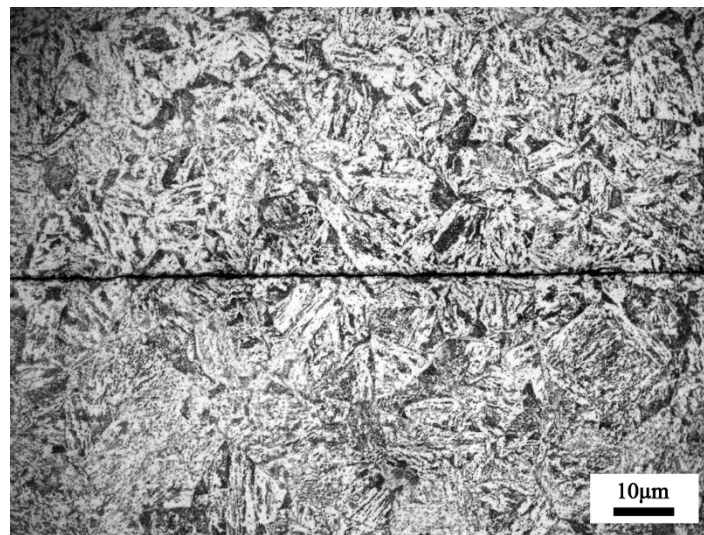
Figure 3 shows the morphology of the original pre-crack zone in SA 508–3 steel. The pre-crack width of the original internal crack was about 1.4 μm in the middle part of the crack, and the length of the crack was more than 100 mm. The original grain size was 17.24 μm . The original matrix phase was characteristic by lath bainite and martensite.

Figure 3. An optical micrograph of the pre-crack zone before the healing treatment.

The original microstructure of the investigated steel was characterized by martensite and lath bainite, as shown in Figure 3. When it was heated to the healing temperatures, which were above A_{c3} , a complete transformation of austenite in the matrix occurred.

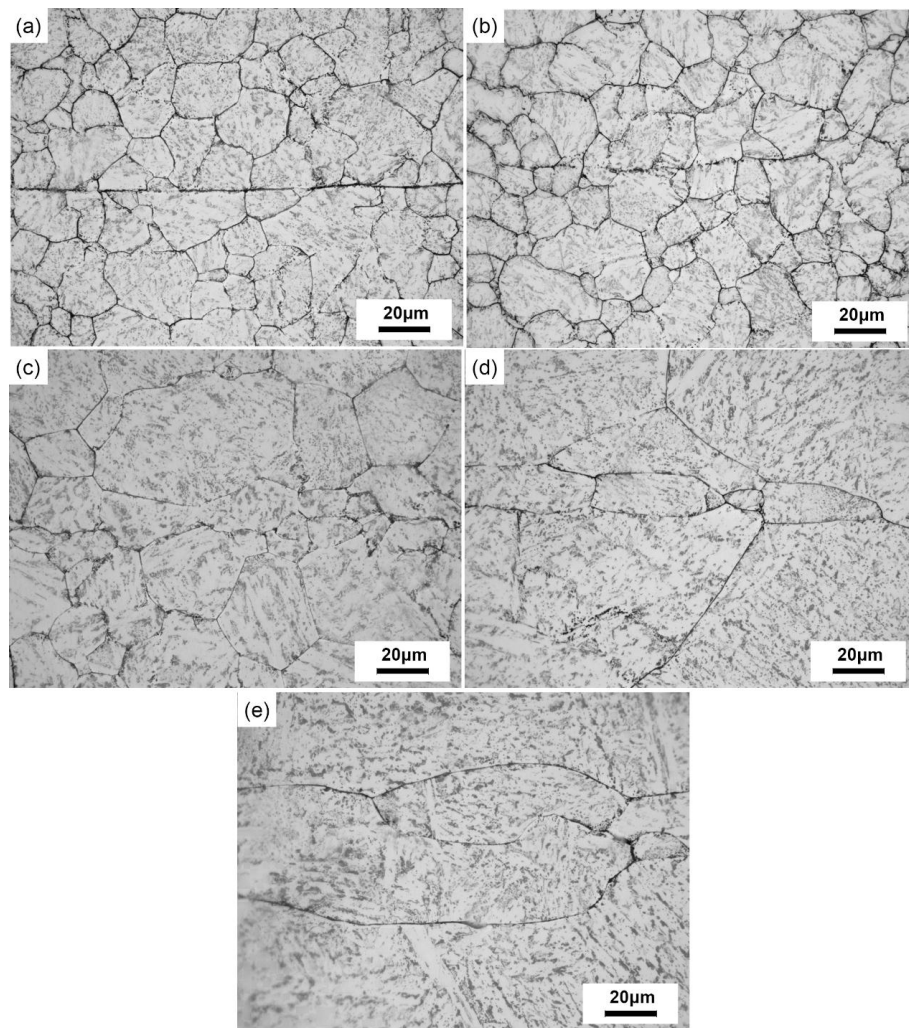
Figure 4 shows the microstructural morphology of crack zones under different healing temperatures.

When the healing temperature was 850 $^{\circ}\text{C}$ (Figure 4a), the crack width was smaller than the original pre-crack. When the temperature was raised to 950 $^{\circ}\text{C}$ (Figure 4b), the crack was segmented into different small parts. While at 1050 $^{\circ}\text{C}$ (Figure 4c), the pre-crack almost disappeared and small-sized grains were observed in the original crack zone, indicating that the internal crack was fully healed. Meanwhile, the grains of the matrix grew rapidly, and there were distinct differences between the microstructures of the crack zone and the matrix. When the healing temperature was above 1150 $^{\circ}\text{C}$ (Figure 4d,e), the microstructures of crack healing zone consisted of coarse grains. The average grain sizes of the matrix and pre-crack zone in different temperatures were shown in Figure 5.

When the sample was healed at 1150 $^{\circ}\text{C}$, recrystallization was the primary crack healing mechanism [21]. The growth of the recrystallized grains is usually described as normal grain growth. However, after holding at the 1150 $^{\circ}\text{C}$ for 10 h, newly formed grains in the crack healing zones had a preferential orientation, in other words, abnormal grain growth, resulting in elongated large grains that can be observed in the present study.

Figure 4. The microstructures on the longitudinal section of the crack healing zones in SA 508–3 steel samples with the reduction ratio of 20% under different healing temperatures for 10 h: (a) 850 °C, (b) 950 °C, (c) 1050 °C, (d) 1150 °C, and (e) 1200 °C.

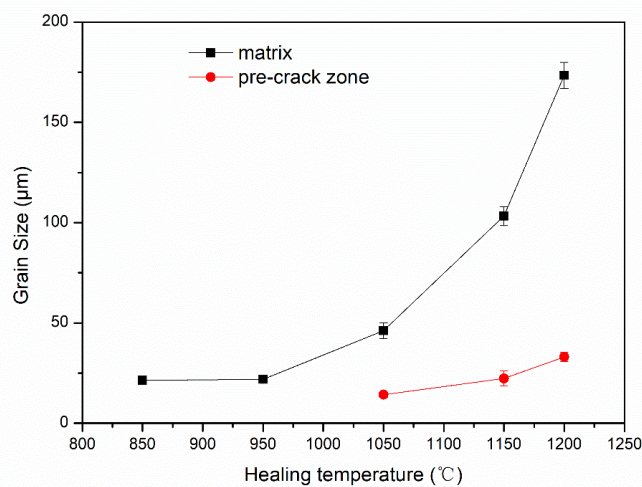
Figure 5. The grain sizes of the matrix and pre-crack healing zones in SA 508–3 steel samples under different healing temperatures.

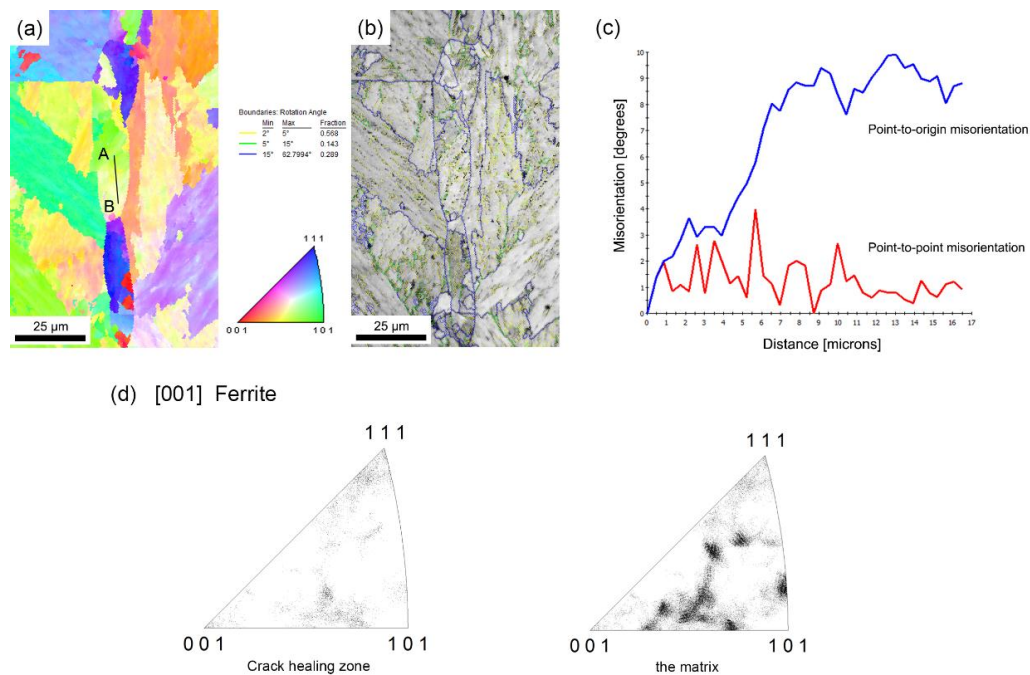
The inverse pole figure (IPF) map of the SA 508–3 steel sample heated at 1150 °C is shown in Figure 6a, and the corresponding grain boundary character distribution map is shown in Figure 6b. Only granular bainite grains were found in the crack healing zone and the matrix (Figure 6a), and their orientations were almost similar (Figure 6d). The distribution of the misorientation profile along the line AB in the newly formed grain is shown in Figure 6c. The morphology feature of the grain can be defined by a minor color variation. The point-to-point misorientation does not exceed 4°, and the point to origin misorientation increased continuously, which indicates the strain gradient within the orientation of the grain. For the present sample, the abnormal growth may be the result of the presence of the pinning effect rather than the texture effect.

Figure 6. (a) An inverse pole figure (IPF) map of the healing zone heated at 1150 °C, (b) the corresponding grain boundary map, (c) the misorientation profile along the line AB, and (d) the IPFs on the crack healing zone and the matrix.

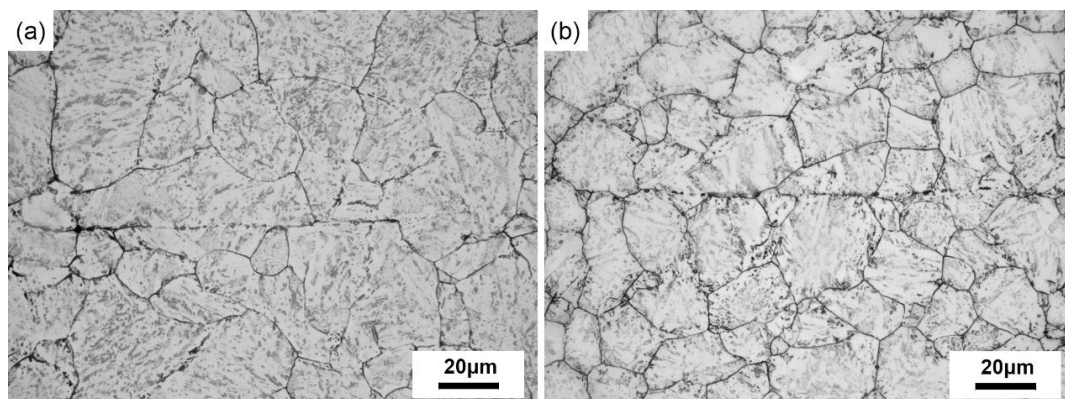
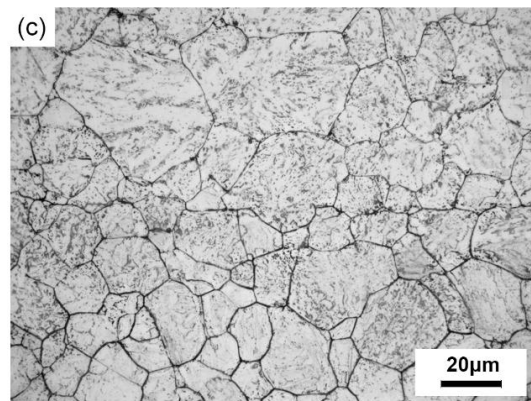
Figure 7 shows the microstructures of crack zones after compression at 950 °C under various reduction ratios.

The grain sizes and the number of micro-voids decreased with increasing reduction ratio. When the reduction ratio increased to 30% (Figure 7c), the micro-voids and micro-cracks in the crack healing zones disappeared totally and were replaced by newly formed fine grains with a continuous grain boundary.

Figure 7. The microstructure of the SA 508-3 after compression at 950 °C with different reduction ratios: (a) 10%, (b) 20%, and (c) 30%.

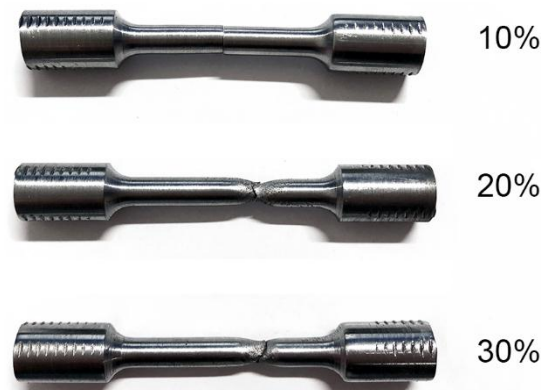
Figure 8 shows the room-temperature tensile macroscopic fractographs under different reduction ratios, healing at 950 °C for 10 h.

When the reduction ratio was 10%, there was no necking in the tensile test. When the reduction ratios were above 20%, the apparent extension and displacement occurred on the other two tensile samples. The tensile fracture positions were located in the matrix rather than in the crack healing zone, which indicated the tensile strength of the crack healing zone was higher than the matrix.

Figure 8. Room-temperature tensile macroscopic fractographs of the crack healing zones under different reduction ratios, healing at 950 °C for 10 h.

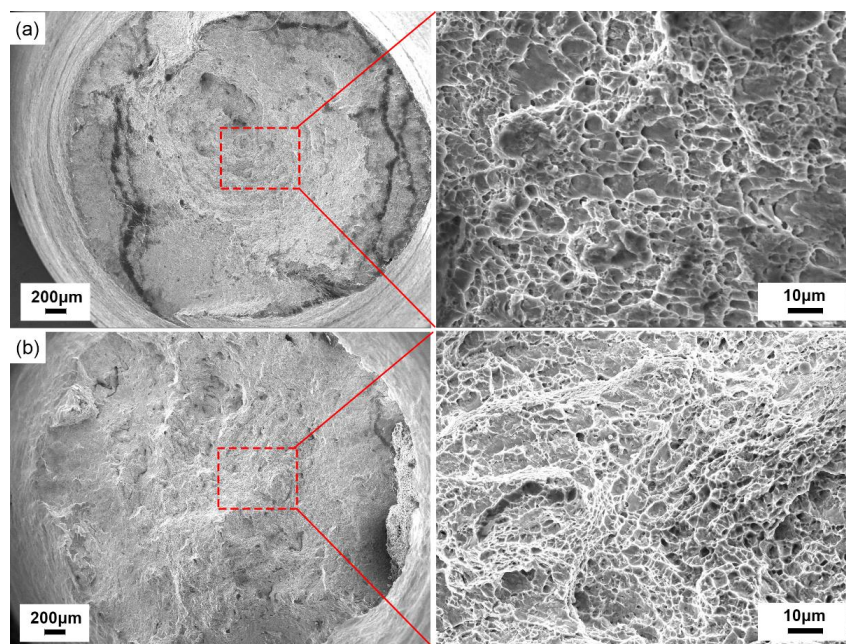
The corresponding tensile fracture morphology of the healing zones under different conditions is shown in Figure 10.

Figure 10. The tensile fracture morphology of the SA 508-3 samples (a) at 950 °C with a 30% reduction ratio holding for 10 h and (b) at 1150 °C with a 30% reduction ratio holding for 10 h.

With the 30% reduction ratio, the fracture morphology was predominantly a typical equiaxial dimple pattern, as shown in Figure 10a,b. When the healing temperature increased from 950 °C to 1150 °C, the area of equiaxial dimples increased gradually and the diameters of the dimples were smaller. However, the ultimate tensile strength and elongation of the sample healed at 1150 °C were relatively lower. The reason was that lower energy was needed in the micro-void formation during the process of dimple fracture after the sample was healed at a higher healing temperature.

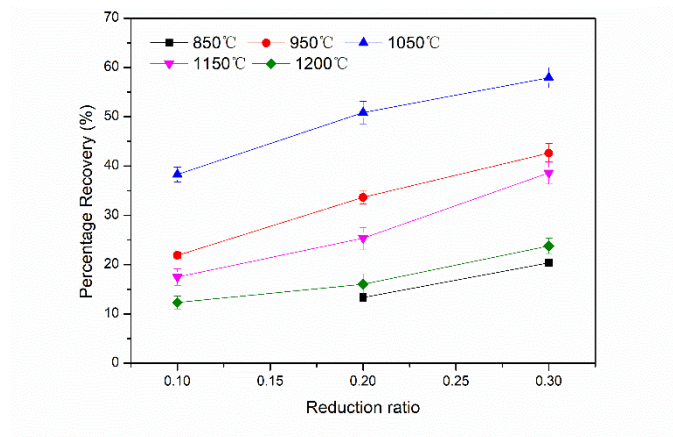
Figure 11 exhibits the percentage recovery of room-temperature Charpy-absorbed energy under various healing conditions. The percentage recovery of impact absorbed energy of crack healing zone increased with an increasing healing temperature. However, when the healing temperature exceeded 1050 °C, the oversized grains in matrix led to a decrement of the recovery rate. Abnormal grain growth was observed after long-time heat preservation, which deteriorated the impact property. Additionally, with the increase of the reduction ratio, their percentage recoveries increased gradually.

Figure 11. The percentage recovery of room-temperature Charpy-absorbed energy under various healing conditions.

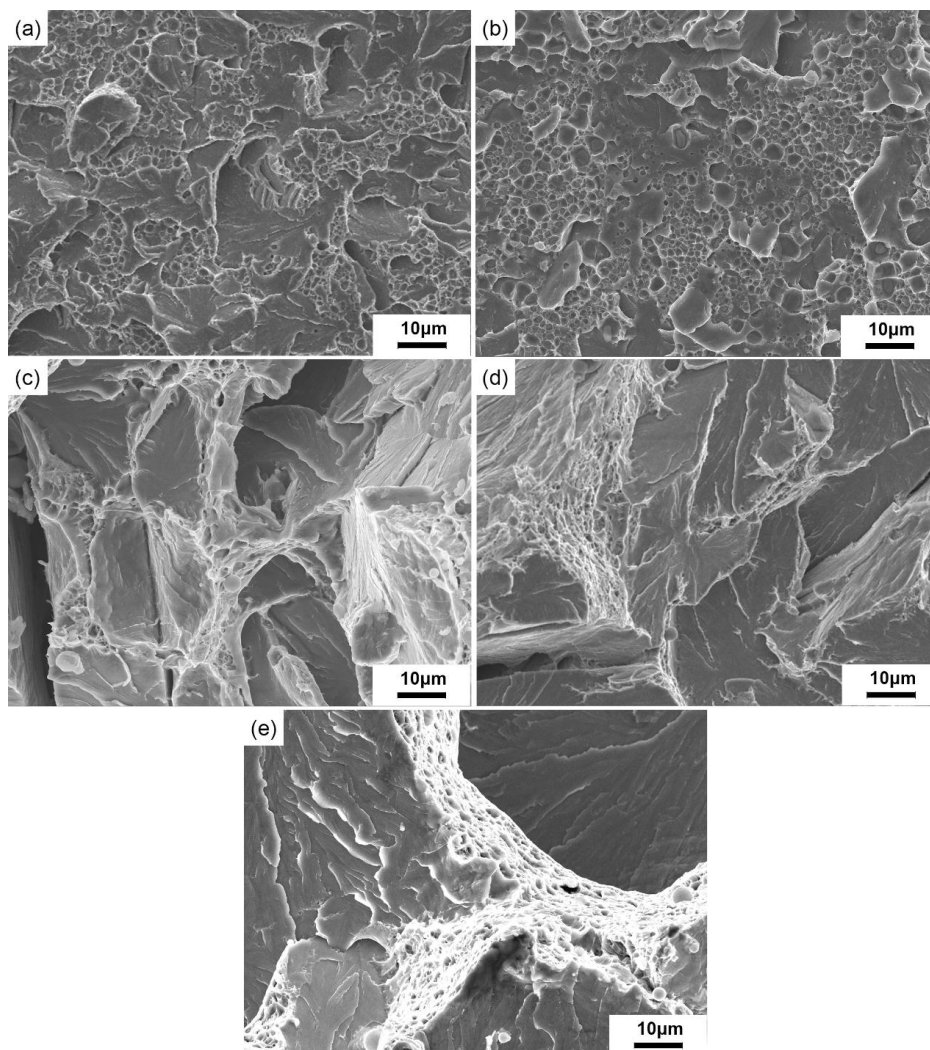
Figure 12 exhibits the SEM impact fractographs of crack healing zones after a 20% height reduction at different temperatures.

Figure 12. The SEM impact fracture of SA 508-3 under different temperatures when the reduction ratio was 20% (a) at 850 °C, (b) at 950 °C, (c) at 1050 °C, (d) at 1150 °C, and (e) at 1200 °C.

At 850 °C, the internal crack began to heal and the impact fracture presented the mixed fracture characterized by unhealed region and dimpled pattern. However, only a small fraction of the fracture presented the dimpled pattern. When the healing temperature was 950 °C, the remanent void coalescence mechanism prevailed in the dimpled region. The dimples were roughly equiaxed, as depicted in Figure 12a,b.

As showed in Figure 12c, when the healing temperature was 1050 °C, the fracture surface showed a river-like pattern cleavage that was surrounded by dimples of different sizes, both of them belonging to the fracture mechanism by the coalescence of the micro-void and quasi-cleavage mechanism. The internal cracks were fully healed at 1050 °C, which corresponded to the maximum percentage recovery. When the healing temperature was further heightened to 1150 °C and 1200 °C, the percentage recovery of the impact property descended gradually. The river pattern cleavage region was enlarged, which was in accordance with the evolution of grain coarsening, shown in Figure 12d,e.

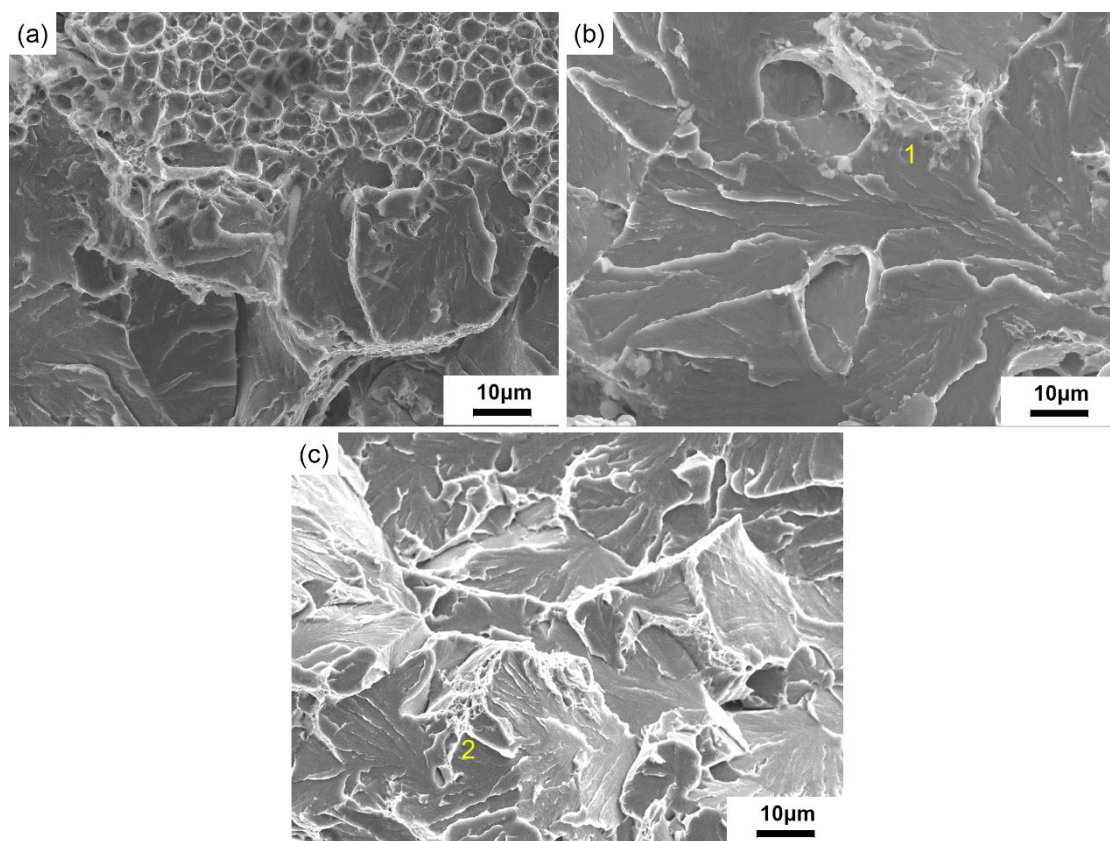
Figure 13 shows the SEM impact fracture of SA 508–3 steel with different reduction ratios; when the healing temperature was 950 °C, the internal crack was not completely healed under the condition of a 10% reduction ratio. The fracture surfaces were predominantly unhealed regions with the dimpled regions, as shown in Figure 13a.

When the reduction ratio reached 20% and 30%, the recovery percentage increased gradually, with similar fracture features. As seen in Figure 13b,c, the fracture surfaces were mainly river-like cleavage fractures. This rupture mechanism model involves a typical fracture surface morphology which consists of an array of cleavage facets or transgranular brittle fracture facets. Meanwhile, several dimples can be seen in region 1 and 2.

Figure 13. The SEM impact fracture of SA 508–3 under reduction ratios when the deformation temperature is 950 °C: (a) 10%, (b) 20%, and (c) 30%.

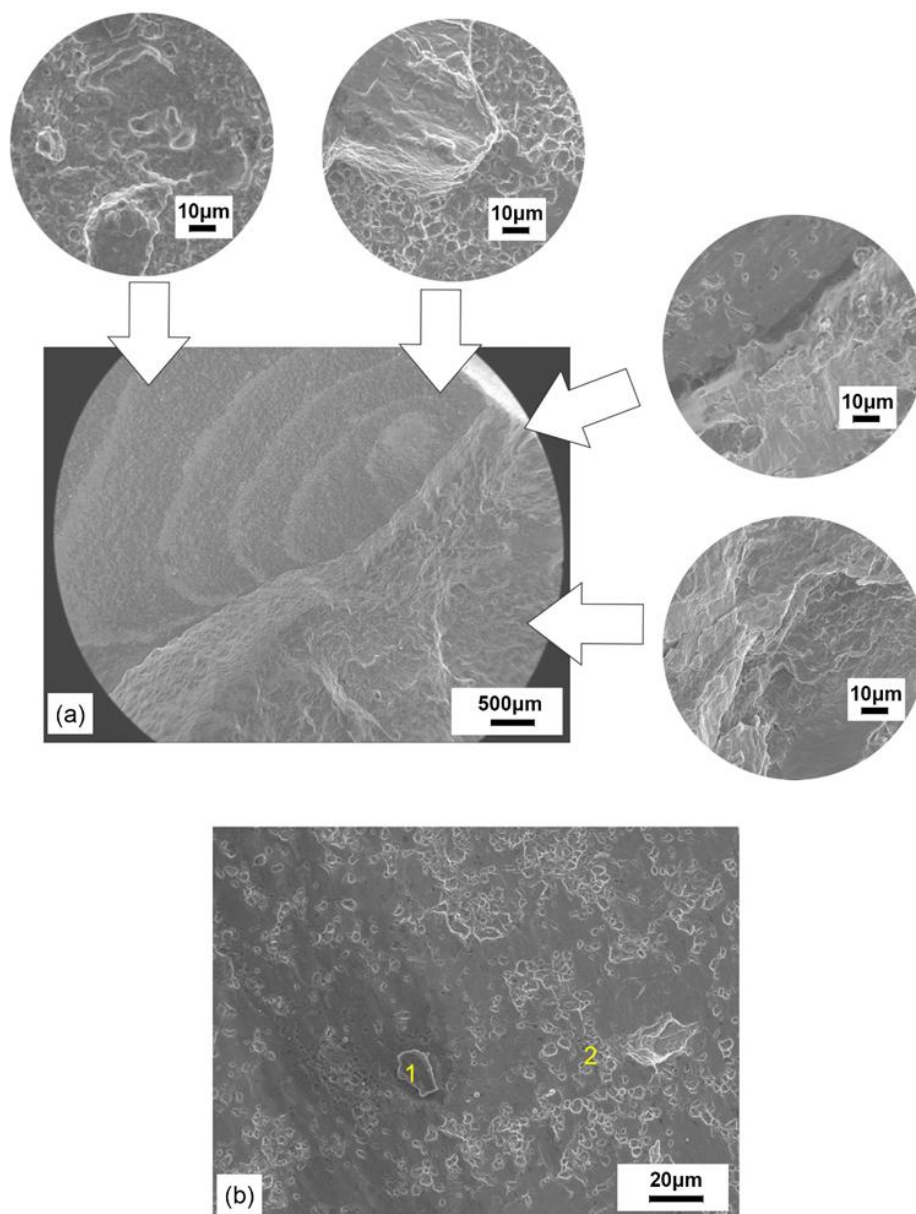
The fatigue fracture was located in the crack healing zone. The SEM images of fatigue fracture surface of SA 508–3 steel are shown in Figure 14. It should be noted that half of the crack healing zone presented characteristics similar to fatigue fracture, and half showed tensile fracture characteristics.

The quasi-fatigue fracture had the morphology of micro-void and unhealed regions, as shown in Figure 14a. Generally, the typical morphology of the fatigue fracture was identified by fatigue striation. However, no obvious fatigue striation or tear ridge could be observed in the quasi-fatigue fracture. Instead, micro-voids and inclusions were observed.

Figure 14. SEM fatigue fractographs of the SA 508–3 specimen healed at 1050 °C with a 20% reduction ratio: (a) the fatigue fracture morphology and (b) the ingredients of inclusion.

As shown in Figure 14b, inclusions (location 1) and micro-voids (location 2) could be observed on the quasi-fatigue surface. It was obtained by composition measurement that location 1 had a relatively high volume of chemical composition of O, which indicated the existence of nonmetallic inclusions, such as oxides.
