Investigation of Structural Degradation of Fiber Cement Boards Due to Thermal Impact

Abstract: The aim of the present study was to investigate the degradation of the microstructure and mechanical properties of fiber cement board (FCB), which was exposed to environmental hazards, resulting in thermal impact on the microstructure of the board. The process of structural degradation was conducted under laboratory conditions by storing the FCB specimens in a dry, electric oven for 3 h at a temperature of 230 °C. Five sets of specimens, that differed in cement and fiber content, were tested. Due to the applied heating procedure, the process of carbonization and resulting embrittlement of the fibers was observed. The fiber reinforcement morphology and the mechanical properties of the investigated compositions were identified both before, and after, their carbonization. Visual light and scanning electron microscopy, X-ray micro tomography, flexural strength, and work of flexural test W_f measurements were used. A dedicated instrumentation set was prepared to determine the ultrasound testing (UT) longitudinal wave velocity c_L in all tested sets of specimens. The UT wave velocity c_L loss

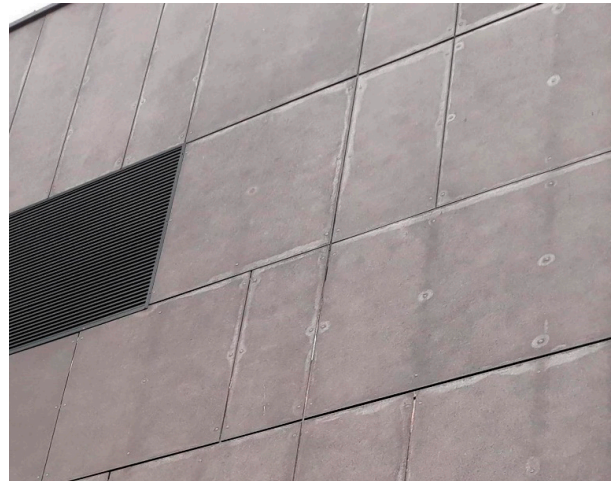
Figure 1. An example of a FCB façade showing considerable damage after ten years of exposure to climate hazards.

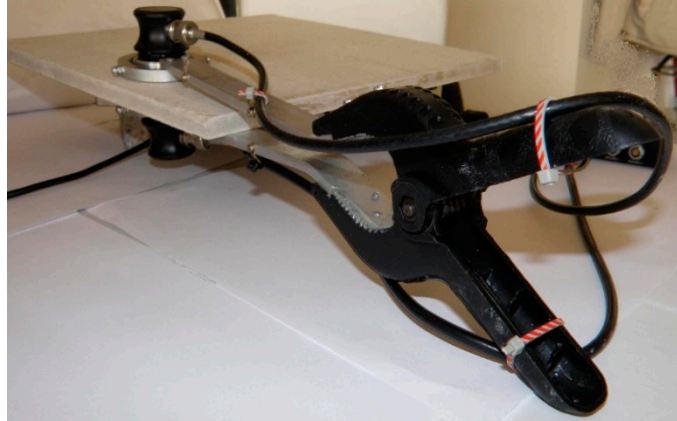
Figure 3. Detailed view of the custom-designed holder for correct coupling between the ultrasonic transducers and both sides of the rough surface board.

a 0.6 mm thick layer of polymer jelly interfacing foil (PM-4-12) produced by Olympus (Waltham, MA, USA) [20]. The custom-designed holder, with articulated joints and a compression spring, was prepared to ensure the correct coupling of the ultrasonic transducers to both surfaces of the investigated boards. A detailed view of the holder is presented in Figure 3.

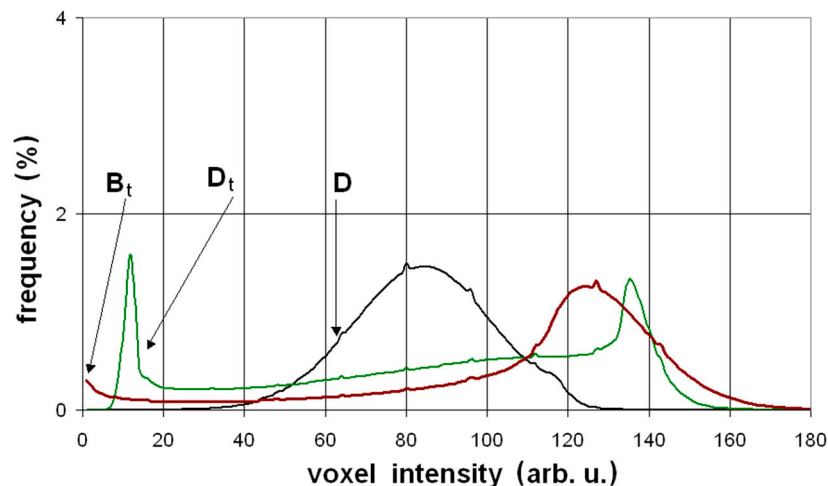
Figure 8. The greyscale brightness distribution (GBD) of all voxels belonging to the three examined specimens: “D”, “D_T” and “B_T”. The occurrence of the delamination processes caused a shift of the affected GBD curves to the left, i.e., in the direction of a region of voids.

Another way to present information about the specimens, derived from the X-ray scanning procedure, is to determine the brightness distribution of all of the examined voxels (i.e., volumetric pixels). The magnitudes of brightness of the different microstructural elements were included in the following ranges: the area of voids and fibers: 0–50 arbitrary units, a.u., fillers: 50–140 a.u., and dense phases; i.e., un-hydrated cement and fine aggregate grains: 140–170 a.u. The greyscale brightness distribution (GBD) of all voxels belonging to the three specimens presented in Figure 7, are shown in Figure 8. It is worth noting that the occurrence of the delamination processes caused a shift of the affected GBD curves to the left, i.e., in the direction of a region of voids.

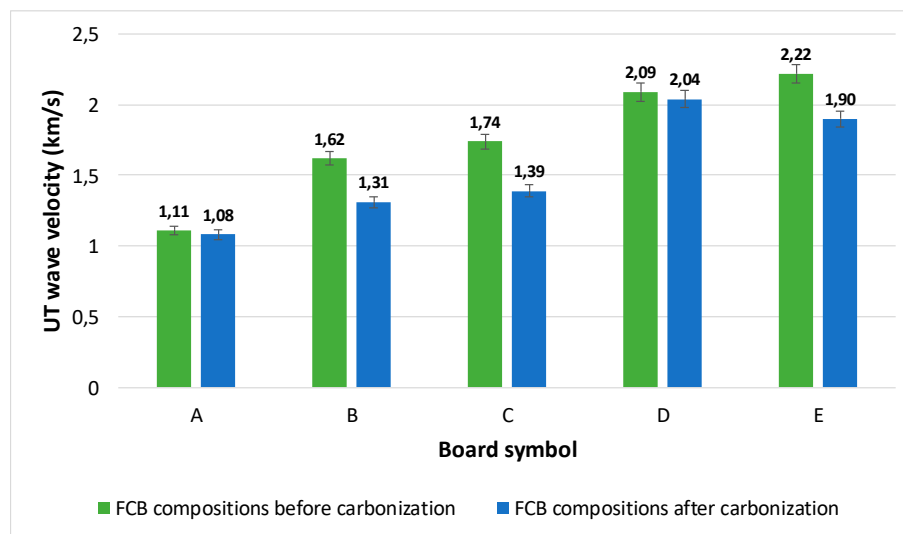
Figure 9. Results of the UT longitudinal wave velocity c_L tests, measured in all FCB compositions, before and after carbonization. The black marks depict standard deviations (2–3%), determined in populations of the measurements.

The results of the UT longitudinal wave velocity c_L tests are presented in Figure 9. For each $30 \times 30 \text{ cm}^2$ FCB board (A, B, C, D, E, A_T, B_T, C_T, D_T and E_T), two series, of ten measurements each, were performed in order to determine the dispersion of the results. The measurements were done, randomly, at different locations, over the entire surface of the boards. The standard deviation of a single series of measurements was included in the range of 2–3% of the average value of the readings. The UT longitudinal wave velocity c_L loss was observed in all cases of thermal treatment; however, that loss varied from 2% to 20% depending on the FCB composition. It is worth mentioning that the time to perform ten UT measurements took approximately 5 min, suggesting that this may be a good method for in-situ application.

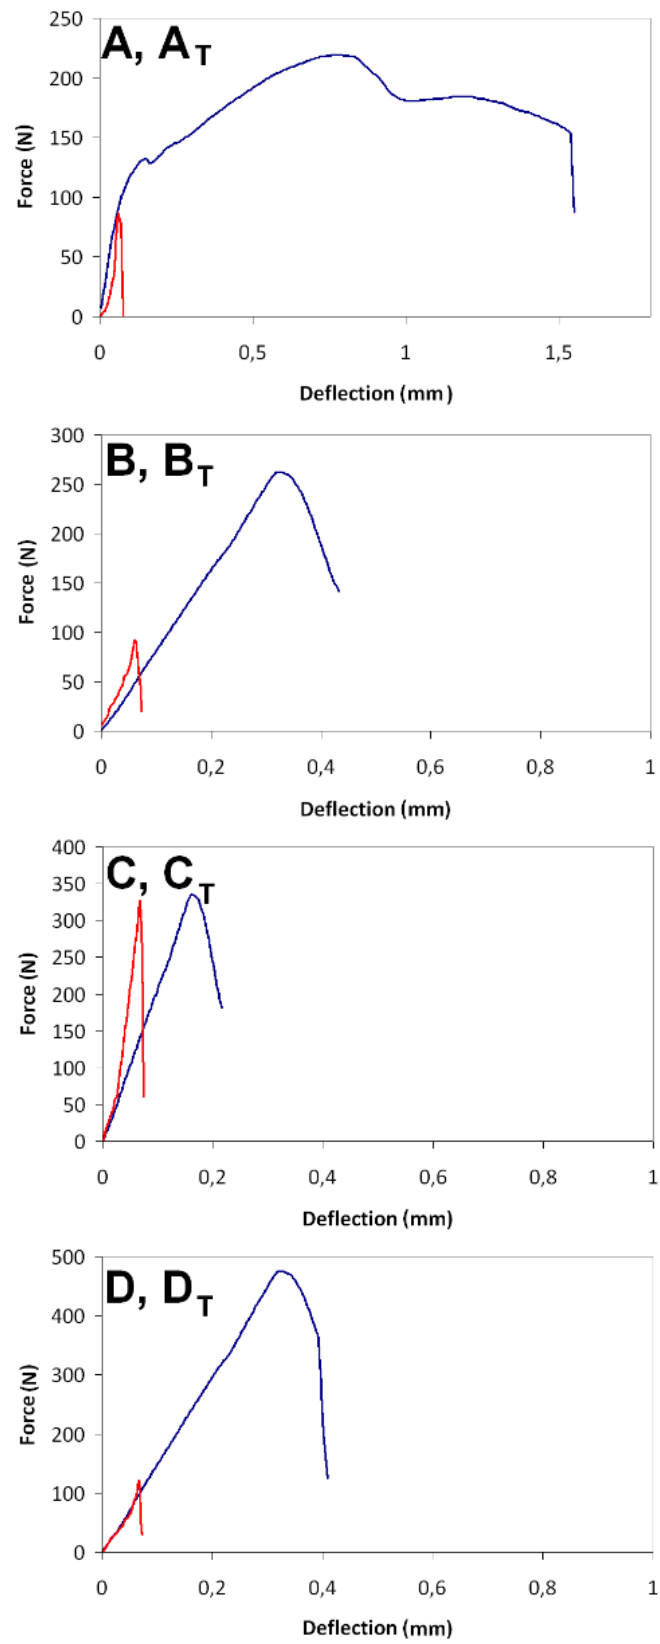
Figure 10. Typical load-deflection curves of the tested FCB compositions. The blue curves show the behavior of the specimen in an as-delivered state and the red curves show the behavior of the specimens with the carbonized reinforcing fibers.

Figure 10 and Table 2 present the results of the mechanical tests. The blue curve shows the behavior of the specimens in an as-delivered state, and the red curve shows the behavior of the specimens with the pyrolyzed reinforcing fibers. Based on an analysis of the curves, the board specimens in an as-delivered state are capable of withstanding a load close to F_{MAX} for the time required to destroy the fiber reinforcement system. The energy required for that damage can be estimated as W_f , by applying Formula (1). The specimens that underwent the cellulose fiber carbonizing process demonstrated the brittle characteristics of the rupture, i.e., the break of the material cross section appeared immediately after reaching the critical F_{MAX} level. Work of flexural test, calculated for the carbonized specimens, equaled approximately 2–5% of the value estimated for the as-delivered state of the FCB specimens. It is also worth mentioning that, in the composition of boards with a low cement content, the brittle matrix broke under a relatively low loading force, while its internal fiber reinforcement system could withstand more stages of the damage process.
