Article

Encapsulation of Electron Beam Melting Produced Alloy 718 to Reduce Surface Connected Defects by Hot Isostatic Pressing

Abstract: Defects in electron beam melting (EBM) manufactured Alloy 718 are inevitable to some extent, and are of concern as they can degrade mechanical properties of the material. Therefore, EBM-manufactured Alloy 718 is typically subjected to post-treatment to improve the properties of the as-built material. Although hot isostatic pressing (HIPing) is usually employed to close the defects, it is widely known that HIPing cannot close open-to-surface defects. Therefore, in this work, a hypothesis is formulated that if the surface of the EBM-manufactured specimen is suitably coated to encapsulate the EBM-manufactured specimen, then HIPing can be effective in healing such surface-connected defects. The EBM-manufactured Alloy 718 specimens were coated by high-velocity air fuel (HVOF) spraying using Alloy 718 powder prior to HIPing to evaluate the above approach. X-ray computed tomography (XCT) analysis of the defects in the same coated sample before and after HIPing showed that some of the defects connected to the EBM specimen surface were effectively encap

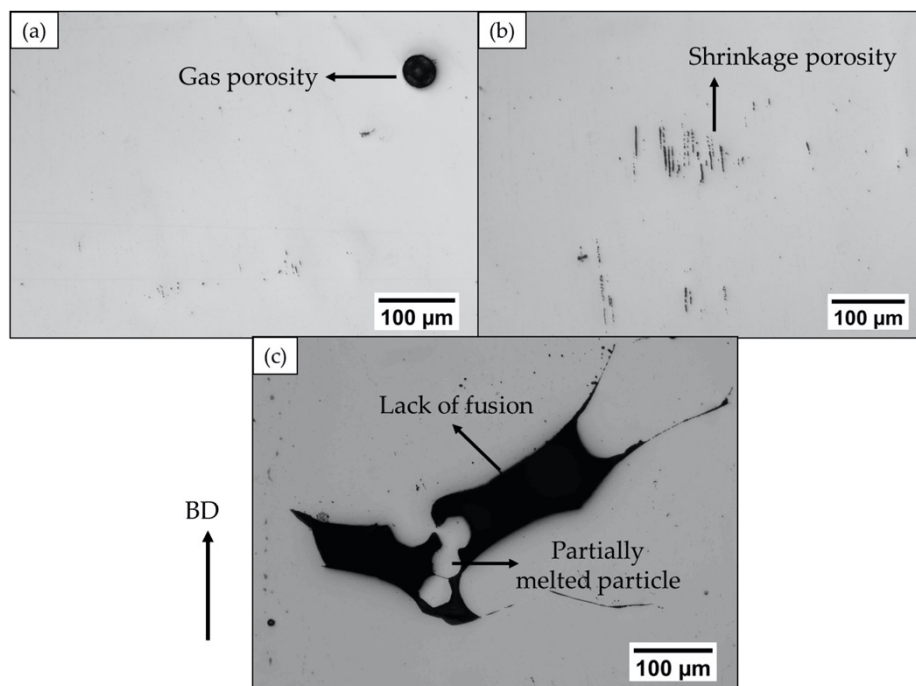
Figure 3. LOM micrographs showing the different kinds of defects present in the as-built EBM Alloy 718: (a) gas porosity, (b) shrinkage porosity, and (c) lack of fusion. The arrow on the left indicates the build direction.

The as-built EBM Alloy 718 specimens were characterized by the presence of defects. Three types of defects were observed, i.e., lack of fusion, shrinkage porosity, and gas porosity, and they are visualized in Figure 3. Such defects have also been previously observed by Goel et al. [3], and the influence of the defects on mechanical properties has been elaborated elsewhere [16,17]. Round-shaped gas porosities (refer Figure 3a) were randomly distributed, and they are attributable to entrapped gas inside the virgin powder, which could have found its way into the EBM build [1]. The shrinkage porosities, shown in Figure 3b, were typically aligned along the build direction, and are reportedly known to form as a result of interdendritic shrinkage after solidification [18]. The lack of fusion defects were primarily concentrated in the contour regions and often contained partially molten powder particles. The main reason for the formation of lack of fusion defects is expected to be inappropriate energy input. Low energy input can result in incomplete bonding between the layers [19], and, as a result, partially molten particles can be observed in these defects (see Figure 3c). On the other hand, high energy input can cause the melt to spatter away [19].

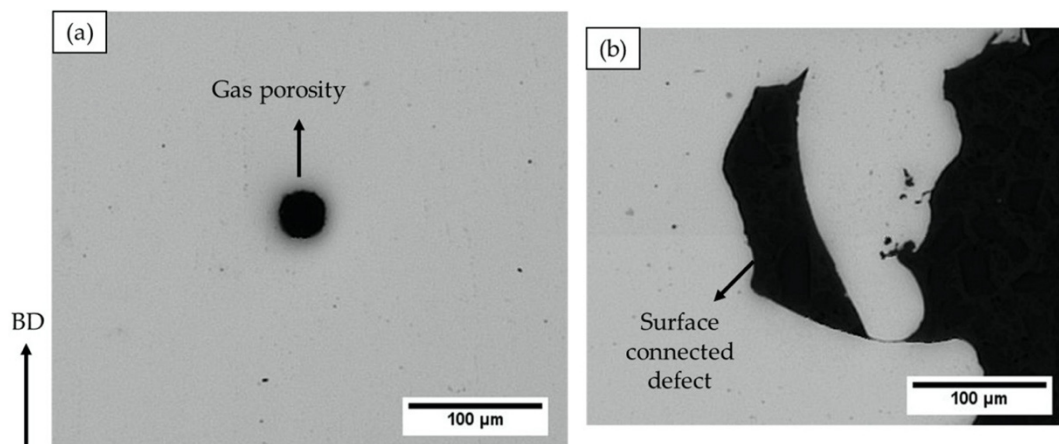
Figure 4. LOM micrographs revealing the remnant defects in the hot isostatic pressed (HIPed) EBM Alloy 718: (a) gas porosity and (b) lack of fusion. The arrow on the left indicates the build direction.

The as-built specimen was also subjected to HIPing, which caused a significant reduction in defect content. A closer investigation of the entire HIPed specimen revealed that nearly all the shrinkage porosities were healed. However, some of the gas porosities and lack of fusion defects were present after HIPing, as shown in Figure 4. A possible explanation for remnant gas porosities after HIPing could be entrapped argon gas, which exerts opposite pressure and can hinder complete closure [6]. However, the defects of typically more serious concern are lack of fusions [6]. A vast majority of remnant lack of fusion defects were found to be surface-connected (open), as exemplified in Figure 4b; therefore, these were not healed after HIPing. This is consistent with several other studies by Tammam-Williams et al. [11] and Tillmann et al. [13], in which XCT was utilized to investigate the effects of HIPing on the defects in EBM-built materials, and it was observed that the remnant lack of fusion defects open to the surface were not closed after HIPing. The reason for this is pressure equalization inside and outside the defect, which can prevent it from closing [13]. In the case of EBM-built Alloy 718, Kotzem et al. [20] have also observed the presence of surface-connected defects. Therefore, to close such defects in EBM Alloy 718, the specimens were coated and HIPed.

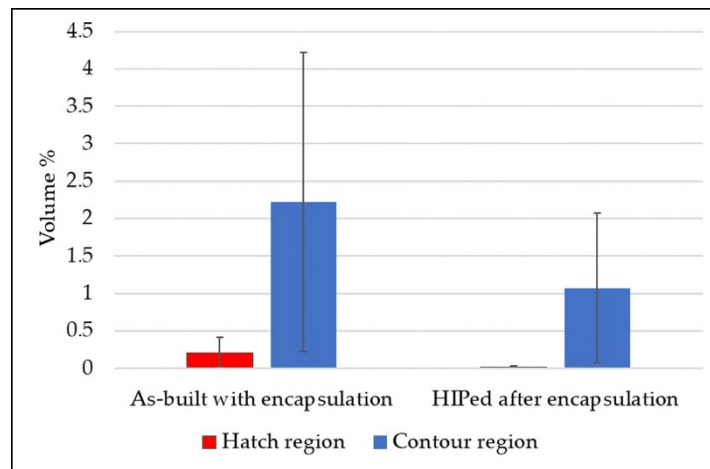
Figure 6. Defect content in the coated condition measured in the hatch and contour regions along the build direction.

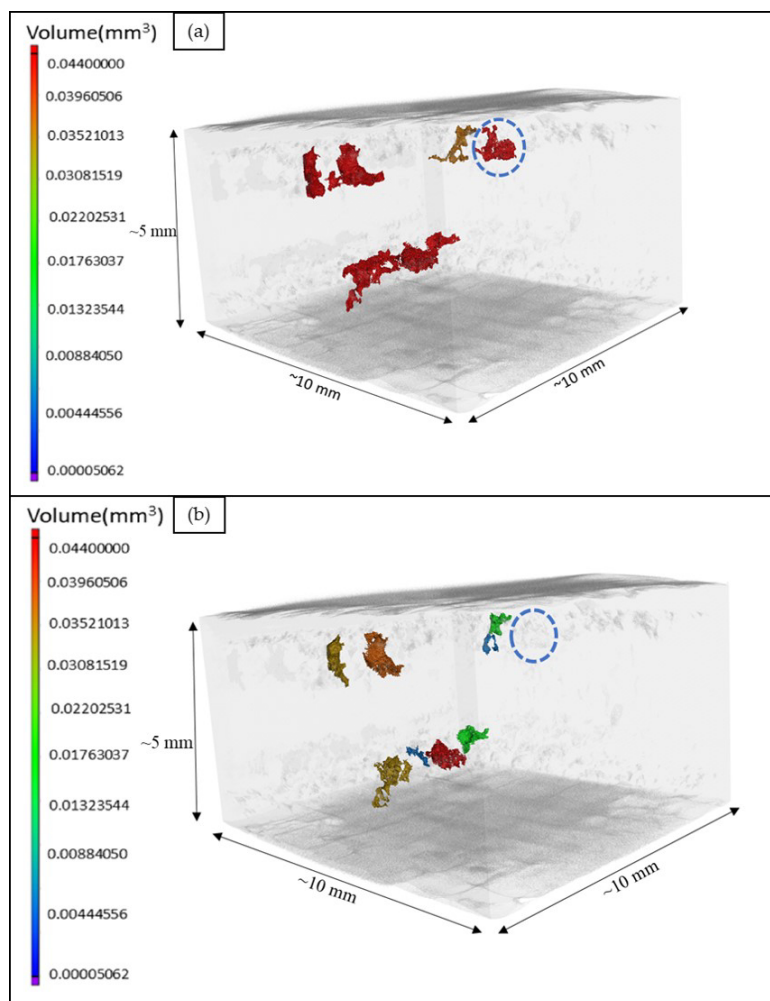
Figure 7. Three-dimensional (3D) views of large defects in the same coated sample (a) before and (b) after hot isostatic pressing (HIPing), obtained from x-ray computed tomography (XCT) analysis.

In order to get a more detailed understanding of the above observation, especially to identify surface-connected defects, further XCT analysis was carried out. A coated sample was analyzed before and after HIPing to precisely track the defects in the two conditions through XCT. The larger lack of fusion defects, which had a connection to the EBM specimen-coating interface, were separately analyzed, as shown in Figure 7. The defect close to the EBM specimen surface marked with the blue dotted circle in Figure 7a appeared to be fully closed after HIPing, or at least reduced to a size below the resolution limit of XCT. This is attributable to the successfully complete encapsulation of this otherwise surface-connected defect, which could be healed during HIPing. However, some other defects appeared to be not fully closed. This could be possibly attributed to incomplete encapsulation

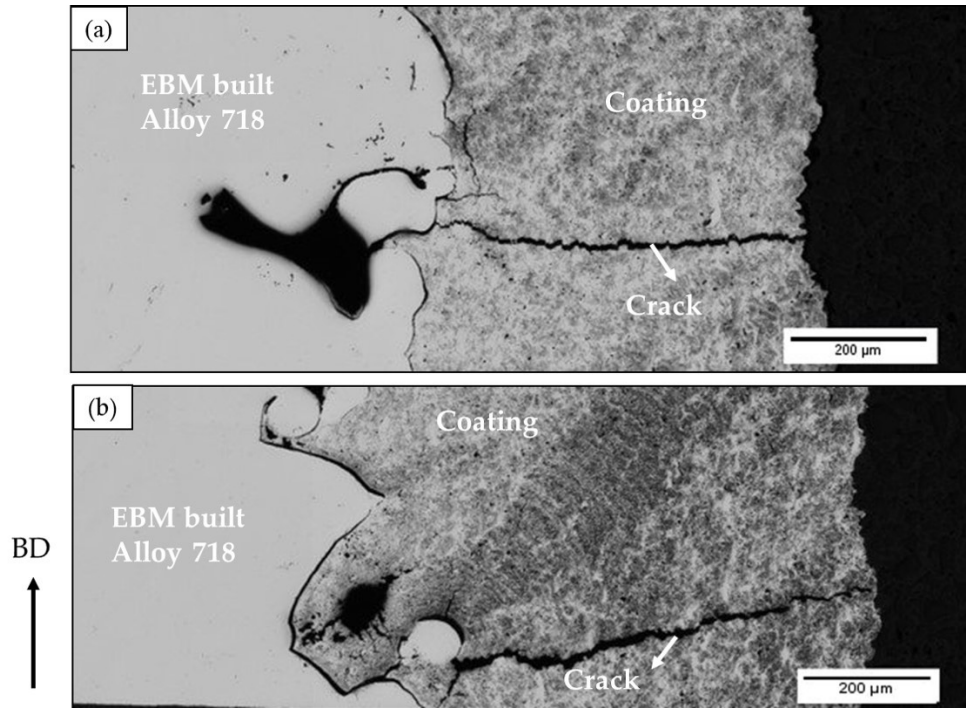
Figure 9. LOM micrographs showing (a) a crack in the as-built sample and (b) a remnant crack present in the HIPed sample.

The interface between EBM specimen and coating exhibited gaps, as shown in Figure 5b, which could be attributed to the high surface roughness of the as-built EBM Alloy 718. It is pertinent to note that the coating was applied on the as-built surface without any prior surface preparation. The surface roughness value of the as-built EBM specimen was nearly $80 \mu\text{m Sa}$, as measured by white light interferometry, and such high roughness could have hindered complete sealing of the specimen surface. In this context, it is worth mentioning that, although it is necessary to have an appropriately rough substrate to be used for any thermal spray coating process, to achieve better coating-substrate adhesion, an excessively high surface roughness can introduce defects at the substrate-coating interface by not permitting the molten splats to completely fill the “valleys” in the existing surface asperities (see Figure 5b). In the present study, the coating was deposited on a rather rough surface ($Sa \sim 80 \mu\text{m}$) compared to what is typically reported in the literature, i.e., about $10 \mu\text{m}$ [21–24]. In addition to these interface defects, several through-thickness vertical cracks were observed in both the coated samples, i.e., HIPed and not HIPed condition, as shown in Figure 9, which could also be possibly attributed to the high surface roughness. The total porosity content of the coatings before and after HIPing, as evaluated by image analysis, is shown in Figure 10. It can be seen from the figure that HIPing resulted in porosity reduction by an order of magnitude. However, some amount of porosity was present after HIPing. The vertical cracks, gaps at the EBM specimen-coating interface, and the porosity

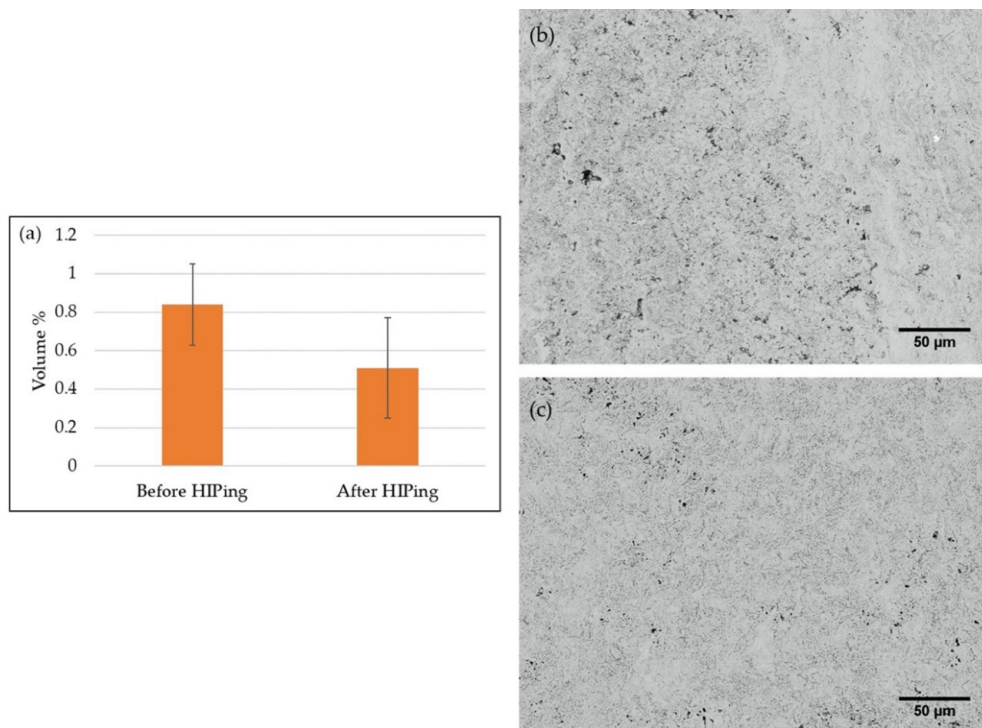
Figure 10. (a) Porosity content in the coatings before and after HIPing, as determined by image analysis, SEM micrographs of the coating (b) before HIPing, and (c) after HIPing.
