Study on Microstructure and Fatigue Properties of FGH96 Nickel-Based Superalloy

Abstract: In this study, using synchrotron radiation X-ray imaging, the microstructure, tensile properties, and fatigue properties of FGH96 nickel-based superalloy were tested, and the fatigue damage mechanism was analyzed. An analysis of the experimental results shows that the alloy structure is dense without voids or other defects. It was observed that the primary γ' phase is distributed on the grain boundary in a chain shape, and the secondary γ' phase is found inside the crystal grains. The X-ray diffraction (XRD) pattern indicates that no other phases were seen except for the γ and γ' phases. The tensile strength of the alloy is 1570 MPa and the elongation is 12.1%. Using data fitting and calculation, it was found that the fatigue strength of the alloy under the condition of 5×10^6 cycles is 620.33 MPa. A fatigue fracture has the characteristics of secondary crack, cleavage step, fatigue stripe, tire indentation, and dimple. The fracture is a mix of cleavage fracture and ductile fracture. Through a three-dimensional reconstruction of the alloy synchrotron radiation imaging area, it was found that

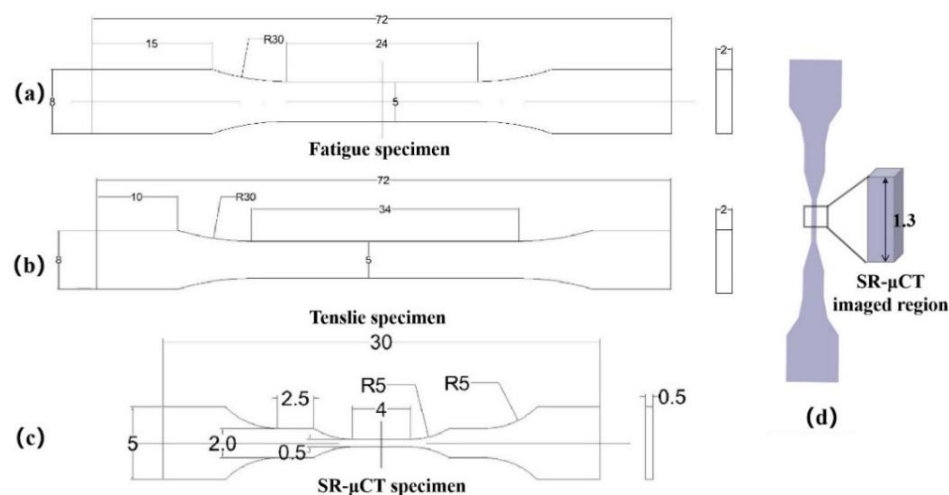
Figure 1. Specimen size: (a) fatigue specimen, (b) tensile specimen, (c) SR- μ CT specimen, (d) synchrotron radiation imaging region (dimensions in mm).

The fatigue test dimensions were designed according to the national standard GB/t3075-2008, as shown in Figure 1a, the tensile test dimensions were designed according to GB/T228-2002, as shown in Figure 1b, and the synchrotron radiation X-ray computed tomography (SR- μ CT) dimensions were designed according to the requirements of the Shanghai light source test samples, as shown in Figure 1c. The three samples were obtained by wire cutting. The microstructure observation, hardness test, fatigue test, fatigue, and tensile specimen fracture observation test were carried out on the material. The test methods and test equipment are shown in Table 2 below.

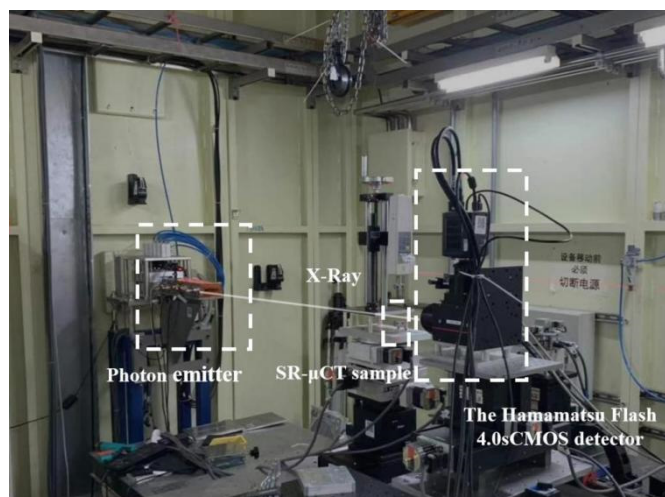
Figure 2. Image of the experimental device for detecting internal defects in the alloy at BL13W1.

The internal defects of the material were detected at BL13W1 of Shanghai synchrotron radiation source (see Figure 2). The SR- μ CT sample was placed 30 cm away from the 4.0 SCMOS detector of a Hamamatsu flash lamp. To ensure penetration, the photon energy was 42 keV. The space pixel size was 0.65 μ m. The exposure time was 4 s, and the imaging area is shown in Figure 1d. In the process of X-ray imaging, the sample is usually rotated 180° around the vertical axis, the rotation angle increment is 0.25°, and 720 projections can be collected at one time. Pitre and P3B software (PITRE V. 3.0, 2013, Shanghai Institute of Applied Physics, Chinese Academy of Sciences) were used to convert the data into 8-bit slices, and Avizo software (Avizo 9.5, 2019, Thermo Fisher Scientific, Waltham, MA, USA) was used to reconstruct the internal defects.

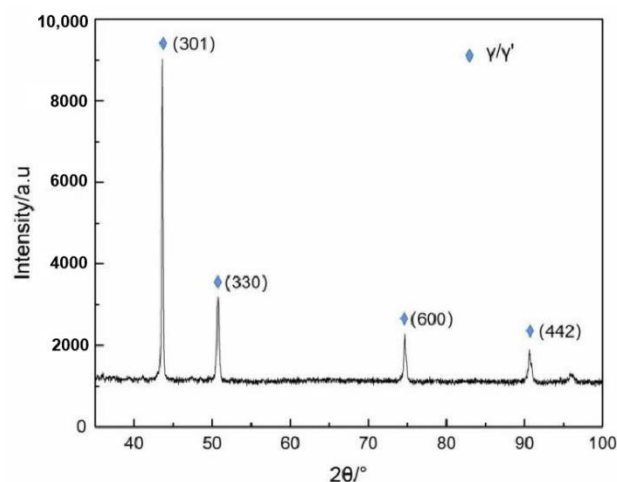
Figure 4. XRD diffraction pattern.

An XRD (X-ray diffraction) analysis of the surface structure of FGH96 nickel-based superalloy shows that it is mainly composed of γ and γ' . The phase composition is shown in Figure 4, and the diffraction pattern shows that there are no other phases in the alloy.

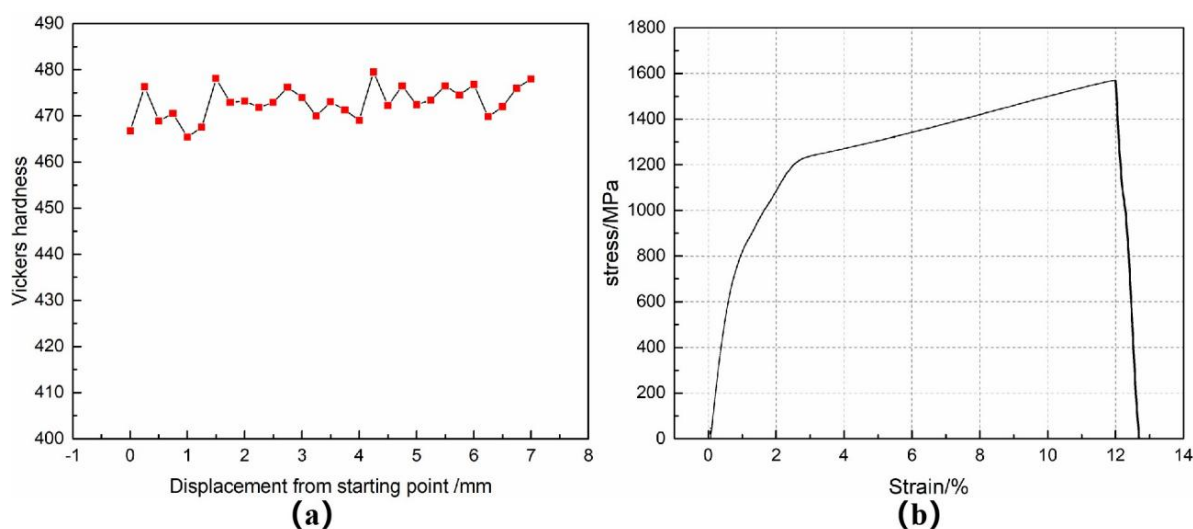
Figure 5. (a) Microhardness curve, (b) tensile stress–strain curve.

The room temperature hardness of the FGH96 nickel-based superalloy sample was measured. To reduce the hardness measurement error and avoid accidental data, it was measured every 0.25 mm from the first point. A total of 20 points were tested, as shown in Figure 5a. It can be seen from the figure that the hardness value does not change much, indicating that the γ' phase distribution on the alloy surface is relatively uniform. After calculating the hardness data of multiple measurements, the average room temperature hardness of the FGH96 nickel-based superalloy is 470.6 HV.

The tensile sample was tested. The relationship between material stress and strain is shown in Figure 5b. It is concluded that the tensile strength of FGH96 nickel-based superalloy is 1570 MPa and the elongation is δ 12.1%. FGH96 nickel-based superalloy relies on Ni to dissolve Cr, Co, W, Mo, and other alloy elements to strengthen the solid solution, weaken the element diffusion, form high-temperature resistant atomic groups, and reduce the stacking fault energy. At the same time, a large number of solute atoms play a pinning role in the dislocation aggregation [21] to reduce the dislocation activity. When the dislocation cuts through γ' , a higher external force is required to produce obvious second-phase strengthening. Through these two strengthening methods, the material has high tensile strength. In the plastic deformation process of FGH96 nickel-based superalloy, it mainly depends on the γ' precipitate phase to hinder the dislocation movement. The

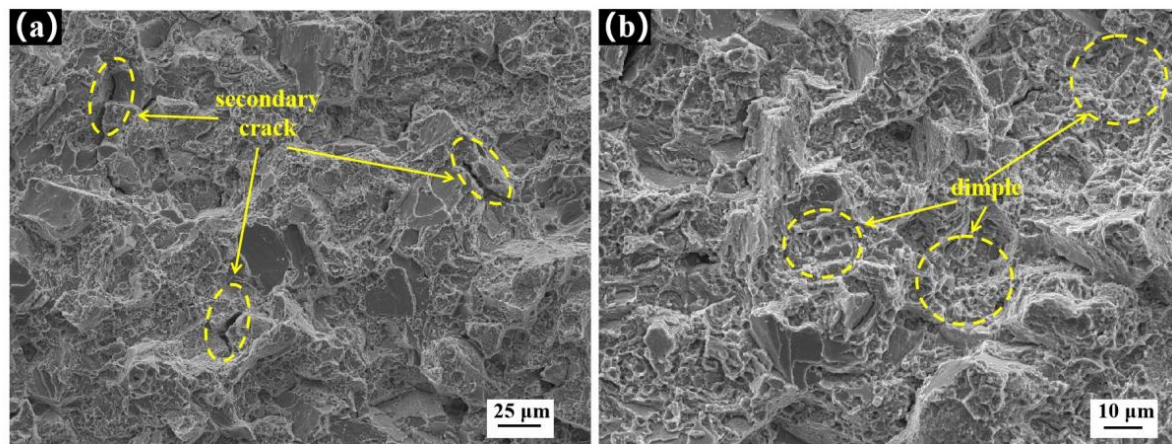
Figure 6. Tensile fracture morphology: (a) secondary cracks, (b) equiaxed dimples.

tensile fracture morphology of FGH96 nickel-based superalloy is shown in Figure 6. In Figure 6a, the secondary crack (in the yellow ellipse) can be observed. The secondary crack grows inward perpendicular to the tensile fracture surface, which shows that the material has a certain brittleness in the tensile process. In Figure 6b, there are many equiaxed dimples, and the large number of dimples shows that the plasticity of the material is high.

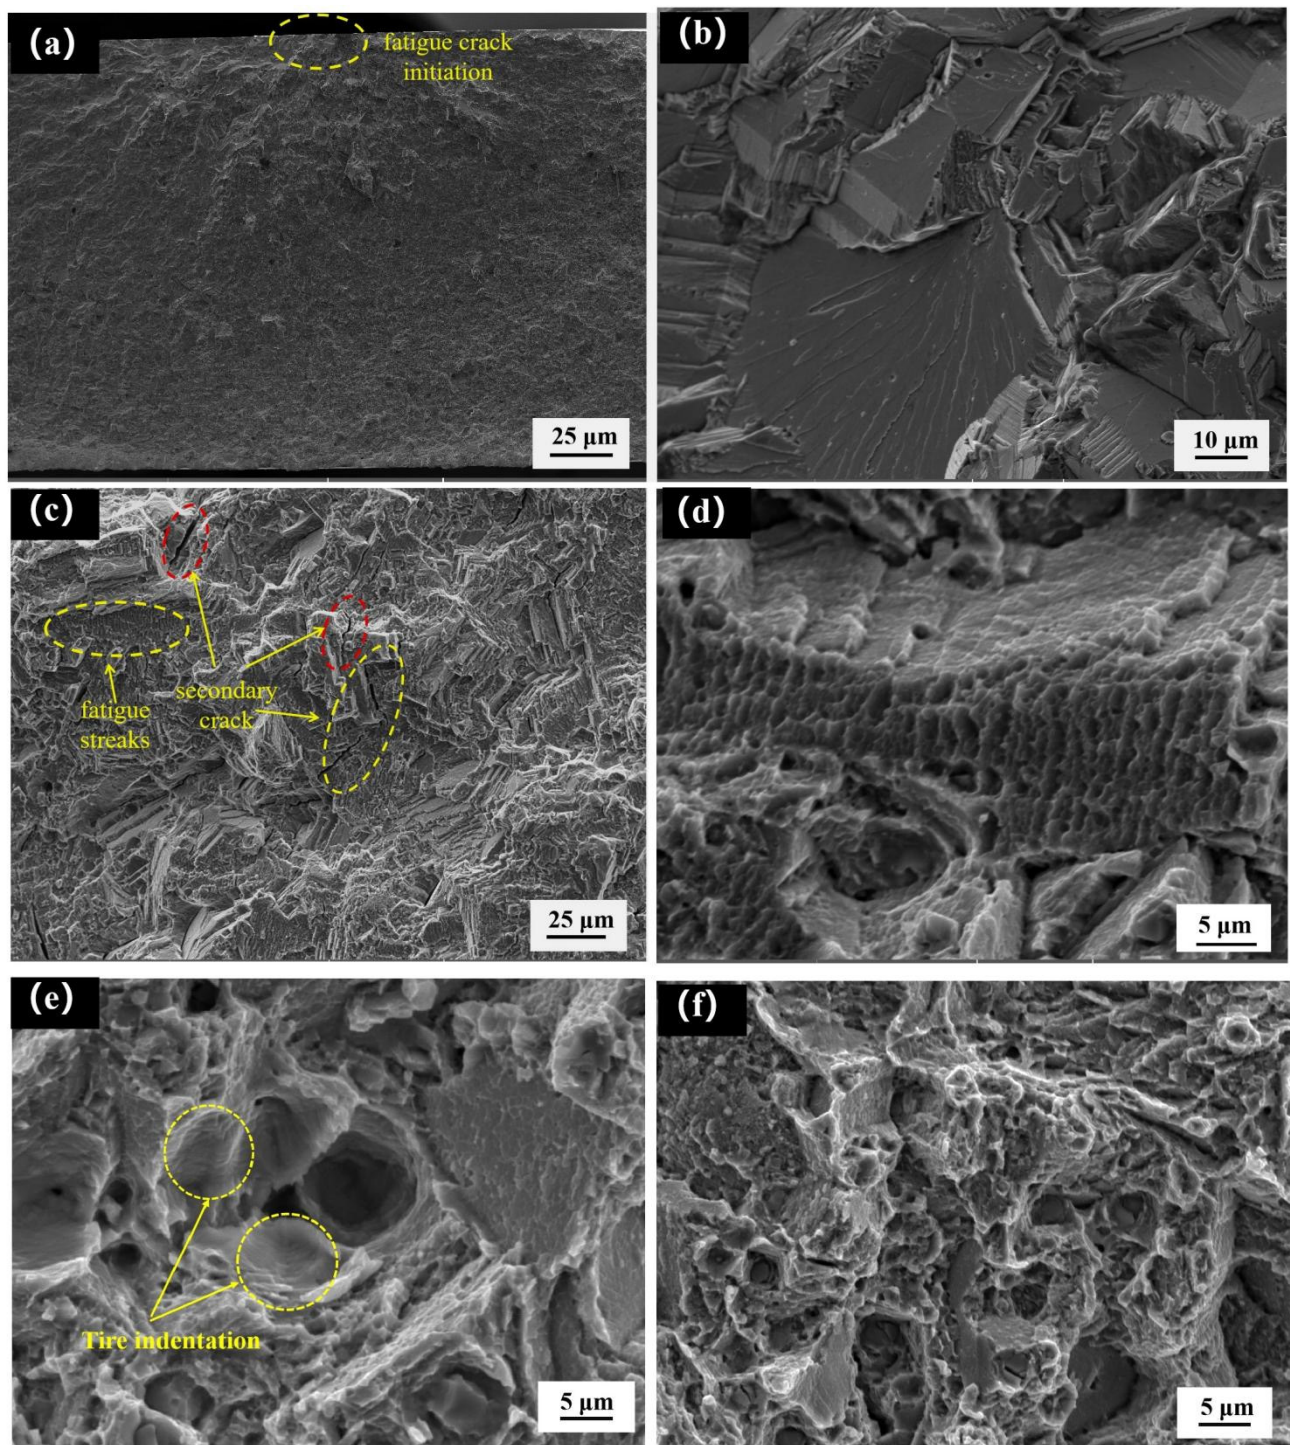
Figure 8. Fatigue fracture topography: (a) fatigue crack initiation, (b) cleavage step, (c) secondary cracks and fatigue streaks, (d) brittle fatigue streaks, (e) tire indentation, (f) dimples.

Figure 8 shows the fatigue fracture morphology at 810 MPa, and the fatigue source area is shown in Figure 8a. It can be seen from the figure that the crack source is formed in the middle of the sample surface, and the crack diffuses around in a fan-shaped manner. At this time, the crack propagation rate is the slowest. Figure 8b shows the cleavage step in the fatigue source area. Figure 8c shows the stable stage of fatigue crack. There are many secondary cracks in the figure. The secondary crack shown in the yellow circle extends along the tear ridge, and the crack as a whole is Z-shaped. The secondary crack shown in the red circle passes through the tear ridge and consumes a large amount of energy, resulting in the stop of crack propagation. The fatigue stripe is a typical feature of stable crack growth. The fatigue stripe shown in Figure 8c is relatively smooth, so it is a plastic fatigue stripe, and the direction of the fatigue stripe is parallel to the direction of the secondary crack. The fatigue stripes shown in Figure 8d are brittle fatigue stripes

with an uneven surface morphology, and there are cleavage steps formed by five cleavage surfaces above the stripes. Figure 8e,f show the morphology of the instantaneous fracture zone. Under a high stress cyclic load, tire indentation appears, as can be seen in Figure 8e,f, dimple morphology appears. In this stage, the crack is in the high-speed propagation phase. Under the action of fatigue cyclic load, dimples of different sizes gradually gather and connect with each other, and finally form a dimple fracture. Combined with the above characteristics, the fracture is a mix of cleavage fracture and ductile fracture.

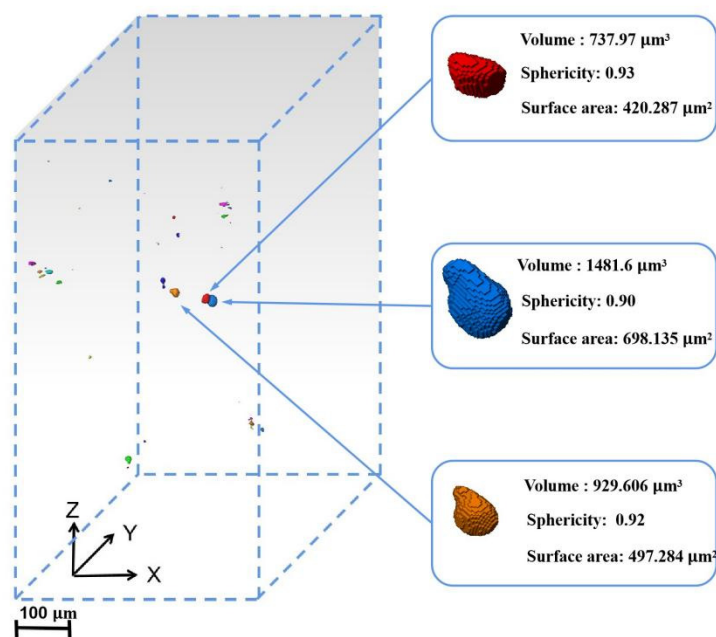
Figure 9. SR- μ CT imaging area reconstruction showing representative defects in the micro sample.

Figure 9 shows the imaging of the SR- μ CT sample with 3000 cycles under 950 MPa stress in the observation area of synchrotron radiation. The experimental data were sliced using Pitre software, and the three-dimensional image was then reconstructed using Avizo software. The volume of all defects in the sample was counted and analyzed, and the results shown in Figure 10b were obtained. There are 50 defects in the imaging area: where the volume is less than $50 \mu\text{m}^3$, there are 40 defects; for $50\text{--}200 \mu\text{m}^3$, there are six; and for more than $200 \mu\text{m}^3$, there are four. The sphericity of several larger defects in Figure 9 was analyzed, and the sphericity of the three defects is greater than 0.9. From the sphericity, it can be judged that the three defects are cavities. The whole defect is concentrated in the middle of the sample due to the high energy required for imaging, which reduces the total number of photons passing through the sample, resulting in the imaging results being concentrated in the middle of the sample. Figure 10a is a top view of the imaging area, and a large number of defects are distributed at the edge of the specimen. During the fatigue loading cycle, the fatigue source area is easily formed in the area where these defects are concentrated.

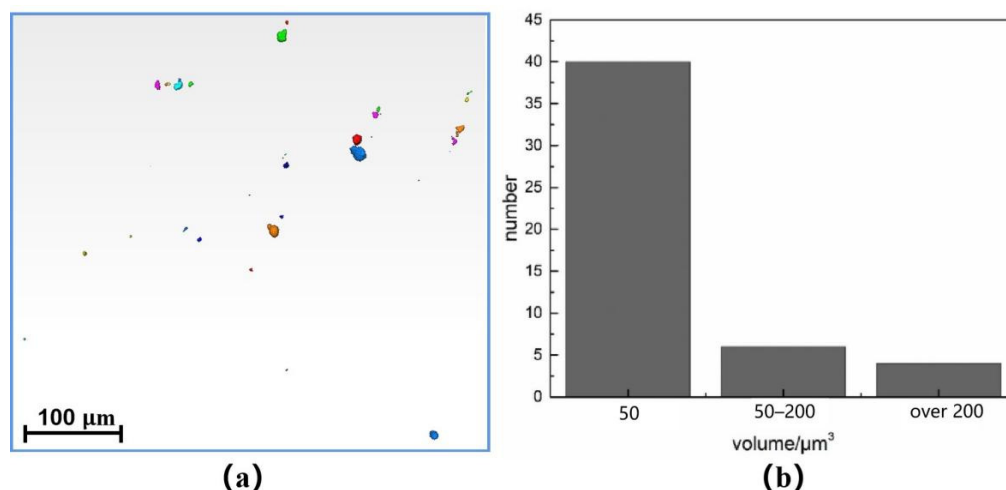
Figure 10. (a) Top view of imaging area, (b) statistical diagram of defect volume size.

- (3) Synchrotron radiation X-ray imaging shows that a defect volume less than $50 \mu\text{m}^3$ accounts for 80% of the total. The dimple morphology is formed by the growth and aggregation of cavities in the material. There are three cases of cavity germination: defects of the material itself, fracture of the second-phase particles, and separation of the interface between the second-phase particles and the matrix.

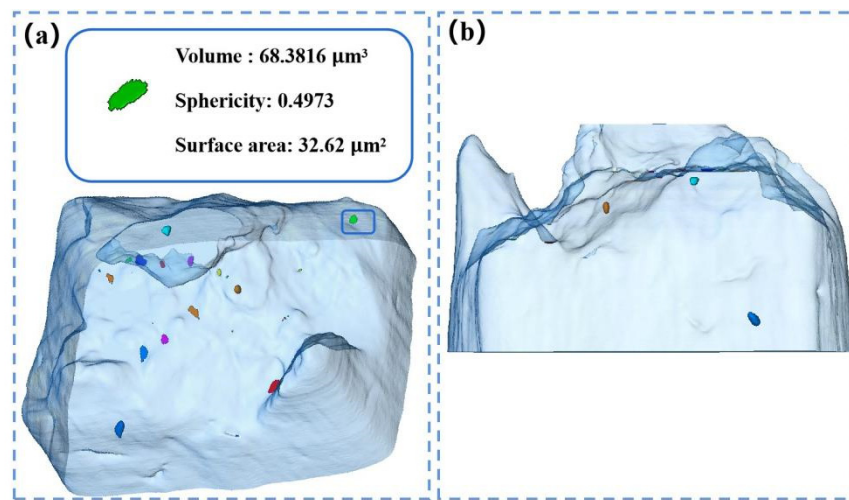
Figure 11. (a) Top view of fracture imaging, (b) side view of fracture imaging.

The fatigue test of the sample was continued, and the sample fractured when the cumulative number of cycles reached 5625. The fatigue fracture was imaged by synchrotron radiation X-ray. Figure 11b is the side view of the fracture 3D reconstruction morphology. It can be seen from Figure 11b that most of the defects in Figure 11a are surface defects. Figure 12 is a SEM diagram of the fatigue fracture of the synchrotron radiation specimen, Figure 12a is the macro morphology of the fatigue fracture, and Figure 12b is the top view of the three-dimensional morphology. It can be seen that the defects shown in the blue box of Figure 11a are in the fatigue source area of Figure 12a. As the number of fatigue cycles is less, the characteristics of the fatigue source region are not obvious, and the whole fracture morphology is similar to that of a tensile fracture. Figure 12c shows the crack growth zone, in which secondary cracks appear, and Figure 12d shows the morphology of the instantaneous fracture zone, with a large number of equiaxed dimples. Through an enlarged observation of this area, it can be seen in Figure 12e that there are complete and broken particles at the lower part of the dimple. An EDS analysis of the particles was carried out. The analysis results are shown in Figure 12f. Through its element content ratio,

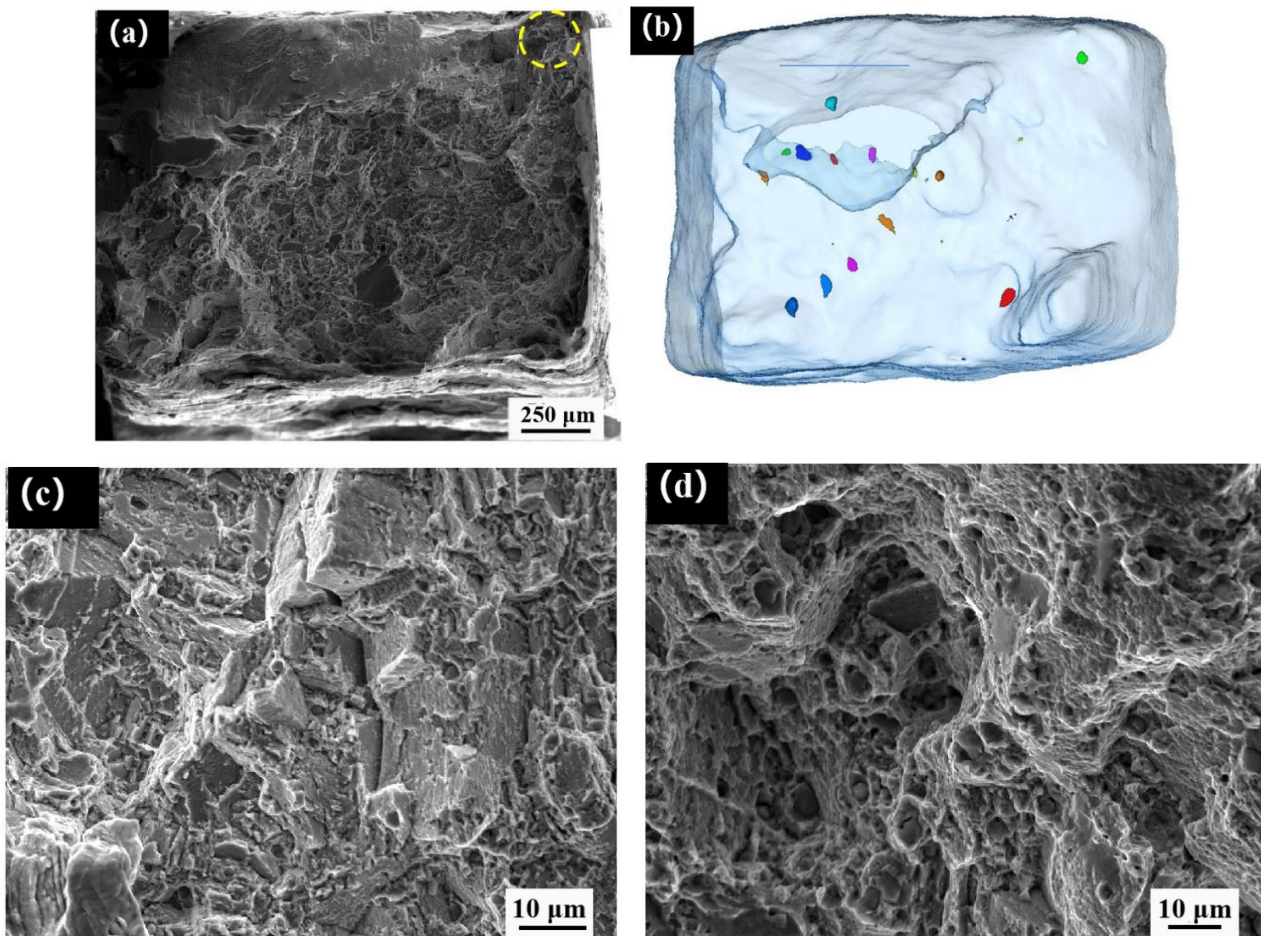
Figure 12. (a) Fatigue fracture morphology, (b) top view of fracture imaging, (c) second crack, (d) dimple morphology, (e) second-phase particles, (f) EDS analysis results.

it can be judged that the particles are Ni_3Al , which is an important strengthening phase of nickel-based superalloy.

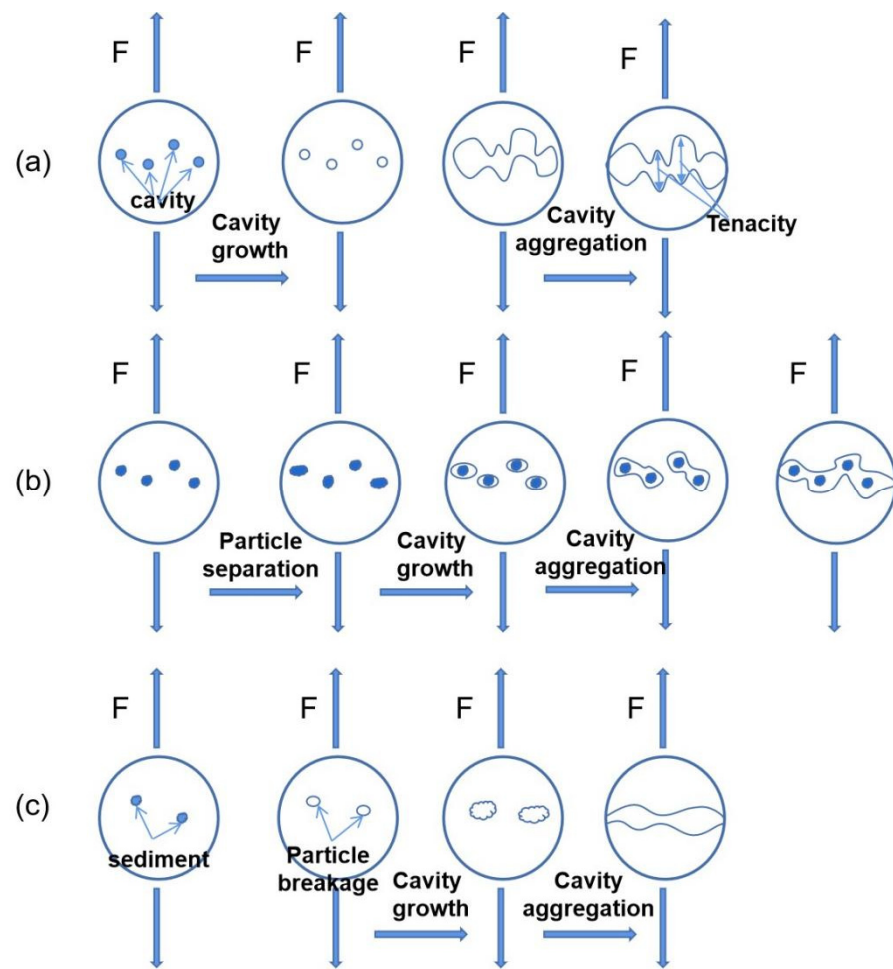
Figure 13. Formation mechanism of fatigue dimple: (a) cavity growth, (b) separation of second-phase particles, (c) fragmentation of second-phase particles.

To analyze this phenomenon, due to the face-centered cubic structure of Ni-based superalloy with good slip properties, the cavities grow up gradually under cyclic loading and connect with other cavities to form dimple fractures, as shown in Figure 13a. Figure 13b shows that the second-phase particles are separated from the matrix to form dimples. According to the dislocation theory, the dislocation loops are stacked around the second-phase particles under cyclic loading. When the external force is small, the dislocation loops keep equilibrium under the interaction of dislocation stacking stress and the repulsive force of the second-phase particles. When the external force gradually increases, the dislocation loops move towards the second-phase particles. When the accumulated elastic strain can overcome the interfacial bonding force between the second-phase particles and the matrix to form a new surface, new micro voids can be formed. At the same time, the repulsive force of the second-phase particles on the dislocation ring is weakened, which makes the dislocation move to a new micro cavity under the action of external force and makes the cavity grow. With the disappearance of stacking dislocation constraints, new dislocations are generated from the dislocation sources, and the cavities expand and aggregate rapidly. Under the action of tensile stress, a large number of cavities grow up, and the cross-section of the matrix between the adjacent cavities gradually becomes smaller. When they connect with each other, fracture occurs, forming dimple fractures. The dimple formation mechanism shown in Figure 13c is similar to that in Figure 13b, except that Figure 13b shows the separation of the second-phase particles from the matrix, and Figure 13c shows the fracture of the second-phase particles. After the fracture of the second-phase particles, micro cavities are formed, which grow and gather to form dimple fractures.

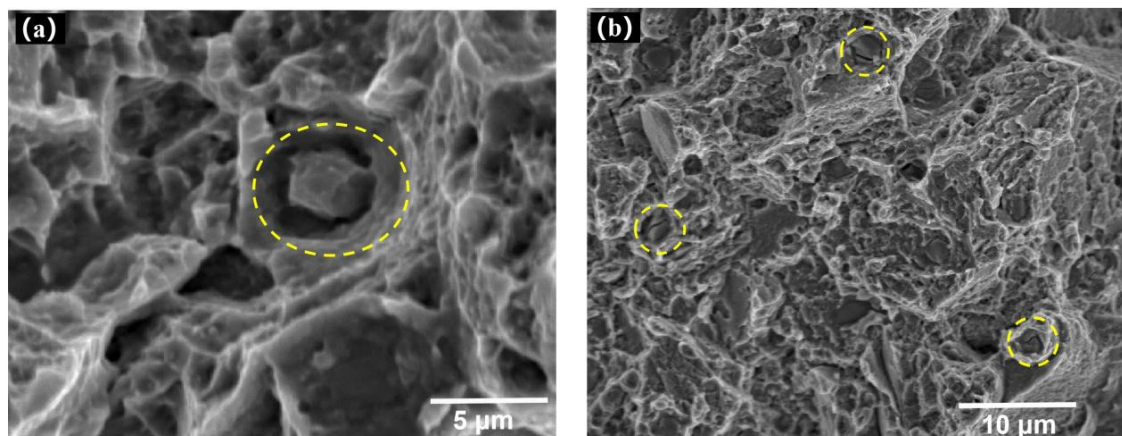
Figure 14. (a) Complete second-phase particle, (b) broken second-phase particle.

Figure 14 shows two kinds of second-phase particles at the bottom of a fatigue dimple. Figure 14a shows the complete second-phase particles at the bottom of the dimple. Figure 14b shows the broken second-phase particles at the bottom of the dimple. The experimental results are consistent with the phenomenon of mechanism formation shown in Figure 13.

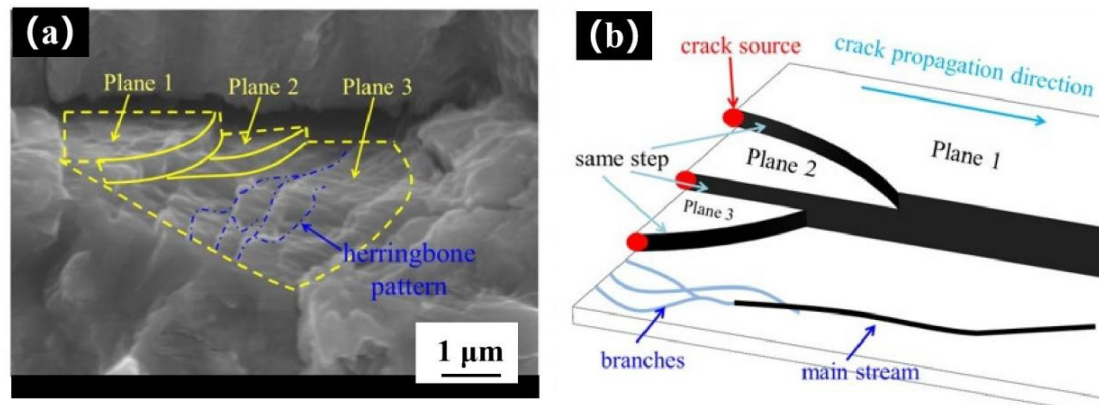
Figure 15. (a) SEM image of cleavage step, (b) schematic diagram of the formation mechanism of cleavage steps.

Figure 15a shows the cleavage planes and cleavage steps found in the fatigue test fracture. There are three cleavage planes in total. There are a large number of river patterns on one of the cleavage planes. The cleavage steps are generated by the propagation along different planes after the fatigue crack initiation, and are typical cleavage fractures.

The cleavage plane and river pattern principle is shown in Figure 15b. The fatigue crack enters the propagation stage after cracking, but it does not propagate along one plane in the propagation process, instead it will propagate along several planes at the same time. The volume of the parallel end of the fatigue test sample at the same height is 40 folds that of the SR- μ CT sample. From the imaging results, it can be judged that there are a large number of small defects in the fatigue sample. When a crack encounters internal defects, grains, and the second equal interface, it may deflect and expand in different planes. The cracks in different planes extend the same distance in the same cycle, and finally form a river pattern. Therefore, a river pattern also contains steps, which are generally shallow and difficult to distinguish from the figure. When steps are formed in the process of fatigue crack propagation, some energy will be lost due to the propagation in other directions. Therefore, a large number of cracks will converge into the main cracks in the process of propagation, and the tributaries will converge into a main stream. Therefore, according to the flow direction, we can know how a crack is propagated. The tributaries of the river pattern continue to gather to form the main stream, which will eventually form cleavage steps, and the fatigue cracks will continue to expand along the cleavage plane, eventually leading to a fracture. This is the formation mechanism of the cleavage plane and cleavage steps.

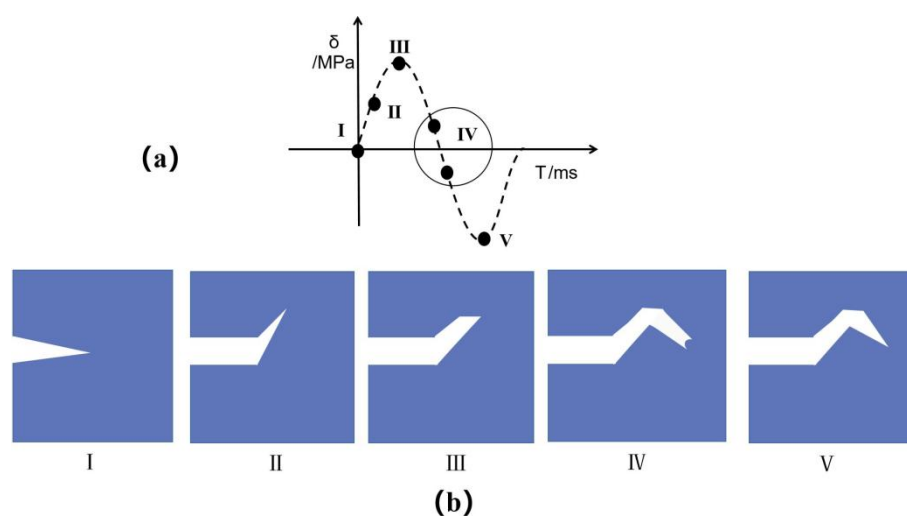
Figure 16. (a) Schematic diagram of cyclic stress, (b) Z-shaped expansion mechanism.

In the fracture morphology, many secondary cracks are found to expand as “Z”. A model was established, as shown in Figure 16, to analyze the crack propagation mechanism. The cyclic stress of a fatigue test is represented as a sine wave, and Figure 16a shows the cyclic stress diagram of one cycle. The whole cycle was divided into five stages to analyze the Z-word expansion mechanism, as shown in Figure 16b. In the first stage, the crack is treated and closed. When the external force gradually increases, the crack begins to expand obliquely above, and then enters the second stage. In the third stage, when the external force reaches the apex, the crack tip is passivated, and the crack cannot continue to expand in the original direction due to a gradual reduction in the external force. In the fourth stage, the stress changes from tensile stress to compressive stress, the crack expands obliquely downward, and the crack tip changes into a folded ear shape under the increasing compressive stress. In the fifth stage, the compressive stress reaches maximum and the crack tip closes again until the end of this cycle. After a cycle, the crack can only advance a short distance, and this process is repeated until the sample breaks.
