Article

Effect of Varying Working Distances between Sandblasting Device and Composite Substrate Surface on the Repair Bond Strength

Keywords: composite repair; aluminum oxide sandblasting; working distance; microtensile bond strength

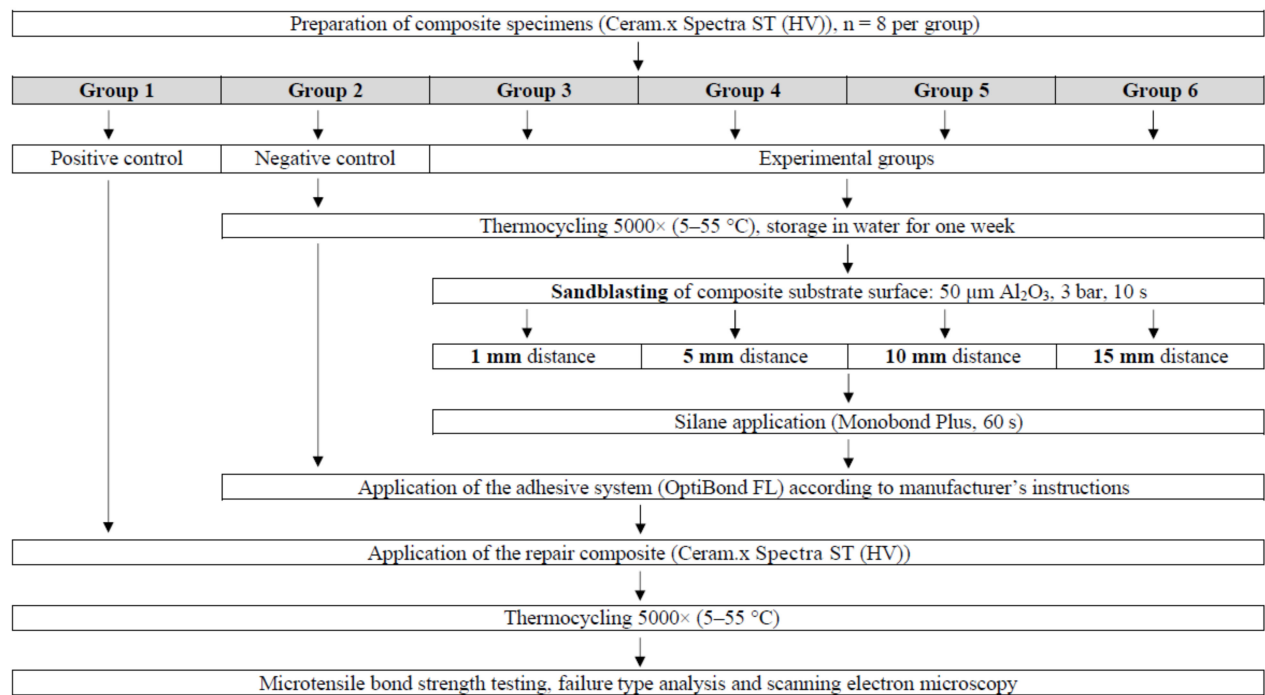
Figure 1. Experimental design.

Figure 1 illustrates the experimental design of the current study. The manufacturer details and the chemical composition of the materials used are provided in Table 1. Forty-eight specimens of a nanohybrid composite with prepolymerized fillers (Ceram.x Spectra ST (HV); Dentsply Sirona, Konstanz, Germany; shade: A4; lot No.: 1907000298) were prepared for this study. This material pertains to contemporary dental resin composites, comprising a modified methacrylate resin matrix filled with ground glass and prepolymerized filler particles. The surfaces of filler particles are typically coated with a silane coupling agent that enables their bonding to the methacrylate resin. The composite material is rendered photosensitive by camphorquinone and tertiary amine, enabling it to set on-demand in clinical work by illumination using blue light [23].

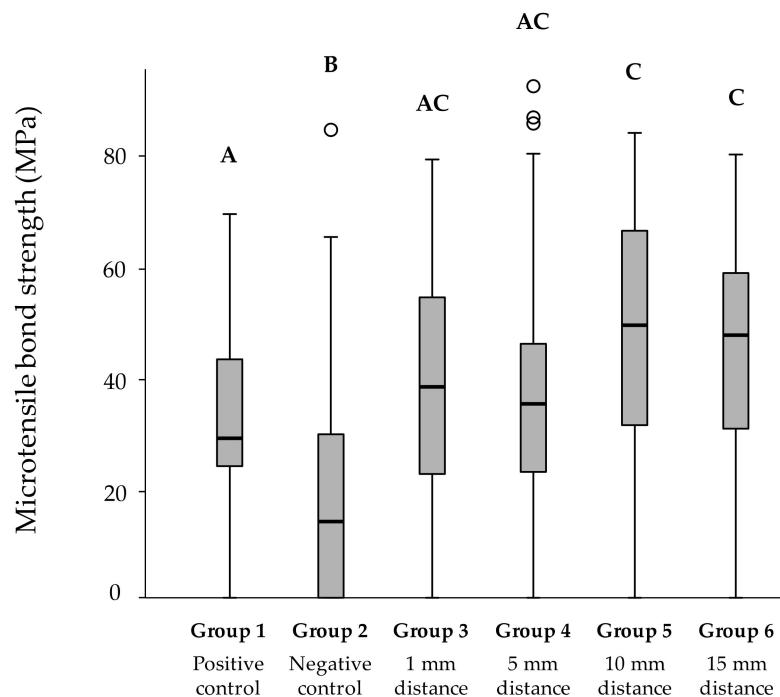
Figure 2. Microtensile repair bond strengths (MPa) of composite surfaces after sandblasting from varying working distances. Significant differences between groups are indicated by different letters ($p < 0.05$). Within each boxplot, the median is represented by a horizontal bold black line. The 25% and 75% data quartiles are shown as boxes, and the whiskers mark the $1.5 \times$ interquartile range (IQR) at the 25th and 75th percentile of each group. The outliers of groups 2 and 4 are shown as circles.

Figure 2 illustrates the microtensile repair bond strengths of the composite substrate surfaces pretreated with aluminum oxide sandblasting from the different working distances. The negative control group (group 2: $19.1\ \text{MPa} \pm 13.0$) reached the significantly lowest microtensile bond strength of all groups ($p < 0.05$). Repair bond strength of the positive control group (group 1: $32.2\ \text{MPa} \pm 4.8$) did not differ significantly from composite surfaces pretreated with aluminum oxide particles at a distance of 1 mm (group 3: $39.1\ \text{MPa} \pm 8.5$) or 5 mm (group 4: $37.8\ \text{MPa} \pm 9.5$). However, significantly higher bond strengths were found for group 5 with a sandblasting distance of 10 mm (group 5: $47.5\ \text{MPa} \pm 12.1$) and group 6 with a distance of 15 mm (group 6: $43.9\ \text{MPa} \pm 10.3$), compared to the positive control group (group 1). No significant differences in repair bond strengths could be observed within the experimental groups (groups 3–6) with working distances from 1 mm to 15 mm between composite substrate surface and tip of the sandblasting device.

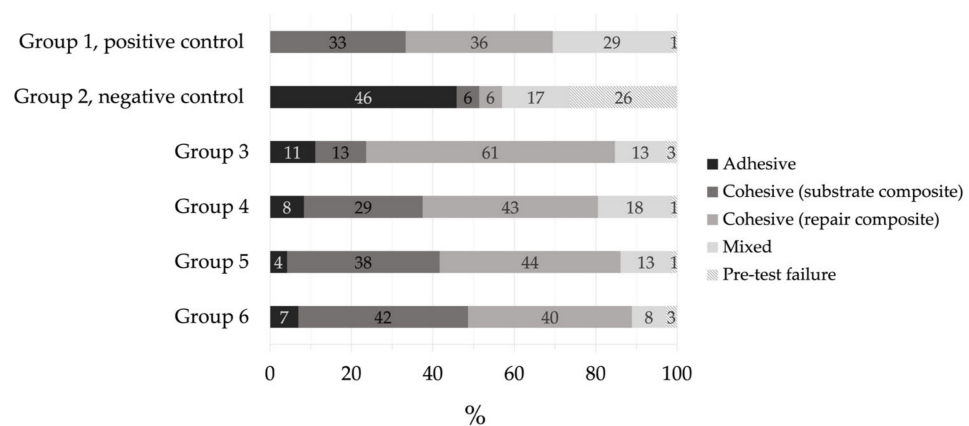
Figure 3. Percentage (%) of failure mode distribution per group.

Figure 3 depicts the failure mode distribution of all groups of the current study assessed at $25\times$ magnification with an optical light microscope. In the majority of groups (groups 1, 3–5), the most frequent failure mode was cohesive within the repair composite. In group 6, however, cohesive failures in the substrate composite were most frequently

observed. The highest percentage of pretest failures was found in the negative control group (group 2).

In the present study, cohesive failures in the repair composite were the predominant failure mode in most of the experimental groups, followed by cohesive failures in the substrate composite. The small number of adhesive failures in all groups except the negative control group (group 2) is noticeable and might be explained by degradation processes in

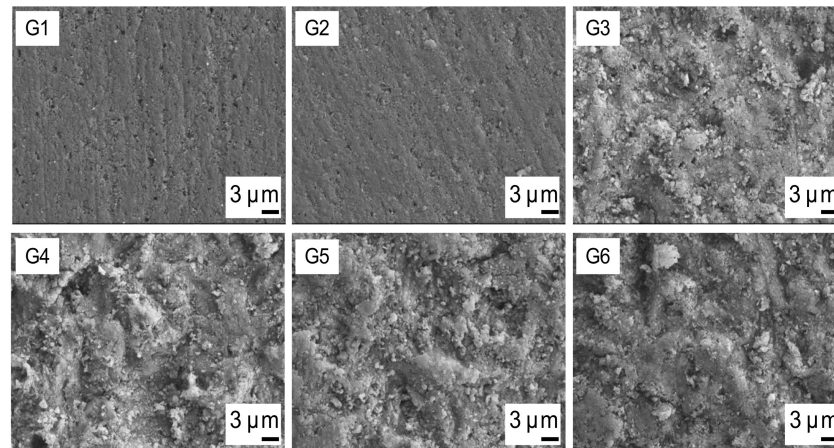
Figure 4. Scanning electron microscopy (SEM) images (5000× magnification) of the composite surfaces of all groups. G1: positive control group; G2: negative control group; G3–G6: composite substrate surfaces sandblasted from working distances of 1 mm (G3), 5 mm (G4), 10 mm (G5), and 15 mm (G6).

Micromorphological SEM images of the composite substrate surfaces are shown in Figure 4. In G1, the untreated composite surface is visible, whereas in G2 the aged composite surface without mechanical pretreatment is presented, both showing similar surface topography. G3–G6 of Figure 4 display the aged composite surfaces sandblasted from the varying working distances of 1 mm (G3), 5 mm (G4), 10 mm (G5), and 15 mm (G6). They exhibit similar surface structures among themselves, but they display a more irregular topography than the untreated positive control group (G1) and the solely aged composite surface of the negative control (G2). In addition, analysis by energy dispersive X-ray

spectroscopy revealed a similar chemical composition of groups 3–6 with no prominently high signals for aluminum. Table 2 presents the percentages of aluminum detected on the substrate surfaces based on the EDX element analysis by the Point-and-ID-method.
