Article

Influence of Elbow Angle on Erosion-Corrosion of 1018 Steel for Gas–Liquid–Solid Three Phase Flow

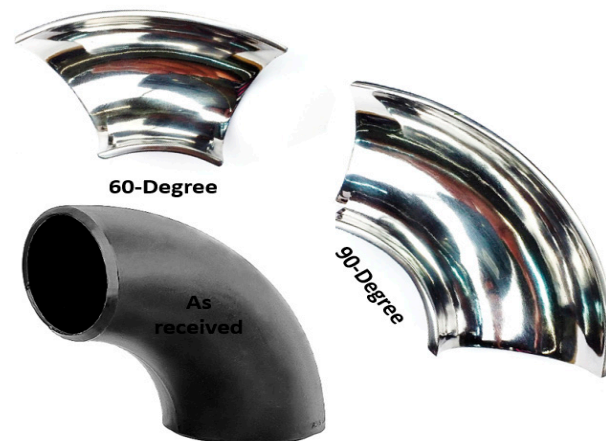
Figure 1. Elbow test specimen.

The elbow specimen used in this experimental study was 1018 carbon steel (CS) used with the following composition (in weight %): 0.2% C, 0.26% Si, 0.52% Mn, 0.21% Cr, and 98.12% Fe. The specimens were obtained from the supplier in the form of 90° elbow pipes and 60° elbow pipes. The elbow pipe, specimens in the shape of an axially cut section, as shown in Figure 1, were machined using wire electric discharge machining (WEDM). The finely polished specimens were obtained by grinding and polishing procedures resulting in a low-level surface roughness. The 10 × 10 mm² sizes of the specimens after the test were cut from the different locations of the elbow for microscopic imaging, as shown in Figure 2. A total of 36 specimens were cut from the upper and bottom walls of the 90° elbows and 60° elbows at various locations. The Vickers hardness of the specimens was evaluated under 5 N load using a diamond indenter for a 15 s indentation time using a Leco LM 247AT microhardness tester. The worn surface of the 90° and 60° elbow specimens was studied with a backscattered electron microscope (Phenom ProX, Eindhoven, The Netherlands). Each 10 × 10 mm specimen mass loss was measured using a precision weighing scale to quantify the wear rate after the test. The device used to acquire surface roughness parameters was Mitutoyo SURFTTEST SJ-210. Details about the testing procedure were published in our previous work [17,18].

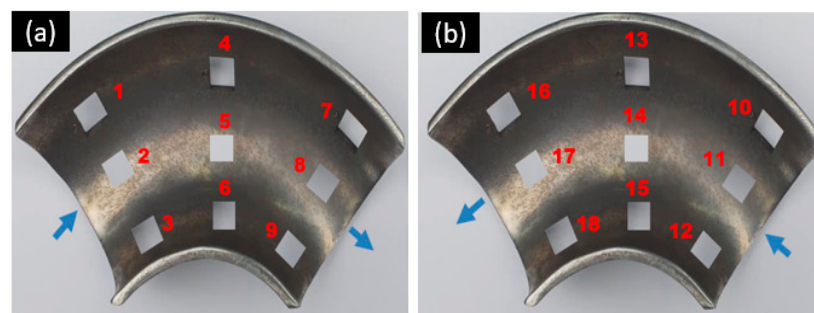
Figure 2. (a,b) Specimen location after test.

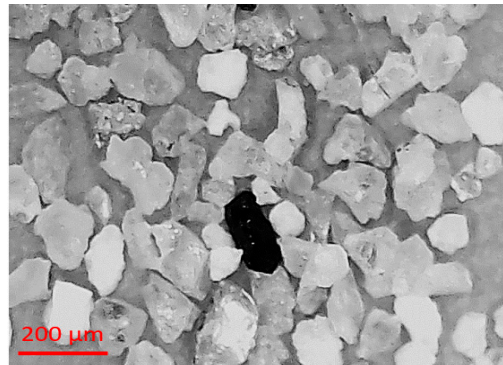
Figure 3. SEM image of silt grain particles.

The locally fabricated erosion test flow loop was fabricated in University Technology PETRONAS, Seri Iskandar, Malaysia, using an abrasive pump that used a rubber liner to avoid wear of the pump. The silt particle (silica sand) was used as an erodent for all the experimental evaluations, as shown in Figure 3. The designed flow loop was semi-automated to simulate multiphase flow test conditions. The silt and water carrier phases were mixed in the slurry tank using a stirrer. The dispersed phase and water were then circulated using a variable speed pump in the flow pipelines, as shown in Figure 4. The liquid flow rate was measured by a magnetic flow meter through a 50.8 mm diameter PVC

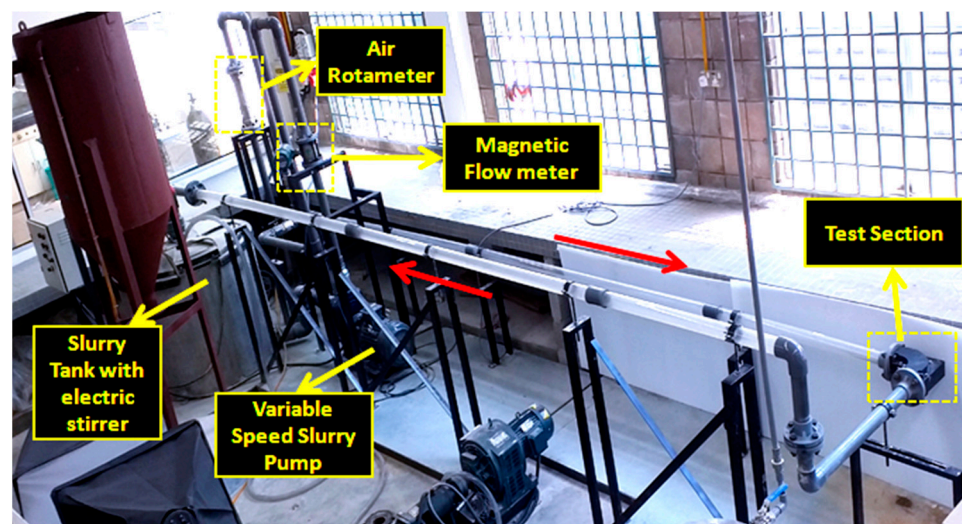
Figure 4. Layout of the experimental setup.

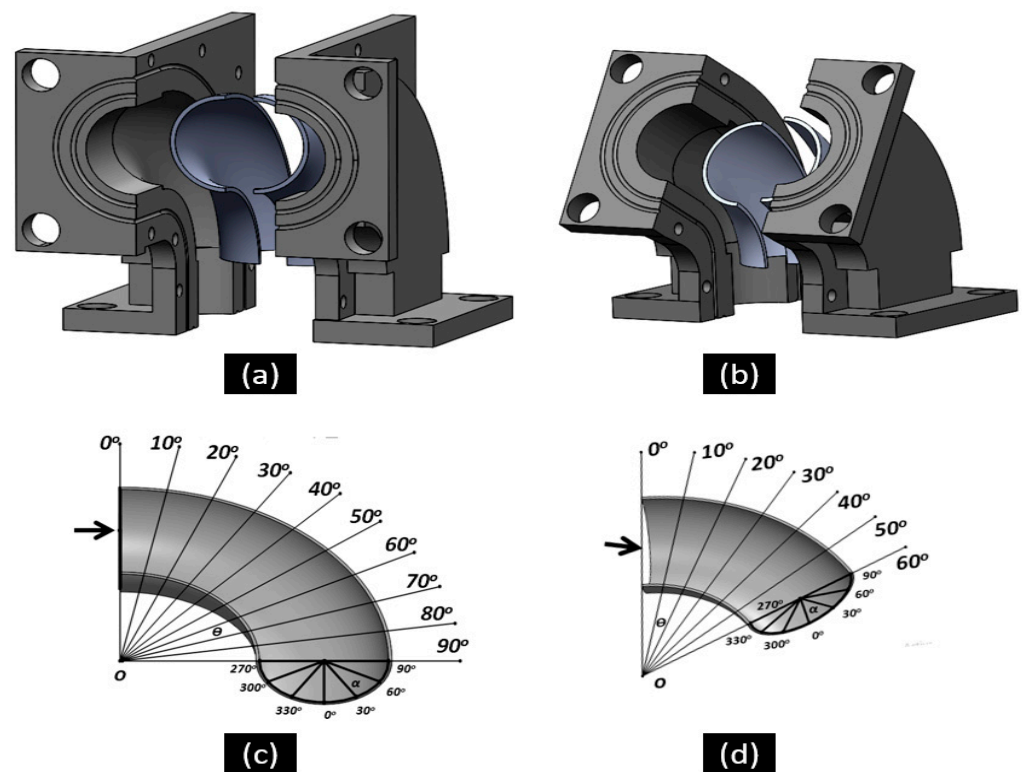
Figure 5. The 90° (a) and 60° (b) elbow test sections used for the erosion–corrosion studies; (c,d) definition of the axial angles.

The literature review showed that various erosion test methods have been implemented to study elbow erosion under different flow conditions [19]. Some of the tests use the square sample in which the flat plate is placed at a different axial angle along the elbow pipe. This method leads to huge mass transfer shifts and inaccuracy in measurements and reduces the accuracy of measured data. To resolve this issue, the finely polished elbow sample cut axially into two sections was integrated with the specimen holder in this study, as shown in Figure 5. To quantify the localized erosion rate, the 36 specimens ($10 \times 10 \text{ mm}^2$) were cut from different locations on the 90° and 60° elbows, and a standard mass loss test was adopted for erosion rate measurement after the test. The initial mass of all the samples was measured before the test using separate specimens. The location numbers of the specimens are shown in Figure 2a,b. The test section designed in this study used the representative elbow configuration, which provided a better understanding of the erosion mechanism.

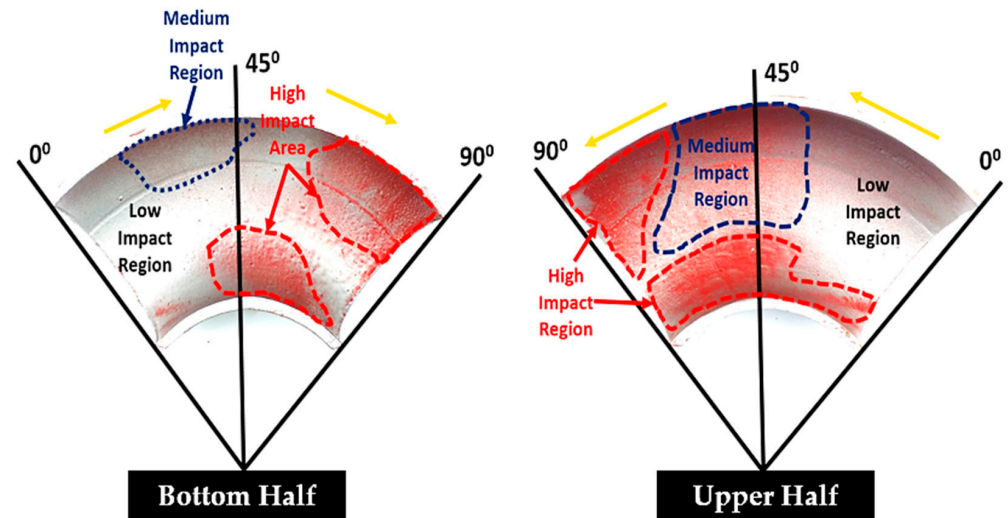
Figure 6. Erosion pattern on the 90° elbow coated with a two-layer paint.

The location of particle impaction in the pipe wall was evaluated after visualization of the paint-eroded regions. Figure 6 shows the paint removal patch in the upper and bottom 90° elbow sections with a 1.5 m/s (liquid velocity) and 0.7 m/s (air velocity) using silt of 70 μm . The high impaction region, on the 90° elbows, tended to be at a location approximately 45° and 90° in the bottom wall and the middle of 0° and 90° in the upper wall of the elbow, respectively. The paint removal marks were nonsymmetric in the top and bottom of the 60° and 90° elbows and the reason air with abrasive particles moving in the upper part and liquid was moving in the bottom section; thus, less erosion occurred in the bottom compared to the top. Figure 7 illustrates the paint erosion pattern in the 60° elbows with silt impact in the bottom and upper half sections for plug flow. For the 60° elbow, the paint was removed between 30° and 60° in the bottom wall and middle of 0° to 60° in the upper section, with greater paint removal pattern clearly seen towards the downstream section in all evaluated cases. In the plug flow regime, the plug body was the key source of erosive wear, because the maximum sand particles were transported by the

continuous phase, i.e., water and the plug body had the highest water phase holdup. The highly turbulent plug front with abrasive particles at the elbow curvature can accelerate erosion-induced damage in the top part of pipelines which was evident in the experimental data collected in this study.

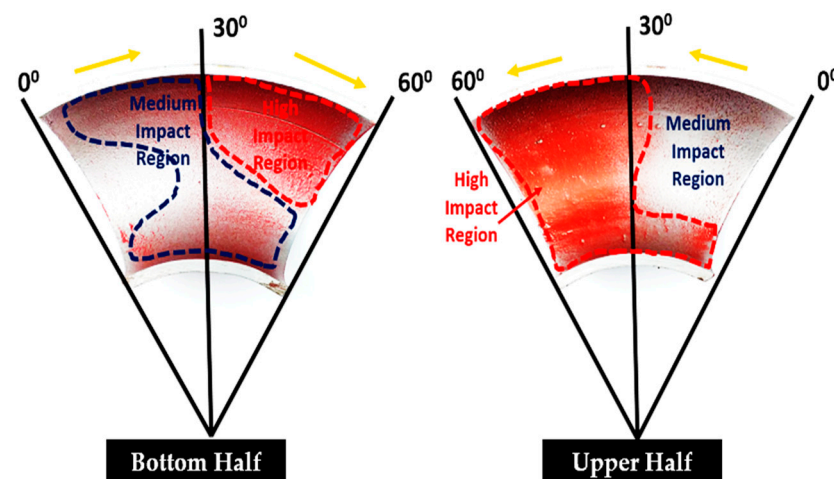
Figure 7. Erosion pattern on the 60° elbow coated with a two-layer paint.

Paint erosion studies were executed on 90° and 60° elbows with a 70 μm particle size for a 90 min flow time. In the paint removal experiment, the inside area of the axially cut elbow specimen was coated with red colored enamel paint and silver colored acrylic paint applied by a spray gun. A digital paint thickness gauge was used to ensure the uniformity of each paint layer. Prior to the paint erosion test, it was necessary to make sure that the paint removal was not caused by flow conditions, and it must be ensured that it was exclusively due to the particle impaction. For tests under nonerosion conditions, it has been concluded that nonerosion flow conditions do not contribute to painting removal in the elbow specimens. Therefore, it can be deduced that the considered paint removal method qualitatively measures the particle impaction regions. Each paint removal test was performed three times to ensure accuracy; it was noticed that the paint erosion pattern tended to be similar for all tests.

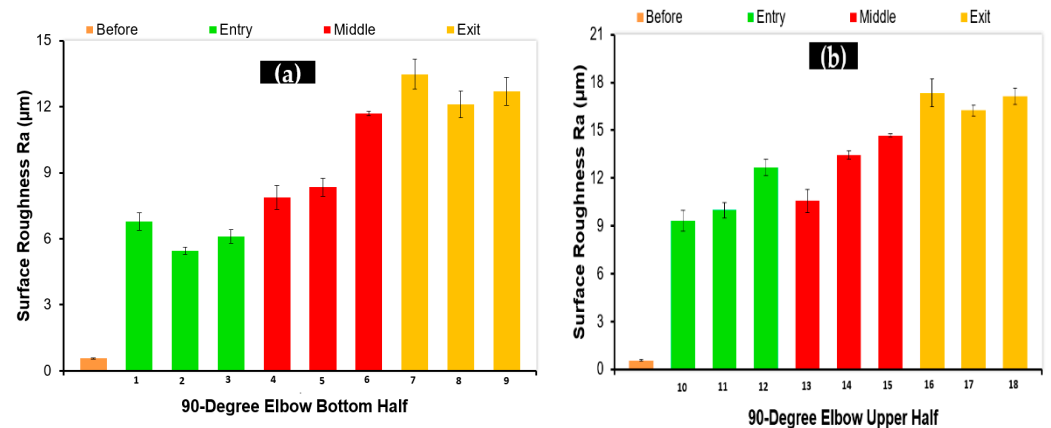
Figure 8. Arithmetic surface roughness values (Ra) before and after the test in 90° elbows: (a) bottom; (b) top.

Surface roughness (Ra) values were measured in the flow direction for all 36 specimens cut from 90° and 60° elbows. Three measurements were conducted along the length of the surface of 10 mm of the cut specimen. In Figure 8a, the arithmetic surface roughness values (Ra) of the 1018 carbon steel depending on the location of the bottom elbow section are given. In Figure 8a,b, the arithmetic surface roughness values of the carbon steel varied dramatically as the flow approached from upstream to downstream. The maximum Ra value was observed between 45° and 90° axial angles at the upper and bottom half of the 90° elbows. Hence, it was concluded that carbon steel 90° elbow showed maximum erosion behavior near the outlet, as mentioned in the literature [17]. On the other hand, the Ra of the samples was maximum in the outer wall in both the top and bottom of the elbow

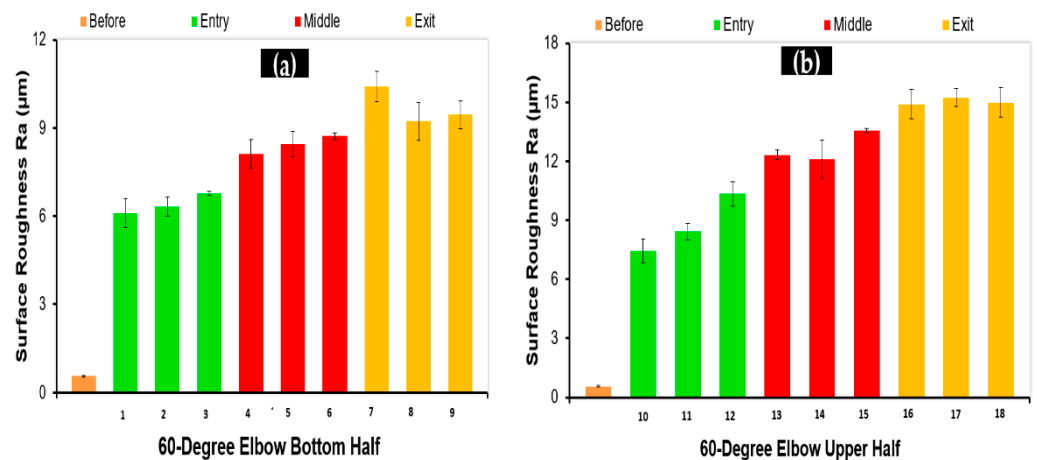
Figure 9. Arithmetic surface roughness values (Ra) before and after tests in the 60° elbows: (a) bottom; (b) top.

pipe. In Figure 9a,b, arithmetic surface roughness values of the 60° elbow samples at the different locations inside the elbow are given. It can be seen that the surface roughness was significantly changed depending on the location. It was clearly observed that surface roughness increased in downstream locations. On the other hand, the maximum surface roughness was between the axial angle of 30° and 60°; however, it decreased in the upstream location. As a result, it can be said that the arithmetic roughness value of the carbon steel generally increased with increases in particle impingement. It was reported in the literature that erosion increases the surface roughness of metallic materials [20].

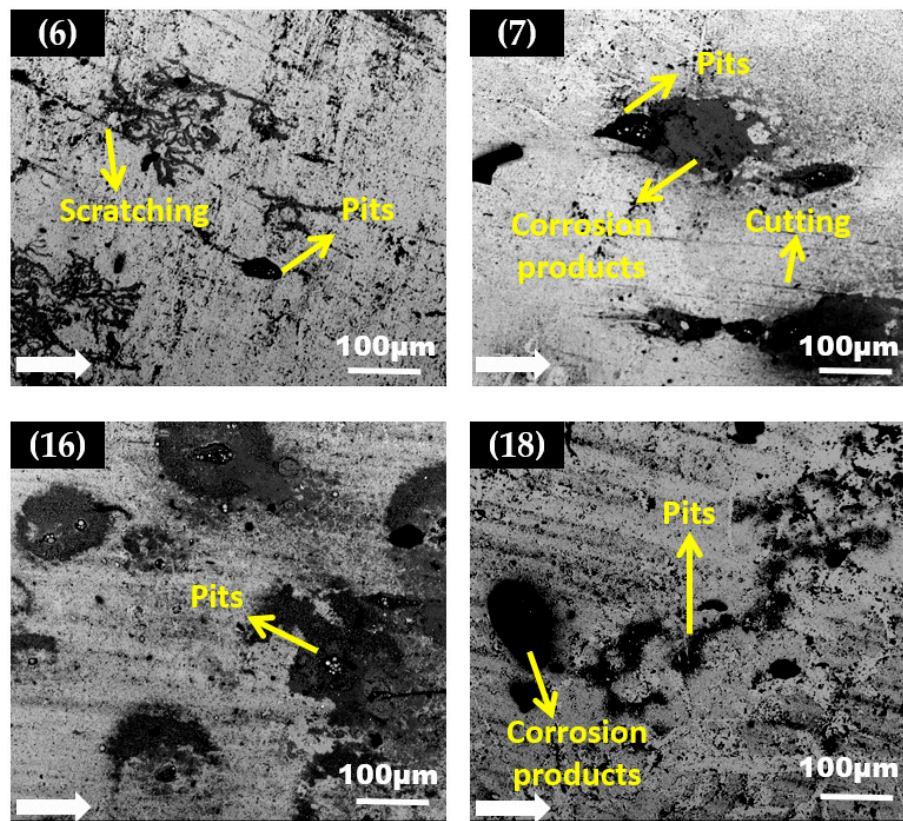
Figure 10. The backscattered electron (BSE) images of a carbon steel 90° elbow after the test.

SEM micrographs of the carbon steel elbow specimen from the upper half and bottom half having maximum arithmetic surface roughness values (Ra) after erosion are shown in Figures 10 and 11. The SEM images showed the surface morphology after the carbon steel elbow was exposed to silt particles under plug flow conditions (a total of 10 h of erosion). Magnified images of sections 6, 7, 16, and 18 with maximum Ra values is shown in Figure 10. Upon impact with silt particles, it locally damaged the surface by the cutting and ploughing action at downstream sections during the erosion and formed pits with corrosion attack at outlet due to the high particle wall impactions.

At the top of the 90° elbow, more areas of pitting and cutting were observed, and this was due to the silt particles impacting with higher kinetic energy which disintegrated materials. Additionally, indentation was also seen at the outlet due to the plastic deformation. Such plastic deformation is usually due to the silt particles redirecting at a curvature and impacting the outer curvature of the elbow pipe. Scratching, pitting, and ploughing are the predominant erosion mechanisms in the downstream section of the elbow. In the outlet, more perforation sites with corrosion attacks were observed which suggests that erosion-corrosion pitting is the dominant erosion mechanism here. Figure 11 presents the erosion mechanism on a carbon steel sample observed after 10 h of testing with silt particles for 60° elbow. After the test, the downstream sections 9 and 18 have smooth areas on the target surface, but in sections 7 and 17 multiple particle impact was visible. In 90° elbow, more pits were detected downstream, pitting corrosion mainly most often at sensitive sites, such as at high particle-wall impaction zones. If these zones are predominant, pitting corrosion is confined to new locations on the surface. Therefore, the number of perforation pits sites will gradually coalesce with the stable pits. In comparison the 60° elbow SEM micrographs showed minimal particle impaction, resulting in the sliding and indentation with relatively small pits.

Significant disparities in the surface morphologies and development of the pattern of corrosion products at the elbow exit surface after 10 h of tests with silt particles were visible from the SEM microscopy analysis. It can be seen from micrographs that after exposure to the silt particles in the plug flow, the pitting corrosion profile was attributed to a large corrosion zone around the pits, which was covered by a corrosion products layer vicinity of elliptical pits and wide–narrow pits that were evident in the micrographs of the elbow exit section. Moreover, the pits in the 60° elbow grew individually, and the 90° elbows showed sensitive sites that grew up to elongated pits as identified in Figure 10.

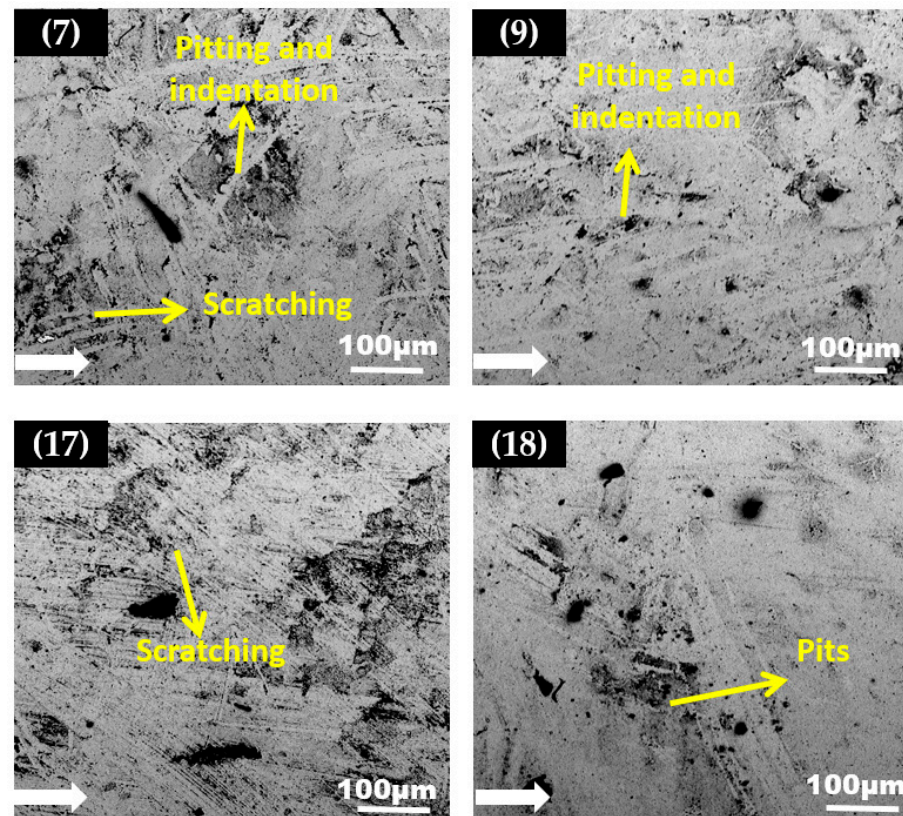
Figure 11. The backscattered electron (BSE) images of a carbon steel 60° elbow after the test.

The corrosion product concentrated around the pits could be seen in the SEM images. An intriguing observation was that corrosion was detected at the pits because the corrosion product washed out the onset of pits with the increase in particle impact. Notwithstanding, the extent of erosion-induced damage to the 90° elbow was more than those of the 60° elbow surface in the same flow conditions. In the 60° elbow, the erosive wear was less, because the change in the flow direction of the 60° (small angle) elbow was not as abrupt as for the 90° (wide angle) elbow. Apparently, fewer particles are prone to impact the 60° elbow's outer curvature compared to a 90° elbow outer wall. At the 60° elbow, the flow was redirected more smoothly, which causes the abrasive particles to follow the flow and impact the bottom part with less frequency as compared to the upper part of the elbow.

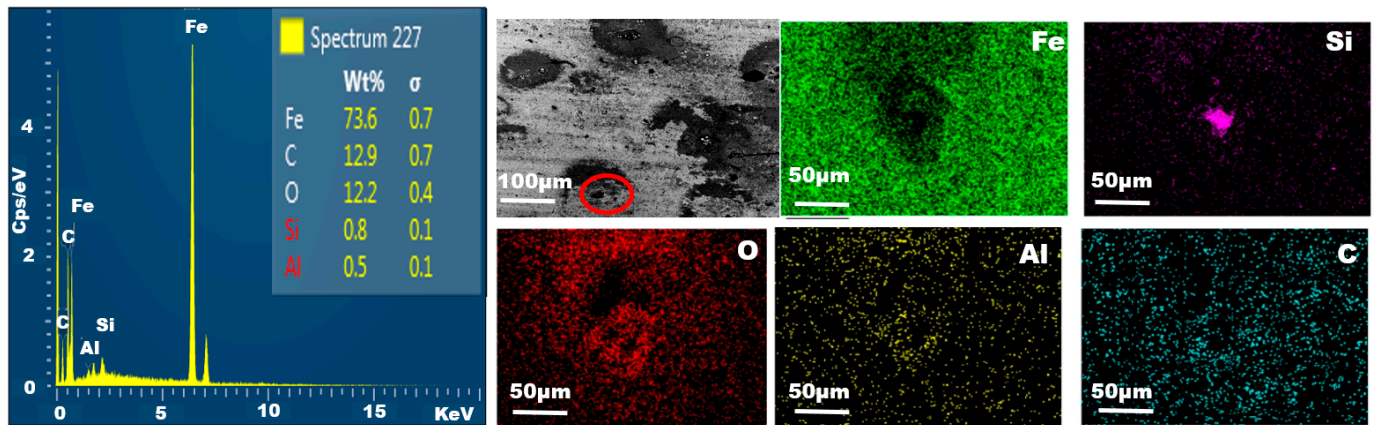
Figure 12. EDS spectra and elemental mapping after erosion in 90° elbow.

The EDS method is used for identification and quantifying elemental compositions after the test for sample #16 in the 90° elbow. The analytical identification of the elements (elemental composition) after the erosion imparted the presence of iron (Fe) and oxygen (O) atoms on sample #16 at the 90° elbows, as shown in Figure 12. In addition, the identification of Si on the eroded surface confirmed that the silt was embedded in the surface after the erosion.

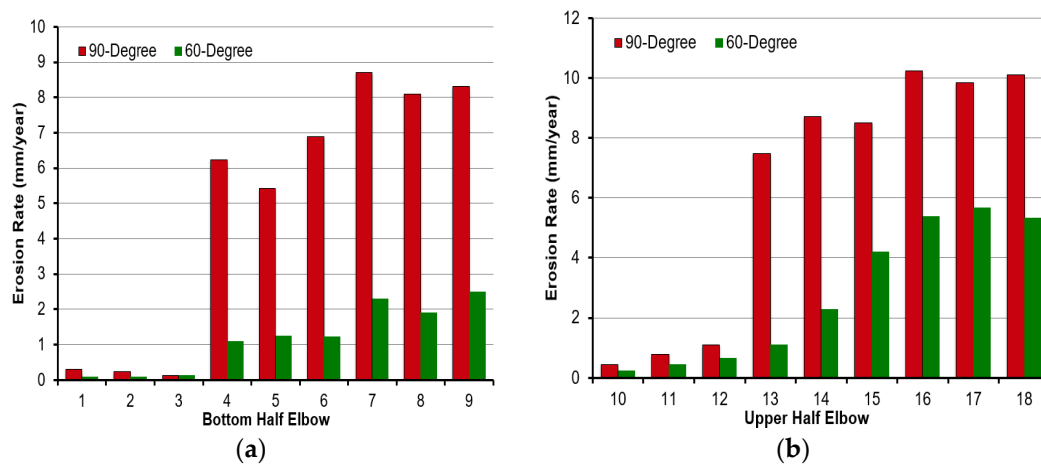
Figure 13. Mass loss in carbon steel elbow section after test: (a) bottom; (b) top.

Figure 13a,b show the erosion rate for 90° and 60° elbow pipes under plug flow with silt particles. For both elbows, the maximum erosion rate occurred downstream near the outlet. In the 90° elbow, the corresponding maximum erosion rates were 10.23 mm/year compared to the 60° elbow which was 5.67 mm/year. Regardless of the elbow angle, Figure 13b shows that specimens at locations 16 and 18 of the 90° elbow's upper half provided the highest erosion, and specimens at locations 16 and 17 of the 60° elbow's upper half reflected the maximum wear rates compared with other positions. This identified that the location adjacent to an outlet for both the 90° and 60° elbows was likely to be eroded during the silt particle's impact under plug flow conditions. Moreover, the wear rate of the upper half elbow section was more than that of the bottom half. It can be concluded that in plug flow, the top of the elbow downstream is more prone to erosion due to the multiple

particle impactions than in other positions. There was an approximately 1.8 times increase in the erosion rate of the maximum impaction region in the 90° elbow compared to the 60° elbow observed for carbon steel for identical flow conditions. The severe silt particle impaction was located at the outer curvature in the 50° position in 60° elbows and the 80° position in 90° elbows in plug flow.

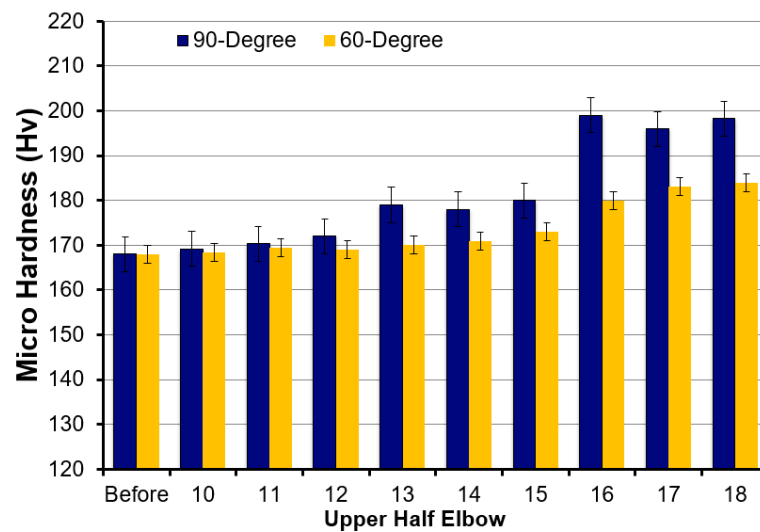
Figure 14. Microhardness of carbon steel elbows' upper half sections before and after the test.

Figure 14 shows the results of microhardness evaluation at the different locations of the 90° and 60° elbows. As indicated in Figure 14, the hardness of the polished specimen after the test of carbon steel 1018 samples increased due to the impact of silt particles as flow approached downstream. Figure 14 shows a similar trend in the results for both the 90° elbow and the 60° elbow. It was clear from the results that the maximum hardness in both 90° and 60° elbows was, however, observed adjacent to the outlet, which was due to maximum particle impaction. The erosive wear leads to strain that hardened the target surface and the hardness of the carbon steel improved from 168 to 199 in the 90° elbow exit section and to 181 in the 60° elbow exit section on the Vickers hardness scale. The escalation in the hardness value after erosive wear in Figure 14 was accordant with the findings in a previous study [20].
