Local Electrochemical Corrosion Properties of a Nano-SiO₂/MAO Composite Coating on an AM60B-Mg Alloy

Abstract: In order to improve the corrosion resistance of the automotive AM60B-Mg alloy, a nano-SiO₂/MAO composite coating was prepared on the surface of the alloy. The electrochemical properties were studied in an 80 °C corrosion environment using potentiodynamic polarization tests. Local Electrochemical Impedance Spectroscopy (LEIS) was used to study the corrosion mechanisms of coating defect zone. The microstructure and phase of the samples were observed by confocal laser microscopy, scanning electron microscopy (SEM) and X-ray diffraction (XRD). Macroscopic electrochemical test results showed that the impedance of the nano-SiO₂/MAO coating was much higher than that of the MAO coating, by about 433 times. Local electrochemical test results showed that the minimum impedance of the nano-SiO₂/MAO coating was 1–2 orders of magnitude higher than the maximum impedance of the MAO coating. The defective SiO₂/MAO coating still had high corrosion resistance compared to the defective MAO coating. A physical model of local corrosion mechanisms was proposed.

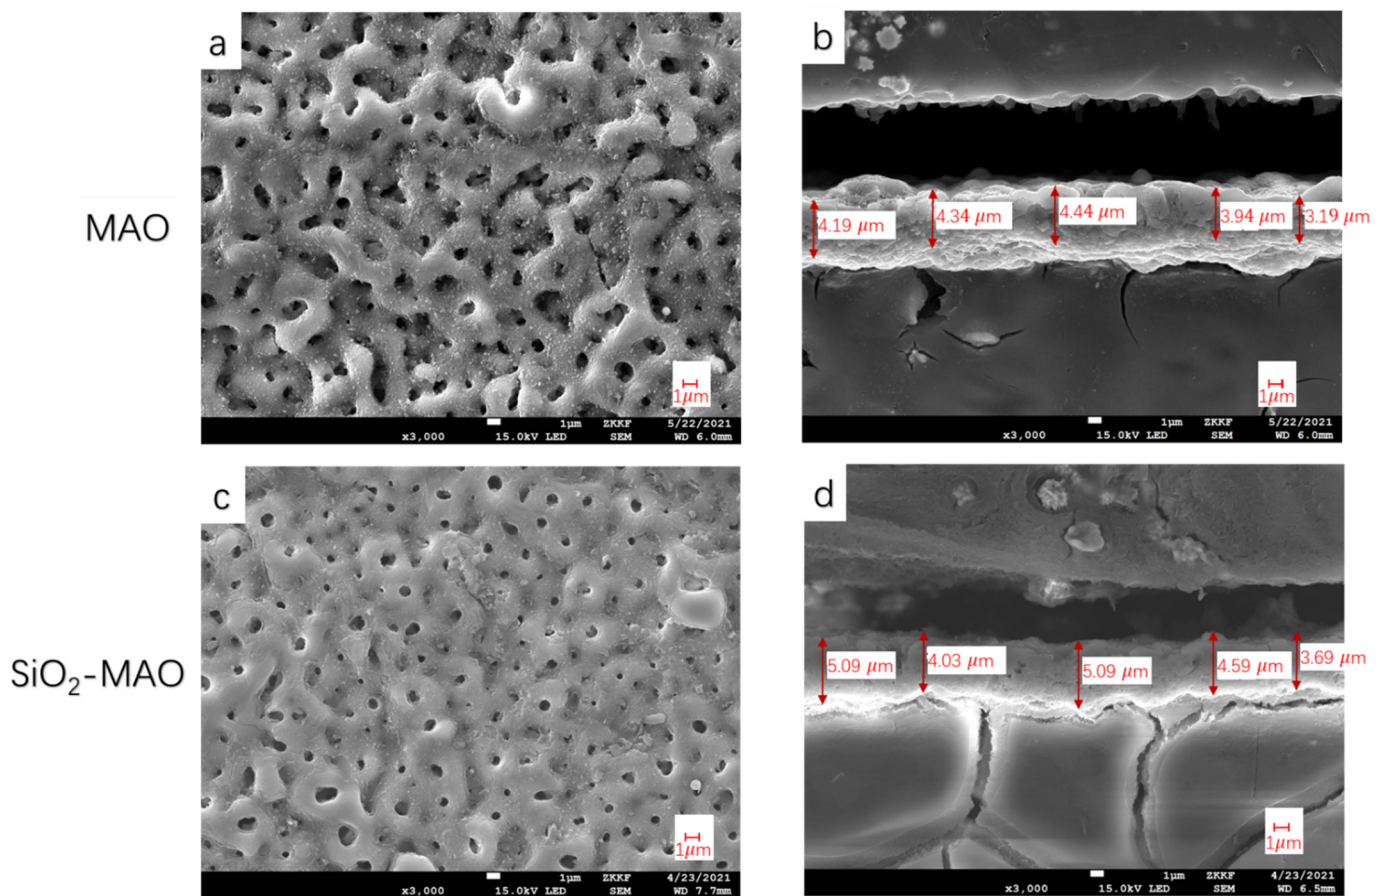
Figure 1 shows the microscopic morphology of two kinds of micro-arc oxide films tested by SEM. Figure 1a,b shows the surface and cross section micromorphology of the MAO coating; Figure 1c,d shows the surface and cross section micromorphology of the

SiO₂/MAO coating. Both coatings had micropores because of the different cooling rates of the molten oxide and the escape of gases during the micro-arc oxidation reaction. The microporosity of the nano-SiO₂/MAO coating was smaller and less than that of the MAO coating. The cross-section morphology of the two samples is shown in Figure 1b,d. It can be seen that compared to the MAO coating, the nano-SiO₂/MAO coating was denser and uniform. In the process of the coating preparation, the micro-arc plasma discharge produced instantaneous high temperatures and high pressure, which resulted in chemical oxidation, electrochemical oxidation and plasma oxidation on the surface of the magnesium alloy substrate [21]; the coating grew directly on the substrate, thus bonding very tightly with the substrate. It also can be seen from the figure that the SiO₂/MAO coating (4.03–5.09 μm) was thicker than the MAO coating (3.19–4.44 μm), indicating that the addition of inorganic nanomaterials can make the coating thicker.

Figure 1. Micromorphology of coatings, (a,b) Surface and cross-section morphology of the MAO coating, (c,d) Surface and cross-section morphology of the SiO₂/MAO coating.

- (1) The microstructure of the coating showed that the SiO₂/MAO composite coating had fewer micropores and higher flatness. The thickness of the SiO₂/MAO coating was larger than the thickness of the MAO coating. As a sealant, nano-SiO₂ was able to reduce the number of micropores in the MAO coating and thicken the coating. Mg(OH)₂ corrosion products were found in both coatings after corrosion, and the corrosion mode was pitting corrosion, without large area corrosion.

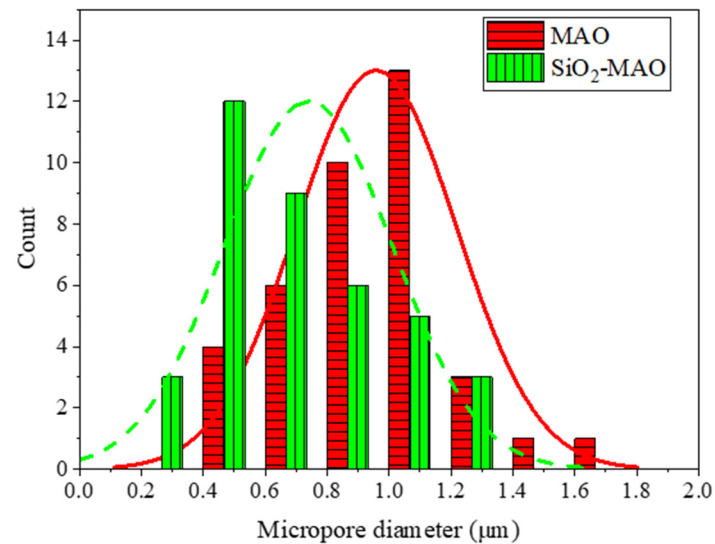
As can be seen in Figure 2, the microporous sizes of the MAO coating ranged from 0.5 to 1.8 μm, with most of them being between 0.85 and 0.9 μm and 1.05 to 1.1 μm, and the micropore size of the nano-SiO₂/MAO composite coating was 0.5 to 0.55 μm and 0.7 to 0.75 μm. The reason for this is that nanoparticles were embedded into the MAO coating by electrophoresis and diffusion [22]. Smaller micropores mean that less corrosive material penetrates the channels of the coating. At the same time, the density of the coating was also improved by inorganic nano additives.

Figure 2. Distribution diagram of micropore diameter on the surface of the MAO coating and SiO_2/MAO coating.

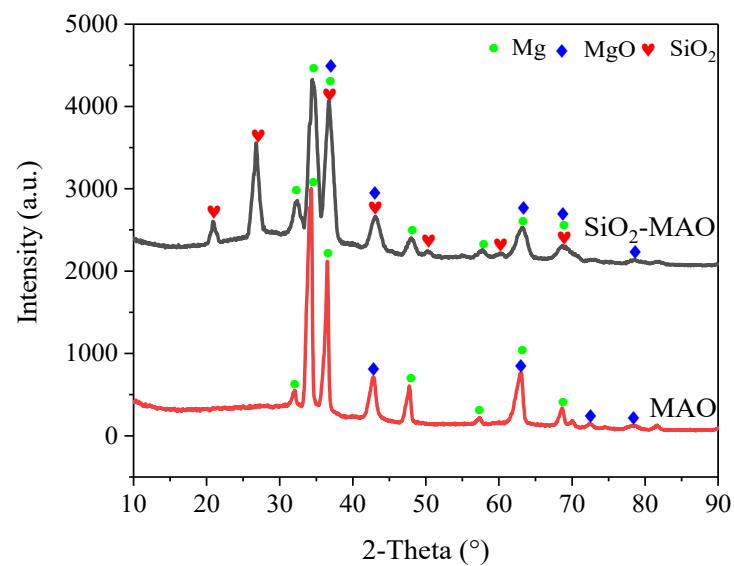
Figure 3 shows the X-ray diffraction detection results of the MAO coating and SiO₂/MAO coating. The relatively strongest peaks of the two coatings were Mg and MgO, respectively. The X-rays penetrated the coating and reached the alloy matrix; thus, Mg appeared in the substance peaks. MgO was the main component of the micro-arc oxidation coating. The

presence of SiO_2 peaks indicated that the nanoparticles had been integrated into the coating. The formation mechanism of MgO is similar to that of conventional anodic oxidation; MgO was formed at the membrane/electrolyte and substrate/membrane interfaces.

Figure 3. XRD scan results of the MAO coating and SiO_2/MAO coating.

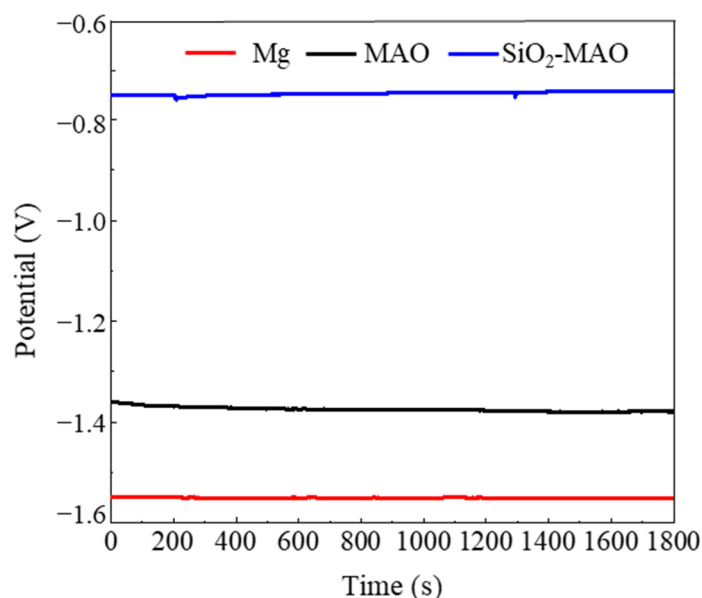
Figure 4 shows the OCP curves of the three samples soaked at 80 °C for 8 h. With the prolongation of continuous determination time, the OCP value of the samples tended to be stable. The OCP test results showed that the SiO₂/MAO composite coating had the largest positive potential, followed by the MAO coating, and that the magnesium alloy substrate sample had the largest negative potential—indicating that the SiO₂/MAO composite coating had the highest corrosion resistance trend.

**Figure 4.** The OCP curves of the AM60B-Mg, MAO coating and SiO₂/MAO coating.

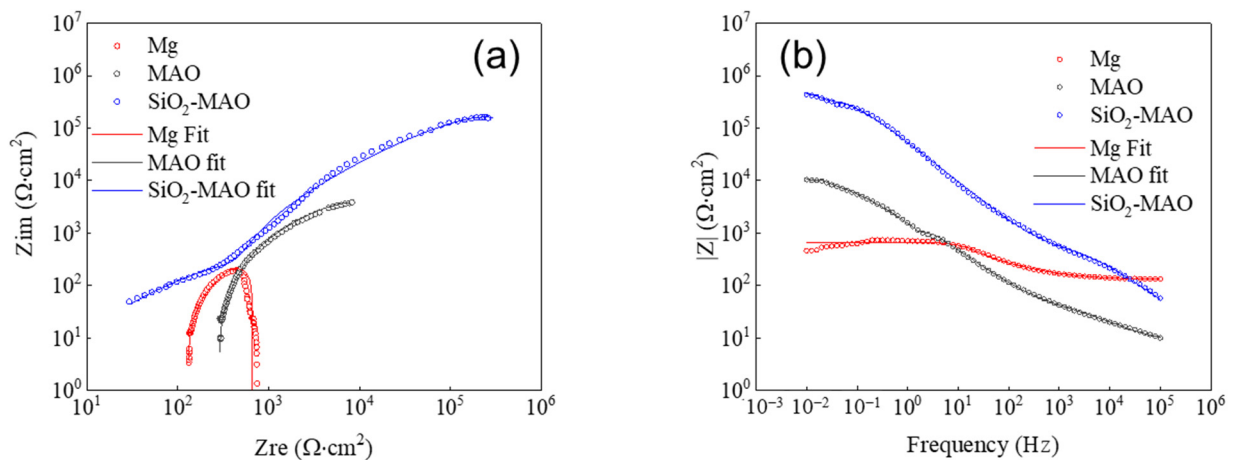
The electrochemical impedance spectrum of the coating is shown in Figure 5. The circle represents the measured data, and the solid line represents the fitting data obtained by the fitting circuit.

The Nyquist curve in Figure 5a could be approximated as a circular arc, and the larger the radius of the arc, the better corrosion resistance of the sample had. The radius of the corrosion resistance arc from large to small was SiO₂/MAO coating > MAO coating > magnesium alloy substrate.

The $|Z|$ value at 0.01 Hz in Figure 5b is the modal value of the impedance for the test piece; the higher $|Z|$ value is, the greater corrosion resistance the sample has. The $|Z|$ values of different samples are listed in Table 4, having the same regularity as the Nyquist curve. The $|Z|$ value of the SiO₂/MAO coating was 185.5 K Ω ·cm² > the MAO coating (18.3 K Ω ·cm²) > the magnesium alloy substrate (0.54 K Ω ·cm²). The addition of SiO₂ showed the strongest corrosion resistance and strengthening effect, indicating that the SiO₂/MAO coating had a good protective effect on the substrate at high temperatures.

Figure 5. The electrochemical impedance spectroscopy (a) Nyquist plot, (b) Bode plot.

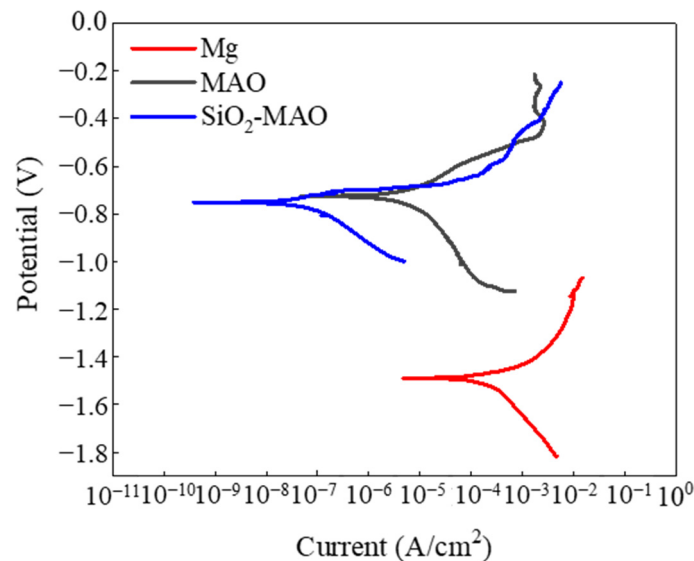
The PDP curves of the samples are shown in Figure 7, and the corrosion potentials and current densities of the samples are listed in Table 5. The test results showed that the SiO₂/MAO coating had the highest positive corrosion potential (−0.73 V) and the lowest corrosion current density (2.45 nA·cm^{−2}); the AM60B-Mg alloy substrate had the largest negative corrosion potential (−1.49 V) and the highest corrosion current density (66,200 nA·cm^{−2}). The results show that the corrosion resistance of the SiO₂/MAO coating was much better than the MAO coating and the AM60B-Mg alloy. The PDP curve and EIS result had the same regularity.

Figure 7. PDP curve of the samples.

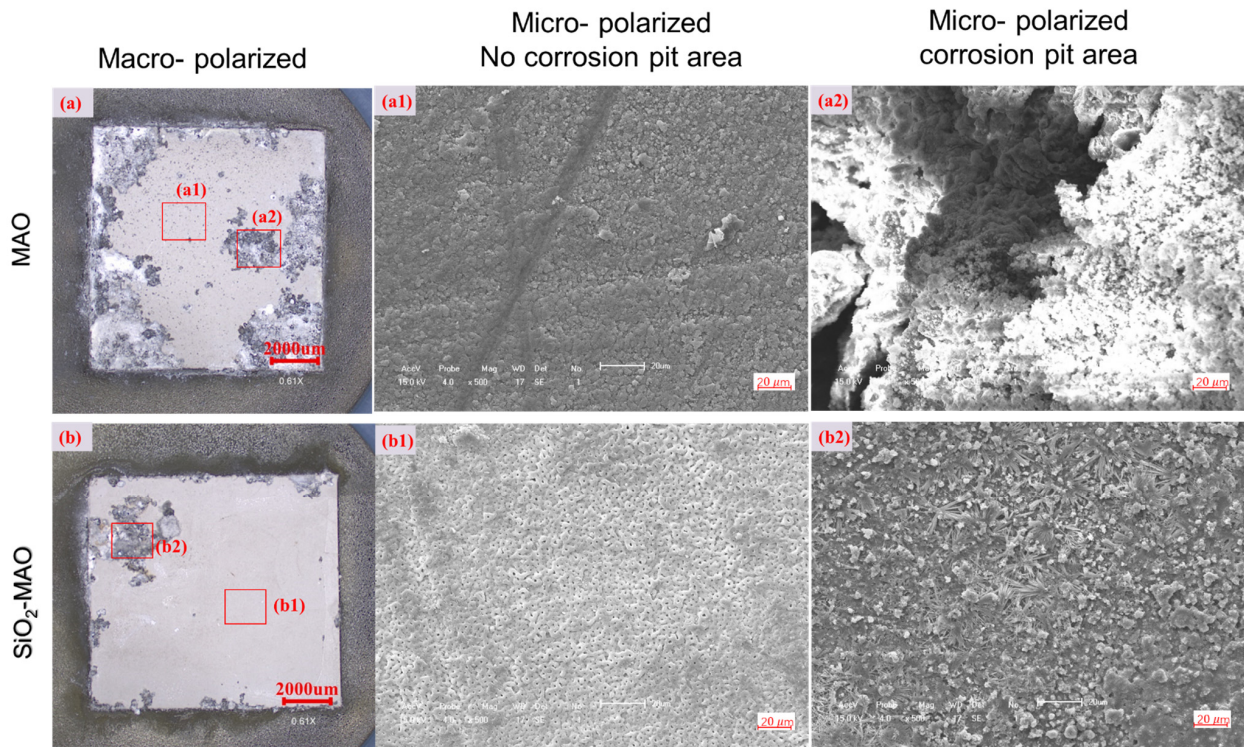
Figure 8a,b show the comparison of the macroscopic morphology of the two coating samples after corrosion. It can be seen from the two figures that the corrosion started from the perimeter and expanded to the center, and that the corrosion mode was pitting corrosion. The pitting pits of the MAO coating were much more extensive than that of the SiO₂/MAO coating. Figure 8(a1,b1) show the microscopic morphology of the corrosion-free pit area of the two coatings; both kinds of coatings remained relatively smooth, but the SiO₂/MAO coating appeared to have smaller micropore morphology. Figure 8(a2,b2) show the microscopic morphology of the corrosion pit area of the two coatings—the MAO coating cracked and collapsed downward, while the SiO₂/MAO coating remained flat, and the acicular material formed on the surface was the corrosion product Mg(OH)₂ [23]. The SEM results following corrosion prove that the addition of nano-SiO₂ enhanced the corrosion resistance of the MAO coating.

Figure 8. Macroscopic and microscopic appearance of the samples after corrosion. (a,b) the macroscopic morphology of the MAO coating and SiO₂/MAO coating after corrosion; (a1,b1) microscopic morphology of the corrosion-free pit area of the two coatings; (a2,b2) the microscopic morphology of the corrosion pit area of the two coatings.

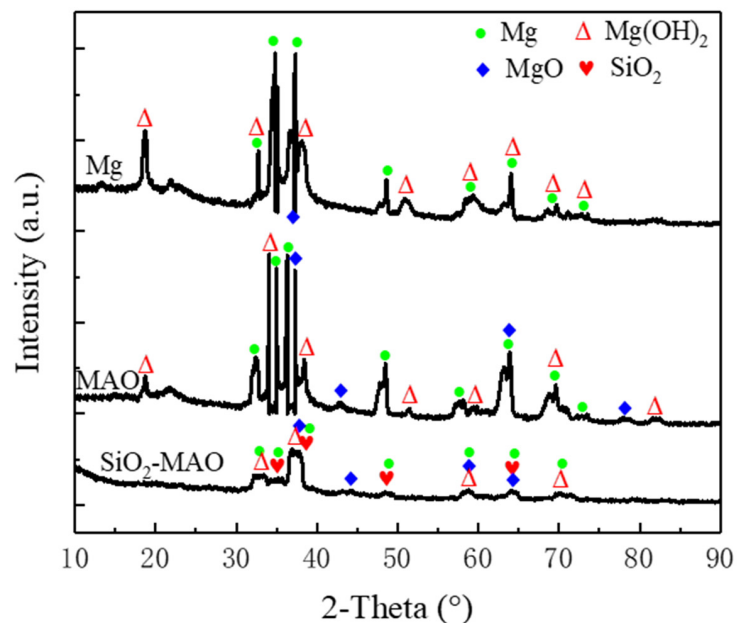
Figure 9 shows the XRD patterns of the three samples etched at 80 °C for 8 h. The results showed that there was a common corrosion product Mg(OH)₂ on the surface of the three samples. In addition to the co-existing Mg(OH)₂ phase, the Mg phase was also present on the surface of the magnesium alloy; there were Mg and MgO phases on the MAO coating surface, and SiO₂, Mg and MgO phases could be detected on the nano-SiO₂/MAO-coated surface. Compared with the magnesium alloy substrate, the number of Mg(OH)₂ peaks in the MAO coating decreased by 1, indicating that the MAO process can slow down the corrosion rate of the magnesium alloy. The Mg(OH)₂ peak number of the SiO₂/MAO coating was the lowest, indicating that the nano-SiO₂ improved the corrosion resistance of the MAO coating. The main reaction equations for the coating in the corrosive solution are as follows [24,25]:

Figure 9. XRD results of the material phase of each sample after corrosion.

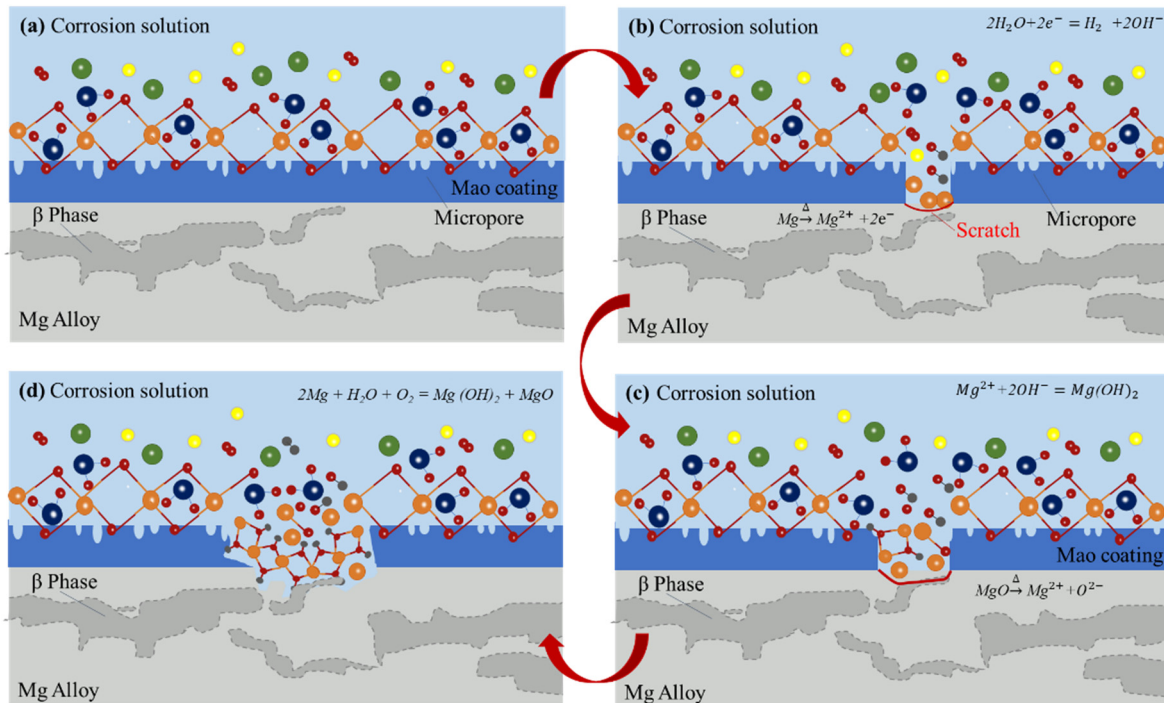
The local corrosion process model was built as shown in Figure 13. Figure 13a shows a situation where a complete coating sample was placed in a corrosive solution and the coating completely sealed the substrate in contact with the corrosive solution. The coating was affected by external mechanical forces and other uncontrollable factors, resulting in scratches on the coating, as shown in Figure 13b. After the coating was destroyed, the matrix came into contact with the corrosion solution, and the magnesium alloy matrix began a slow oxidation reaction. The reaction equations were as follows [23]:

Figure 13. Local corrosion process model of coatings. (a) The sample coated with a complete coating is placed in a corrosive solution; (b) The coating is scratched by uncontrollable factors such as external mechanical forces; (c) The magnesium alloy substrate begins to oxidize when contacting with the corrosion solution, and the coating loses its support, leading to cracking; (d) The local corrosion at the coating defect gradually expands to form corrosion pits.

In this process, magnesium absorbs oxygen and corrodes, forming $\text{Mg}(\text{OH})_2$ and MgO (Equation (6)). At the same time, some of the magnesium ions enter the corrosion solution and hydrolyze; $\text{Mg}(\text{OH})_2$ is also produced (Equation (7)), and corrosion products begin to accumulate in the scratch area. After a period of corrosion, the substrate under the scratch is corroded and dissolved, resulting in the formation of a cavity. The coating on the top of the cavity then loses the support of the original matrix and is subjected to various external forces, eventually resulting in cracking, as shown in Figure 13c. There are an α phase and β phase in the magnesium alloy matrix. When the coating was defective, the corrosion development at the scratch location was determined by whether it was in the α -phase or β -phase. When corrosion occurs in the α phase, the electrode potential of the α phase is negatively correlated with the potential of the oxide film, and the α phase corrodes as an anode; the corrosion process will continue into the Mg alloy matrix. When corrosion occurs in the β -phase, the electrode potential of the β -phase is positively correlated with the potential of the oxide film, and the β -phase is not corroded, while the nano- SiO_2 /MAO film is corroded as an anode [26]. As the corrosion time continues to increase, the local corrosion at the coating defect will follow the pattern shown in Figure 13, gradually expanding the corrosion and eventually forming a corrosion pit, as shown in Figure 13d.

- (3) A model for the local corrosion process of the SiO₂/MAO coating was constructed. When the coating was scratched, the corrosion development of the defect location depended on whether the corrosion point was in the α phase or the β phase. The alloy substrate was corroded and dissolved first, and then the coating lost the support of the substrate; cracks and spalling appeared under the action of external forces and finally led to the appearance of corrosion pits.
