# Effect of Impact Velocity and Angle on Impact Wear Behavior of Zr-4 Alloy Cladding Tube

**Abstract:** In the pressurized water reactor nuclear power plant, 316L SS chips were captured by the support grid and continued to affect the Zr-4 cladding tube, causing the fuel rods to wear and perforate. In this work, a 60° acute angle cone of 316L SS was used to simulate the cyclic impact of debris on a Zr-4 alloy tube with different initial impact velocities and impact angles. Results showed that increasing the initial impact velocity will generate a wear debris accumulation layer with a wear-reducing effect, but also promote the extension and expansion of fatigue cracks, resulting in the delamination of Zr-4 alloy tubes. The inclination of the impact angle increases the energy loss. The energy loss rate of the 45° impact is as high as 69.68%, of which 78% is generated by the impact-sliding stage. The normal force is mainly responsible for the wear removal and plastic deformation of Zr-4 alloy tubes. Tangential forces cause severe cutting in Zr-4 alloys and pushes the resulting wear debris away from the contact surfaces.

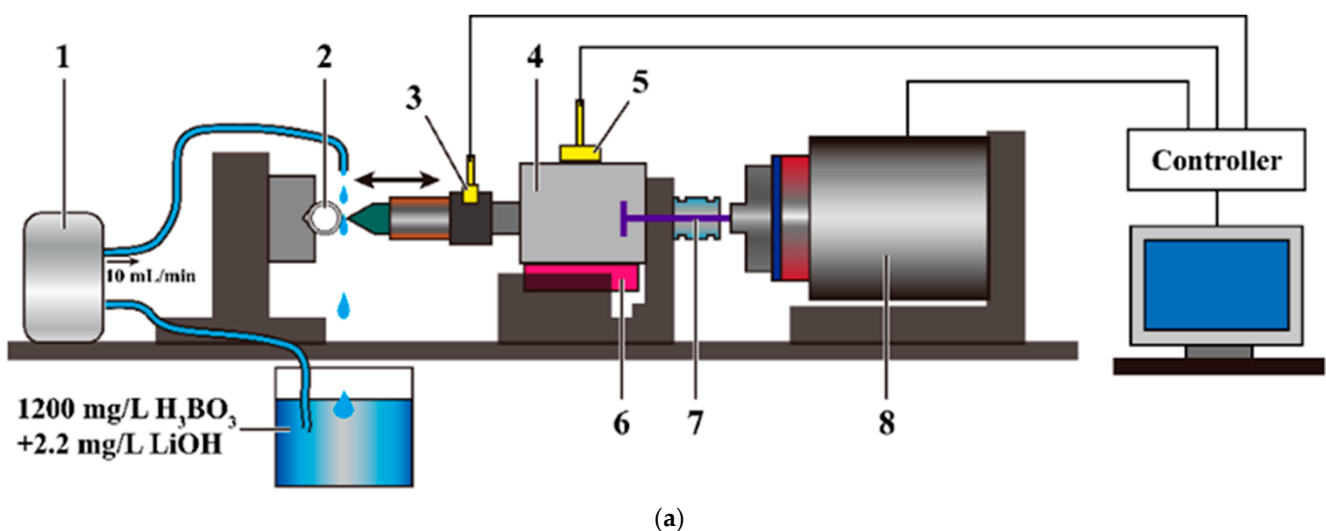
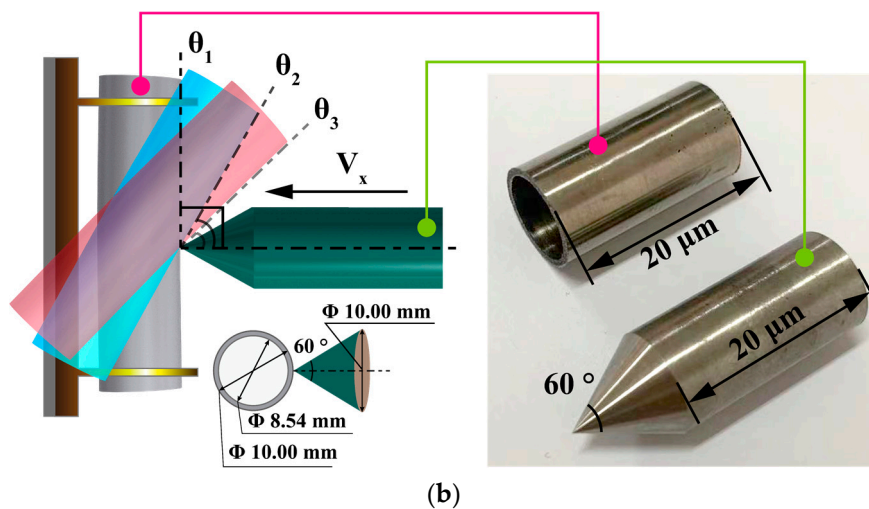
**Figure 1.** Schematic of self-developed impact wear tester (a): (1) water pump; (2) sample; (3) force sensor; (4) mass block; (5) displacement sensor; (6) liner guide; (7) tie rod; (8) voice coil motor, and schematic diagram of motion (b).

This impact wear test used a self-developed impact wear tester with controllable kinetic energy, as shown in Figure 1a. The contact force and impact velocity were recorded in real time with force sensors and displacement sensors. Based on the change in velocity, the kinetic energy theorem  $E = \frac{1}{2}mv^2$  and the integral of velocity versus time  $s = \int v dt$  can be used to deduce the change in kinetic energy and the relative deformation of the impact process. After further analyzing the contact force, displacement, velocity and other effective data recorded by the testing machine during the test, the response and evolution of impact force, relative deformation, velocity, and energy during the testing process can be obtained.

It can realize different impact velocities by changing the speed of the voice coil motor; it can also realize different angle impacts by changing the angle of fixture. Figure 1b shows the diagram of motion, in view of the impact velocity/angle of 316L SS on the impact wear of Zr-4 alloy cladding tube, five initial impact velocities ( $V_i = 50, 75, 100, 125,$  and  $150$  mm/s) of  $\theta = 90^\circ$  and three impact angles ( $\theta_1 = 90^\circ, \theta_2 = 60^\circ,$  and  $\theta_3 = 45^\circ$ ) of  $V = 100$  mm/s were set. The solution of  $1200$  mg/L  $\text{H}_3\text{BO}_3 + 2.2$  mg/L  $\text{Li}(\text{OH})$  was used to wash the impact contact surface at the flow rate of  $10$  mL/min to simulate the flow of water in the primary loop of a pressurized water reactor. Each group of experiments was repeated three times, using an  $800$  g mass block, with a frequency of  $5$  Hz and  $N = 5 \times 10^5$  cycles. After the test, the average value was obtained, and the corresponding standard deviation was calculated.

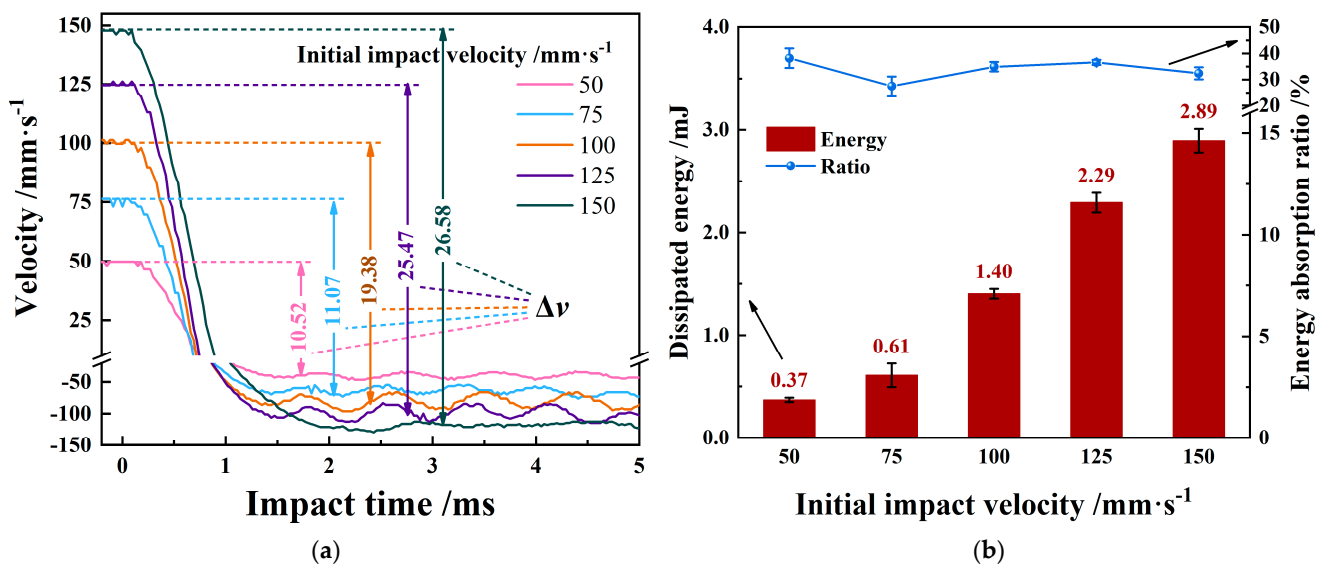
Figure 3. Dynamic response of velocity and dissipated energy with varying initial impact velocities. (a) Impact velocity response vs. time; (b) absorbed energy evolution.

Figure 3 shows the dynamic response of velocity and energy when the initial impact velocity is increased. As shown in Figure 3a, with the increase in the initial impact speed, the difference ( $\Delta v$ ) between the rebound speed ( $V_2$ ) and the initial impact speed ( $V_1$ ) becomes larger.

Figure 3b shows the response of energy dissipation calculated by kinetic energy theorem  $E = \frac{1}{2}mv_1^2 - \frac{1}{2}mv_2^2$ . The increase in initial impact velocity dissipates more energy,

but its energy absorption rate is always maintained in the range of 30–40%. The Zr-4 alloy tube mainly undergoes elastic deformation during impact, and only produces evident elastic plastic deformation in the impact contact area due to the high hardness and high strength of Zr-4 alloy material. Therefore, more energy is dissipated, indicating greater plastic damage in the impact contact area.

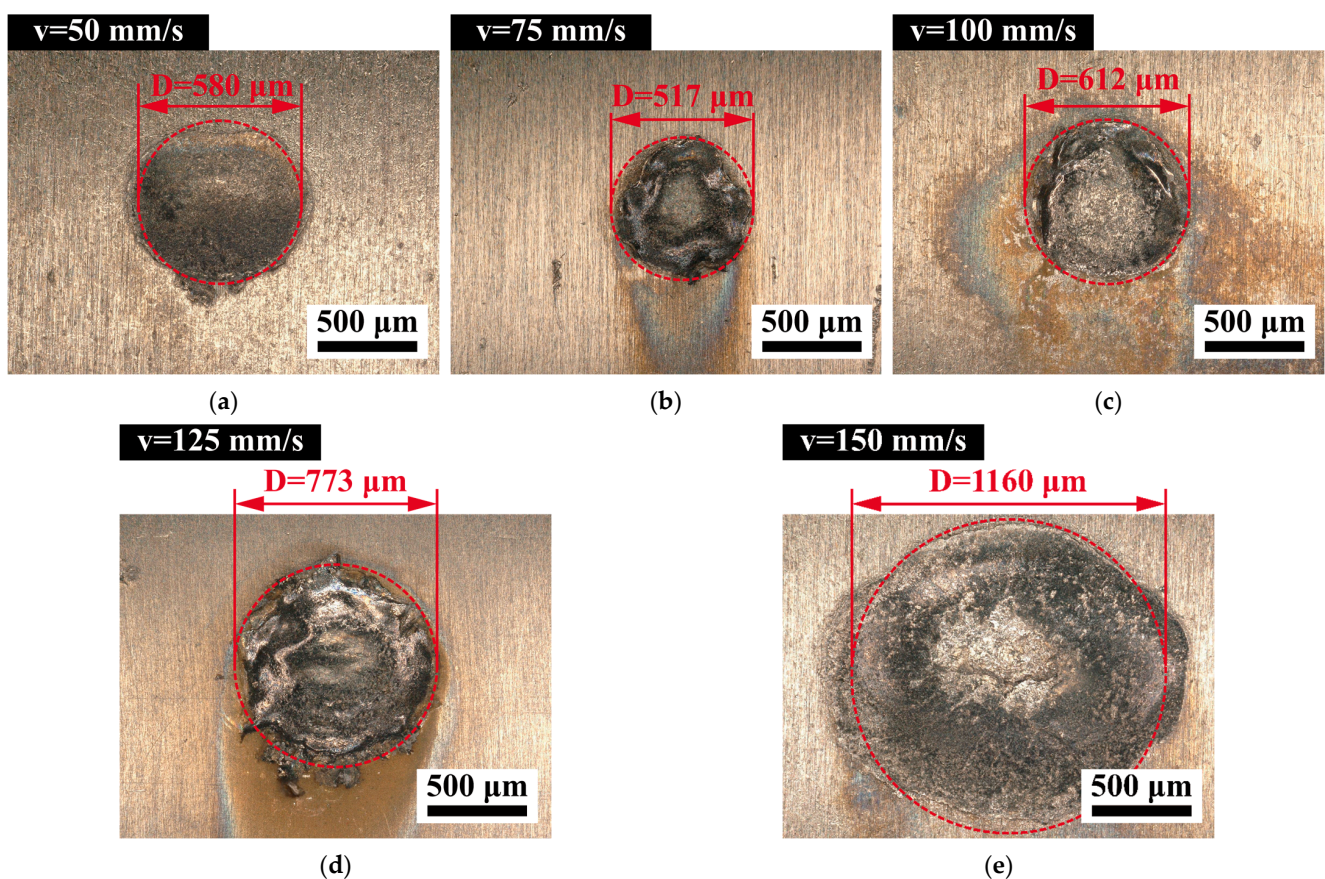
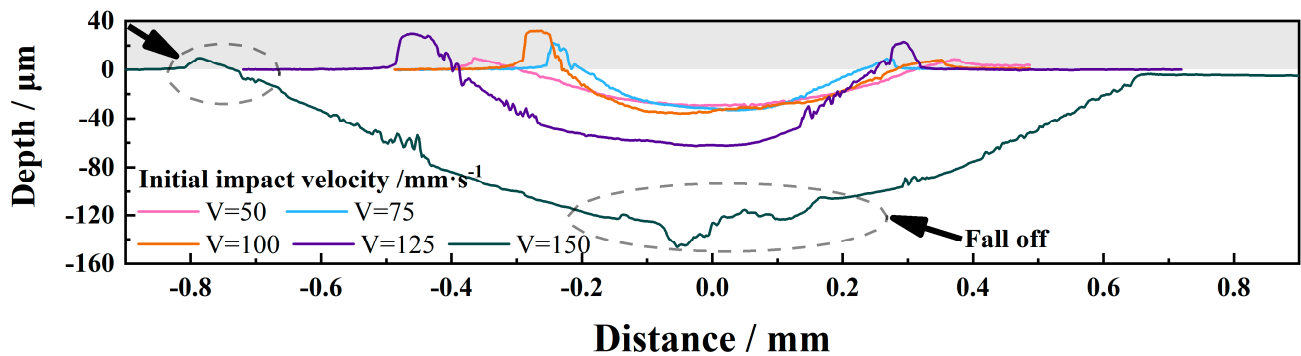
**Figure 4.** OM images and profile micrographs of the worn surfaces with varying initial impact velocities. (a)  $V = 50$  mm/s, (b)  $V = 75$  mm/s, (c)  $V = 100$  mm/s, (d)  $V = 125$  mm/s, (e)  $V = 150$  mm/s, and (f) sectional profiles of worn scars under varying impact velocities.

As shown in Figure 4a–e, with the increase in the initial impact speed, the size of the worn scar decreases slightly and then increases significantly, and some of the wear mark edges exhibit evident plastic deformation bulges. The contact area between the 316L SS and Zr-4 alloy tube is small during impact because the shape of the impact block used in the test is  $60^\circ$  acute angle conical, resulting in much concentrated stress. The increase in the initial impact velocity leads to the increase in the contact stress, resulting in severe plastic flow of the material at the edge of the worn scar.

As shown in the cross-sectional profile of the worn scar in Figure 4f, with the increase in the initial impact velocity, the plastic flow of the material is intensified, and the material bulge at the edge of the worn scar is increased. However, when the initial impact velocity  $V = 150$  mm/s, the plastic deformation bulge at the edge of the worn scar is low, but the damage at the center of the wear mark is more serious, and the profile of the worn scar at the bottom of the wear mark is rough. The simulation results of Qi et al. [21] show that during the high-speed impact process, a large amount of energy is consumed in the formation and expansion of cracks, and the proportion of energy loss caused by the plastic deformation of the material is reduced.

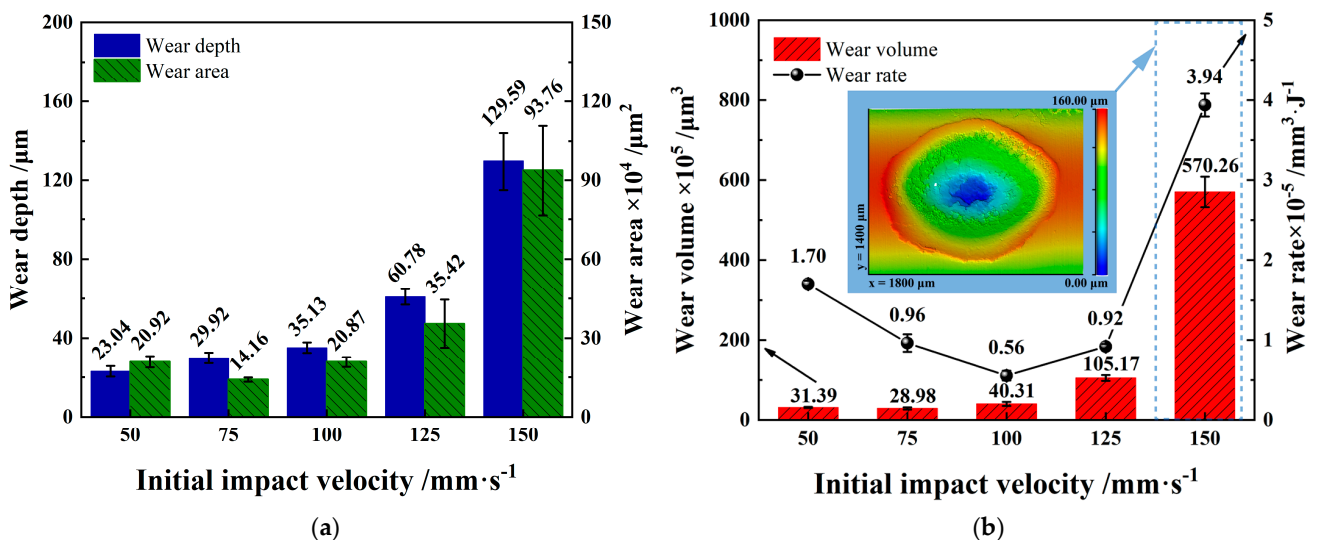
**Figure 5.** Wear statistics under varying initial impact velocities. (a) Wear depth and wear area; (b) wear volume and wear rate.

Figure 5 shows the statistics of maximum wear depth, wear area, wear volume, and wear rate under different initial impact speeds. With the increase in initial velocity and impact velocity, the maximum wear depth gradually increases, where the wear area, wear volume, and wear rate of the worn scar initially decrease slightly and then increase significantly. When the initial impact velocity is  $V = 50$  mm/s, the energy dissipated by the impact is the lowest, but the wear volume and wear rate are higher than  $V = 75$  mm/s,  $V = 100$  mm/s, and  $V = 125$  mm/s, as shown in Figure 5b.

When the initial impact velocity  $V = 150$  mm/s, the wear rate increases significantly, higher than other initial impact velocities, reaching  $3.94$  mm<sup>3</sup>/J. Evidently, materials fall off at the bottom of the worn scar with initial impact velocity  $V = 150$  mm/s.

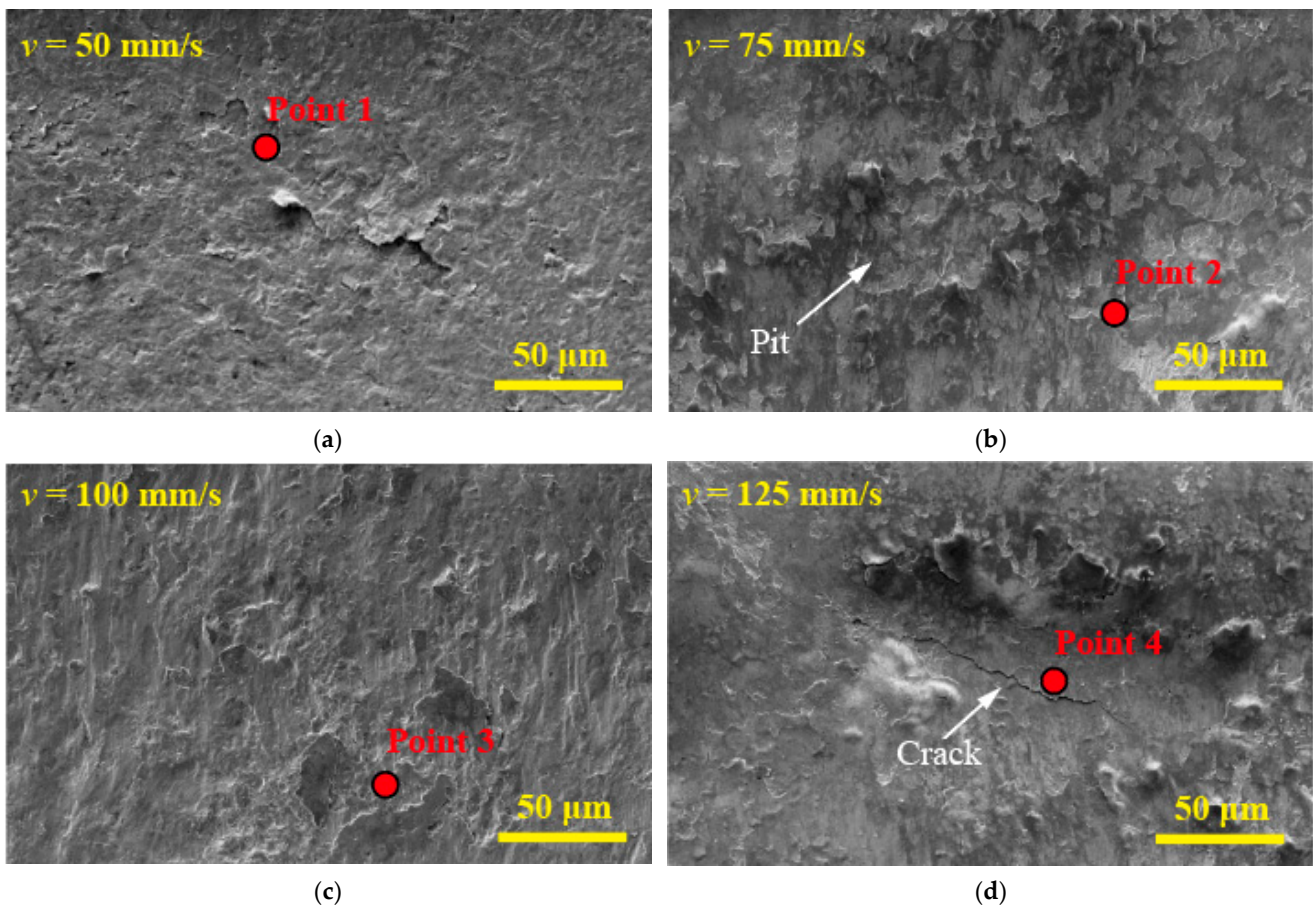
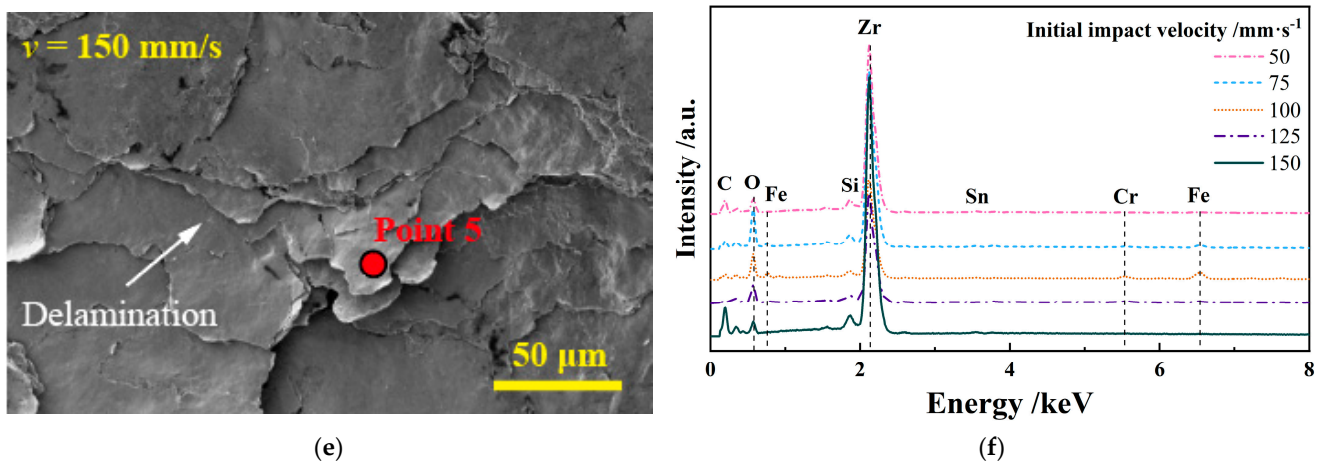
**Figure 6.** SEM morphology and EDS of wear scar center under varying initial impact velocities. (a)  $V = 50$  mm/s, (b)  $V = 75$  mm/s, (c)  $V = 100$  mm/s, (d)  $V = 125$  mm/s, (e)  $V = 150$  mm/s, and (f) EDS.

The causes of these phenomena are further explored by analyzing the morphology and composition of the wear debris in the central area of the worn scar caused by different initial impact velocity. As shown in Figure 6a, the impact contact force is low when  $V = 50$  mm/s, and the material damage caused by impact wear is small. In addition, the wear debris generated in the impact process leaves the contact area under the washing of lithium borate solution, resulting in only a small amount of wear particles adhering to the wear marks. The abrasive particles generated by impact adhere to the contact surface after high deformation, grinding, and oxidation when the initial impact velocity increases to  $V = 75$  and  $100$  mm/s. As a result, a debris accumulation layer, which reduces wear [22,23], is formed, as shown in Figure 6b–c. Compared with the debris accumulation layer with complete surface structure formed when the initial impact velocity  $V = 100$  mm/s, there are many pits on the surface of the debris accumulation layer with the initial impact velocity  $V = 75$  mm/s. The surface of the debris accumulation layer falls off under the action of repeated tensile and compressive stresses due to the weak bonding strength between wear debris and Zr-4 alloy.

In Figure 6d, when the initial impact velocity  $V = 125$  mm/s, fine cracks are evident in the debris accumulation layer in the center of the worn scar. Under the normal impact force, the relative displacement of the material due to plastic deformation causes shear stress in the secondary surface layer, promoting the initiation and propagation of microcracks [24]. As shown in Figure 6e, severe delamination and fall off occur in the center area of the worn scar when the initial impact velocity  $V = 150$  mm/s.

With the increase in the initial impact velocity, the formation of the debris accumulation layer increases the content of Fe, O, and Cr elements in the debris and decreases the content of Zr elements. The spalling of the debris accumulation layer decreases the content of Fe, O, and Cr elements in the debris and increases the content of Zr elements, as shown in Figure 6f and Table 3.

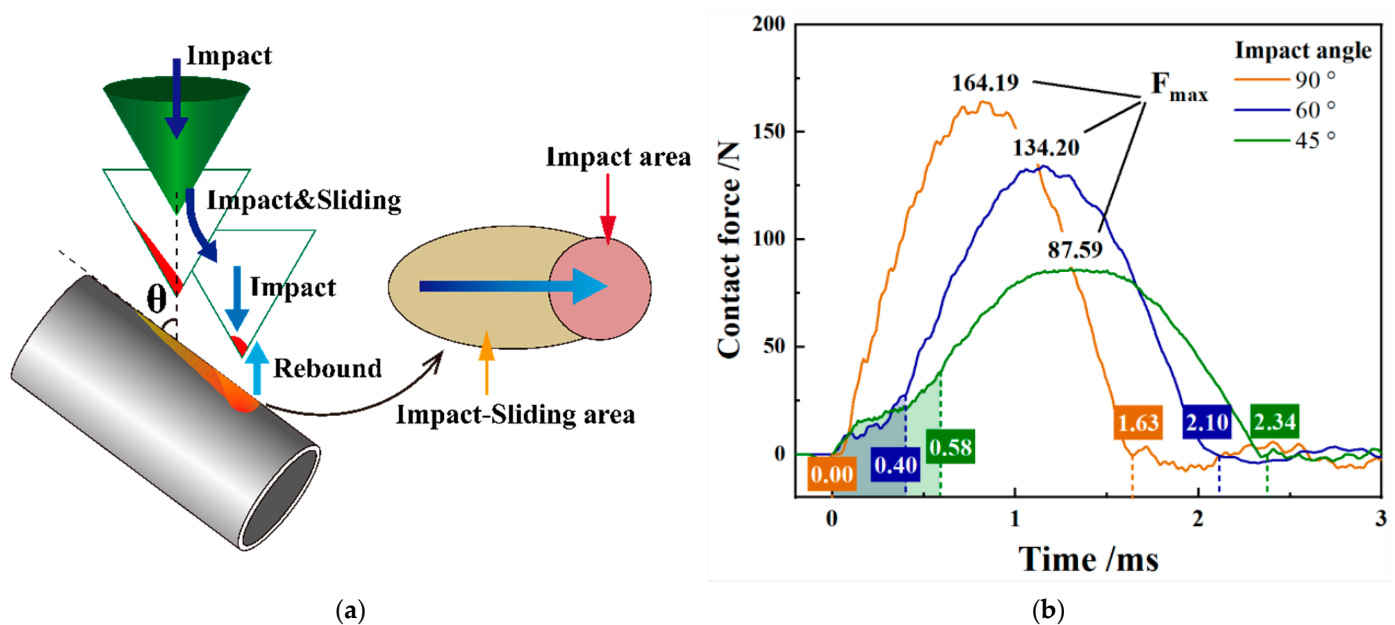
**Figure 8.** Wear statistics of the worn area under varying initial impact velocities. (a) Impact velocity response vs. time; (b) impact contact force vs. time.

As shown in Figure 8a, the impact process of the inclined angle is divided into two stages: the impact-sliding stage and the impact stage. The damage to the Zr-4 alloy pipe corresponds to the impact-sliding area and the impact area [27]. In Figure 8b, the impact contact force only increases slightly in the impact-sliding stage but increases greatly and peaks in the impact stage. The research shows that the lower initial impact velocity indicates smaller peak value of the contact force generated.

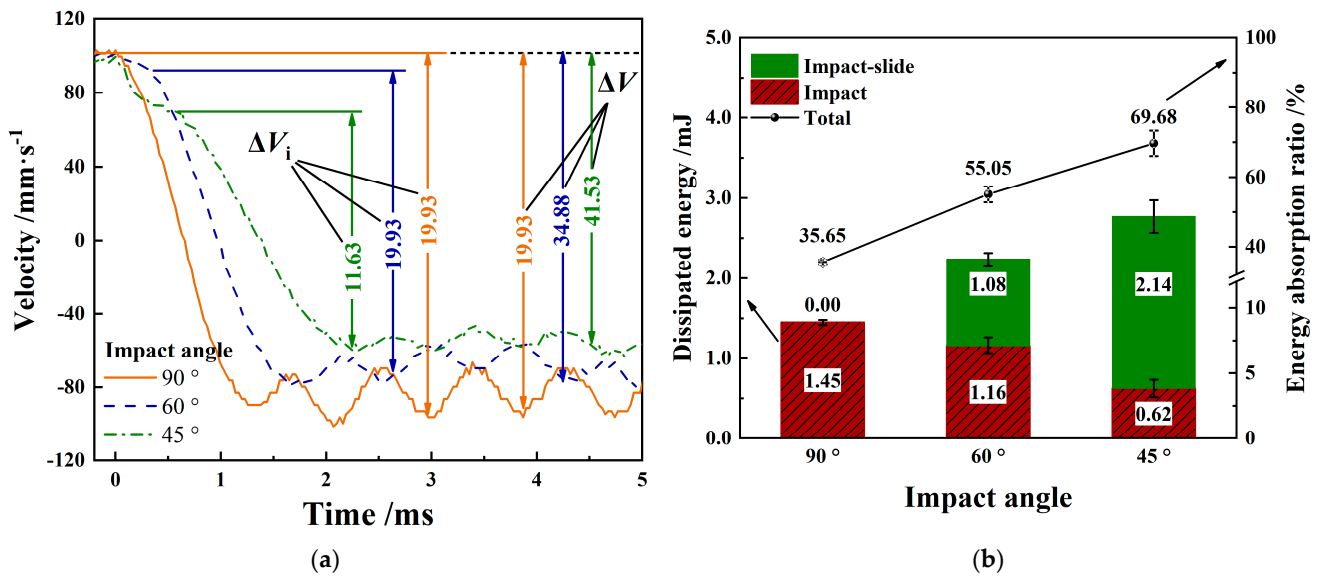
Figure 9. Energy response with varying impact angle. (a) Energy response vs. time; (b) dissipated energy evolution.

Figure 9a shows that the presence of the impact-sliding stage reduced the initial impact velocity of the impact stage to lower than  $V = 100$  mm/s. The contact peak force ( $F_{max}$ ) of  $\theta = 60^\circ$  and  $\theta = 45^\circ$  impact decreases from 164.19 N to 134.20 N and 87.59 N, respectively. In addition, with the inclination of the impact angle, the time of impact sliding stage becomes longer, and the contact time between the 316L SS impact block and the Zr-4 alloy tube becomes longer.

The energy response curve of Figure 9a can be obtained using the kinetic energy theorem. Through the energy at the time of contact  $E_0$ , the energy at the time of initial impact  $E_1$  and at the time of rebound separation  $E_2$ , the energy dissipated at the impact-sliding stage, and the impact stage at three different angles can be obtained.

As shown in Figure 9b, with the inclination of the impact angle, the energy consumption in the impact-sliding stage gradually increases, the energy consumption in the impact stage gradually decreases, and the impact-sliding stage becomes the main stage of energy dissipation. At  $\theta = 45^\circ$  impact, the energy dissipation in the impact-sliding stage accounts for 78% of the total energy dissipation. Moreover, the energy absorption rate gradually increases with the inclination of the impact angle. When the impact angle is  $\theta = 45^\circ$ , the

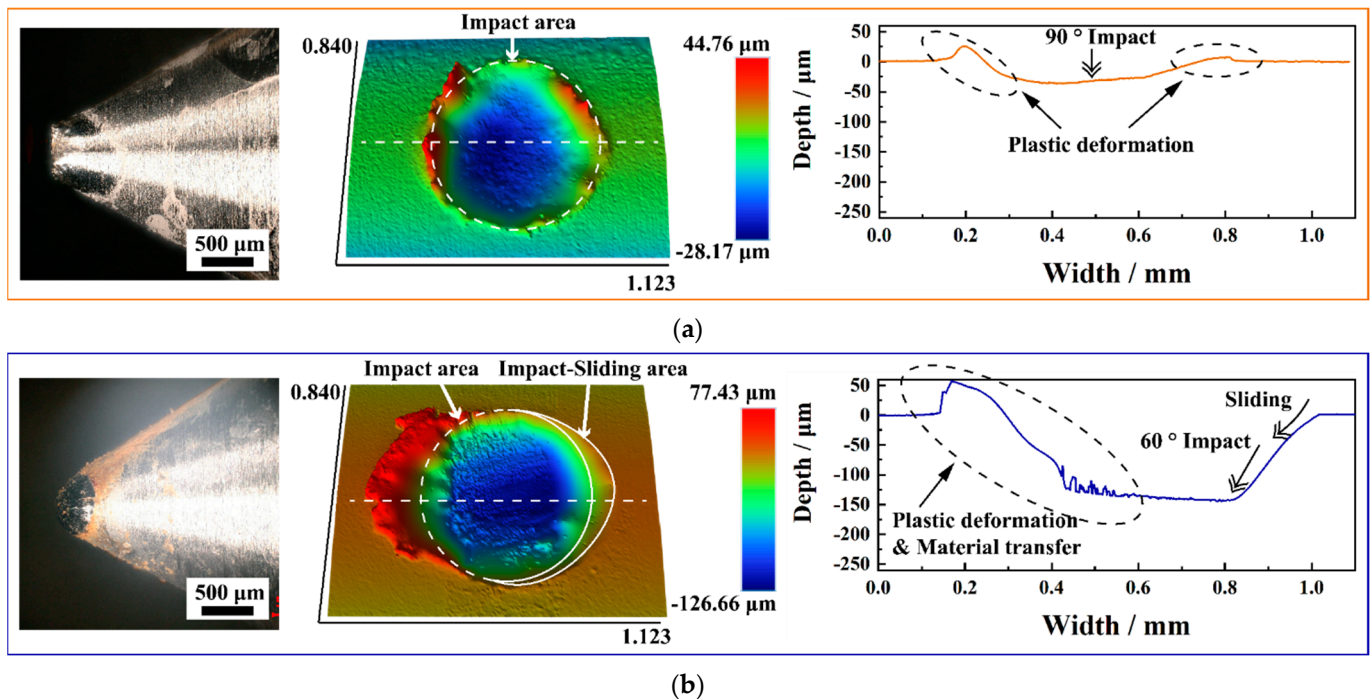
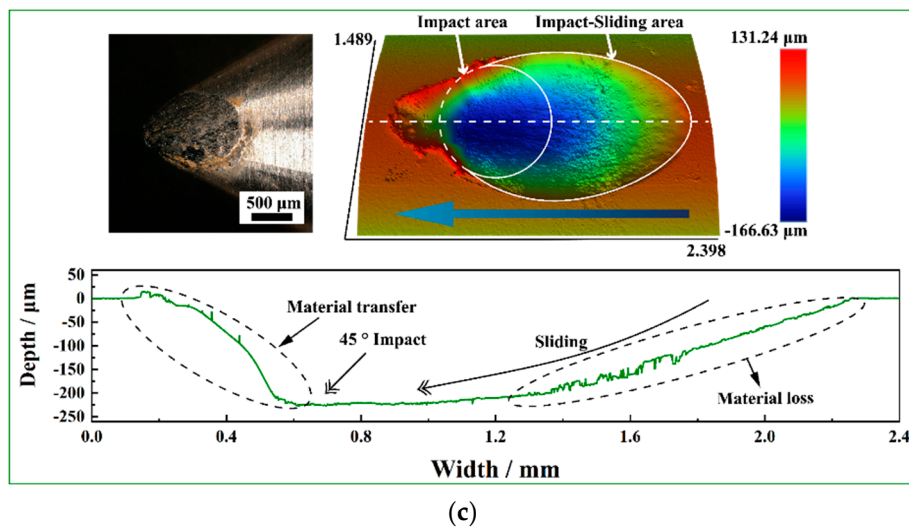
**Figure 10.** Wear of impact blocks and tube specimens at different impact angles. (a)  $\theta = 90^\circ$ ; (b)  $\theta = 60^\circ$ ; (c)  $\theta = 45^\circ$ .

Figure 10 shows the wear morphology of impact block 316L SS and the 3D topography and sectional profiles of worn scars of Zr-4 alloy tube under different impact angles. The damage area of the acute angle cone impact block increases with the inclination of the impact angle, and the damage changes from complete top wear to side wear.

Correspondingly, the morphology of the worn scars on the Zr-4 alloy tubes changed from a circular impact area formed only by the impact stage to a composite area of an elliptical impact sliding area formed by the impact-sliding stage and a circular impact region formed by the impact stage; the length of the worn scars increased [28]. The existence of the impact-sliding stage reduces the initial impact velocity entering the impact stage with the inclination of the impact angle; thus, the size of the circular impact area decreases. As shown in the 3D topography in Figure 10, the maximum wear depth of the worn scars of  $\theta = 90^\circ$ ,  $\theta = 60^\circ$ , and  $\theta = 45^\circ$  impact is located in the circular impact area.

Figure 10a shows high bulges around the  $\theta = 90^\circ$  impact worn scar; however, in Figure 10b–c, the protrusions of  $\theta = 60^\circ$  and  $\theta = 45^\circ$  impact worn scar edge only occur at the edge of the circular impact area on the left, and no evident bulges are found at the edge of the elliptical impact-sliding area. Moreover, the sectional profiles of the impact-sliding area of the  $\theta = 45^\circ$  impact worn scar is rough, and a large amount of material wear removal is found.

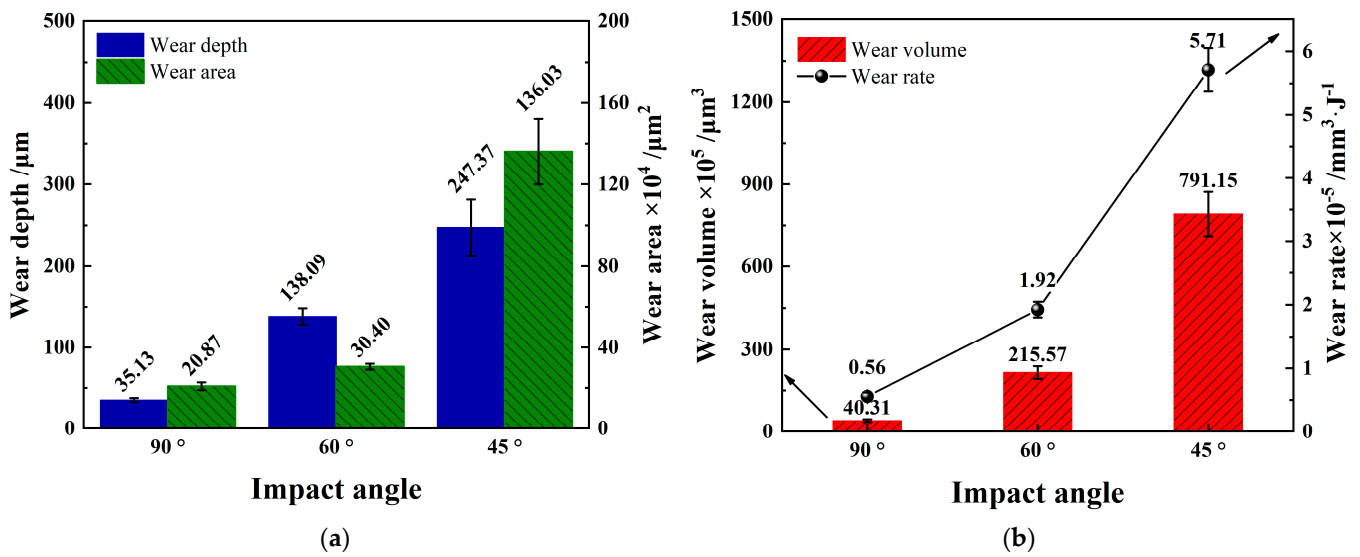
Figure 11. Wear statistics of the worn under varying impact angles. (a) Wear depth and wear area; (b) wear volume and wear rate.

Figure 11 shows the statistics of the maximum wear depth, wear area, wear volume, and wear rate of the Zr-4 alloy tube caused by different impact angles. With the inclination of the impact angle, the maximum wear depth, wear area, wear volume, and wear rate increase, and the wear rate of  $\theta = 45^\circ$  impact with the most energy loss in the impact-sliding stage is much higher than  $\theta = 90^\circ$  and  $\theta = 60^\circ$ . This phenomenon shows that the impact-sliding stage is more likely to cause material damage than the impact stage.

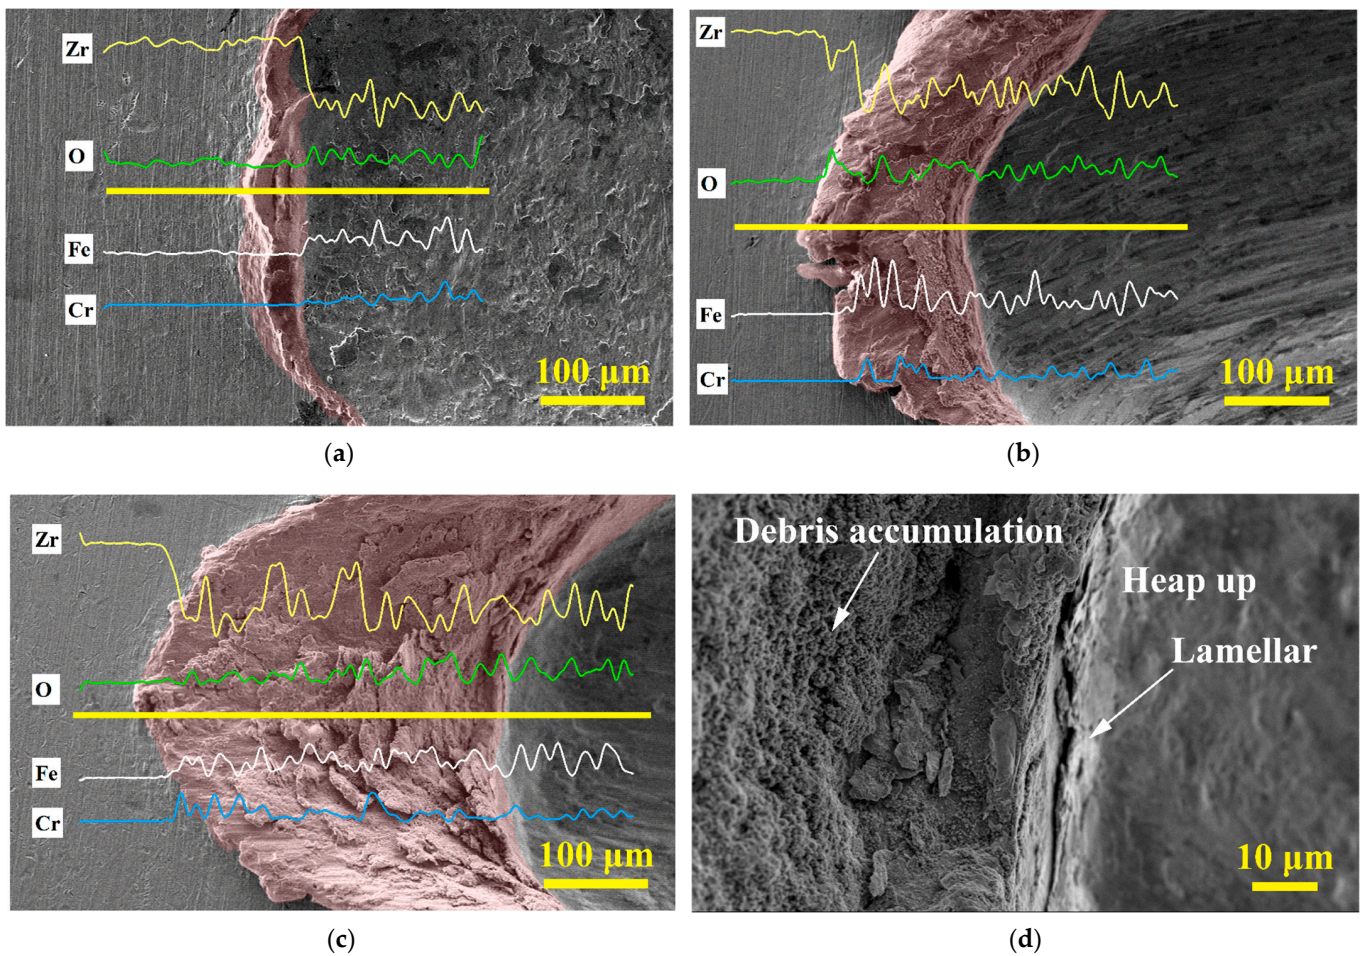
Figure 12. Material accumulation on the left side under different impact angles. (a)  $\theta = 90^\circ$ ; (b)  $\theta = 60^\circ$ ; (c)  $\theta = 45^\circ$ ; and (d) wear debris accumulation.

Material accumulation is observed on the left side of the impact area at different impact angles, and the area of material accumulation increases with the inclination of the impact angle. The line scan data in Figure 12a show that the material accumulation on the left side of  $\theta = 90^\circ$  impact is the plastic deformation of Zr-4 alloy matrix, and the wear debris is accumulated on the impact contact surface. However, the material accumulation on the left side of the impact at  $\theta = 60^\circ$  and  $\theta = 45^\circ$  represents a large amount of wear debris generated during the wear process. The wear debris accumulation at  $\theta = 45^\circ$  impact is more serious than that at  $\theta = 60^\circ$  impact, as shown in Figure 12b–c. The debris are stacked into lamellar under the joint action of the normal impact force and the tangential force as shown in Figure 12d.
