# Microstructural Understanding of Flow Accelerated Corrosion of SA106B Carbon Steel in High-Temperature Water with Different Flow Velocities

**Abstract:** All light or heavy water reactors fabricated with carbon steels suffer from flow-accelerated corrosion (FAC). The FAC degradation of SA106B with different flow velocities was investigated in terms of microstructure. As flow velocity increased, the major corrosion type changed from general corrosion to localized corrosion. Severe localized corrosion occurred in the pearlite zone, which can be the prior location for generating pits. After normalizing, the improvement in microstructure homogeneity reduced the oxidation kinetics and lowered cracking sensitivity, causing a decrease in FAC rates of 33.28%, 22.47%, 22.15%, and 17.53% at flow velocity of 0 m/s, 1.63 m/s, 2.99 m/s, and 4.34 m/s, respectively. Additionally, localized corrosion tendency was decreased by reducing the micro-galvanic effect and tensile stresses in oxide film. The maximum localized corrosion rate decreased by 21.7%, 13.5%, 13.8%, and 25.4% at flow velocity of 0 m/s, 1.63 m/s, 2.99 m/s, and 4.34 m/s, respectively.

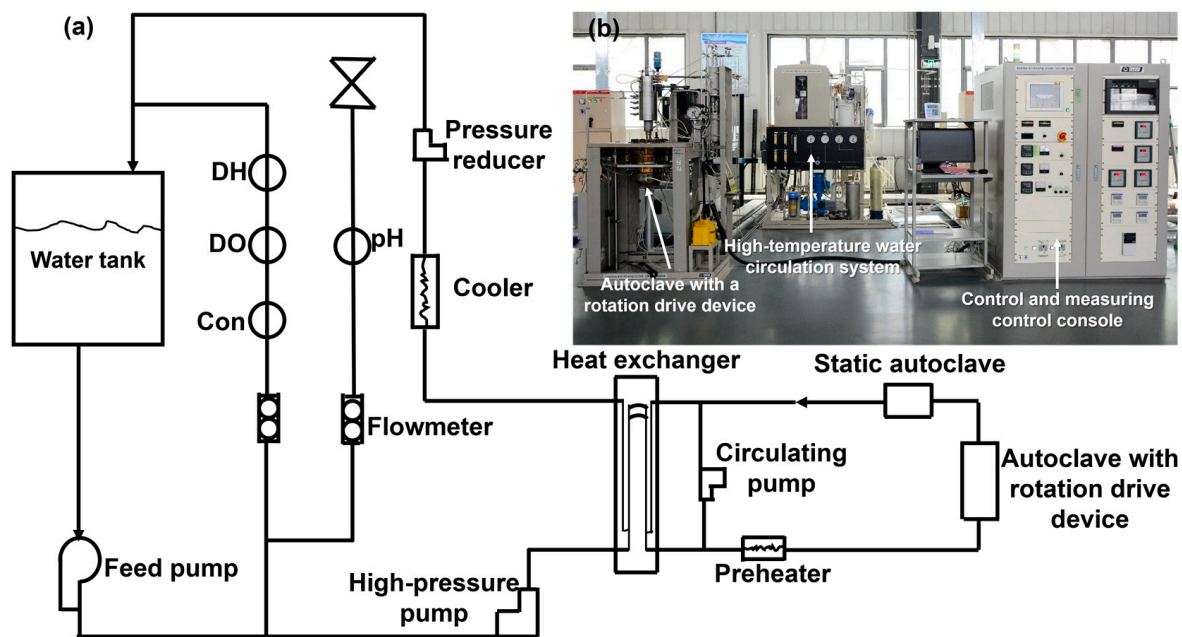
**Figure 1.** (a) The schematic of the high-temperature water FAC test facility and (b) its real picture in our lab.

The FAC tests were performed by the subcritical water environment rotating-cylinder electrode testing system (SW-RETS) in our lab. Figure 1a shows the schematic of the FAC test facility. It contains the high-temperature water circulation system, an autoclave with a rotation drive device, a static autoclave, control and measuring control console, and data-acquisition system. Figure 1b shows the real scene for the working FAC test facility. The temperature, pressure, pH, dissolved oxygen (DO), dissolved hydrogen (DH), and conductivity can be controlled and measured by the high-temperature water circulation system. High pure nitrogen gas was pumped into the loop continuously to control the DO concentration. The pH value was modified by ammonia water. The autoclave with a rotation drive device and the static autoclave are manufactured by SUS 316L with 3.5 L

(Toshin Kogyo Co., Ltd., Tokyo, Japan). The type of rotation drive device is the servo motor control, by which the rotational speed can be outputted within 20–2000 rpm.

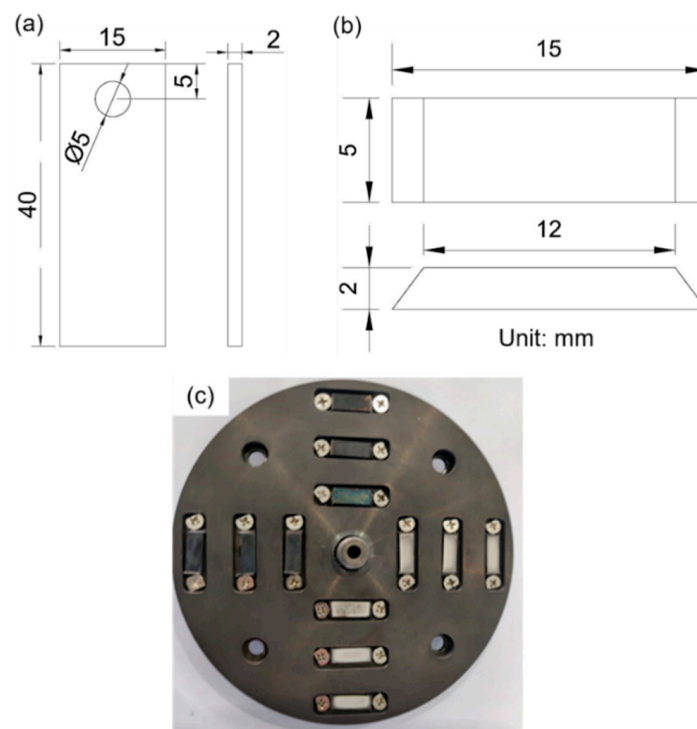
**Figure 2.** The specimen size in the (a) static autoclave and (b) dynamic autoclave with the rotation drive device. (c) The rotating disc with mounted samples.

Figure 2a shows the specimen size in the static autoclave. The specimens were insulated and assembled to a holder. Then, the holder with specimens was fixed in the static autoclave. This is regarded as the flow velocity of 0 m/s. Figure 2b shows the specimen size in the autoclave with a rotation drive device. As can be seen, the specimen has a trapezoid shape. After mechanical polishing, the specimens were mounted into the rotating disc (Figure 2c). The trapezoid specimens were insulated from the fixture by the zirconia sheets. Only the test surface (area: 12 mm × 5 mm) was exposed to the high-temperature water. The testing rotational speed was chosen as 865 rpm. Correspondingly, the linear velocity of the inner, middle, and outer circle could be calculated as 1.63 m/s, 2.99, m/s, and 4.34 m/s. Each circle had four specimens.

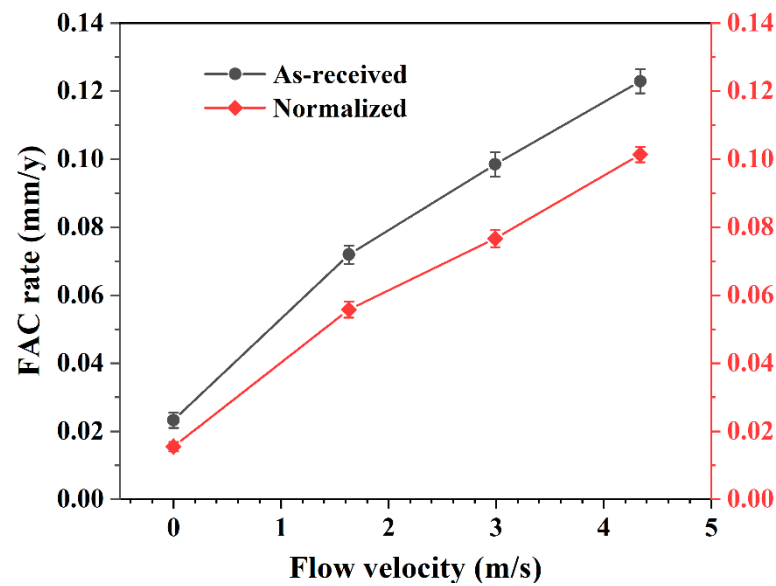
**Figure 4.** FAC rates of as-received and normalized samples under different flow velocities. The error bars are calculated by the standard deviation of at least three measurements from each sample.

Figure 4 shows the FAC rates of as-received and normalized samples under different flow velocities. Compared to static conditions, the FAC rate under dynamic conditions was much larger. Furthermore, the FAC rate increased linearly with the increasing flow velocity under dynamic conditions. For as-received samples, the FAC rate increased from 0.072 mm/y to 0.123 mm/y as the flow velocity increased from 1.63 m/s to 4.34 m/s. Compared with the as-received samples, the FAC rate of normalized samples was obviously smaller. It increased from 0.056 mm/y to 0.101 mm/y as the flow velocity increased from 1.63 m/s to 4.34 m/s.

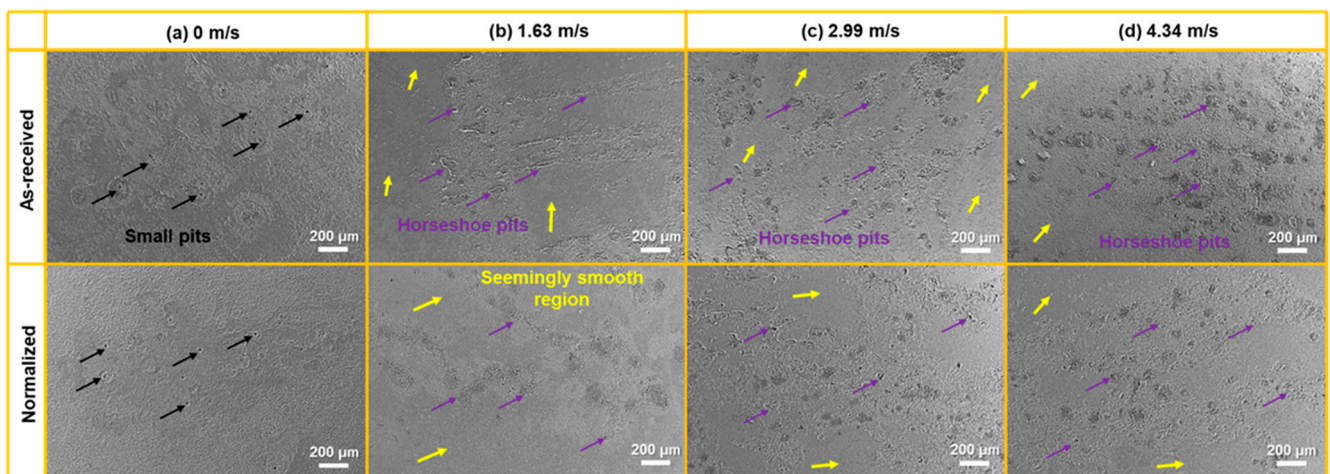
**Figure 5.** Low-magnification SEM images of the corrosion surfaces at the velocities of (a) 0 m/s, (b) 1.63 m/s, (c) 2.99 m/s, and (d) 4.34 m/s in as-received and normalized samples. The small pits, horseshoe pits, and seemingly smooth region are marked by black, purple, and yellow arrows, respectively.

Significant differences in the SEM surface morphologies at different flow velocities in as-received and normalized samples are clearly visible in Figure 5. After being exposed in the static autoclave (0 m/s), corrosion was general with some small pits (marked by black arrow) which can be observed in Figure 5a. The number of small pits in normalized sample seems to be smaller than that in as-received sample. This is in agreement with the small weight loss in the normalized sample. As the flow velocity increased to 1.63 m/s (Figure 5b), the surface morphology obviously changed to be a combination of horseshoe pits (marked by purple arrow) and the seemingly smooth region (marked by yellow arrow). Some horseshoe pits were isolated while others gathered together to form a strip parallel to the flow direction. As the flow velocity further increased (Figure 5c,d), the area of horseshoe pits increased, while the area of the seemingly smooth region decreased.

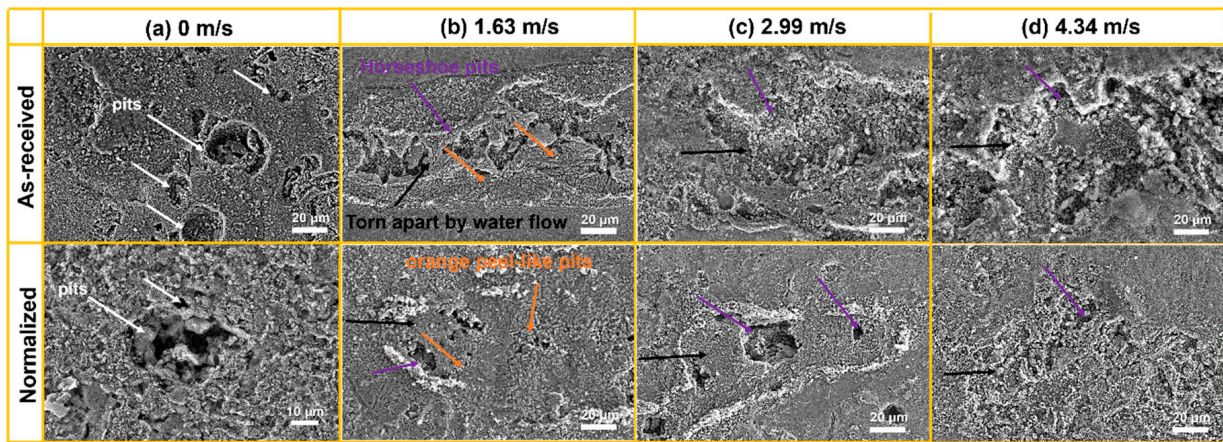
**Figure 7.** The magnified SEM images of the pit region at the velocities of (a) 0 m/s, (b) 1.63 m/s, (c) 2.99 m/s, and (d) 4.34 m/s in as-received and normalized samples. The pits, horseshoe pits, orange peel-like pits, and area torn apart by water flow are marked by white, purple, yellow, and black arrows, respectively.

Figure 7 shows the magnified SEM images of the pit region at different flow velocities in as-received and normalized samples. At 0 m/s, the pits with different size could be found in as-received and normalized samples (Figure 7a). As the flow velocity increased to 1.63 m/s, orange-peel-like or horseshoe-like pits appeared. The pits in as-received sample seemed to be torn apart by the water flow. The accumulation of local oxide particles could be found in the normalized sample (Figure 7b). As the flow velocity further increased to 2.99 m/s, the pit size obviously increased. However, the pit size in normalized sample was smaller (Figure 7c). As the flow velocity increased to 4.34 m/s, the pit size further increased. The pit size in normalized sample was still smaller than in as-received sample (Figure 7d).

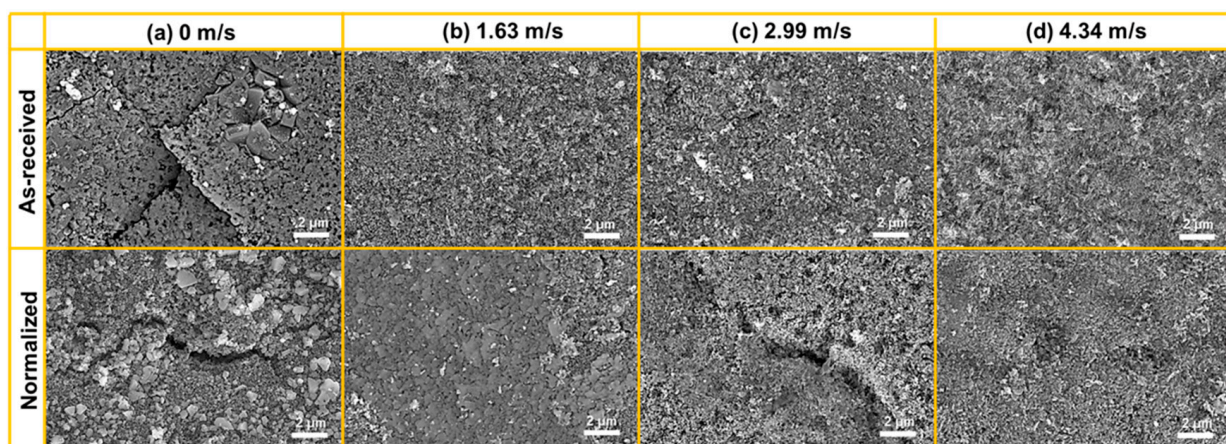
**Figure 9.** The magnified SEM images of the seemingly smooth region at the velocities of (a) 0 m/s, (b) 1.63 m/s, (c) 2.99 m/s, and (d) 4.34 m/s in as-received and normalized samples.

Figure 9 shows the magnified SEM images of the seemingly smooth region at different flow velocities in as-received and normalized samples. Actually, the seemingly smooth region (SSR) at 0 m/s consisted of the surface oxide film in which the cracking with random direction can be seen (Figure 7a). As the flow velocity increased to 1.63 m/s, the size of oxide particle obviously decreased. However, the aggregation of small-size oxides was still obvious in normalized sample (Figure 7b). As the flow velocity further increased to 2.99 m/s and 4.34 m/s, the size of oxide particles was almost unchanged (Figure 7c,d). In

addition to a few cracks in normalized sample at 2.99 m/s, cracks rarely appeared from 1.63 m/s to 4.34 m/s.

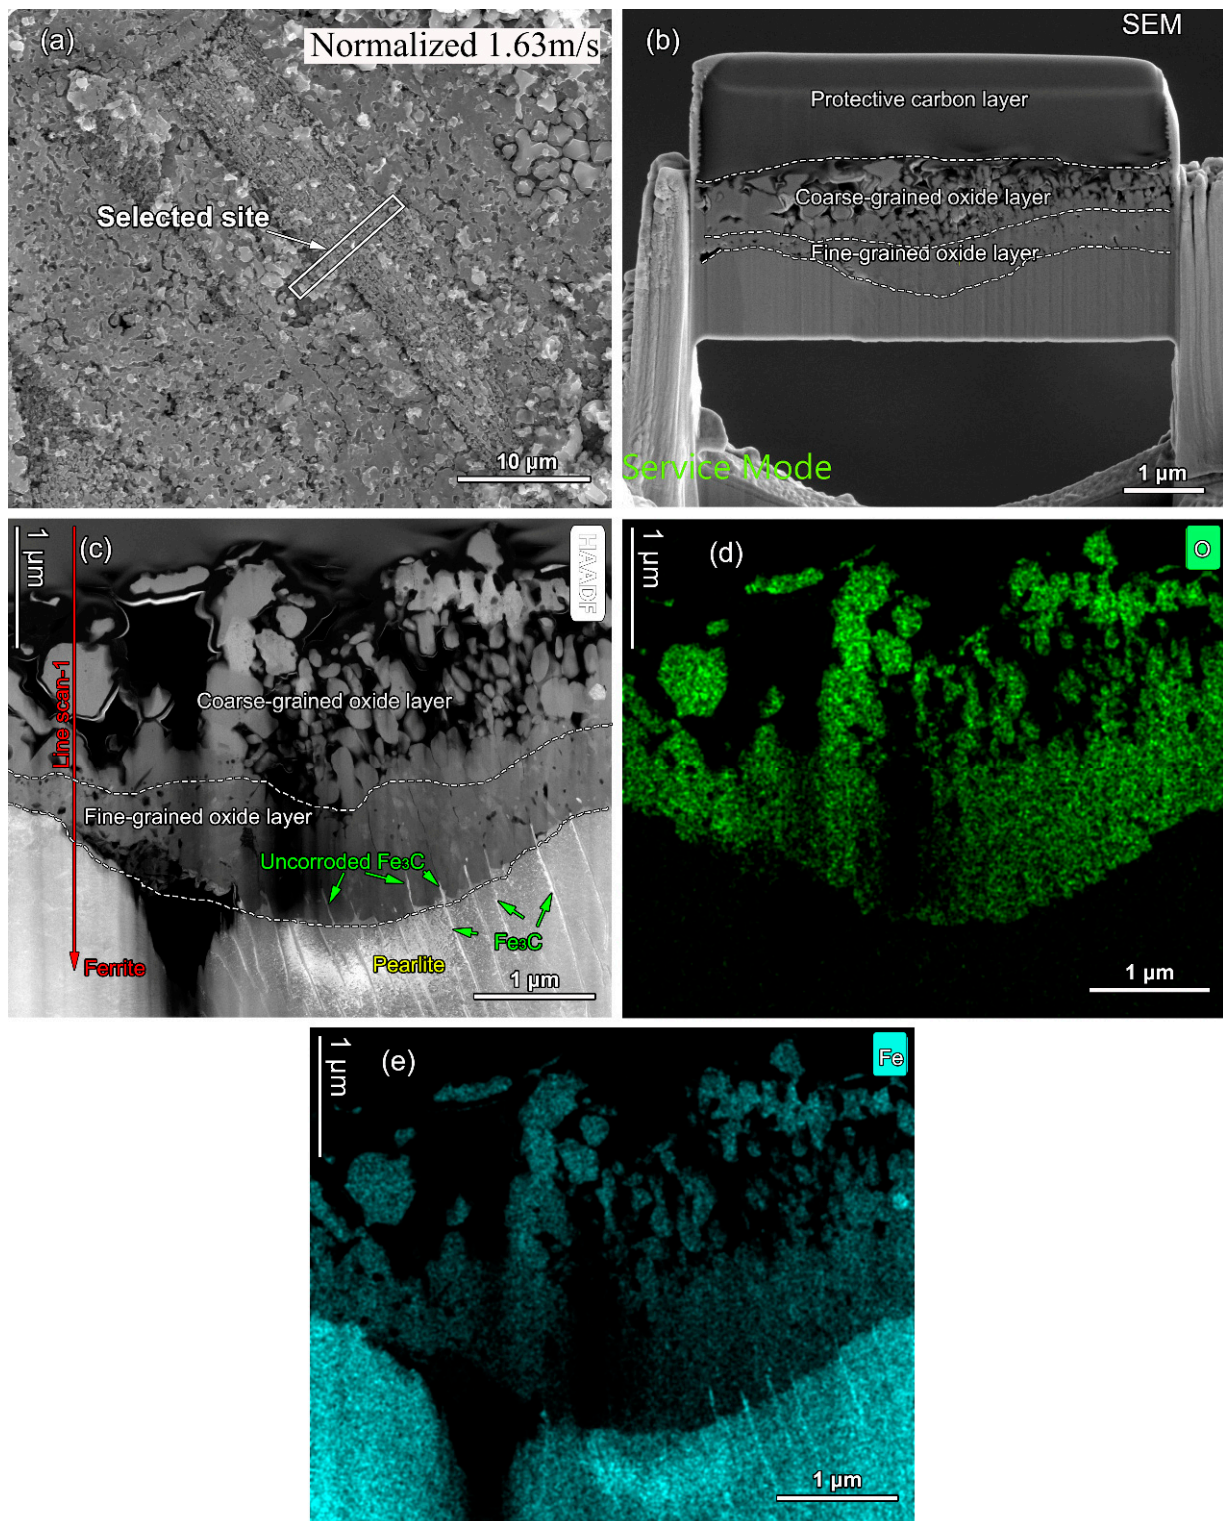
**Figure 11.** (a) The SEM image of the horseshoe pit region at a flow velocity of 1.63 m/s in normalized sample showing the selected site for TEM thin foil during the FIB lift-out process. (b) The cross-section SEM image of the thin foil. (c) The corresponding STEM-HAADF image and the EDX elemental mapping of (d) O and (e) Fe.

Figure 11a shows the SEM image of the horseshoe pit region at the flow velocity of 1.63 m/s in normalized sample showing the selected site for TEM thin foil during the FIB lift-out process. Figure 11b shows the cross-section SEM image of the thin foil. The protective carbon layer was just above the oxide film. The oxide film can be divided into the coarse-grained oxide layer and fine-grained oxide layer. Figure 11c–e shows the corresponding STEM-HAADF image and the EDX elemental mapping of O and Fe. Under STEM-HAADF imaging, the oxide film was dark while the bulk material was bright. Furthermore, the ferrite and pearlite can be properly distinguished due to the highlight of the cementite ( $\text{Fe}_3\text{C}$ ) in pearlite. It can be noted that there is uncorroded  $\text{Fe}_3\text{C}$  in the oxide film, which is rich in Fe and O.

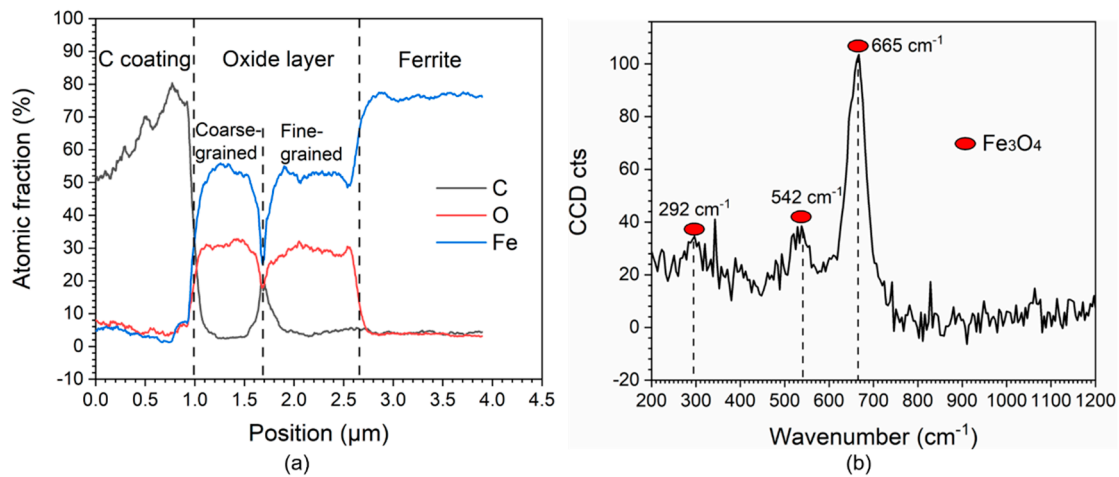
**Figure 12.** (a) The EDX line scanning analyses along line 1 in Figure 11c. (b) Raman mapping analyses for the oxide film.

Figure 12a shows the EDX line scanning analyses along line 1 in Figure 11c. It can be seen that the coarse-grained and fine-grained oxide layers had same the chemical elemental content with ~52 at. % Fe and ~30 at. % O. Figure 12b shows the Raman mapping analyses for the oxide

film. Only one type of oxide  $\text{Fe}_3\text{O}_4$  was detected, with one major peak at the wavenumber of  $665\text{ cm}^{-1}$  and two minor peaks at the wavenumber of  $292\text{ cm}^{-1}$  and  $542\text{ cm}^{-1}$ .

As shown in Figure 15b, in high-temperature deaerated water, the only redox reaction of the ferrite in the iron/water system was reduction forming hydrogen. Iron was oxidized to produce Fe<sub>3</sub>O<sub>4</sub> (Figure 12) based on the following Equation (2):

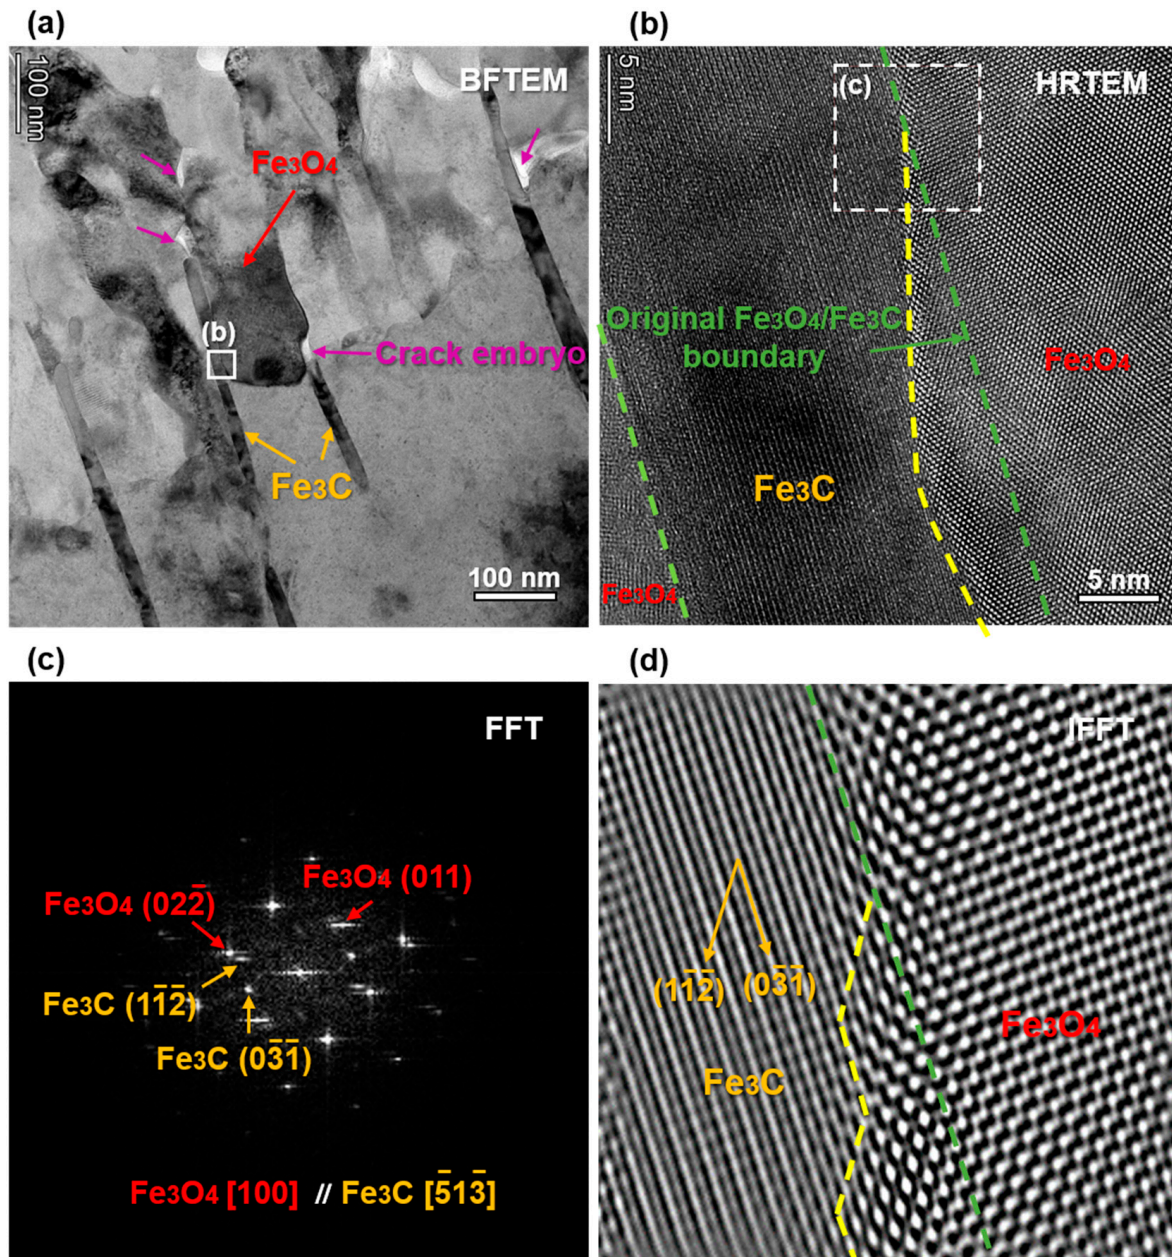
**Figure 14.** (a) The BFTEM image almost consistent with the HAADF image in Figure 13. (b) The HRTEM image taken from the rectangle in (a). (c) FFT and (d) IFFT images taken from the dash rectangle in (b).

Figure 14a shows the BFTEM image, which is almost consistent with the HAADF image in Figure 13. Crack embryos appeared bright under the BFTEM imaging. Additionally, crack embryo were located at the top and lateral of the  $\text{Fe}_3\text{C}$ , the interface of  $\text{Fe}_3\text{O}_4/\text{Fe}_3\text{C}$ , and the grain boundary of  $\text{Fe}_3\text{O}_4$ . Figure 14b shows the HRTEM image taken from the rectangle in Figure 14a. The original  $\text{Fe}_3\text{O}_4/\text{Fe}_3\text{C}$  boundary can be clearly seen, and is marked by the green dash line. The fresh  $\text{Fe}_3\text{O}_4/\text{Fe}_3\text{C}$  boundary is also clear, and is marked by the yellow dash line. The corrosion of  $\text{Fe}_3\text{C}$  is likely preferential along a certain direction. In order to determine it, the FFT and IFFT analyses shown in Figure 14c,d were

taken from the dash rectangle in Figure 14b. From Figure 14c, there was a relationship of  $\text{Fe}_3\text{O}_4\{100\} // \text{Fe}_3\text{C}\{\bar{5}\bar{1}\bar{3}\}$  with an incoherent boundary. The corrosion invasion into  $\text{Fe}_3\text{C}$  took priority in the direction of  $\text{Fe}_3\text{C}(\bar{1}\bar{1}\bar{2})$ , as shown in Figure 14d.

As shown in Figure 15c, although the dissolution rate of Fe<sub>3</sub>C was lower than other phases, such as ferrite, the exposed Fe<sub>3</sub>C and the surrounding corrosion product film could sequentially form the condition of “small anode–large cathode” according to the following reaction (5) [32]. Furthermore, the reaction of Fe<sub>3</sub>C took priority in the direction of Fe<sub>3</sub>C (112) (Figure 14) having the largest crystal plane spacing, which was beneficial to the element diffusion.

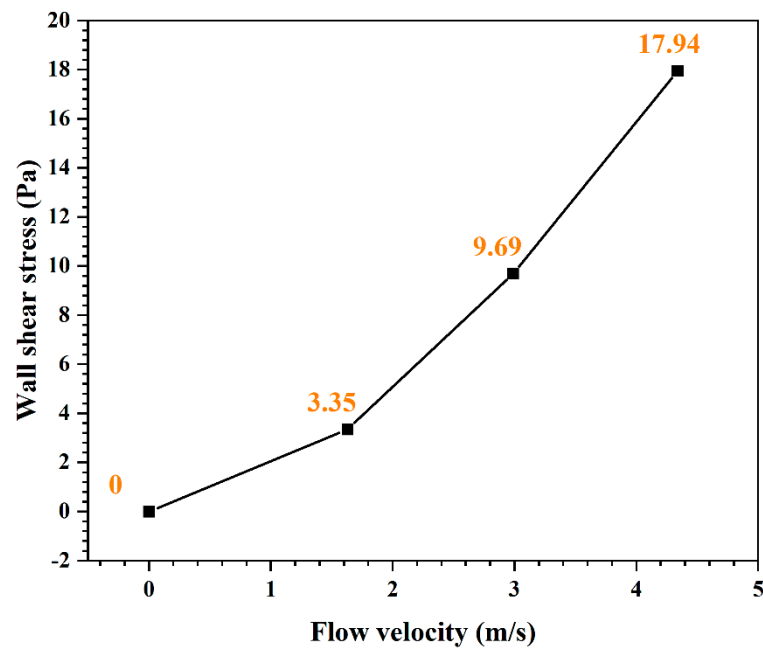
Figure 16. The change in wall shear stress of dynamic high-temperature water with flow velocity.

Figure 16 shows the change in wall shear stress with flow velocity, which is calculated by Equation (10). The wall shear stress increases with increasing flow velocity. When the flow velocity increases to 4.34 m/s, the wall shear stress grows to 17.94 Pa, which is much lower than the bonding strength ( $1\text{--}10^2$  MPa) between the film and the substrate [41]. Although wall shear stress is inadequate to lead to mechanical damage of complete  $\text{Fe}_3\text{O}_4$  film, it still plays a significant role in the formation process of the oxide film. As the oxide film becomes denser, the internal stress simultaneously enhances with enlarging thickness of the oxide film [42], which could give rise to cracking in the film [43]. The spalling of oxides can be intensified by wall shear stress in the meantime, as shown in Figure 8. Additionally, the growth in  $\text{Fe}_3\text{O}_4$  inside localized corrosion pits can also be influenced by the flow velocity. With increasing flow velocity, the vortex was readily created inside the pit to accelerate the mass transfer and prevent the formation of  $\text{Fe}_3\text{O}_4$  film inside the pits. Then, severe localized corrosion was formed. The study [13] verified that 0.2 Pa of wall shear stress was already enough to exacerbate localized corrosion. Furthermore, the adjacent small pits could merge into a large pit under the impact of high flow velocity to worsen localized corrosion.
