# Parameters Optimization of Laser-Grinding Chain for Processing Groove of 2.5-Dimensional C/SiC Composites

**Abstract:** Aiming at problems such as poor precision of laser processing C/SiC composites, low efficiency of grinding C/SiC composites, and serious wear of grinding wheel, a method of laser-grinding chain processing C/SiC composite groove was proposed in this paper. The method combined the high efficiency characteristic of laser ablating and the high precision characteristic of grinding. The relationship between laser processing parameters and the characteristics of ablative grooves was investigated, and the appropriate laser processing parameters were optimized, and then, to further improve the processing quality of the grooves, the grinding parameters optimization experiments of the grooves of C/SiC composites were carried out. The results showed that the C/SiC composites could be quickly removed by laser processing, and the grooves with relatively good size and shape accuracy could be obtained by laser parameters optimization experiments, but the side wall of the groove still had a certain inclination and the surface quality of the groove was yet poor; meanwhile, the s

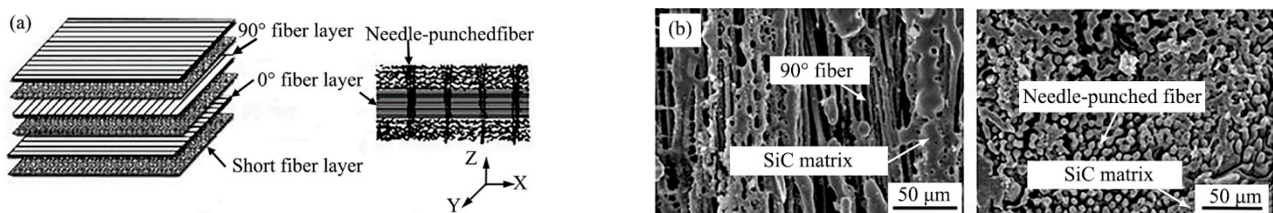
**Figure 1.** Fiber arrangement pattern and microstructure (a) Fiber arrangement pattern, (b) Microstructure.

C/SiC composite workpieces used in this experiment were manufactured by the chemical vapor infiltration (CVI) method of Gong Yi Van-Research Innovation Composite Material Co. Ltd. (Kongyi, China), the workpiece size was 30 mm × 15 mm × 9.8 mm, the internal structure consists of carbon fibers, SiC matrix, and randomly distributed pores, the volume fraction of carbon fibers was 40–50%, the mass fraction of carbon fibers was 27–36%: the fiber arrangement and microstructure are shown in Figure 1. The fiber arrangement and microstructure are shown in Figure 1. The tool selected in this paper was an electroplated diamond grinding wheel, which was prepared by Zhengzhou Abrasives Grinding Research Institute Co., Ltd. (Zhengzhou, China), and its specific parameters were as follows: particle size of 120 #, abrasive concentration of 100%, wheel diameter of 4 mm, tool holder diameter of 6 mm, and grinding wheel handle length of 60 mm. The experiments were processed by a nanosecond laser marking machine (Shenzhen Orena Laser Equipment Co., Ltd., Shenzhen, China) and a small CNC milling machine JX300 (Yornev Automation Equipment Co., Ltd., Foshan, China) for C/SiC composites, as shown in Figure 2. The experiments were processed by a nanosecond laser marking machine and a small CNC milling machine JX300 for C/SiC composites, as shown in Figure 2.

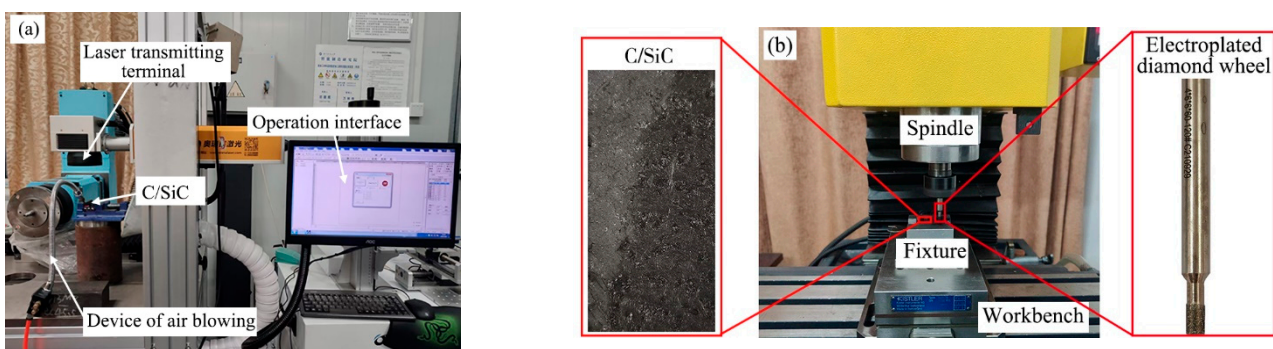
**Figure 2.** Processing equipment diagram (a) Laser process equipment, (b) Grinding equipment.

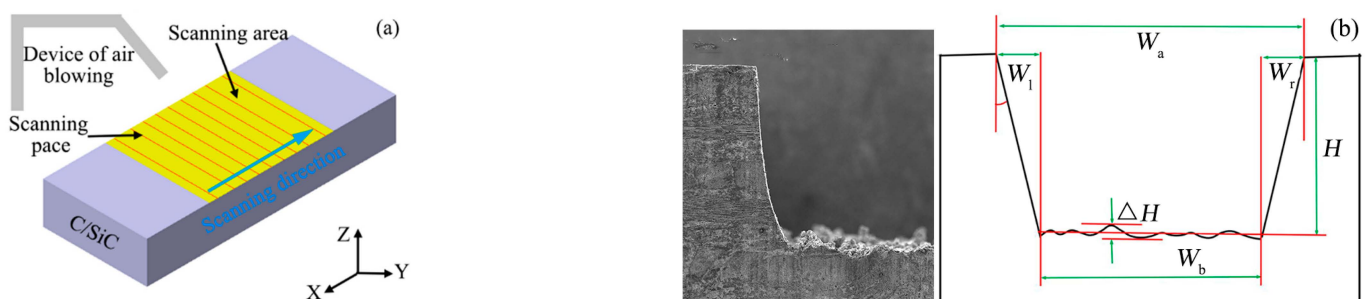
**Figure 3.** Schematic diagram of groove scanning trajectory and evaluation characteristics of grooves. (a) Schematic diagram of groove scanning trajectory. (b) Evaluation characteristics of grooves.

The important indicators which could express the efficiency and quality of nanosecond laser ablation groove in 2.5-dimensional C/SiC composites include the width of the upper surface of the groove ( $W_a$ ), the width of the lower surface of the groove ( $W_b$ ), the average

depth of the grooves ( $H$ ), the taper of the groove side wall ( $\theta$ ), and the depression depth of the groove bottom ( $\Delta H$ ) [41], as shown in Figure 3b, where the most influential factors were the taper of the groove side wall and the depression depth of the groove bottom.

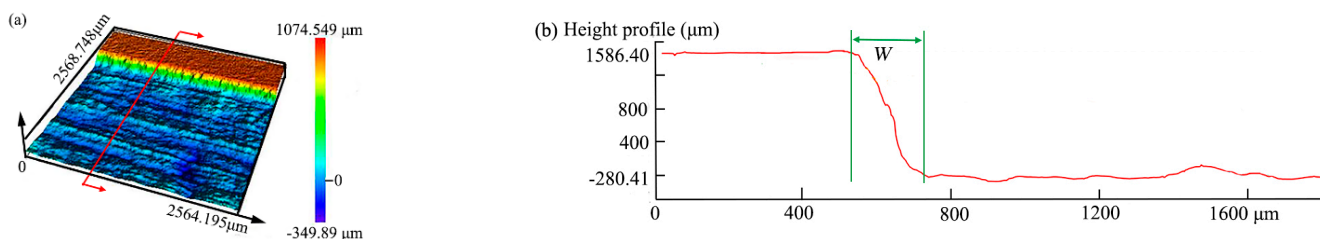
**Figure 4.** Three-dimensional surface morphology and contour morphology of C/SiC composites obtained by confocal microscopy (a) Three-dimensional surface morphology. (b) Contour map of C/SiC composites.

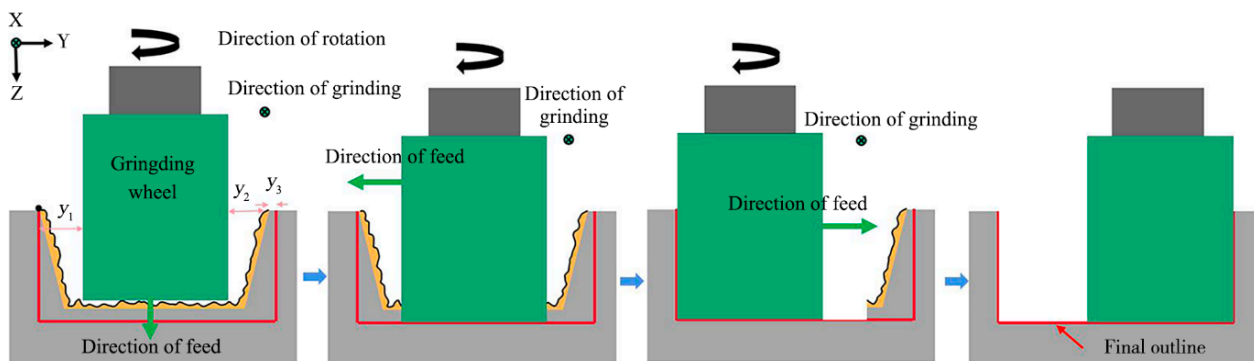
**Figure 5.** Grinding process.

The scheme of grinding processing was designed in Figure 5. Firstly, the grinding wheel was moved along the Y+ direction to the center of the ablation groove, and moved along the Z+ direction to contact the groove bottom, and then, the bottom of the grinding wheel was tooled at the center of the ablation groove bottom. Secondly, the grinding wheel was moved to the end face of the groove along the X- direction, the processing allowance and ablative oxide layer on the surface of the groove was removed by grinding wheel outwards and inwards from the workpiece end face, and, according to the calculation, the depth of the groove reached the ideal size when grinding  $n$  times. Then, the grinding wheel was moved to Y- with cutting depth of 50  $\mu\text{m}$  each time, and the groove was ground from the workpiece end face from outside to inside, the sidewall taper of the left groove was removed after grinding  $y_1$  to the left. Finally, the grinding wheel was moved  $y_1$  mm along the Y+ direction, it began grinding to the right side of the groove, the right-side wall taper of the groove was removed when ground  $y_2$  to the right, and the width of the groove was qualified when ground  $y_3$  to the right.

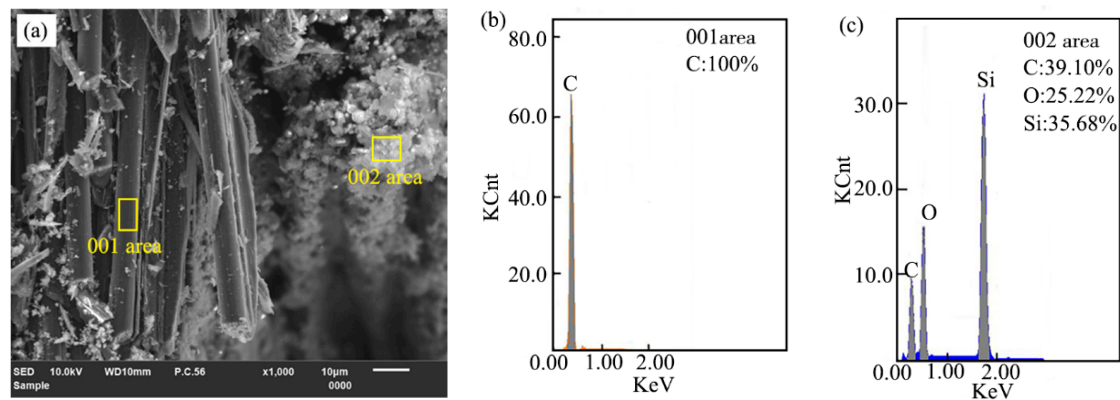
**Figure 9.** Detection of EDS components at the groove bottom ablation: (a) Micromorphology, (b) 001 area, (c) 002 area.

In order to confirm the composition of material adhering on the groove surface after laser ablation of 2.5-dimensional C/SiC composites, the EDS composition analysis was performed at random detection locations in the bare-leakage carbon fiber and material covered areas. As shown in Figure 9, only carbon elements were detected on the bare leaking carbon fiber surface, while C, O, and Si elements were detected in the material covered area, where the percentages of C, O, and Si contents is 39.10%, 25.22%, and 35.68%, respectively. The results indicated that the composition of substances adhering to the C/SiC composites ablation groove surface were silicon oxygen compounds and silicon carbide, this was because C/SiC composites underwent a series of physicochemical reactions under the action of high local temperature for the laser beam, with the accumulation of heat and the increase in temperature, the carbon fiber reached its sublimation temperature and formed carbon vapor, and the part of silicon carbide matrix reached its decomposition and sublimation temperature, and the cracked Si (g) was oxidized to generate a large amount of hot SiO<sub>2</sub> gas and a small amount of SiO (g), which was vaporized and splashed out of the groove surface, and as the temperature decreased, the groove surface was covered with gaseous SiO<sub>2</sub> and SiO in the form of smoke dust [45].

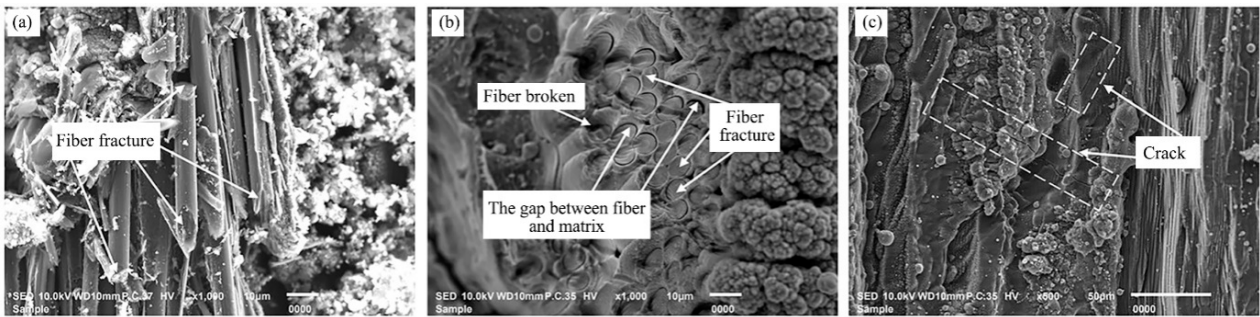
**Figure 10.** Microstructure of the ablative groove bottom in different regions: (a) the longitudinal fiber region, (b) the needled fiber region, (c) the SiC region.

Figure 10 shows the microscopic morphology of the longitudinal fiber region, the needled fiber region and SiC region at the bottom of the ablation groove. From the longitudinal fiber region after laser ablation in Figure 10a, the clear carbon fiber fractures could be observed, the fibers and matrix were not removed at the same time, the lengths of exposed longitudinal fibers were different, and the fibers all showed the state of being mitred. In addition, as can be seen from the needle-punched fiber region after laser ablation in Figure 10b, compared with the longitudinal fiber area after laser ablation, only a very small portion of the fibers were broken, the needle-punched fiber fracture was almost flush with the SiC substrate material, and the fiber fracture surface was flat, indicating that the needle-punched fibers were removed simultaneously with the matrix; meanwhile, the gap between fiber and matrix was found. From Figure 10c, it can be seen that cracks appeared on the surface of the SiC matrix, which was because of the Gaussian distribution of laser energy, with high energy in the center of the spot and low energy at the edges, and the surface temperature of the central irradiation area raised rapidly, resulting in the material in the center of the ablation area being melted, while the material at the edges of the ablation zone was not yet melted, resulting in a strong thermal stress concentration, and when the stress accumulated to a certain limit, the surface of the SiC substrate cracked or even the surface broke off [46].

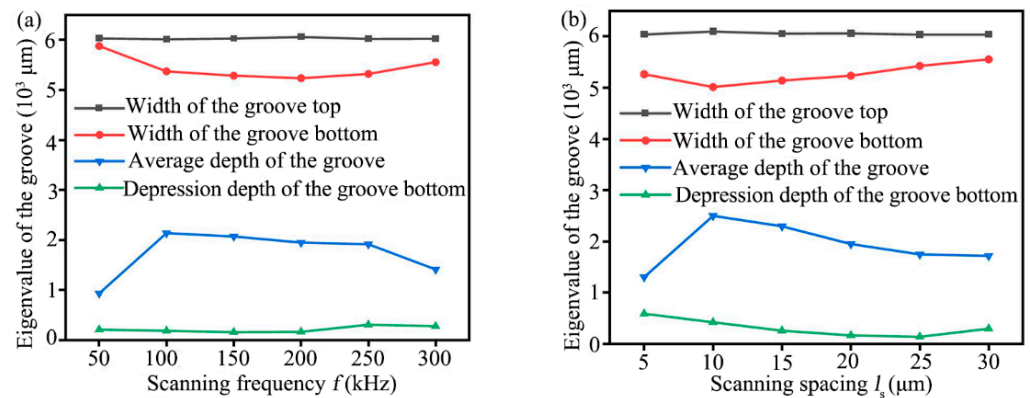
**Figure 11.** Relationship between different laser processing parameters and the eigenvalue of groove (a) Scanning frequency, (b) Scanning spacing.

When the laser power was 80 W, the scanning speed was 300 mm/s, the scanning spacing was 20  $\mu\text{m}$ , and the scanning times were 20, the effects of different scanning frequency on the width of the groove top and bottom, the average depth, and the depression depth were investigated, as shown in Figure 11a. According to Figure 11a, the width of the groove top hardly changed as frequency increased, but the actual processed width of the groove top was slightly larger than the standard groove size; the width of the groove bottom decreased first and then increased with the increased frequency. Meanwhile, the average depth of the grooves increased sharply to 2141.022  $\mu\text{m}$  when the scanning frequency was increased from 50 kHz to 100 kHz, and then, as the scanning frequency was increased further, it changed little and showed a slightly decreasing trend: the former was due to the increase in the frequency of laser spot with the increase in scanning frequency, at the same time, the number of times of laser spot ablation on the workpiece surface increases, and the amount of material removal increases [28]; the latter was because as the scanning frequency continues to increase, the number of pulses increased, and the energy obtained by each pulse was small, when the pulse energy density was lower than the ablation threshold of the material, the material was not removed by ablation [39]. Moreover, the depression depth of the groove bottom decreased first and then increased with the increased scanning frequency, and the minimum value of the depression depth was 160.447  $\mu\text{m}$  when the frequency was 200 kHz.

When the laser power was 80 W, the scanning speed was 300 mm/s, the scanning frequency was 50 kHz, and the scanning times were 20, the effects of different scanning spacing on the width of the groove top and bottom, the average depth, and the depression depth were investigated, as shown in Figure 11b. When the laser scanning spacing increased from 5  $\mu\text{m}$  to 30  $\mu\text{m}$ , the width of the groove top hardly changed, and the actual width of the groove top obtained was slightly larger than 6 mm. The width of the groove bottom decreased first and then increased, and the width of the groove bottom was less than 6 mm. Meanwhile, the average depth of the grooves increased first and then decreased with the increased scanning spacing, and when the scanning spacing was 10  $\mu\text{m}$ , the average depth of the grooves reached the maximum value of 2501.528  $\mu\text{m}$ . Moreover, the depression depth decreased first and then increased with the increased scanning spacing, and the minimum value of 141.915  $\mu\text{m}$  was reached when the scanning spacing was 25  $\mu\text{m}$ .

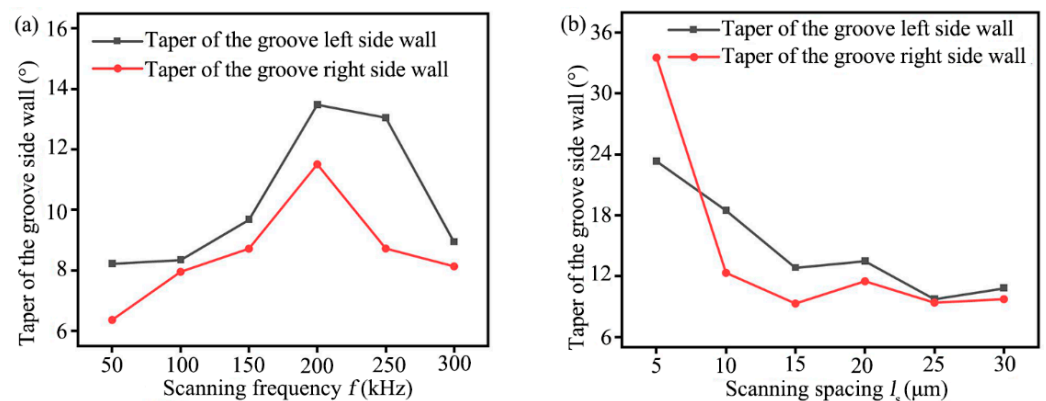
**Figure 12.** Relationship between different laser processing parameters and the taper of groove side wall (a) Scanning frequency, (b) Scanning spacing.

The taper of the ablation grooves side wall with different laser scanning frequency and scanning spacing can be calculated by Equation (3), as shown in Figure 12. From Figure 12a, it can be seen that when the scanning frequency increased from 50 kHz to 300 kHz, the taper of the groove side wall increased first and then decreased with the increased scanning frequency, and the taper of the groove left side wall was larger than that of the right side wall, and when the scanning frequency was 50 kHz, the taper of groove both left and right sidewall were the minimum value. From Figure 12b, it can be seen that when the scanning spacing was 25  $\mu\text{m}$ , the taper of the groove left side wall reached the minimum value of  $9.3172^\circ$  and the taper of the groove right side wall reached the minimum value of  $9.3943^\circ$ . Mostly, the taper of the groove left side wall was larger than the taper of groove right side wall in the experiment, it was because of the accumulation of laser heat when ablating from left to right, and the temperature was low when the ablation began at the left, and the temperature was high when the ablation process reached the right [24].

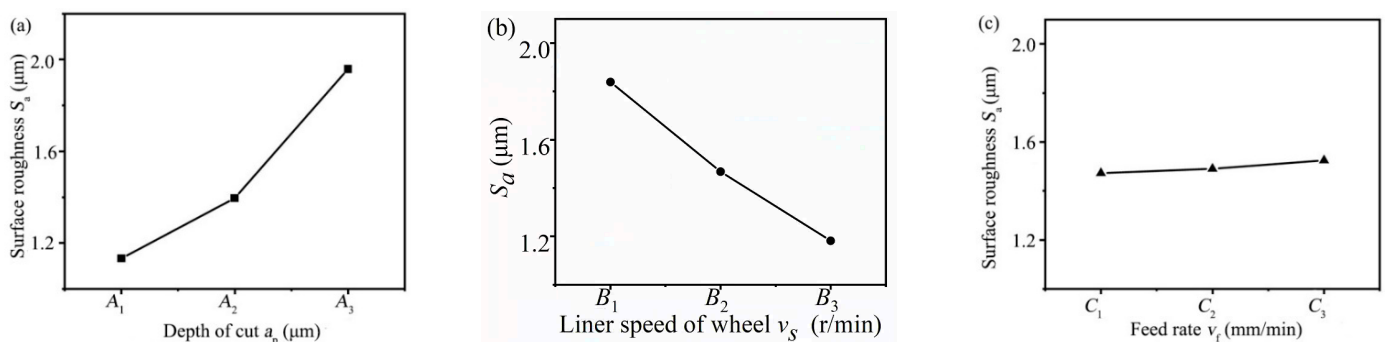
**Figure 13.** Response curve of the surface roughness  $S_a$ . (a) Depth of cut, (b) Liner speed of wheel, (c) Feed rate.

The response curve of the surface roughness  $S_a$  is shown in Figure 13. The abscissa was different processing levels, and the ordinate was the mean value of surface roughness  $S_a$  with the same factor and different levels. As can be seen from the response curve of  $S_a$  in Figure 13, the surface roughness  $S_a$  both increased with the increased depth of cut  $a_p$  and feed rate  $v_f$ , but in different ways, the former increased sharply while the latter increased slowly, and the surface roughness  $S_a$  was negatively correlated with liner speed of wheel  $v_s$ .

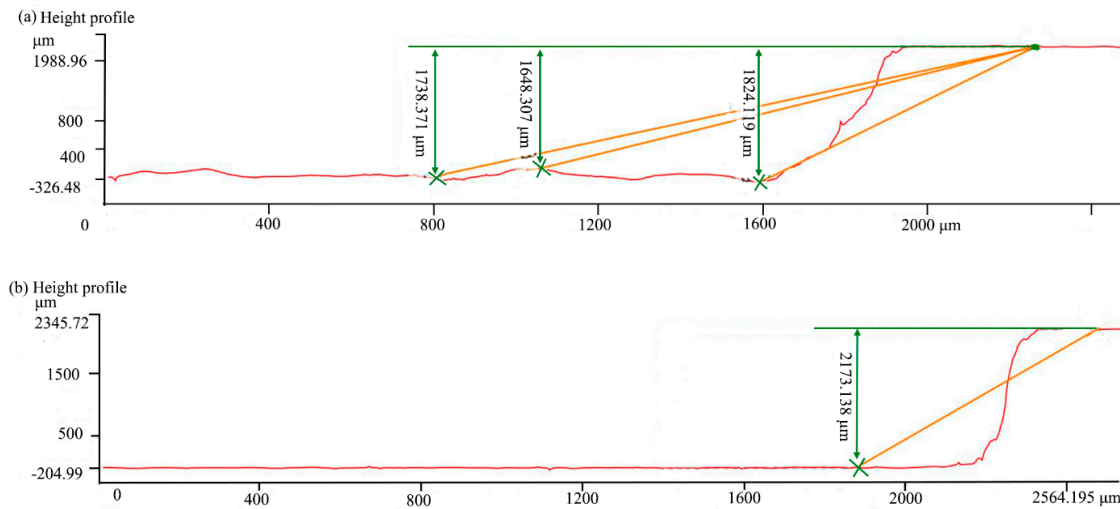
**Figure 15.** Confocal profile of the groove with different processing methods (a) laser; (b) laser-grinding chain.

Figure 14 only analyzes the macroscopic morphology of the end surfaces of the grooves by laser and laser-grinding chain processing, but did not analyze the inner cross section of the grooves. In order to investigate the characteristics of the grooves at any inner cross section of the grooves, the confocal microscopy was used to detect the grooves after laser and laser-grinding chain processing of C/SiC composites. The confocal profiles at any position of C/SiC composite grooves of laser processed and laser-grinding chain processed are, respectively, shown in Figure 15. From Figure 15a, the side walls of the groove were inclined apparently, the maximum depth of the groove was  $1824.119 \mu\text{m}$ , the minimum depth was  $1648.307 \mu\text{m}$ , the average depth was  $1738.371 \mu\text{m}$ , and the depression depth was  $175.712 \mu\text{m}$ ; therefore, the groove bottom fluctuated greatly. From Figure 15b, the

average depth of the C/SiC composites groove processed by the laser-grinding chain was 2173.138  $\mu\text{m}$ , the fluctuation of the groove bottom could hardly be observed, and only a small inclination between the side wall and the groove bottom. However, the size deviation between the actual depth and the ideal depth still existed, and the side wall was not perpendicular: this was because some errors were unavoidable, such as grinding wheel wear, low process precision, and tool setting errors [48]. Therefore, it can prove the feasibility of laser grinding chain processing of C/SiC composite grooves in terms of size accuracy, shape accuracy, processing efficiency, and surface quality; meanwhile, some errors in chain processing should be adjusted and compensated to further improve the groove quality.

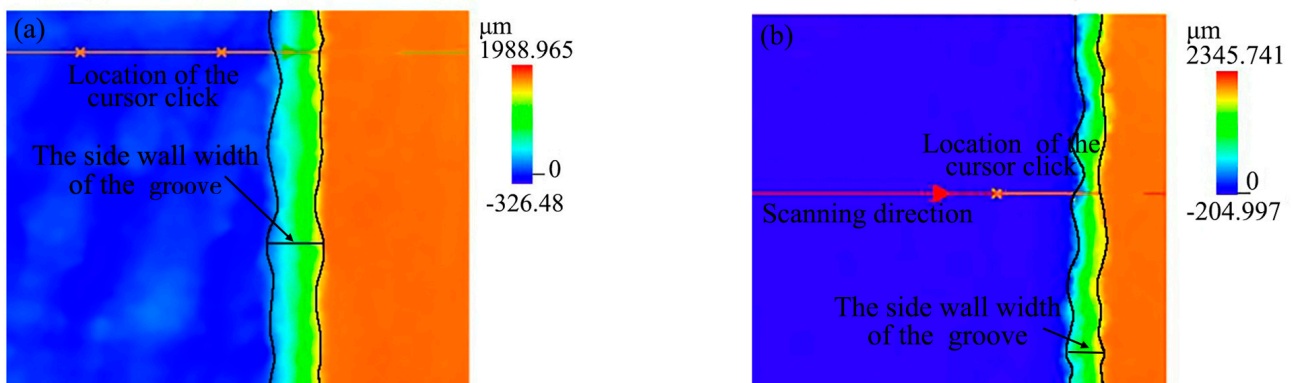
**Figure 16.** The two-dimensional confocal topography of the groove with different processing methods: (a) laser; (b) laser-grinding chain.

The two-dimensional confocal topography of the grooves with different processing methods is shown in Figure 16, the color of the grooves both changed from the bottom to the top surface of the grooves followed by dark blue, light blue, green, yellow, and brown. Differently, from the two-dimensional confocal topography, the side wall width of the ablation groove was larger than that of the groove processed by the laser-grinding chain; meanwhile, the color of the ablation groove bottom was relatively complex, while the color of the groove processed by the laser-grinding chain was pure blue without other colors. It indicated that the form accuracy and flatness of the groove were better with the laser-grinding chain process.
