2. Statistics of LOOP Related Events in China’s NPPs

3. Analysis of LOOP Events

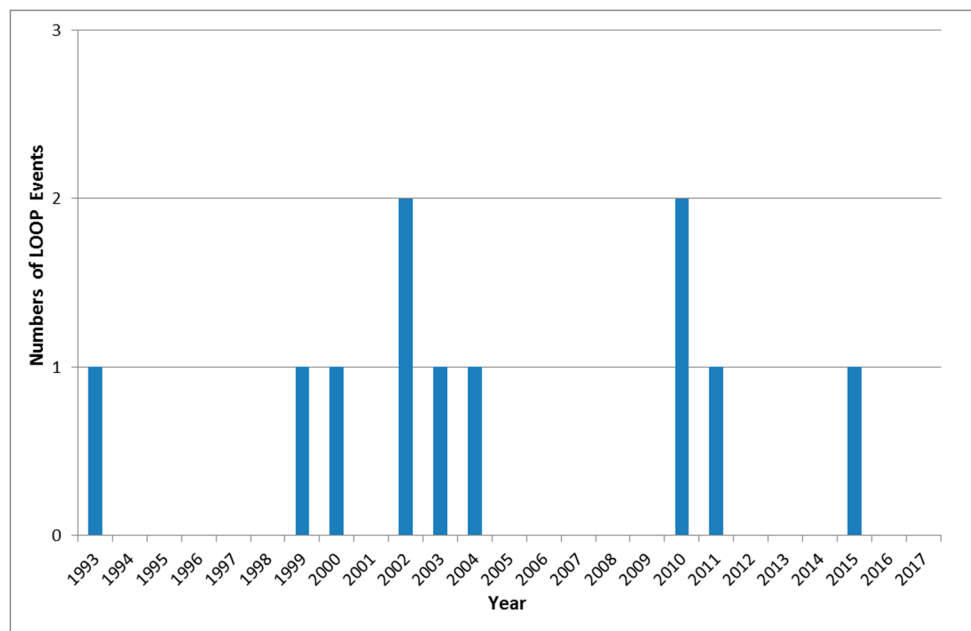
A total of 11 LOOP events in China’s NPPs were collected from 1993 to the end of 2017 in the National Nuclear Safety Administration Experience Feedback System [2] (Table 1). Figure 2 shows the numbers of LOOP Events per year at NPPs of China during 1993 to 2017.

Figure 2. The numbers of LOOP Events per year at NPPs of China during 1993 to 2017.

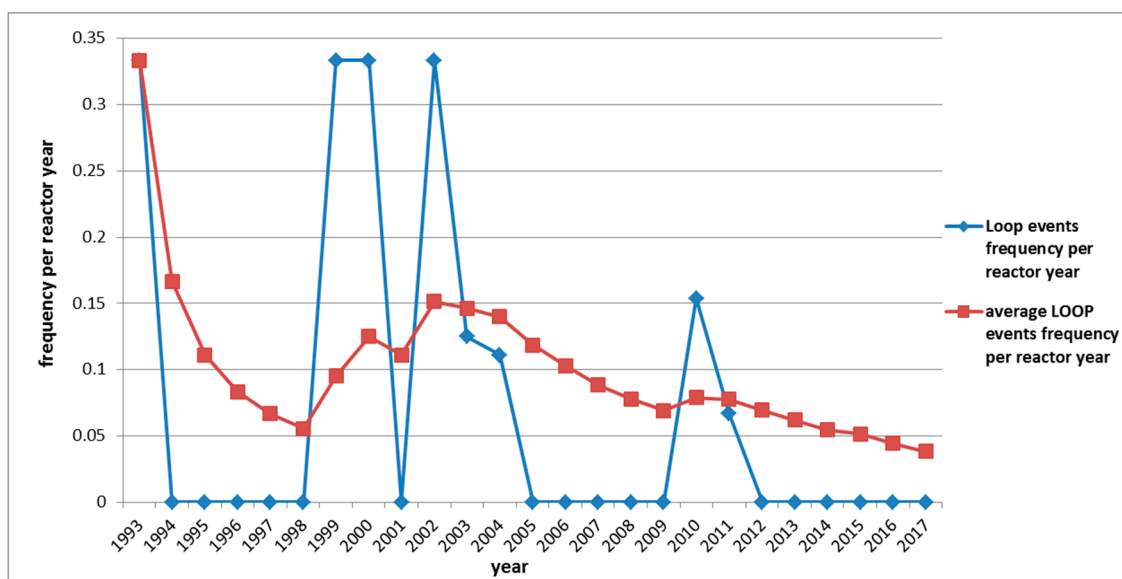
Figure 3, the average occurrence frequency of LOOP events per unit per year, illustrates a decreasing trend. By the end of 2017, the average frequency of LOOP events was 0.0385/reactor year.

Figure 3. Frequency of LOOP events at NPPs of China from 1993 to 2017 (/reactor year).

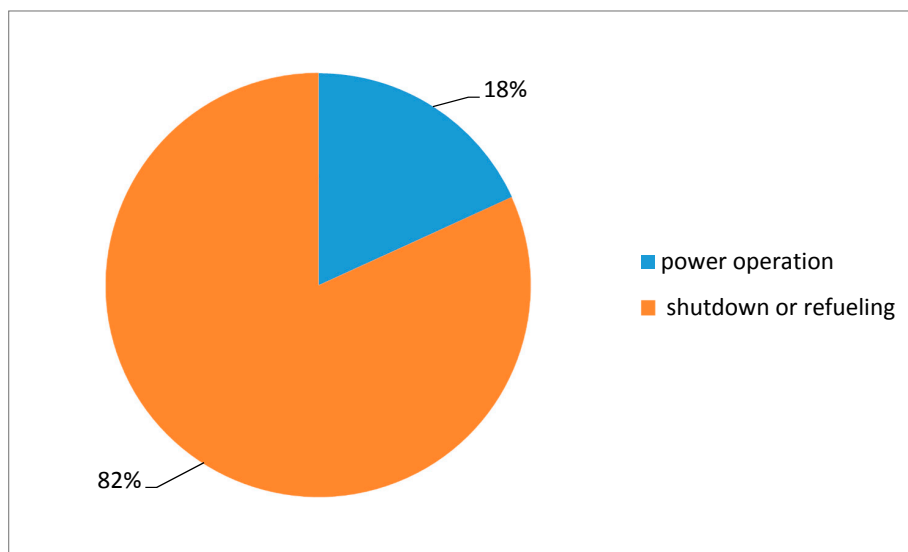
Reactors were in power operation and shutdown or refueling when 11 LOOP events occurred. Two events occurred during power operation, accounting for 18%, and nine events occurred in the shutdown or refueling stage, accounting for 82%. Figure 4 shows the proportion of reactors' status at the time of the events.

Figure 4. Status of reactors before LOOP events.

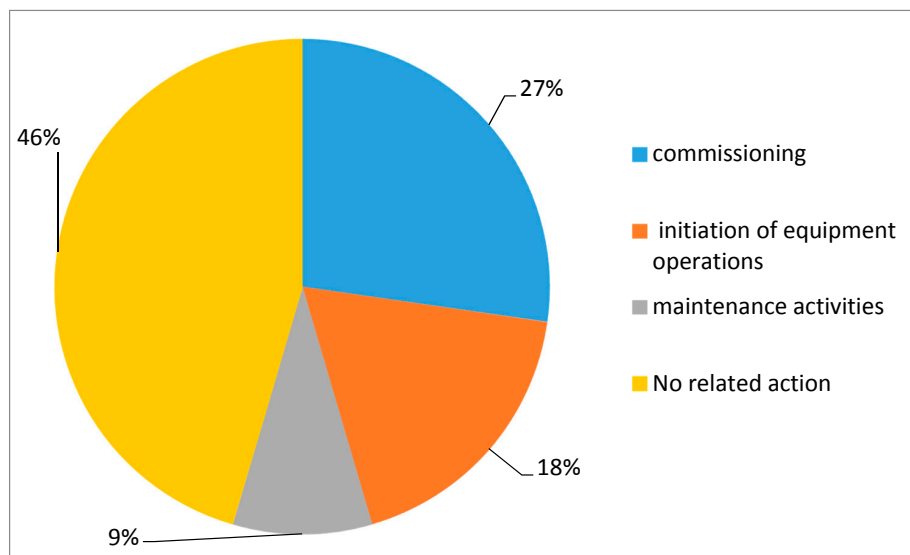
Figure 5 shows the proportions of the plant activities at the time of the events.

Figure 5. Actions taken by NPPs at the time of the event.

The total number of LOOP events related to commissioning, initiation of equipment or maintenance was six, five of which happened during the shutdown or refueling stage, these activities pose a high risk to the reliability of the offsite power sources.

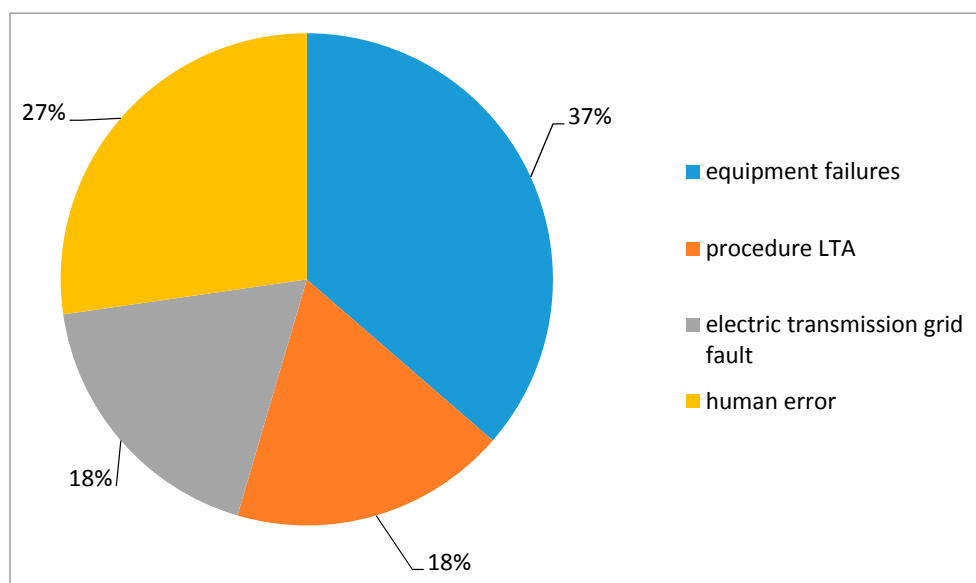
Causes for these 11 events can be divided into four categories: electric transmission grid fault, equipment failures, procedure LTA (less than adequate), and human error. Event statistics in terms of causes is shown in Figure 6.

Figure 6. Causes for LOOP events.

Four events, No. 3, 6, 7, and 10 in Table 1, were due to electrical equipment failure, accounting for 37% of the total LOOPS.

Events caused by grid fault account for 18% of the total 11 events. The offsite power supply of nuclear power plants in China is provided by the State Grid Corporation of China and the China Southern Power Grid, considering the huge span of the grid and the massive equipments in the grid, the licensee should stay vigilant to the vulnerability of the grid to various severe weather conditions.

There are three events caused by human error, accounting for 27% of the total 11 events.
