Effect of Time-Real Marine Environment Exposure on the Mechanical Behavior of FRP Composites

Abstract: Fiber reinforced polymer (FRP) composites coupons were exposed to real sea environment to assess the influence on the mechanical behavior of composite materials used in the construction of marine structures. Real-life sea environment conditions were opted for instead of the more common simulated and laboratory versions of seawater in the attempt to obtain more realistic structural modeling environmental input design parameters for marine structures. Exposure was performed over prolonged time span instead of the usual accelerated tests. Epoxy and polyester resins, reinforced with glass fibers in three fiber layout configurations, were used to manufacture standardized tensile testing coupons. Mass changes due to seawater absorption, microorganism growth, changes in tensile strength (standard tensile tests), and surface morphology of the coupons were evaluated after 6- and 12-month long periods of submersion in the sea in the Rijeka bay, Croatia. All specimens showed mass increase due to water absorption and growth of attached algae and sea microorganisms. Various levels of reductio

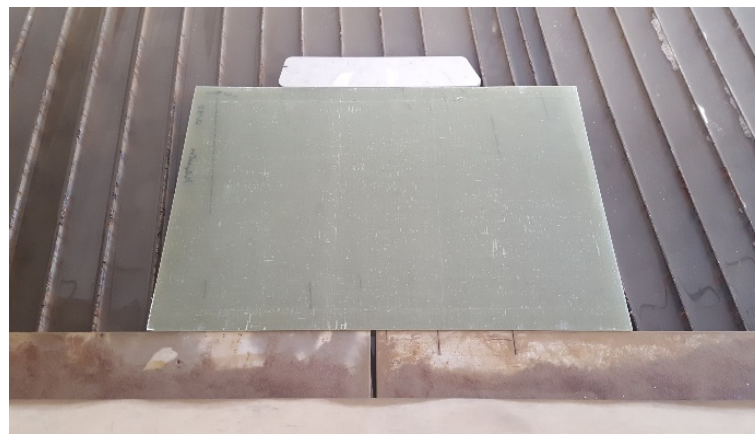
Three rectangular plates measuring 300 × 450 mm with three different layup schemes UD0, 0/90, (0/45/90), were produced for each of the material combinations using 8 plies of the UD fabric per plate, Figure 1. The epoxy/glass plates were produced by vacuum assisted infusion process, resulting in 3 ± 0.2 mm thick plates. The infusion process proved problematic for the polyester resin as it was resulting in dry fibers on the tool surfaces, so the polyester/glass plates were finally produced by hand layup process, resulting in 5 ± 0.5 mm thick plates.

Figure 1. Composite plate prepared for waterjet cutting.

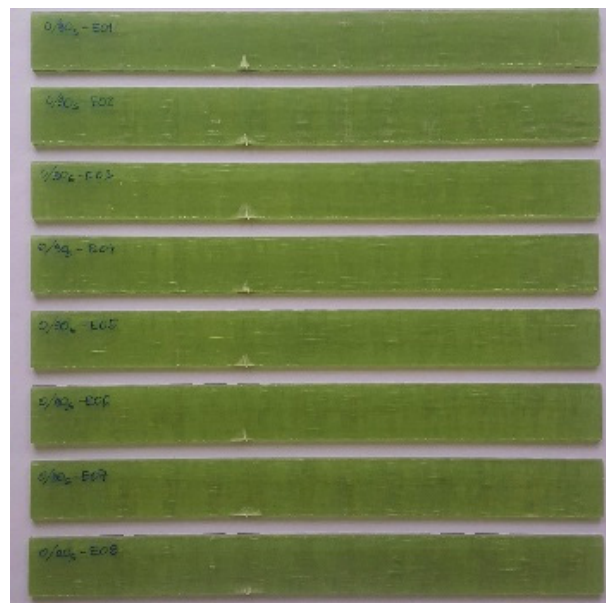
Coupons measuring 250 mm in length and 25 mm in width [33] were then cut out of the plates on a waterjet cutting machine (OMAX Maxiém series), Figure 2. The cutting pressure was between 1400 and 3400 bar, with the average cutting speed of 1187 mm/min.

Figure 2. Cut-out coupons.

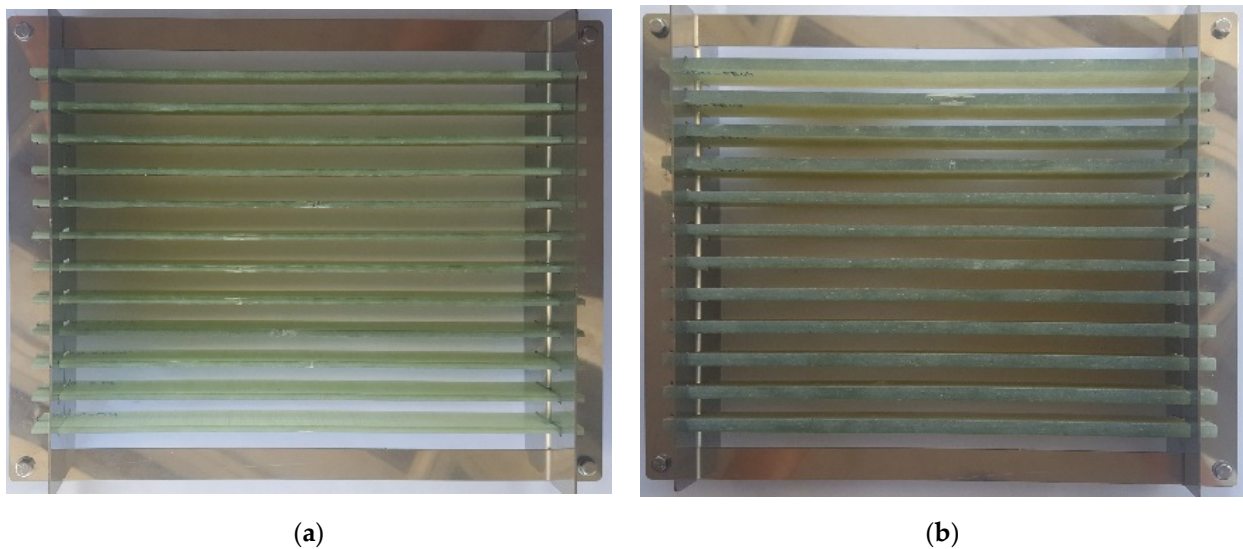
The other two subgroups were exposed to real-life sea environment, i.e., submerged into the sea on a depth of 10 m, at northern Adriatic in front of the city of Rijeka in Croatia for a duration of 6 and 12 months, respectively. The sea temperature at the location of experiment varies between 10–14 °C annually, salinity changes between 37.8–38.3 PPT, while the pH value is between 8.22–8.29 [35]. The coupons were mounted on special stainless-steel frames (AISI 316L), shown in Figure 3.

Figure 3. Coupons mounted on special stainless-steel frame before submersion: (a) epoxy/glass; (b) polyester/glass.

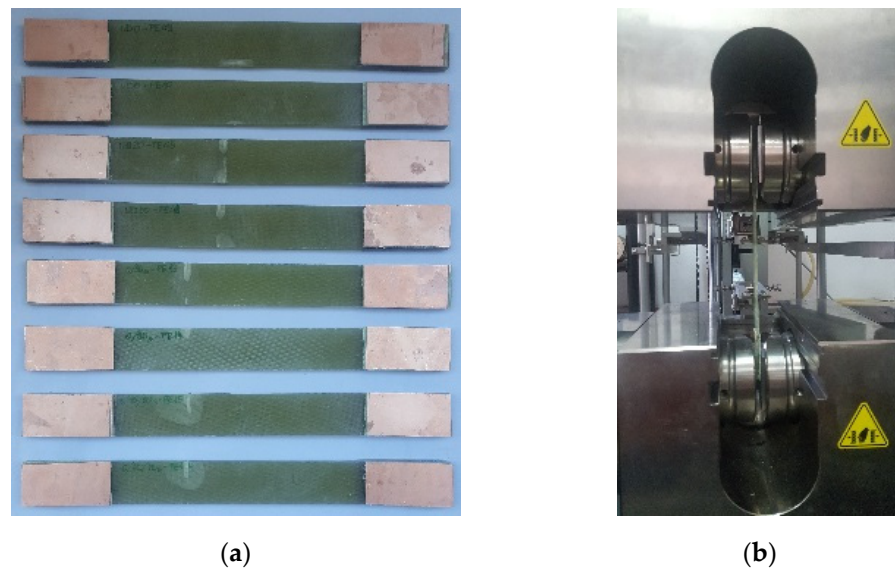
Reinforcement tabs, made of printed circuit board cutouts, were added at the coupon ends before the tensile test to minimize the influence of the grips pressure on the test results [36]. The size of the tabs was chosen based on ISO 527-4 recommendations, Figure 4.

Figure 4. Coupons: (a) with reinforcement tabs; (b) gripped in tensile testing machine.

Uniaxial tensile tests used for the determination of the material properties were performed on a Zwick 400 kN (ZwickRoell GmbH, Germany) universal testing machine. A macro extensometer was used to measure the specimens' elongation. The displacement rate of the testing machine crosshead during testing was 2 mm/min.

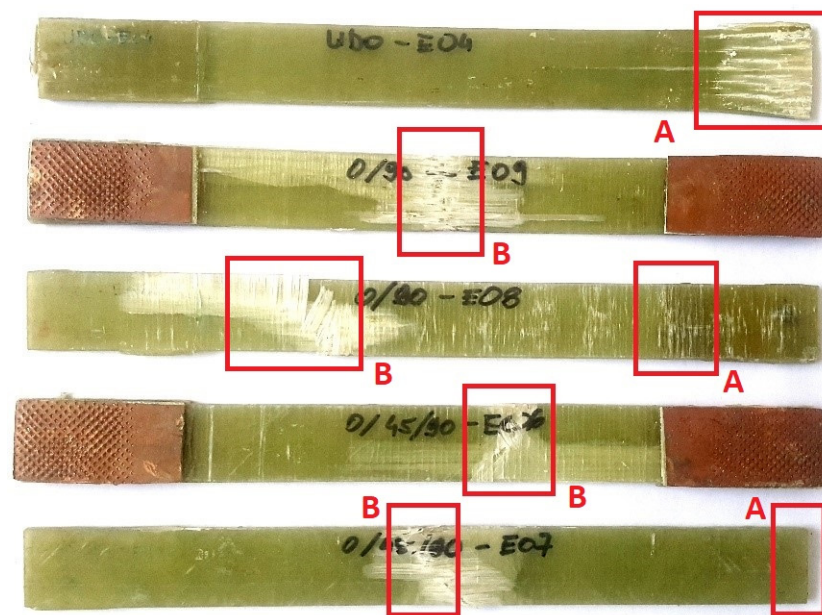
Microscopical investigation was performed on fractured coupons of three fiber layout configurations (UD0°, (0/90)s, (0/45/90)s) and for both dry coupons and coupons submerged in the sea for different periods i.e., 6 and 12 months. Surface and cross-sectional images were taken of all coupons, with special attention given to the grips areas (A) and locations with observed damage after the tensile test (B), Figure 5.

Figure 5. Coupons after tensile testing; locations for microscopical examination.

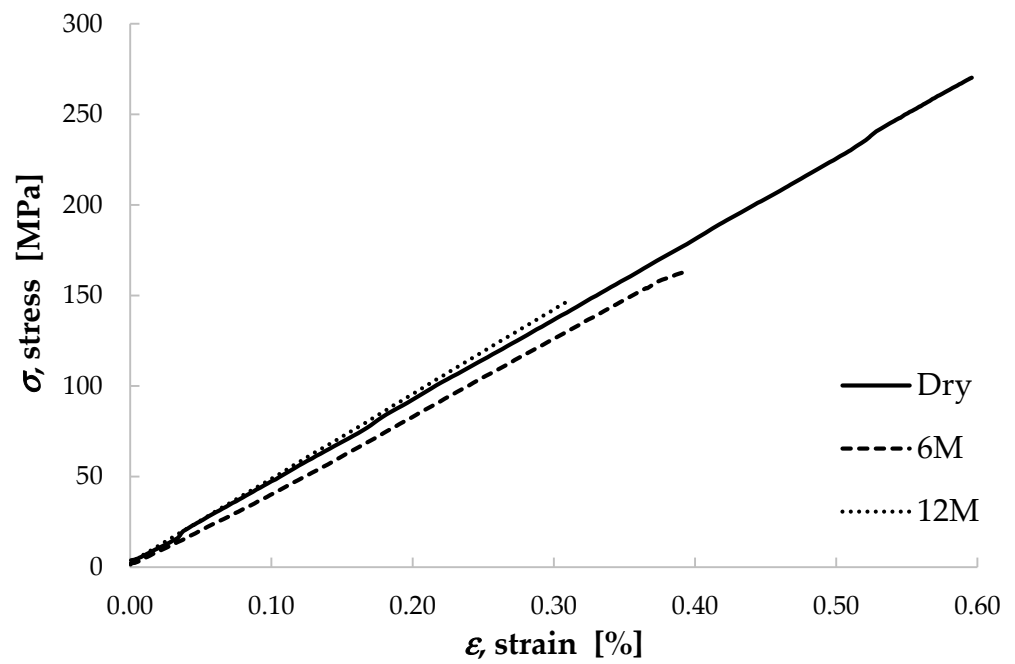
Figure 7. Engineering stress-strain diagrams for epoxy/glass UD0° coupons submerged in sea for 6 (6 M) and 12 months (12 M).

Engineering stress-strain diagrams were obtained from performed uniaxial tensile strength on dry coupons and wet coupons that were submerged in the sea for 6 and 12 months, Figures 7–12.

In all the diagrams in Figures 7–12, the reference stress-strain curve is designated as “Dry”. This curve represents the tensile mechanical properties of coupons not exposed to seawater. All submerged specimens had reduced tensile strength on average. Polyester resin coupons had a more pronounced drop in strength in the period from the 6th to the 12th month, Figure 13b, while the epoxy resin coupons exhibited greater tensile strength loss after the first 6 months of submersion. The only exception of this behavior was noticed in the epoxy coupons with the (0/90)s fiber layout configuration, Figure 14a. This is to be attributed to a single specimen from the group of this material and fiber layout combination submerged in the sea for 6 months exhibiting “extreme” tensile strength. By further examination, a higher fiber content in the said specimen was identified compared to that of the other specimens from the same group. This demonstrates that the manufacturing process has a strong impact on the mechanical properties of the finalized composite part.

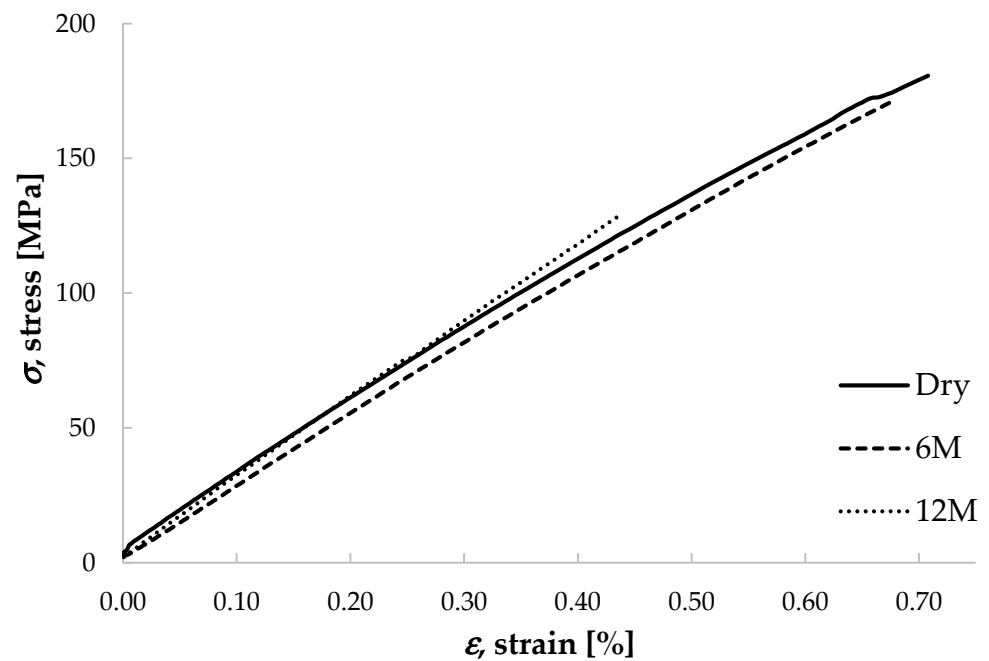
Figure 8. Engineering stress-strain diagrams for epoxy/glass (0/90)s coupons submerged in the sea for 6 (6 M) and 12 months (12 M).

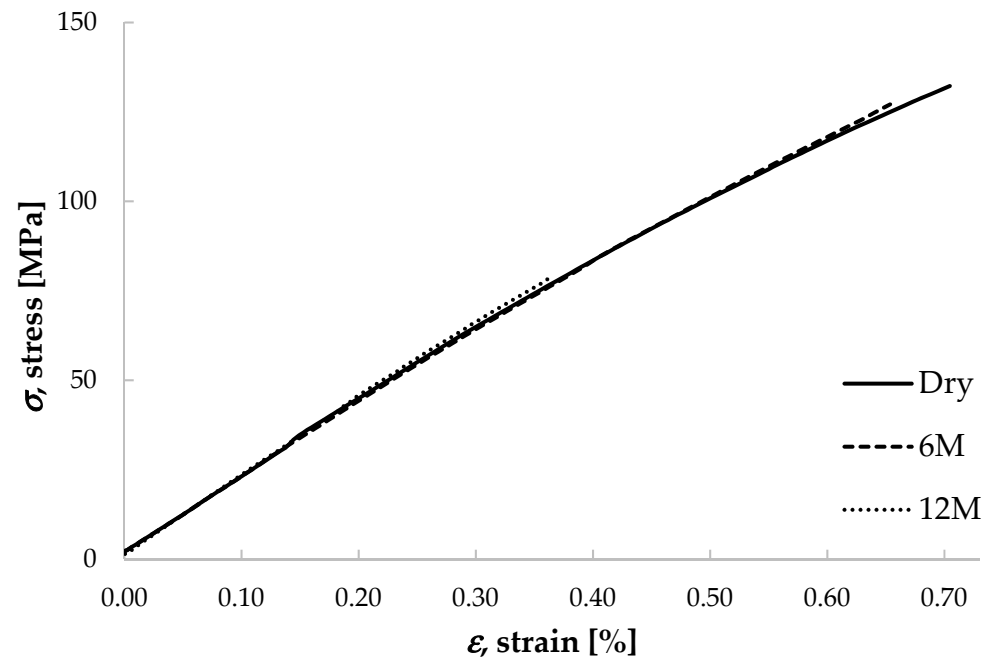
Figure 9. Engineering stress-strain diagrams for epoxy/glass (0/45/90)s coupons submerged in sea for 6 (6 M) and 12 months (12 M).

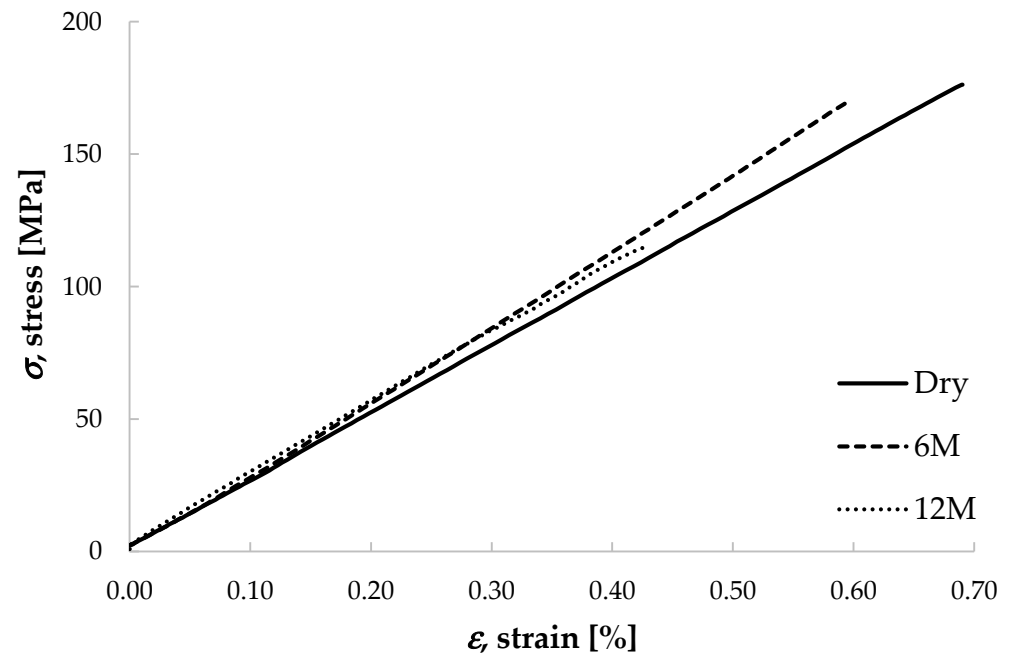
Figure 10. Engineering stress-strain diagrams for polyester/glass UD0° coupons submerged in sea for 6 (6 M) and 12 months (12 M).

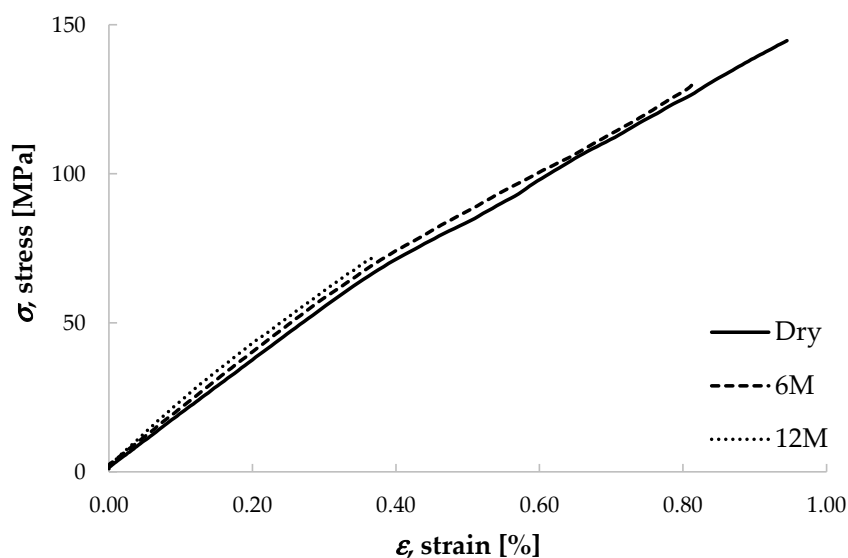
Figure 11. Engineering stress-strain diagrams for polyester /glass (0/90)s coupons submerged in sea for 6 (6 M) and 12 months (12 M).

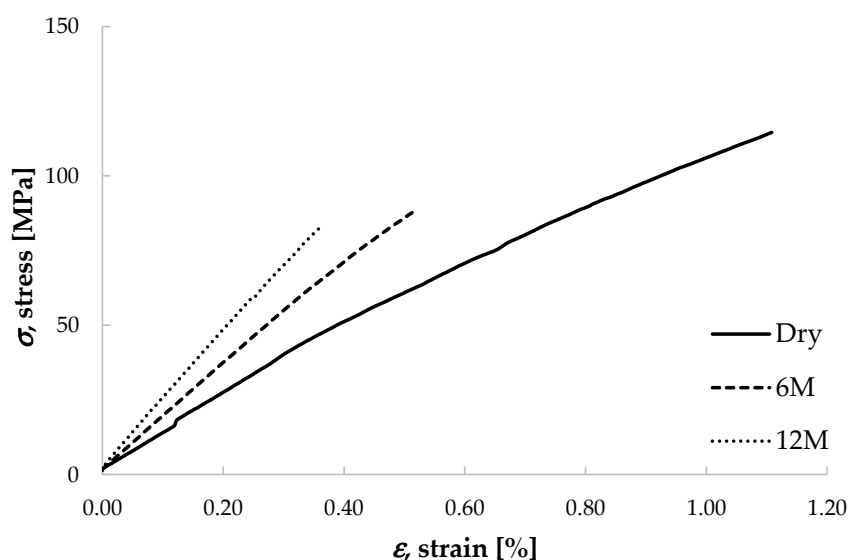
Figure 12. Engineering stress-strain diagrams for polyester /glass (0/45/90)s coupons submerged in sea for 6 (6 M) and 12 months (12 M).

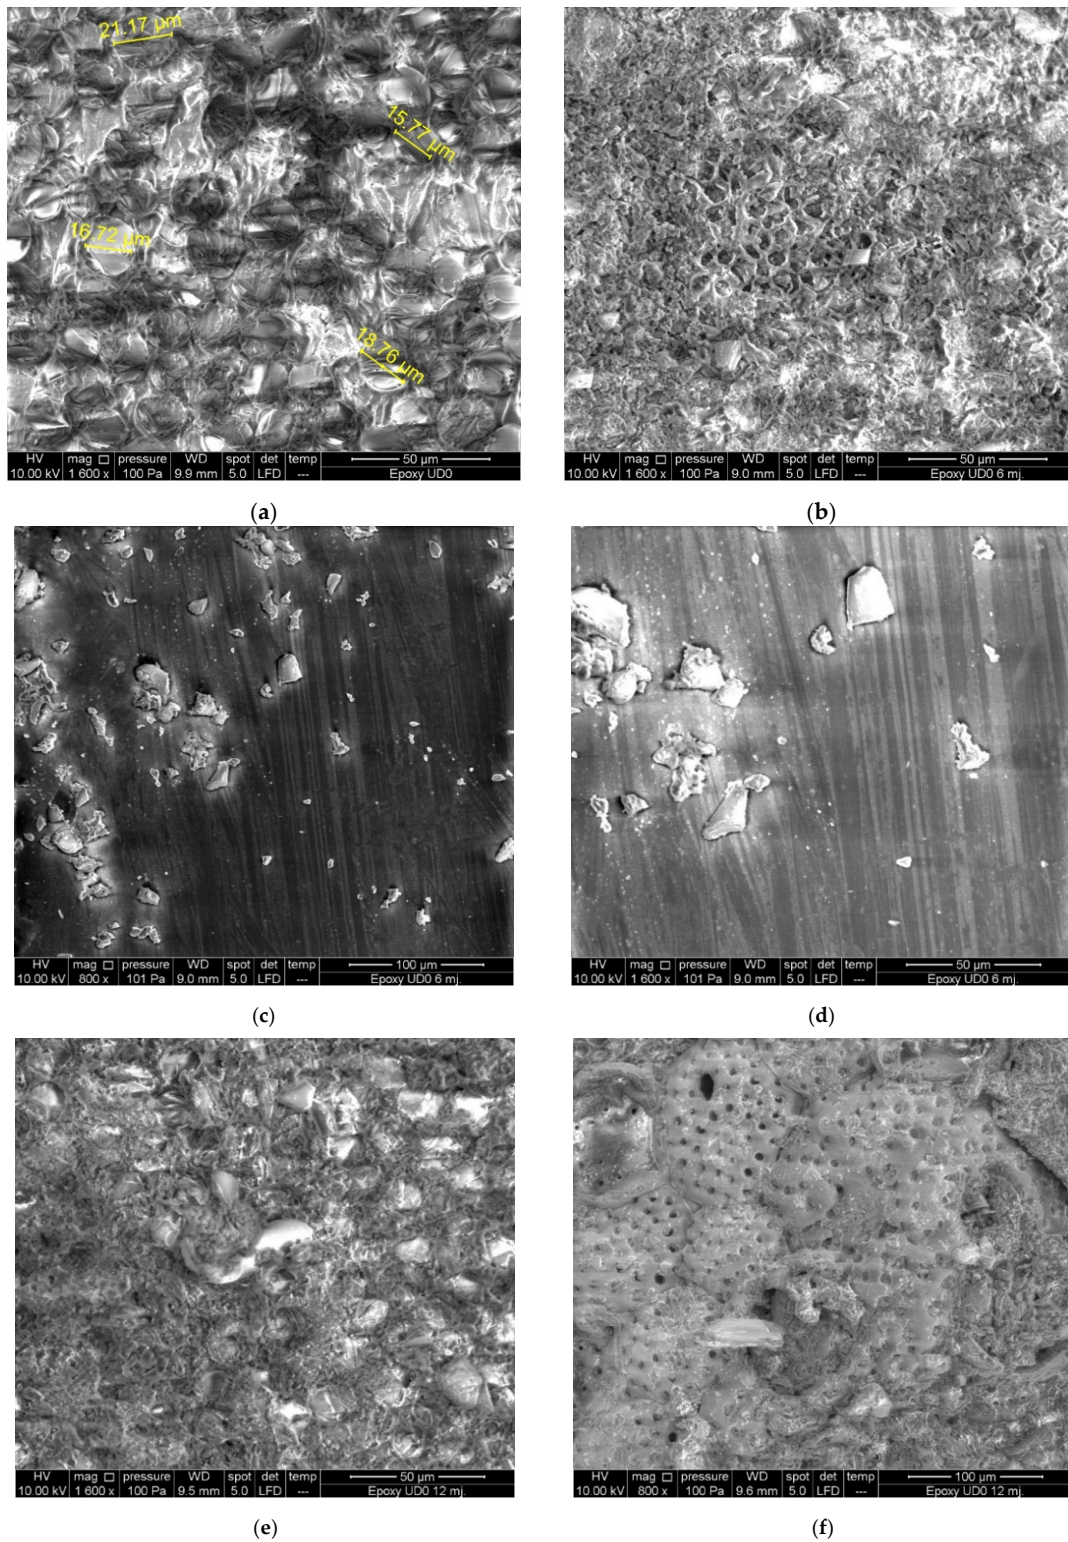
Figure 14. SEM epoxy UD0°: (a) dry; (b) 6 months submersion; (c,d) salt crystals after 6 months; (e,f) microorganisms' growth after 12 months.

The images obtained by SEM investigation are presented in Figures 14–19. Only some representative images were chosen as a portrayal of the performed research to limit the length of the paper, whilst the complete set of all obtained images is posted on an online repository as Supplementary Materials to this article.

Analysis of the images collected during the microscopical investigation showed formation of salt crystals on the surface layers of the coupon as well as embedded salt crystals in both resins. The epoxy resin coupons showed a greater accumulation of salt crystals, Figures 14c, 15e and 16c, than polyester ones, Figures 17c, 18d and 19d, regardless of the fiber orientation setups.

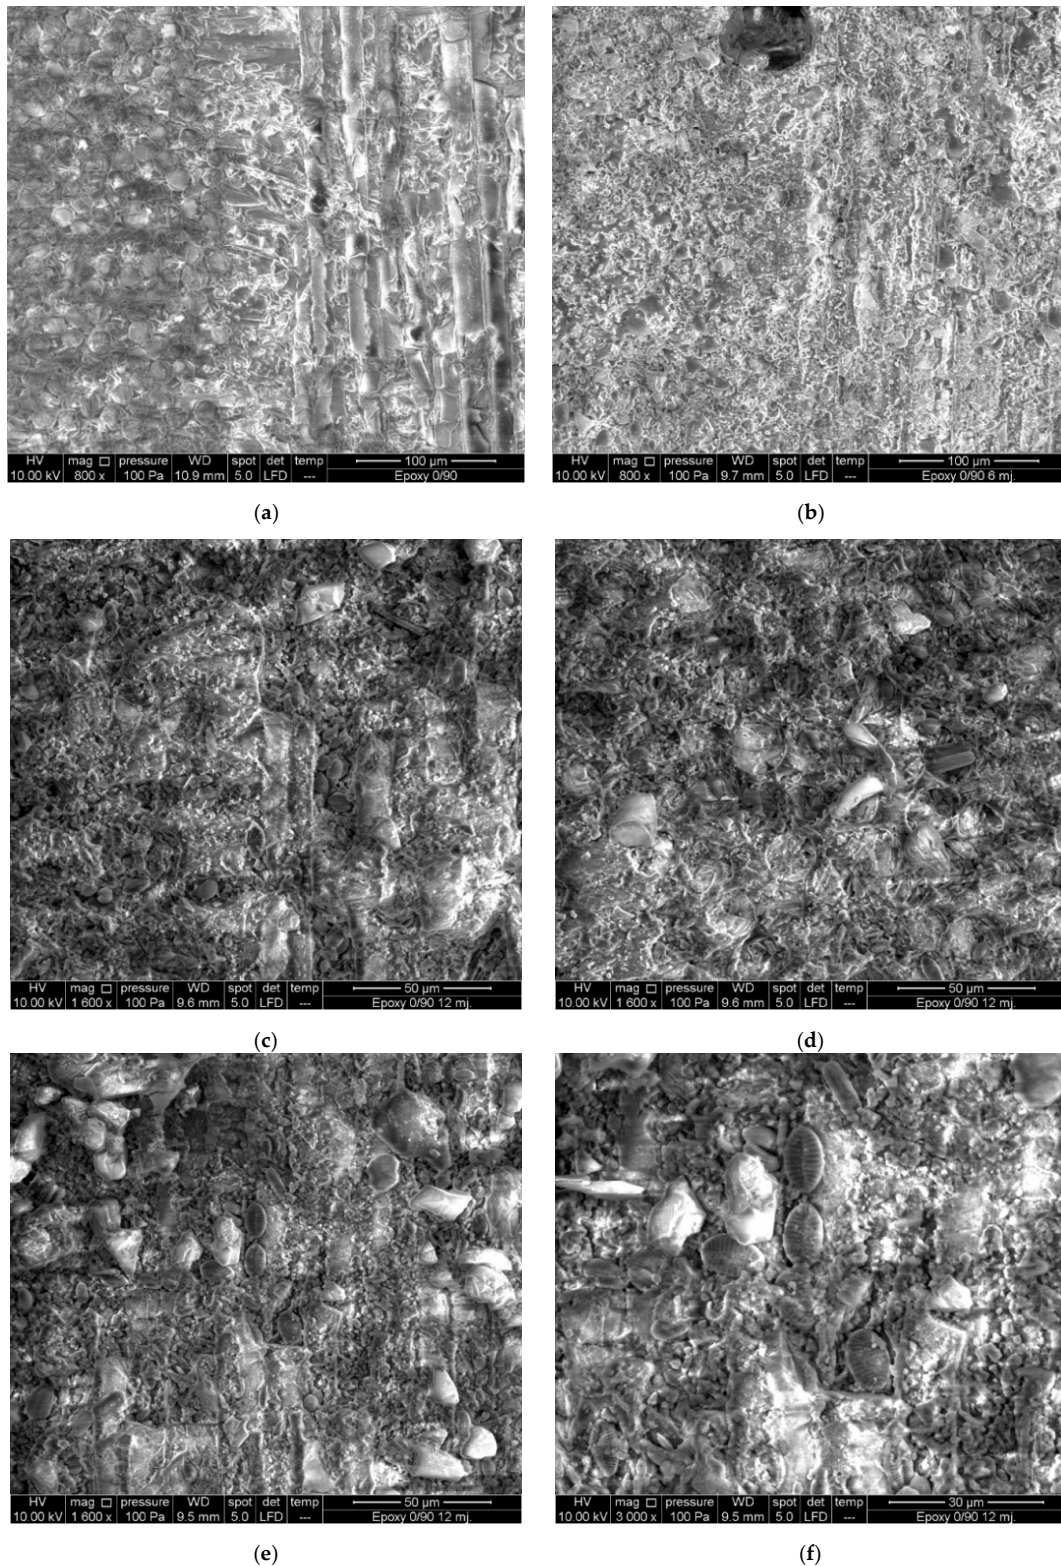
Figure 15. SEM epoxy (0/90): (a) dry; (b) 6 months submersion; (c,d) salt crystal formations; (e,f) microorganisms' growth after 12 months.

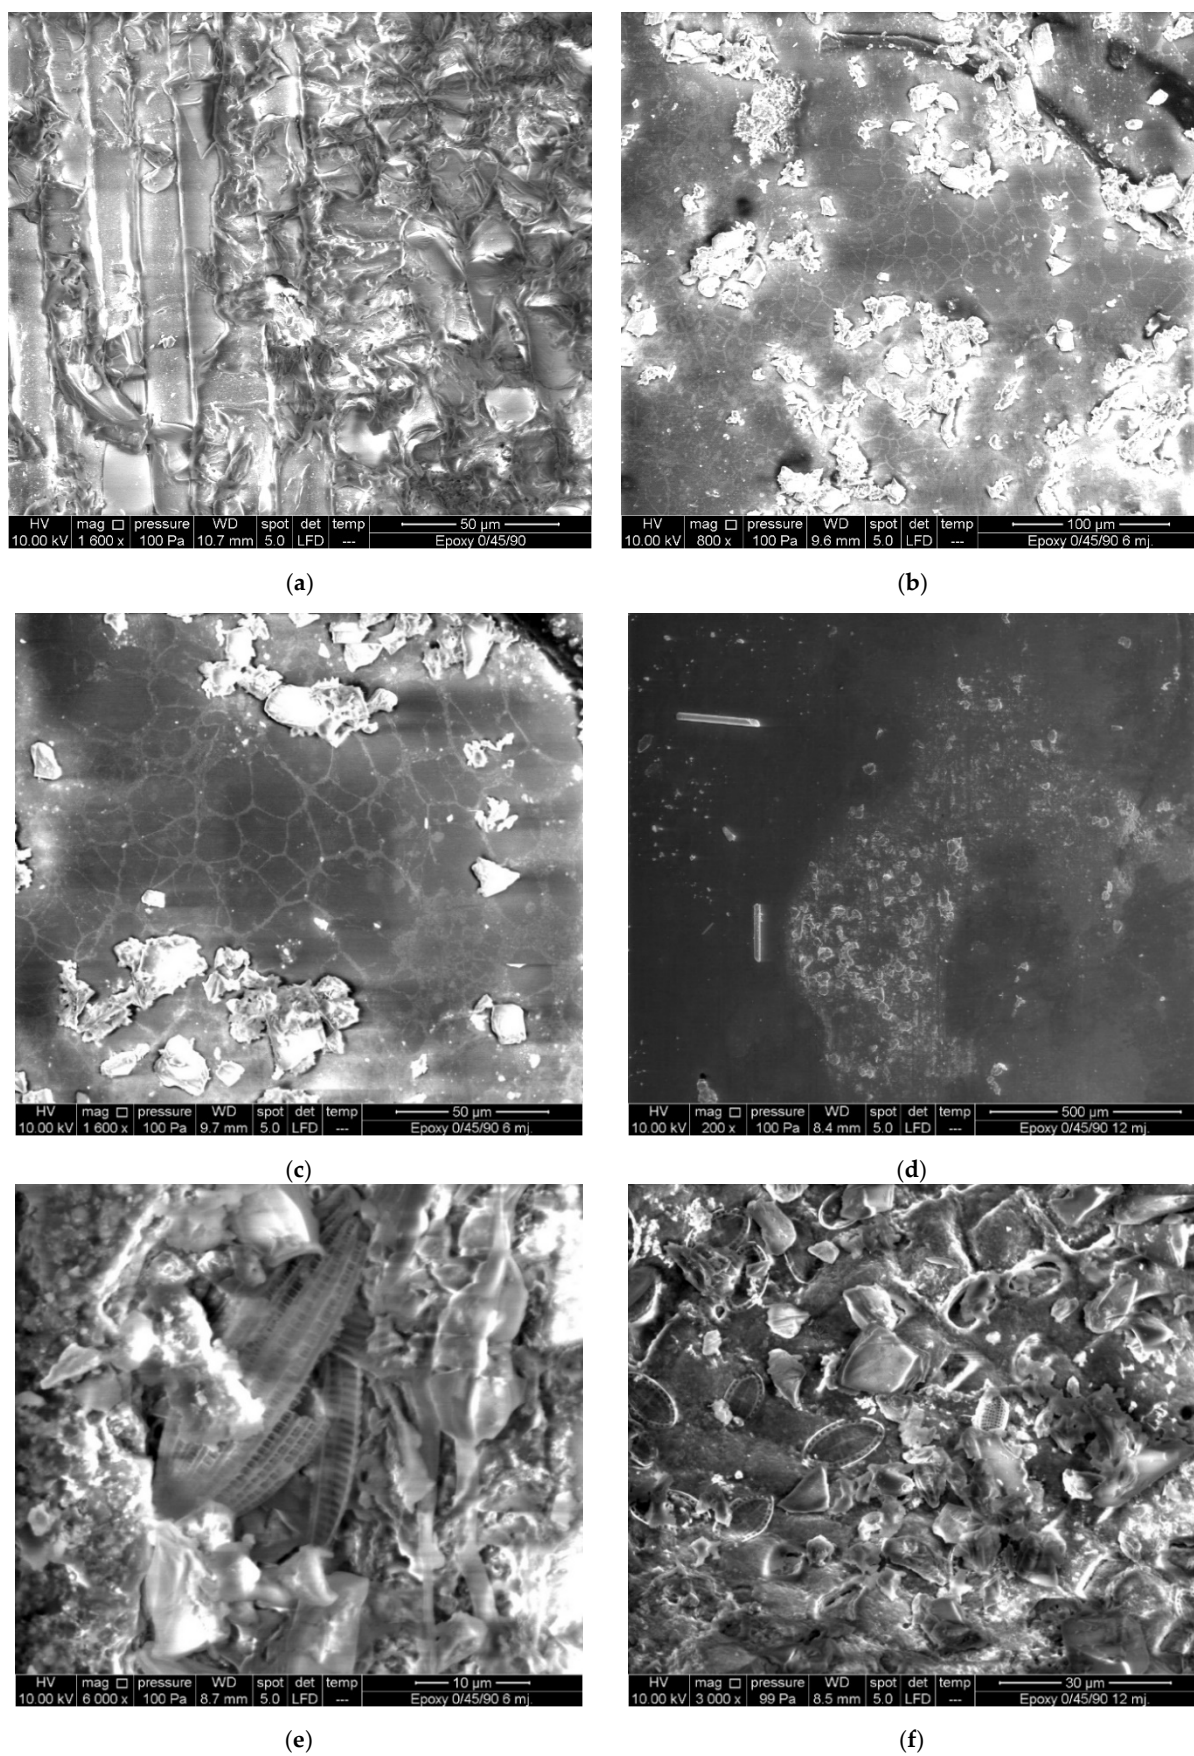
Figure 16. SEM epoxy (0/45/90)s: (a) dry; (b–d) salt crystals 6 and 12 months submersion; (e,f) microorganisms' growth after 6 and 12 months.

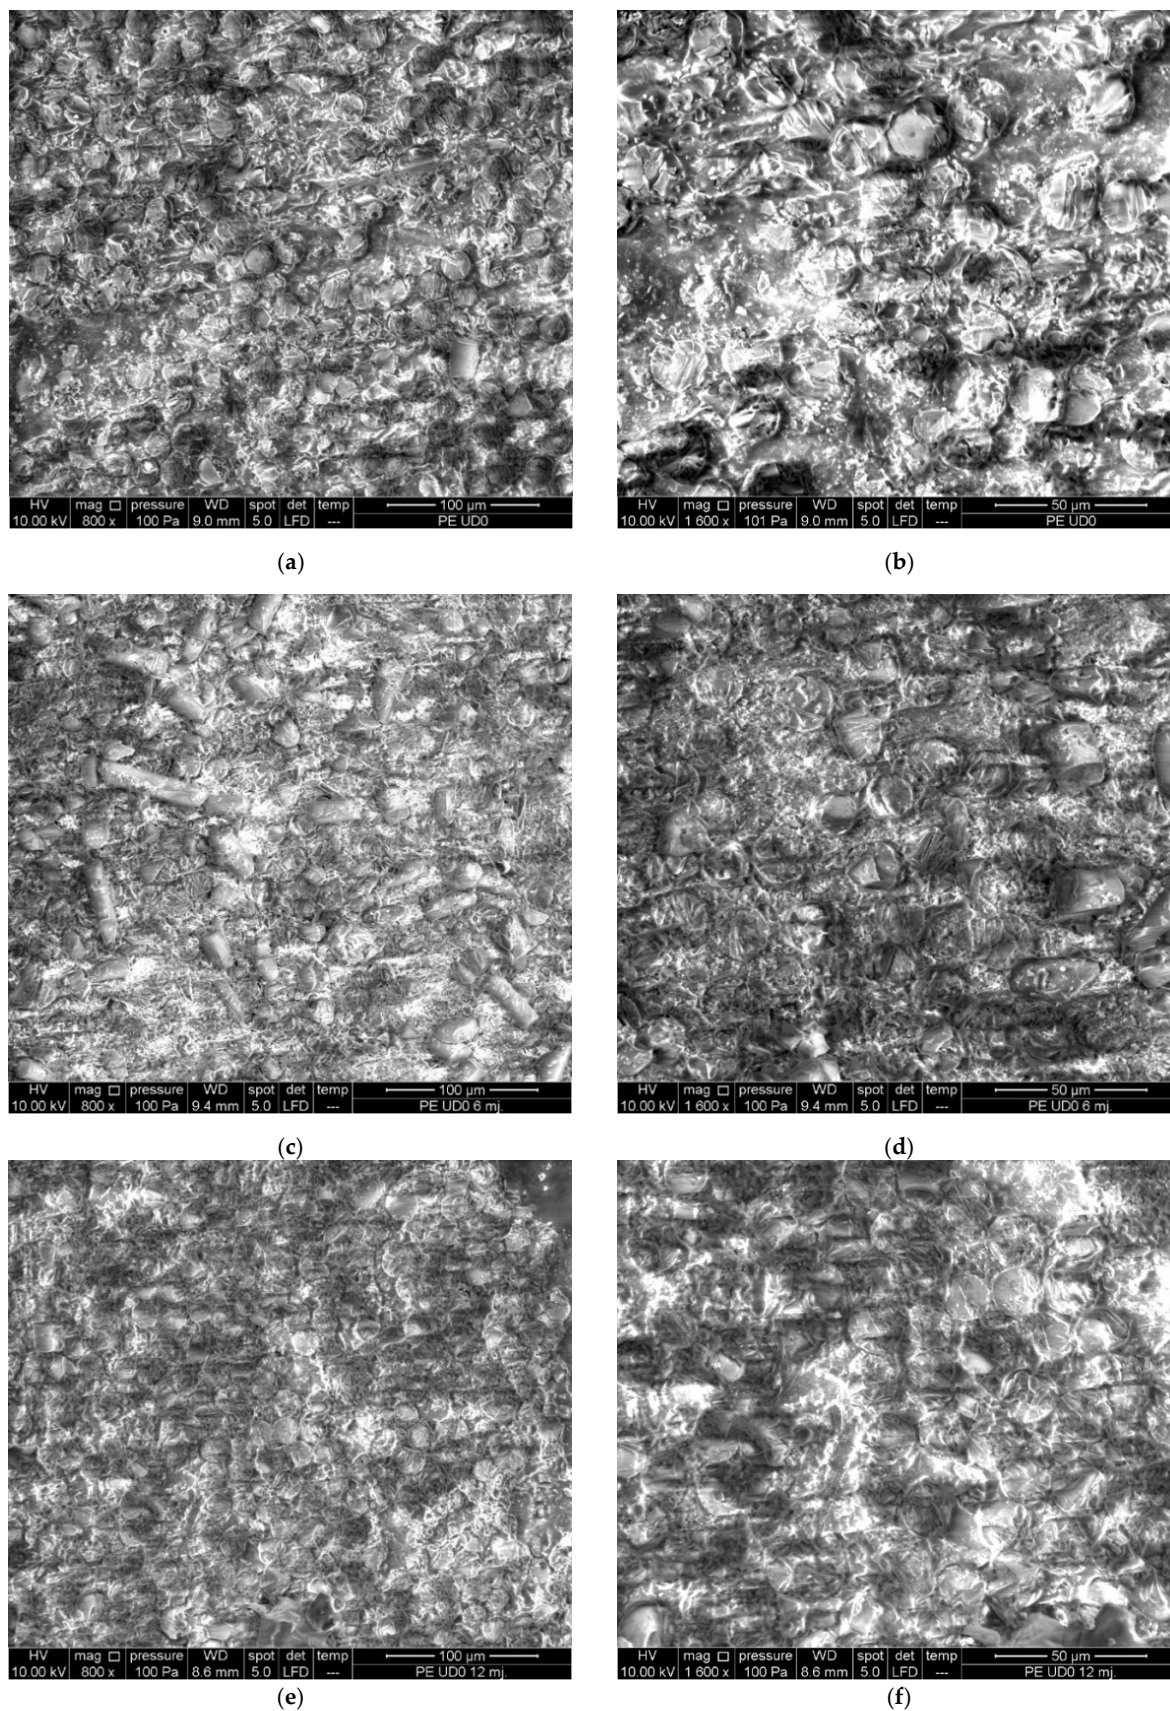
Figure 17. SEM polyester UD0^o: (a,b) dry; (c,d) salt crystals 6 months submersion; (e,f) 12 months submersion.

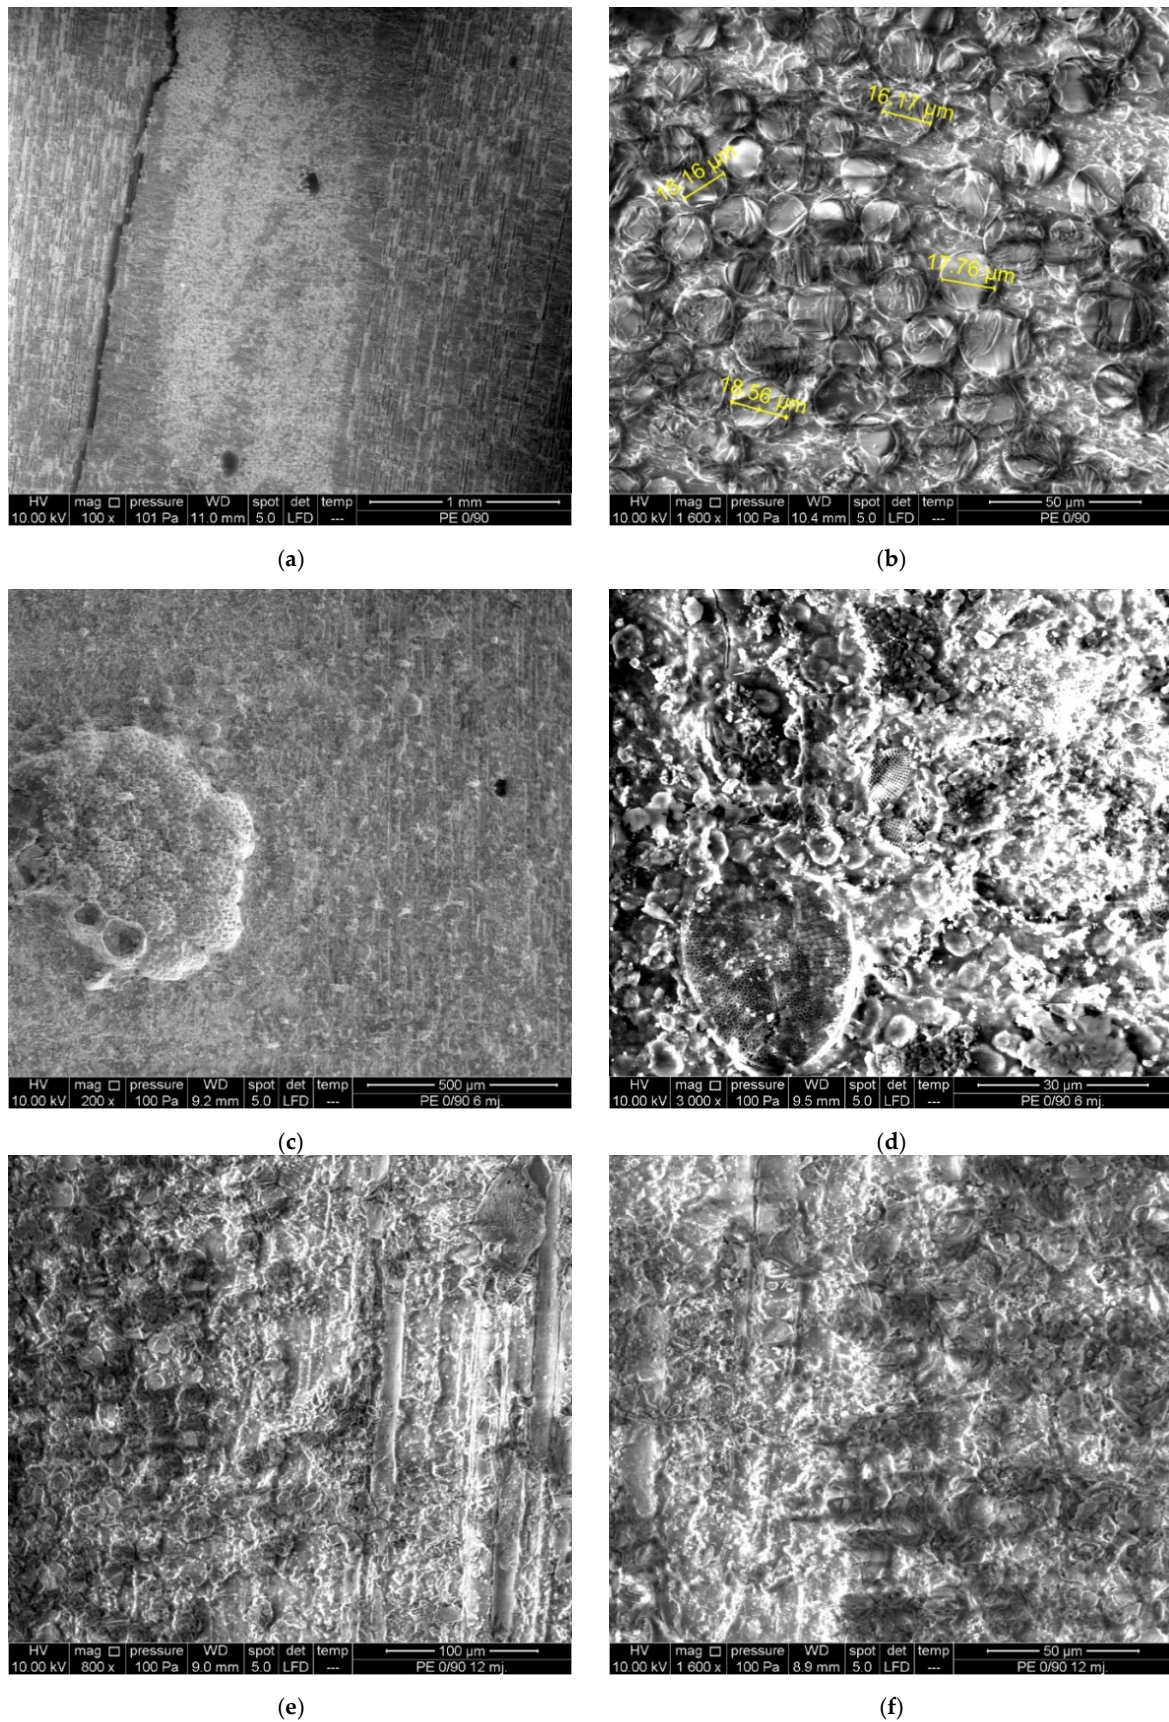
Figure 18. SEM polyester (0/90)s: (a,b) dry, manufacturing imperfections; (c,d) microorganisms' growth after 6 months of submersion; (e,f) 12 months of submersion.

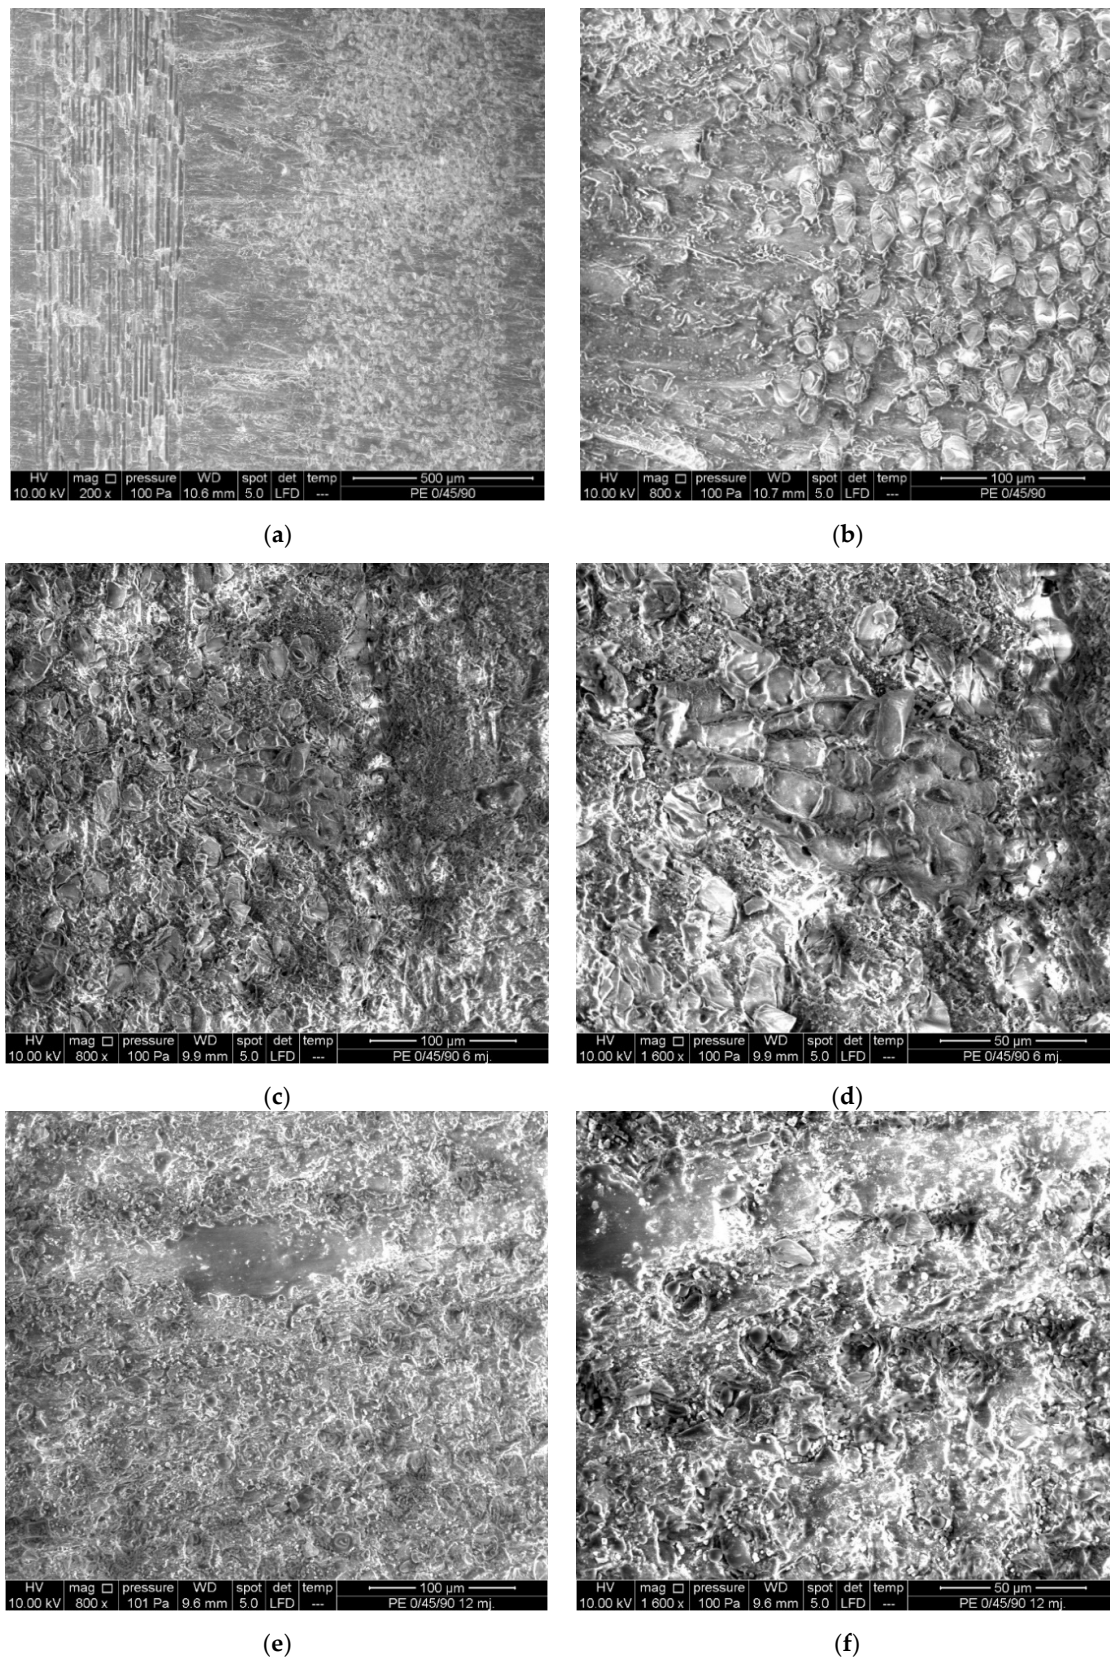
Figure 19. SEM polyester (0/45/90)s: (a,b) dry; (c,d) resin degradation, 6 months submersion; (e,f) microorganisms in the resin, 12 months of submersion.
