Article

A Sustainable Approach to Reconstruction: Historical Roof Structure Interventions

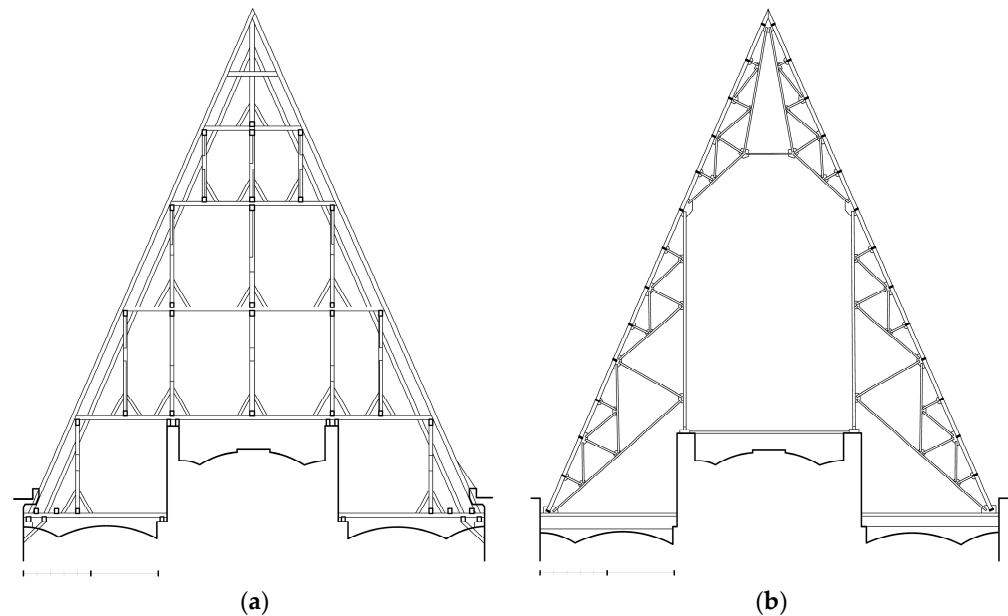
churches destroyed during the Second World War, the well-documented historic medieval roofs were replaced by metal structures, with or without wooden structural elements, focusing on the preservation of the roof shape. This reconstructed solution was chosen for St. Stephen's Cathedral in Vienna, Cologne Cathedral, and Nuremberg. In case of Vienna's Dome, the 34.20 m span roof, dating to 1440, covered all three naves in one roof structure (Figure 8).

Figure 8. St. Stephen's Cathedral: (a) original roof structure; (b) structure after reconstruction.
