# Investigation of Hydrogen Embrittlement Susceptibility and Fracture Toughness Drop after in situ Hydrogen Cathodic Charging for an X65 Pipeline Steel

**Abstract:** The present research focuses on the investigation of an in situ hydrogen charging effect during Crack Tip Opening Displacement testing (CTOD) on the fracture toughness properties of X65 pipeline steel. This grade of steel belongs to the broader category of High Strength Low Alloy Steels (HSLA), and its microstructure consists of equiaxed ferritic and bainitic grains with a low volume fraction of degenerated pearlite islands. The studied X65 steel specimens were extracted from pipes with 19.15 mm wall thickness. The fracture toughness parameters were determined after imposing the fatigue pre-cracked specimens on air, on a specific electrolytic cell under a slow strain rate bending loading (according to ASTM G147-98, BS7448, and ISO12135 standards). Concerning the results of this study, in the first phase the hydrogen cations' penetration depth, the diffusion coefficient of molecular and atomic hydrogen, and the surficial density of blisters were determined. Next, the characteristic parameters related to fracture toughn

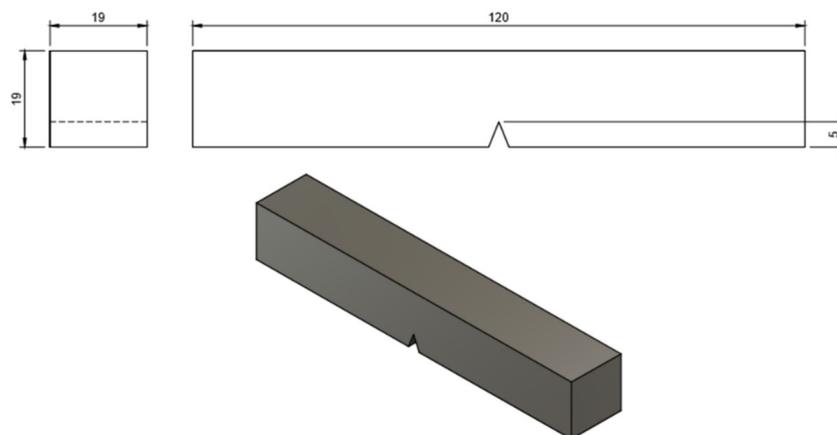
**Figure 1.** Dimensions of the crack tip opening displacement test (CTOD) specimen.

The dimensions of the crack tip opening displacement test (CTOD) specimen are shown in Figure 1. The Crack Tip Opening Displacement test took place in two separate stages. In the first stage, the controlled crack propagation rate during fatigue loading in air environment was realized (fatigue pre-crack) for the X65 pre-notched specimens. At this stage, the crack length was monitored using an Alternative Pulse Current Device (ACPD). As the fatigue crack propagated, the continuous variation of the electric voltage field and the resistance drop were measured. By means of a calibrated transfer function, the gradient of the electric voltage field and the resistance drop were transformed into fatigue crack propagation length (Figure 2).

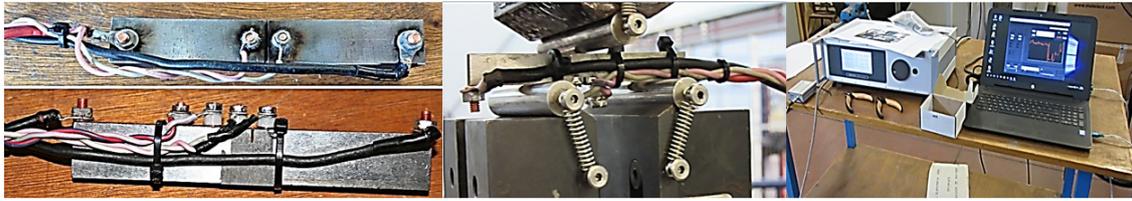
**Figure 2.** CTOD testing by the applicability of a fatigue pre-crack stage to the notched specimens on air environment.

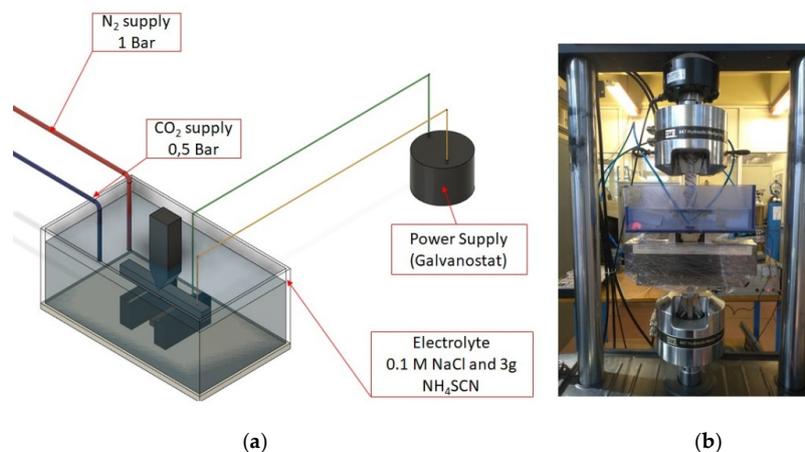
**Figure 3.** (a) Schematic illustration of the in situ hydrogen cathodic charging device, (b) Second stage of CTOD testing by the applicability of slow strain rate bending loading under in situ hydrogen cathodic charging conditions (polarization process).

More precisely, in the electrolytic cell during the electrochemical charging process, as cathode was imposed the pre-notched CTOD specimen of X65 steel and as anode was selected a platinum coated titanium electrode. The electrolytic solution used in the cathodic polarization process was consisted of 0.2 M NaCl and 3 g/L  $NH_4SCN$  (which reacts as a poison recombination inhibitor of hydrogen cations on the metal surface). The electrochemical system was stirred by a mixture of  $CO_2$  and  $N_2$  gases in order to stabilize the pH value between 5 and 5.2 and promote its electrochemical activity. During the in situ hydrogen cathodic charging process the applied current density was stabilized at 10 and 20  $\text{mA}/\text{cm}^2$ , for a cathodic polarization duration of 26 h (according to Petroleum Industry Standard ISO 3183) (Figure 3). The surface of the cathodically charged specimens was insulated with polyurethane, except of the notched area, in order to promote the hydrogen cation electrodiffusion process specifically in this area.

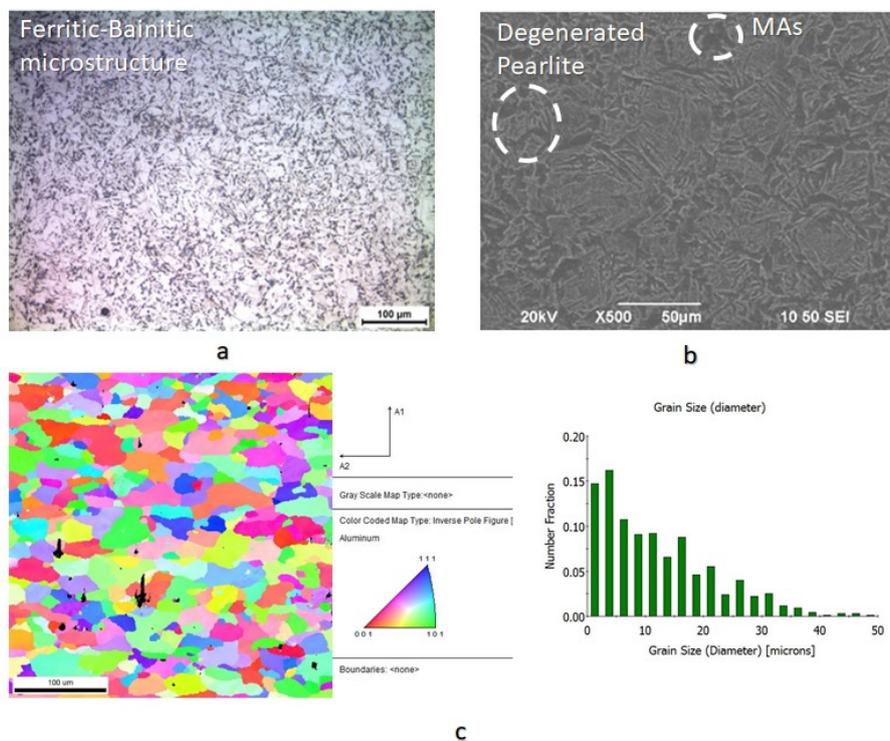
**Figure 4.** (a) Ferritic-Bainitic microstructure of X65 pipeline steel by means of Optical Microscopy, (b) Degenerated perlite islands and MAs micro/constituency within the crystallographic and (c) grain orientation mapping and average grain size by EBSD analysis.

The microstructure of X65 pipeline steel consisted of ferritic and bainitic grains with high volume fraction of degenerated pearlite islands. It was also detected the existence of limited proportion of non-metallic inclusions (manganese sulfide, aluminum oxide) and embrittling Martensite-Austenite phases (MAs). The average grain size of the ferritic-bainitic microstructure was evaluated by means of Electron Backscatter Diffraction technique (EBSD) equal to 18  $\mu\text{m}$  (Figure 4). The chemical composition and mechanical properties of X65 steel are shown in Tables 2 and 3. The studied specimens had dimensions 120  $\times$  19  $\times$  19 mm and had been extracted from pipelines with external diameter 29 in (736.6 mm). These pipelines emanated from the last stage of thermo-mechanical production process without being subjected to sour service conditions. The X65 pipeline steel was developed by a continuous casting process with the imposition of de-oxidation mechanism of Al-killed during industrial refining process.

The microstructure of X65 pipeline steel consisted of ferritic and bainitic grains with a high volume fraction of degenerated pearlite islands. The average grain size of the ferritic-bainitic microstructure was evaluated by Electron Backscatter Diffraction technique (EBSD) equal to 18 μm.

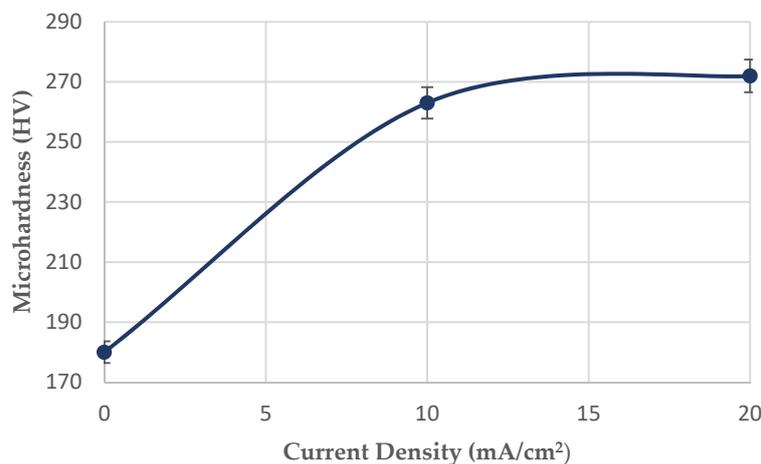
**Figure 5.** Effect of the applied current density (10 and 20 mA/cm<sup>2</sup>) during the in situ hydrogen cathodic charging process and bending loading on the surface microhardness increment.

After applying the in situ hydrogen cathodic charging process at 10 and 20 mA/cm<sup>2</sup> current densities, a severe increase in surface hardness was detected (Figure 5). This effect is attributed according to international literature to the interaction between dislocation networks and hydrogen Cottrell atmospheres, to the creation of high volume fraction of hydrogenated vacancies (V-H clusters), and the expanded development of interstitial solid solution [27–35]. In particular, the above phenomenon is attributed to the fact that hydrogenated interstitial vacancies of the crystalline structure impede the movement of dislocations, resulting in their interlocking and immobilization effect. The immobilized dislocation networks cannot act as active diffusion channels and the localized supersaturation in hydrogen leads to the accumulation of residual stresses, microplastic zones and slip bands. As a result of the above, the yield stress and the surface micro hardness increase. In any case, the highest rate of the surface microhardness increment was detected during the devolution from the uncharged condition to the cathodically charged under 10 mA/cm<sup>2</sup> (in comparison to the transition from the charged condition under a current density field of 10 to 20 mA/cm<sup>2</sup>).

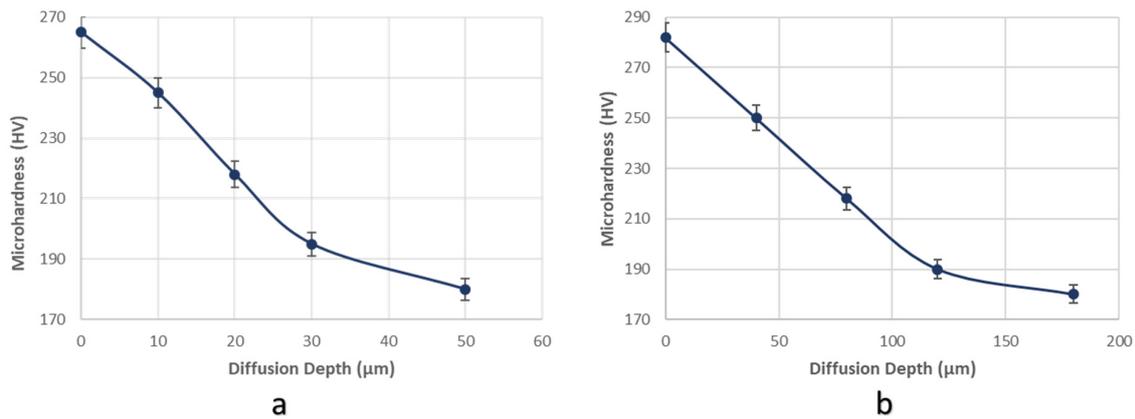
**Figure 6.** Determination of hydrogen cations' diffusion depth into the polycrystalline matrix by conducting microhardness measurements at the cross sections of the specimens, after in situ hydrogen cathodic charging polarization process during slow strain rate bending loading at (a) 10 mA/cm<sup>2</sup> and (b) 20 mA/cm<sup>2</sup> current density.

Additionally, the diffusion depth of hydrogen cations into the microstructure of X65 steel, was validated after in situ hydrogen cathodic charging process by conducting microhardness measurements at the cross section of the specimens. With the increment of the cathodic charging current density from 10 to 20 mA/cm<sup>2</sup>, the diffusion depth of hydrogen cations into the crystal structure augmented from 50 to 180 μm (Figure 6).

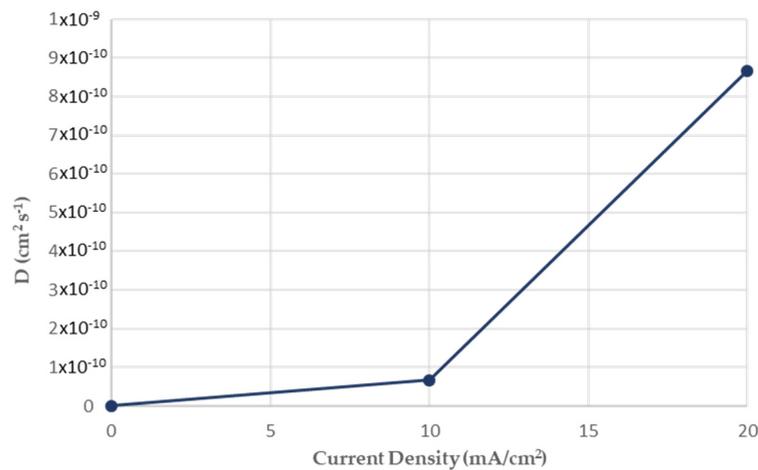
**Figure 7.** Effect of the applied current density (10 mA/cm<sup>2</sup> and 20 mA/cm<sup>2</sup>) on the diffusion coefficient of hydrogen cations into the ferritic-bainitic microstructure of X65 pipeline steel.

As it can be seen from Figure 7 the diffusion coefficient of hydrogen atoms into crystalline structure during the in situ hydrogen cathodic charging process and bending loading until fracture was increased linearly from  $6.67735 \times 10^{-11} \text{ cm}^2\text{s}^{-1}$  to  $8.65385 \times 10^{-10} \text{ cm}^2\text{s}^{-1}$  by increasing the current density field from 10 to 20 mA/cm<sup>2</sup>. This observation can be correlated with the expansion of the electrodiffusion fronts due to the activation of hydrogen cations' migration effect by easy paths-channels (ferrite-pearlite interfaces) and the excess of the electrostatic-thermodynamic barrier of reversible hydrogen traps (pearlite-bainite interfaces and low angle grain boundaries).

- The diffusion coefficient of hydrogen atoms into the crystalline structure during the in situ hydrogen cathodic charging process and slow strain rate bending loading until fracture was increased linearly from  $6.67735 \times 10^{-11} \text{ cm}^2\text{s}^{-1}$  to  $8.65385 \times 10^{-10} \text{ cm}^2\text{s}^{-1}$  by increasing the current density field from 10 to 20 mA/cm<sup>2</sup>.

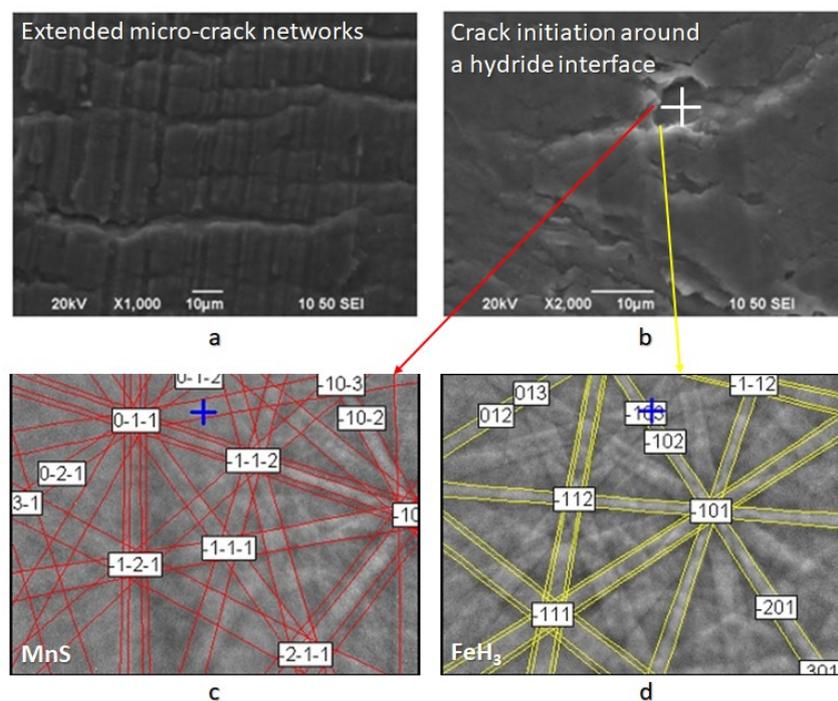
**Figure 8.** (a) Stepwise micro-cracking and micro-cracking branching, (b) crack initiation points at hydride/ non-metallic inclusion interfaces, (c,d) identification of a non metallic inclusion at a high bridge formation from Electron Backscatter Diffraction technique (EBSD).

As it can be seen from Scanning Electron Microscopy images (Figure 8), after the in situ hydrogen cathodic charging process both at 10 and 20 mA/cm<sup>2</sup>, in the surface structure of the X65 pipeline steel was detected micro-cracking phenomenon around the interfaces of blisters and non-metallic inclusions. These micro-cracks propagated by a crooked line morphology (stepwise micro-cracking) as the non-metallic inclusions and the blister formations act like electrokinetic barriers to the development of electrodiffusion process. More precisely these microstructural components act like high-energy irreversible traps and lead to the supersaturation in hydrogen of the matrix material, resulting in the excess of critical stress intensity factor value and the development micro-cracking phenomenon.

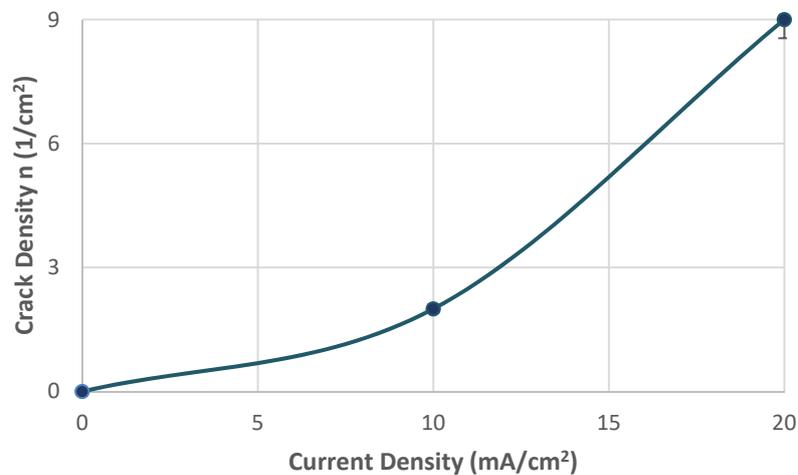
**Figure 9.** Correlation between surficial density of microcracks and applied current density during in situ hydrogen cathodic charging and slow strain rate bending loading.

As it can be seen from Figure 9 the surficial density of microcracks was observed to increase exponentially (from 2 cracks/cm<sup>2</sup> to 9 microcracks/cm<sup>2</sup>) with the increment of the required polarization current density during the in situ hydrogen cathodic charging process. The rate of this increase appeared to be higher when switching from 10 to 20 mA/cm<sup>2</sup> current density compared to switching from the uncharged condition to the charged condition under 10 mA/cm<sup>2</sup> current density.

- The surficial density of microcracks was observed to increase exponentially (from 2 cracks/cm<sup>2</sup> to 9 microcracks/cm<sup>2</sup>) with the increment of the required polarization current density during the in situ hydrogen charging process and slow strain rate bending loading. For a 10 mA/cm<sup>2</sup> current density field, the maximum crack width was determined at 2.2 μm and the maximum crack length at 2.4 μm. Correspondingly for a current density field of 20 mA/cm<sup>2</sup>, the maximum crack width was determined at 2.75 μm and the maximum crack length at 3.1 μm.

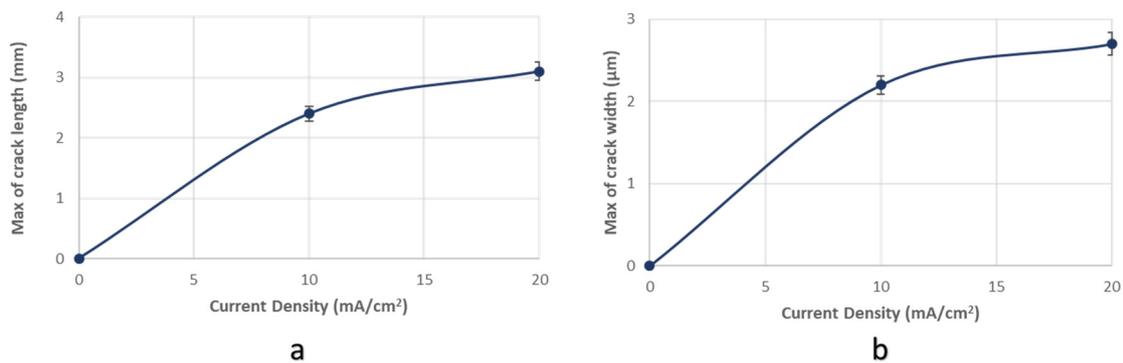
**Figure 10.** (a) maximum crack length and (b) maximum crack width of surficial microcracks in conjunction with the applied current density during in situ hydrogen charging process and slow strain rate bending loading.

In addition, the maximum width and maximum length of the microcracks were observed to increase continuously with the increment of the applied current density during cathodic polarization process. For a 10 mA/cm<sup>2</sup> current density field, the maximum crack width was determined at 2.2 μm and the maximum crack length at 2.4 μm. Correspondingly for a current density field of 20 mA/cm<sup>2</sup>, the maximum crack width was determined at 2.75 μm and the maximum crack length at 3.1 μm. It is, therefore, conceivable that the growth rate of the microcracks is higher during the transition from the

uncharged state to the cathodically polarized state under  $10 \text{ mA/cm}^2$  compared to the corresponding one during the transition from the charging process at a current density field of  $10 \text{ mA/cm}^2$  to that of  $20 \text{ mA/cm}^2$  (Figure 10).

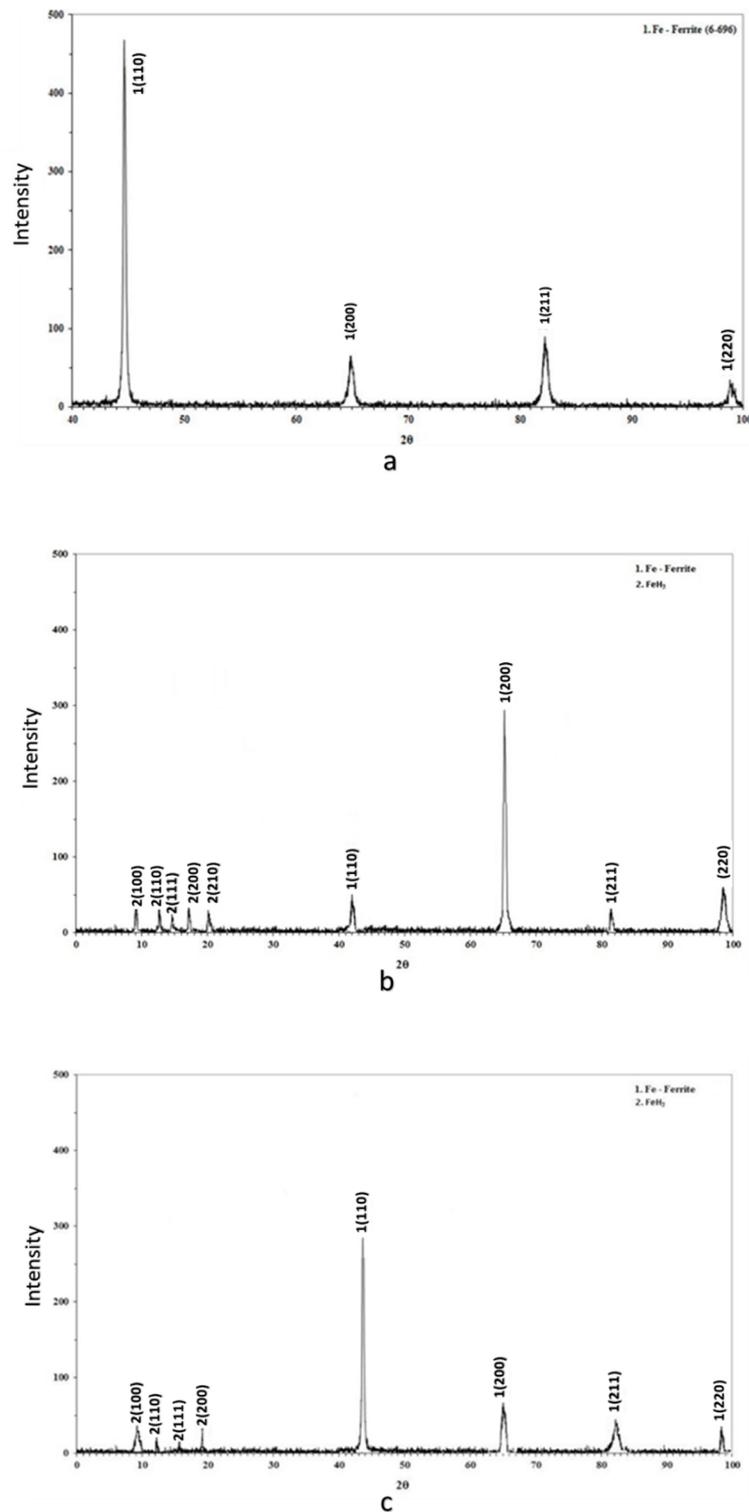
**Figure 11.** Identification of phases by X-Ray Diffraction patterns (a) for the uncharged condition; (b,c) after cathodic polarization at 10 and 20 mA/cm<sup>2</sup> current density.

Through X-ray diffractometry, the existence of hydrides with  $\text{FeH}_3$  stoichiometry after in situ cathodic charging process both at  $10$  and  $20 \text{ mA/cm}^2$  was detected. In addition, the shift of the main diffraction peaks, compared to those of the uncharged specimens, at lower diffraction angles is related to the development of compressive residual stresses within the crystallographic structure during the electrochemical process (Figure 11).

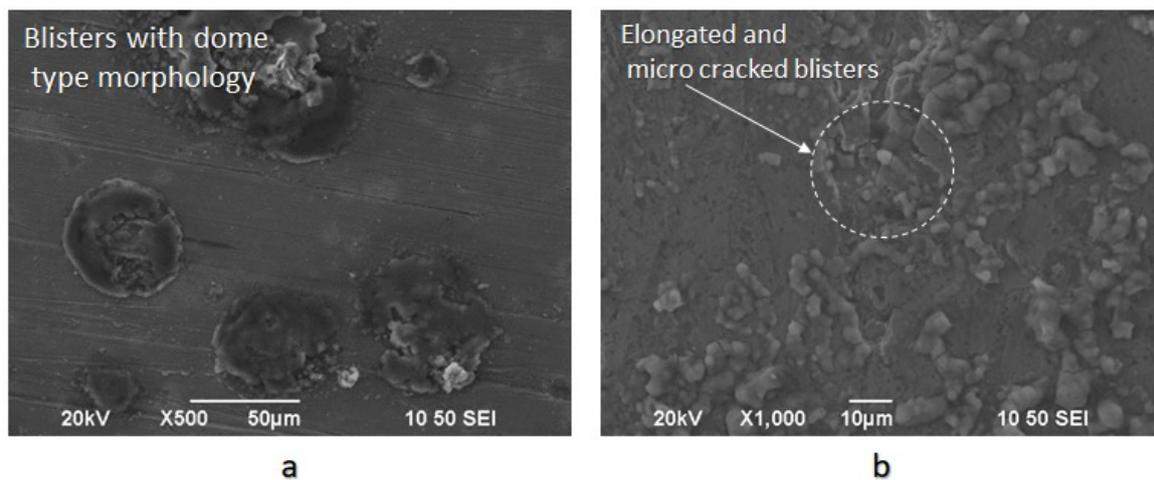
**Figure 12.** (a) Blister formations with a dome-type morphology after the in situ hydrogen cathodic charging process at  $10 \text{ mA/cm}^2$  current density under slow strain rate bending loading; (b) Elongated blisters with surficial micro-cracks and blistering on blistering nucleation effect after the in situ hydrogen cathodic charging process at  $20 \text{ mA/cm}^2$  current density under slow strain rate bending loading.

In the surface area of the cathodically charged specimens of X65 pipeline steel, for a current density field of  $10 \text{ mA/cm}^2$ , an increased volume fraction of blisters with dome-type morphology was detected. After the polarization process of the specimens at a current density field of  $20 \text{ mA/cm}^2$ , the development of elongated blisters was observed, with extended microcrack branching networks at their surface. The microstructural locations correlated with the nucleation process of blisters were the energy upgraded areas, such as the triple junction locations, or the non-metallic inclusions and hydride interfaces (Figure 12) [36–38].

- In the surface area of the cathodically charged specimens of X65 pipeline steel for a current density field of 10 mA/cm<sup>2</sup>, an increased volume fraction of blisters with dome-type morphology was detected. After the polarization process of the specimens at a current density field of 20 mA/cm<sup>2</sup>, the development of elongated blisters was observed, with extended microcrack branching networks at their surfaces. Concerning the average growth size of blister formations, it seems to decrease from 180 μm to 110 μm by increasing the required cathodic polarization current density from 10 to 20 mA/cm<sup>2</sup>.

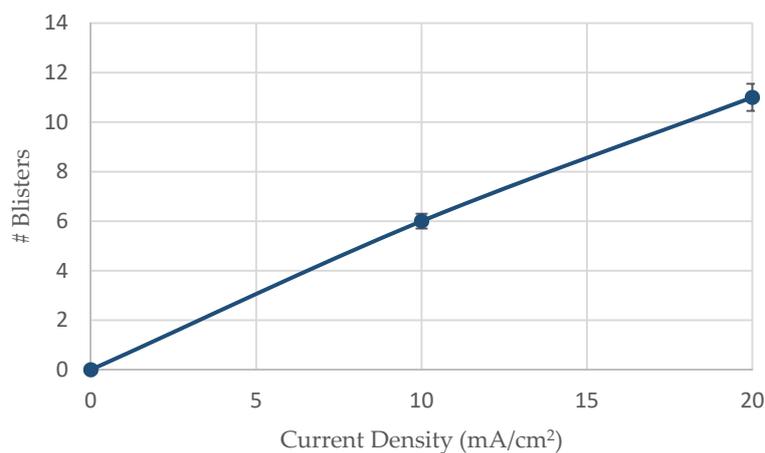
**Figure 13.** Surficial density of blister formations related to the applied current density during the in situ hydrogen cathodic charging process and slow strain rate bending loading.

As it can be seen from Figure 13 the surficial density of blisters increases proportionally and linearly with the cathodic polarization current density during the electrochemical charging process. The rate of this increment is observed to be higher during the transition from  $10$  to  $20 \text{ mA/cm}^2$  current

density compared to the transition from the uncharged condition to the polarized condition under 10 mA/cm<sup>2</sup> current density.

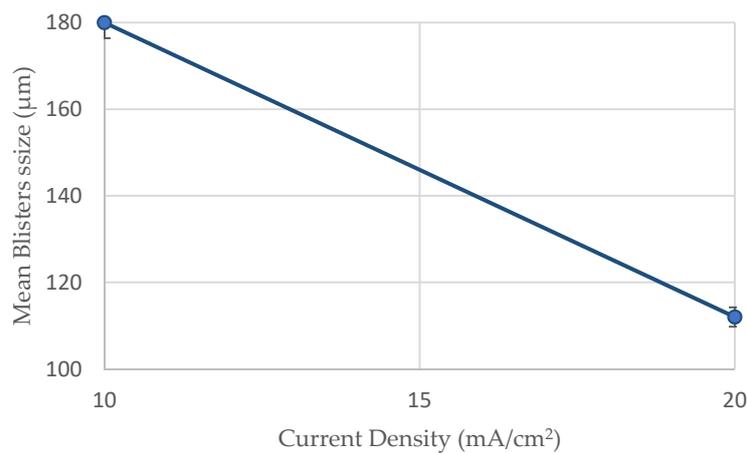
**Figure 14.** Mean size of blisters developed under the in situ hydrogen cathodic charging process (10 and 20 mA/cm<sup>2</sup>) and slow strain rate bending loading.

Concerning the average growth size of blister formations, it seems to decrease from  $180 \mu\text{m}$  to  $110 \mu\text{m}$  by increasing the required cathodic polarization current density from  $10 \text{ mA/cm}^2$  to  $20 \text{ mA/cm}^2$  (Figure 14). The above observation is attributed to the fact that by the increment of current density field during cathodic polarization process, more nucleation centers for blister formation are activated, thereby limiting their growth rate and mean size.

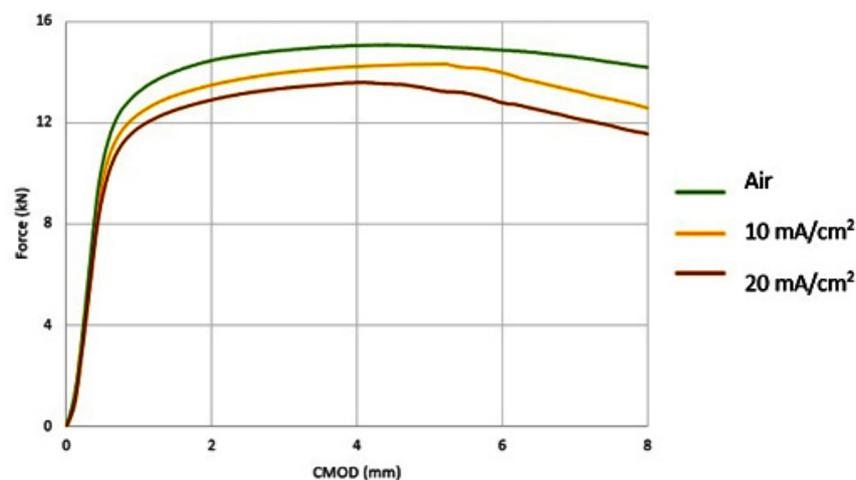
**Figure 15.** Force-Crack Mouth Open Displacement (CMOD) curves of CTOD tested X65 pipeline steel (a) in the uncharged condition; (b) after in situ hydrogen cathodic charging at 10 mA/cm<sup>2</sup> current density; (c) after in situ hydrogen cathodic charging at 20 mA/cm<sup>2</sup> current density.

For the X65 steel specimens subjected to CTOD mechanical testing in ambient air, the mechanical values associated with the fracture toughness parameter were determined as follows:  $K_Q = 42.070 \text{ MPa}\cdot\text{m}^{1/2}$ ,  $J = 280.76 \text{ KN/m}^2$ ,  $\text{CTOD}_{el} = 0.0061 \text{ mm}$ ,  $\text{CTOD}_{pl} = 1.92 \text{ mm}$ .

For the specimens subjected to in situ hydrogen cathodic charging process during slow strain rate bending, a significant decrease in fracture toughness was observed, as it can be seen from the characteristic mechanical values for applied current densities of  $10 \text{ mA/cm}^2$  and  $20 \text{ mA/cm}^2$ . More precisely after the in situ hydrogen cathodic charging effect at  $10 \text{ mA/cm}^2$  the main parameters correlated with toughness properties were calculated as follows:  $K_Q = 35.04 \text{ MPa}\cdot\text{m}^{1/2}$ ,  $J = 202.01 \text{ KN/m}^2$ ,  $\text{CTOD}_{el} = 0.0054 \text{ mm}$ ,  $\text{CTOD}_{pl} = 1.44 \text{ mm}$ . Respectively after the in situ hydrogen cathodic charging procedure at  $20 \text{ mA/cm}^2$ , the above parameters were identified as follows:  $K_Q = 30.04 \text{ MPa}\cdot\text{m}^{1/2}$ ,  $J = 175.8 \text{ KN/m}^2$ ,  $\text{CTOD}_{el} = 0.0037 \text{ mm}$ ,  $\text{CTOD}_{pl} = 0.98 \text{ mm}$  (Figure 15).

Consequently, during the transition from the uncharged state of X65 pipeline steel to the cathodically polarized, for a current density field of 10 mA/cm<sup>2</sup>, the parameters  $K_Q$ ,  $J$ , CTOD<sub>el</sub> and CTOD<sub>pl</sub> decreased by 16.71%, 28%, 11.48%, 25% respectively. During the transition from the charged condition for a current density field of 10 mA/cm<sup>2</sup> to that with a current density field of 20 mA/cm<sup>2</sup>, the parameters  $K_Q$ ,  $J$ , CTOD<sub>el</sub> and CTOD<sub>pl</sub> decreased by 28.6%, 37.4%, 39.34%, 48.95% respectively.

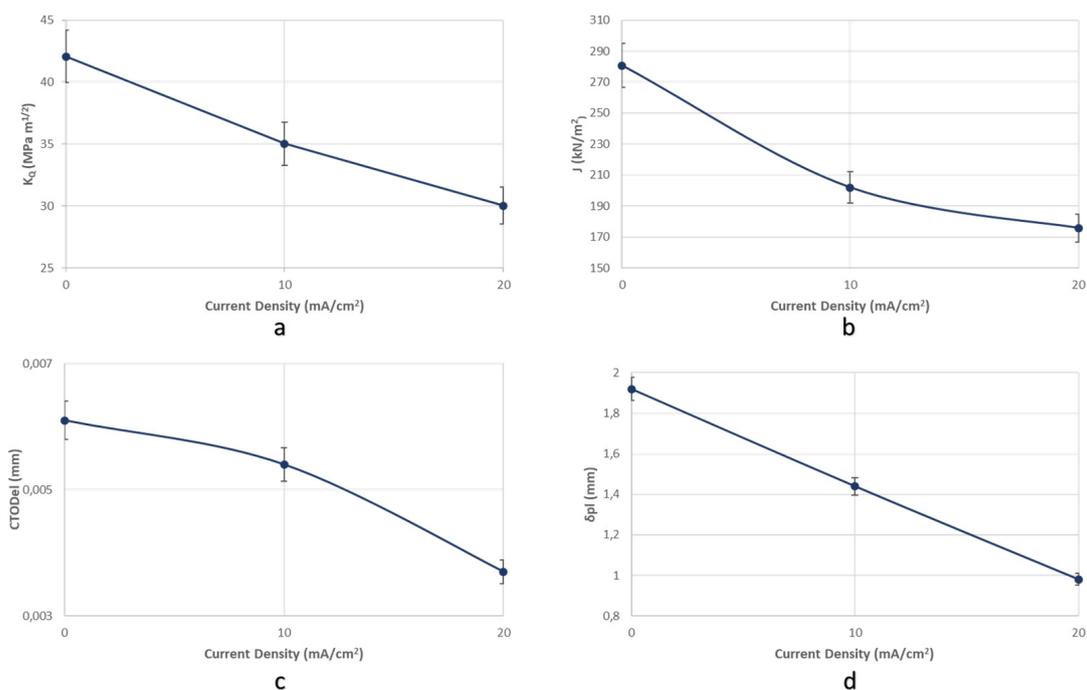
**Figure 16.** Reduction rate of the main toughness parameters (a)  $K_Q$ , (b)  $J$ , (c)  $CTOD_{eI}$ , and (d)  $CTOD_{pI}$  in function with the applied current density during the in situ hydrogen cathodic charging process and slow strain rate bending loading.

The rate of the drop of the main toughness parameters was considered to be higher during the transition from 10 to 20 mA/cm<sup>2</sup> current density, as compared to the transition from the uncharged condition to the cathodically polarized condition under 10 mA/cm<sup>2</sup> (Figure 16).

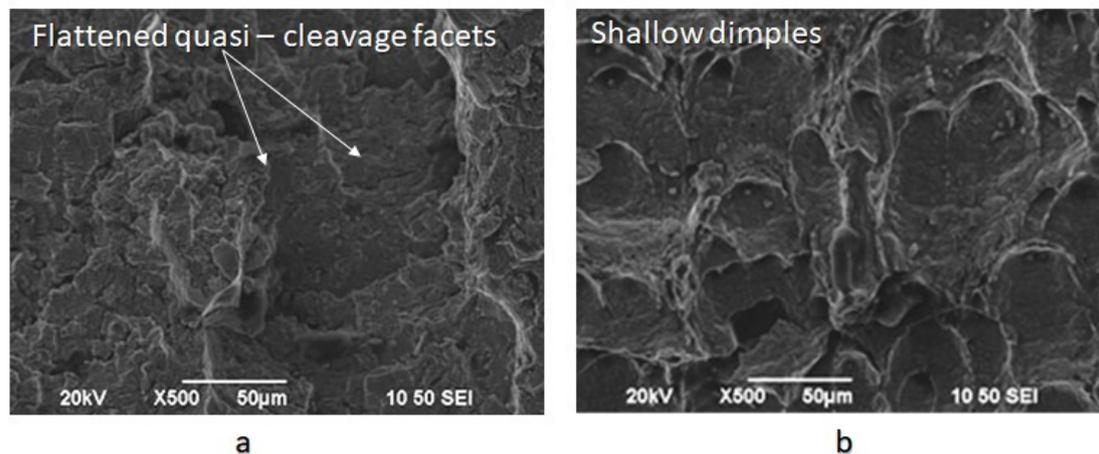
**Figure 17.** Fractured surfaces after CTOD testing of X65 steel for the uncharged condition (a) fatigue pre-cracked area; (b) bended area.

Specifically for the uncharged and CTOD tested specimens, the fatigue pre-cracked area appeared to consist of benchmark formations, with extended width and intense topographic relief, expanded about  $45^\circ$  from the loading axis (due to the excess of the critical resolved shear stress  $\tau_{crss}$ ).

The bended area consisted of equiaxial craters with homogeneous distribution and spherical symmetry (Figure 17).

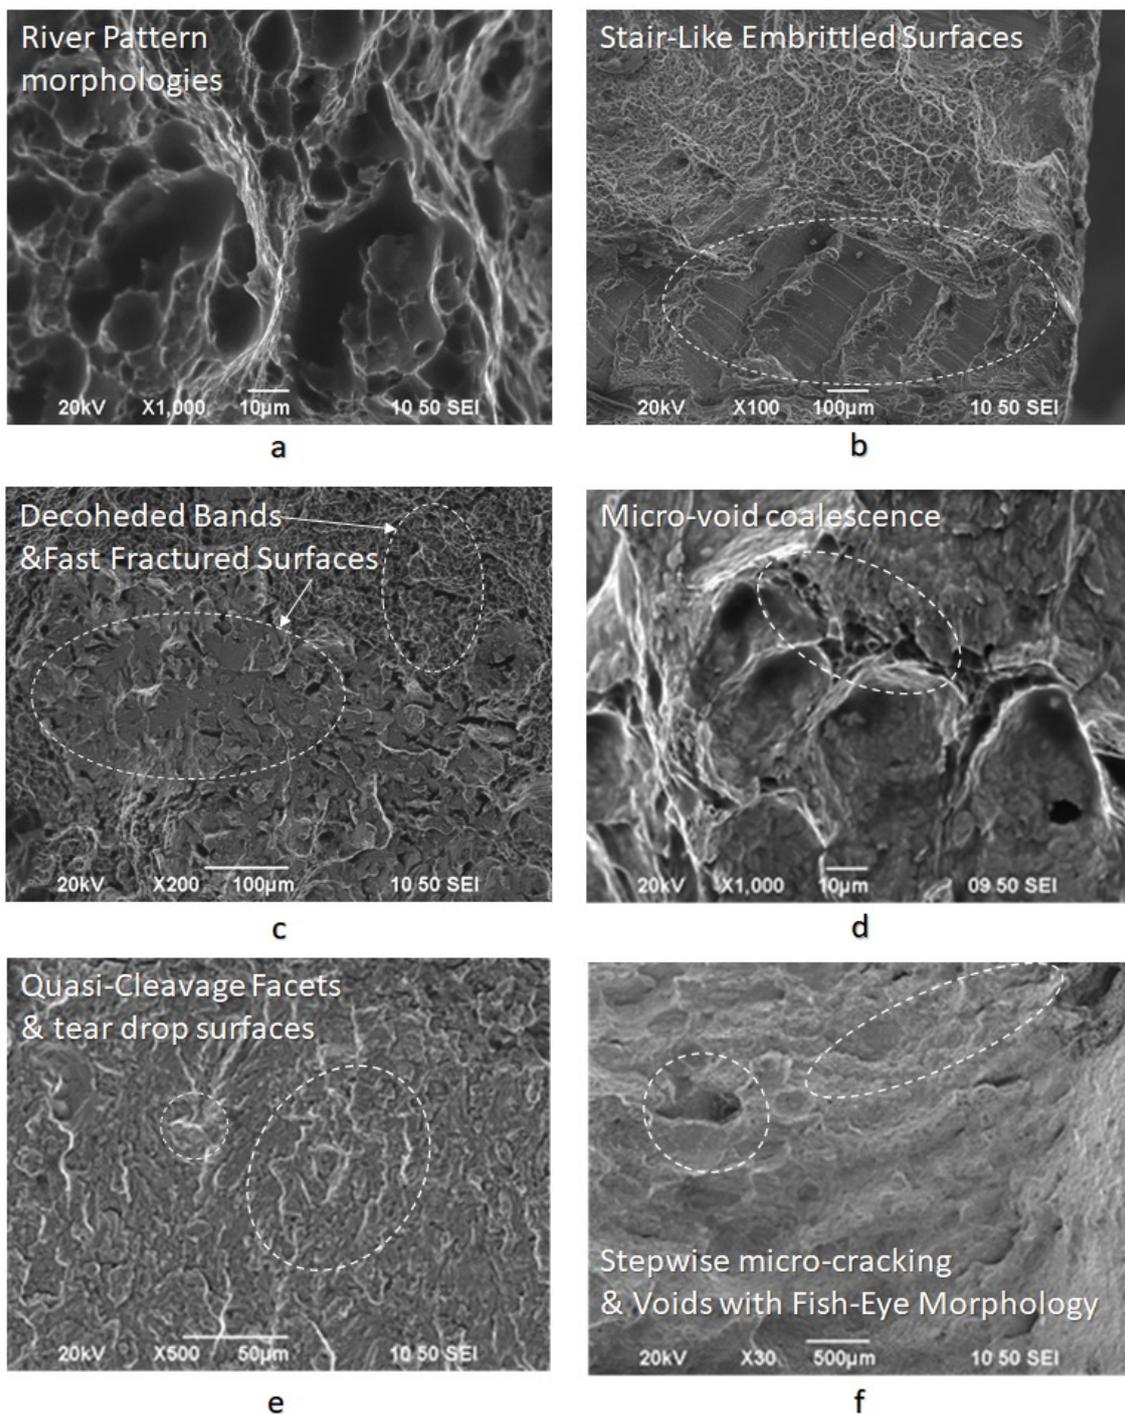
**Figure 18.** Fractured surfaces after CTOD testing under in situ hydrogen cathodic charging condition at 20 mA/cm<sup>2</sup>, (a) river pattern morphologies, (b) stair-like embrittled surfaces, (c) decoched bands and fracture surfaces, (d) micro-void coalescence effect, (e) quasi-cleavage facets and teardrop surfaces and (f) voids with fish eye morphology and stepwise micro-cracking.

For the specimens subjected to slow strain rate bending loading, under the effect of hydrogen cathodic charging process at a current density field of  $10 \text{ mA/cm}^2$  and for  $20 \text{ mA/cm}^2$ , the extensive appearance of embrittled regions, such as quasi-cleavage facets, river pattern morphologies, fast fracture surfaces (FFS), teardrop ridges and stair-like features was detected. The stepwise microcracking phenomenon was also observed simultaneously by the appearance of micro-voids with fish eye morphology due to the evacuation of craters with trapped hydrogen (Figure 18).

The fast fracture surfaces, the tear-drop ridges, and the quasi cleavage facets on the fractured surfaces of the CTOD tested specimens are indicative of the manifestation of the Hydrogen Enhanced Decohesion mechanism (HEDE). Correspondingly, the microvoid coalescence effect and the stair-like/saw-teeth embrittled surfaces confirm the development of Hydrogen Enhanced Localized Plasticity mechanism (HELP) and Elastic shielding reactions phenomenon. Finally, river patterns, micro-voids with fish eye morphology and stepwise micro-cracking are characteristic features of the Hydrogen Embrittlement effect (HE) and are mainly attributed to the mechanisms of Hydrogen Induced Cracking (HIC), Internal Pressure theory (IP) and the development of hydride phases and blister formations.
