# Low-Velocity Impact Analysis of Pineapple Leaf Fiber (PALF) Hybrid Composites

**Abstract:** The low-velocity impact behaviour of pineapple leaf fiber, PALF reinforce epoxy composite (P), PALF hybrid (GPG), and four-layer woven glass fiber (GGGG) composite was investigated. As for post-impact analysis, the damage evaluation was assessed through photographic images and X-ray computed tomography, using CT scan techniques. The key findings from this study are that a positive hybrid effect of PALF as a reinforcement was seen where the GPG shows the delayed time taken for damage initiation and propagation through the whole sample compared to GGGG. This clearly shows that the addition of fibers does have comparable composite properties with a fully synthetic composite. Through the visual inspection captured by photographic image, the presence of woven fiber glass mat in GPG presents a different damage mode compared to P. Moreover, CT scan results show extended internal damage at the cross-section of all impacted composite.

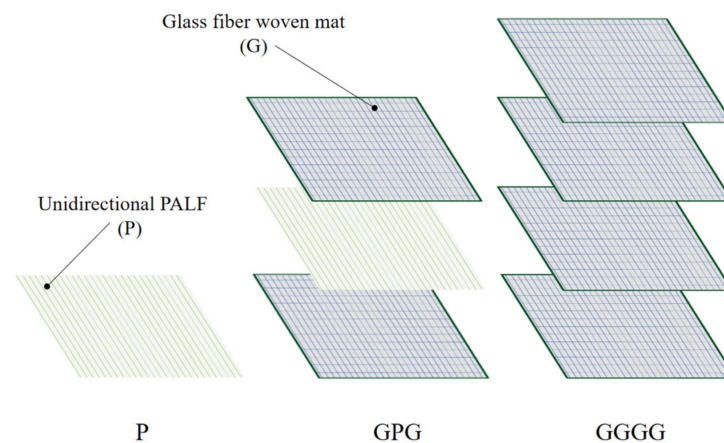
**Figure 1.** Schematic of fiber composition layup.

The PALF/epoxy composites were produced by aligning the PALF in unidirectional (UD). Thermoset composites epoxy were used because of their favorable properties, such as good chemical resistance, light weight, good mechanical strength, and high glass transition temperature [16]. The loading of PALF was fixed at 10% by weight, and the thickness of composite produced was 3 mm. The respective PALF loading was chosen based on previous studies affirming its high mechanical properties [17]. As for the hybrid composite, the weight of PALF is 5% wt because it has glass fiber mat on the top and bottom layers of the composite. Reddy et al. (2021) shows that this layering sequence has the highest strength and as for synthetic composite, the layering is made up to four layers so that the fabricated composite is 3 mm which is constant with all fabricated composites [18]. Those composites manufactured for the experiment are described in Table 1 and the schematic of the fiber composition is presented in Figure 1. The composites were prepared using the hand layup method. Before starting the fabrication process, the surface of the mold was waxed for ease of removal. The ratio used for epoxy to hardener was 3:1 and the mixture was stirred uniformly, and was then used to impregnate with the fiber in a mold. The curing process of the composite is at room temperature for 24 h.

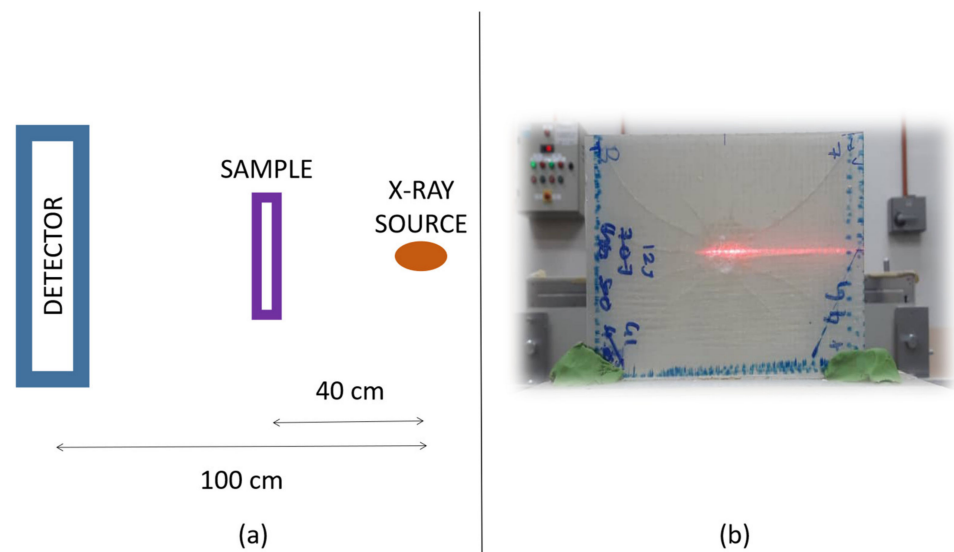
**Figure 2.** (a) The distance between X-ray source and the detector; (b) horizontal sample setup.

The low-impacted damage mode on composite was evaluated using X-ray computed tomography. The instrument used was a YXLON (Germany), MGC 41, and 160 kV. The X-ray was set at 30 kV and 2 mA, using linear array detector. The distance between the X-ray radiation source and the sample was set at 40 cm; and distance between the source and detector was fixed at 100 cm as shown in Figure 2a. The sample was placed horizontally, and scanning was carried out at the center of the composite as shown in Figure 2b.

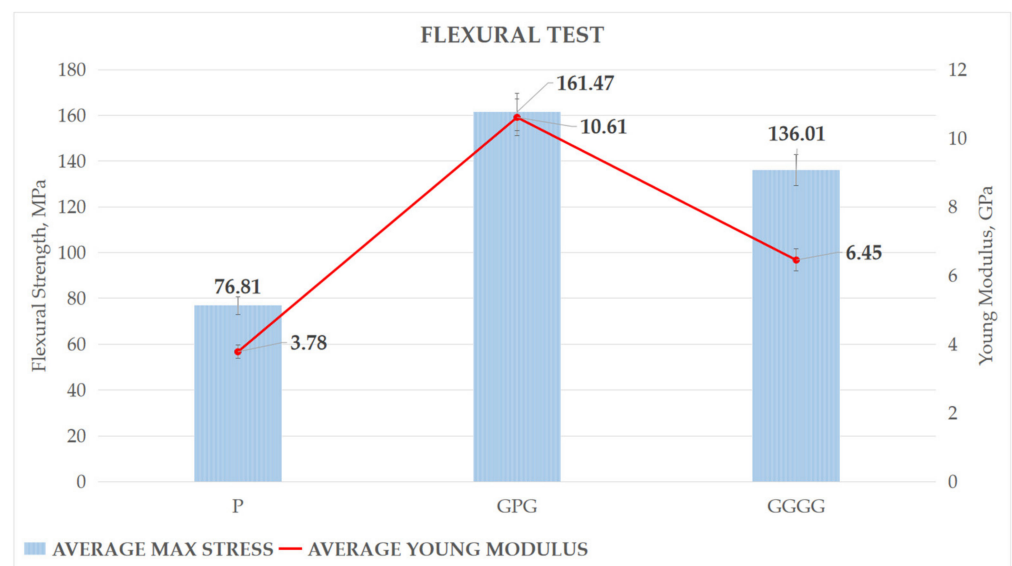
**Figure 3.** Flexural strength and young modulus of composites.

Flexural strength results of all three composites are presented in Figure 3. Figure 3 shows that P had the lowest flexural strength about 76.81 MPa. A positive impact of hybridization shows that the highest flexural strength was shown by GPG composite, 161.47 MPa, which is about 18.72% more than GGGG. Besides GPG having the highest flexural strength, it also shows highest stiffness, where the young modulus shows 10.61 GPa, followed by GGGG and P, 6.45 GPa, and 3.78 GPa, respectively. This means the GPG has the smallest elastic deformation for a given applied load followed by GGGG and P. Permanent deformation represents material failure. The findings were further supported by literature where hybridized fiber glass with kenaf fiber composite yields 142% more flexural strength compared to kenaf composite [19]. Besides that, studies on banana fiber (B)/glass fiber hybrid with stacking sequence G/B/G shows that hybrid banana poses higher flexural properties compared to banana epoxy composite which is 78.7 MPa and 46.04 MPa, respectively [18]. Studies show that plant fiber has good bonding between the fibers and matrix that evince the improvement in the flexural properties of the composite [20,21]. The findings were supported by the scanning electron microscope, using SEM morphology analysis, which showed the intimate contact between the fiber and matrix [21]. This results in slowing down the crack propagation between the layers as the load stress is distributed uniformly throughout the composite by the fibers and matrix. Apart from that, such properties were achieved in hybrid composite because the composite properties are mainly dependent on the modulus and the elongation at break of the individual reinforcing fibres [22]. E-glass fiber display 73 GPa of young modulus and 4.8% of elongation at failure, while most plant leaf fiber had 20–40 GPa of young modulus and 1.5–7% elongation at failure [23]. Moreover, Figure 4 shows the stress–strain, or SS, curve of the composite. It shows that GPG, after peaking at maximum stress, has a sudden drop in stress, indicating that the sample is cracked. However, with the presence of PALF as the internal layer in the hybrid composite, GPG helps to extend the composite bending performance before it reaches a fracture stage. This shows that the presence of PALF broadens the plastic region of the composite, as shown by P–SS curve, where P physical deformation up to 4.4%, compared to GGGG which has 3.9% only. The natural fiber PALF is better at distributing the load between fiber and matrix compared to glass fiber.

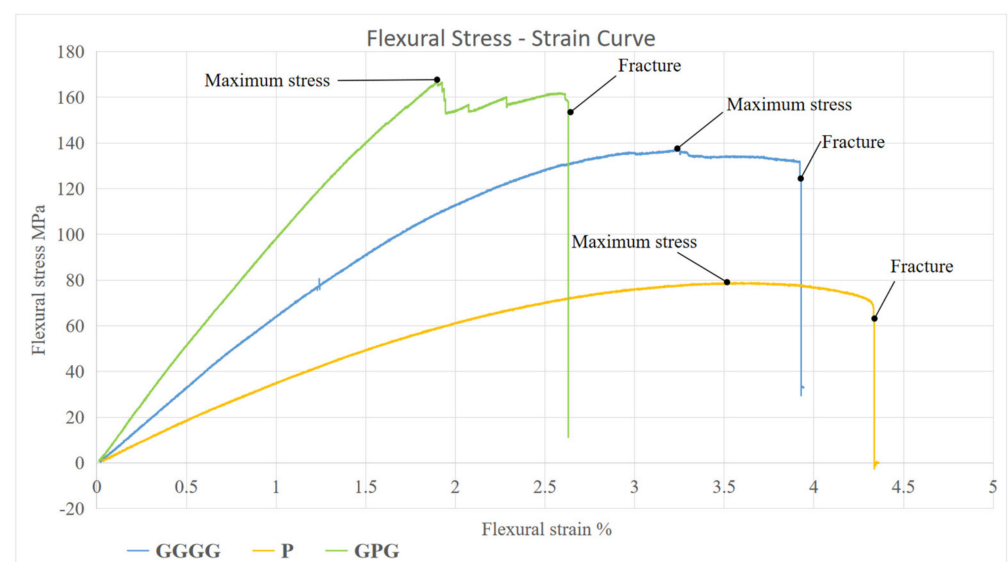
**Figure 4.** Stress-strain curve of composites.

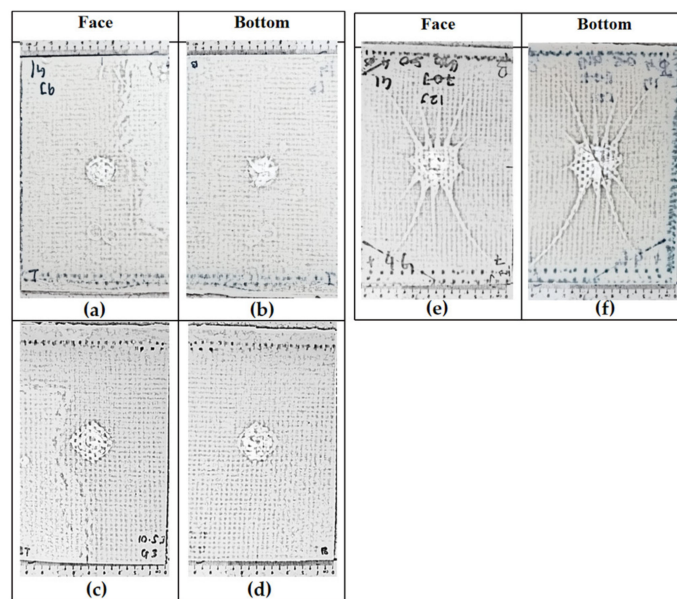
**Figure 6.** Schematic diagram of the GGGG impacted samples according to the energy level: (a) GGGG 9.0 J, (b) GGGG 9.0 J, (c) GGGG 10.5 J, (d) GGGG 10.5 J, (e) GGGG 12.0 J and (f) GGGG 12.0 J.

An impact test was carried out after ascertaining the strength of each composite based flexural property. Bensadoun et al. (2017) reported the relation between flexural test with impact test [24]. In his study, the author found that the composite with high flexural strength displays high peak-impact force, where strong material will sustain more load under impact before it fractures, leading to an increase in energy absorption. From Section 3.1, it was ascertained that GPG and GGGG possess higher flexural strength and stiffness compared to P. The flexural test gave the author the early idea to set up the impact energy range for each composite. The aim of this impact study is to observe the impact damage characteristic up to its prior perforation (before total failure) for each composite. Therefore, it is not necessary to begin the testing for GPG and GGGG at lower energy because the damage is not significant. The impact energy range for respected composite is presented in Table 2. Figures 5 and 6 show the schematic diagram of P, GPG and GGGG impacted composite.

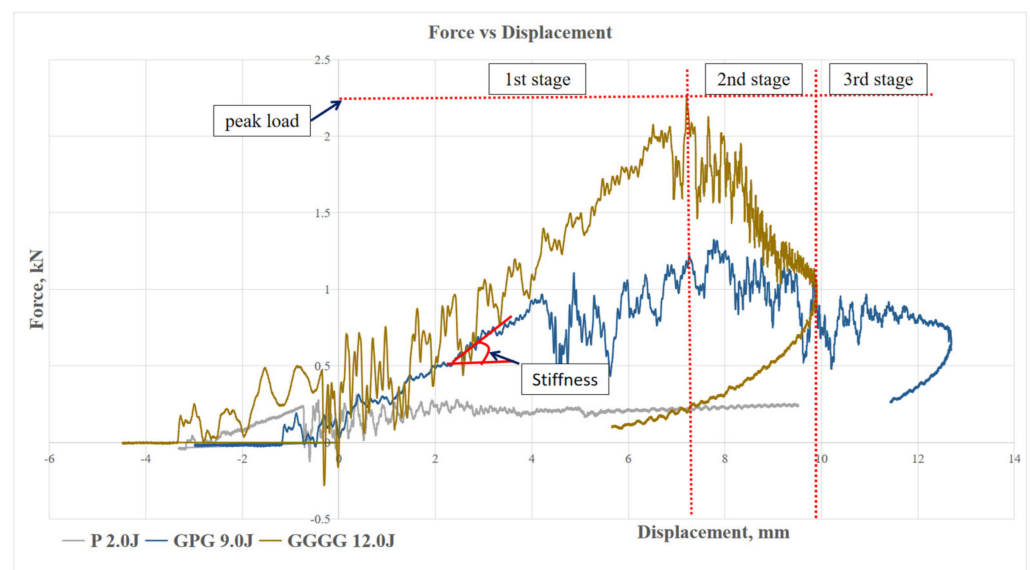
**Figure 7.** Force–Displacement curve of maximum impact energy prior to composites perforation.

Figures 7–10 show the impact force–displacement curve of three composite samples, namely P, GPG, and GGGG, at various energy levels. The oscillations observed on the force–displacement curves are associated with the natural modes of vibration of the impacting system (shaft, hammer, and impact sensor) [25]. The P was subjected to impact energy of 1 J and 2 J. The P experienced perforation when subjected to impact energy above 2 J. Therefore, in this study the maximum impact energy for P was limited to 2 J. The experiment showed that the GPG can withstand up to 9 J impact energy, which is 350% higher than P, before experiencing perforation. Meanwhile, the GGGG composite can withstand a maximum impact energy of 12 J, which is 33.33% higher than GPG, before experiencing perforation.

As shown in Figure 7, P shows the lowest slope compared to GPG and GGGG composite in the first stage of the graph. This indicates that P has the lowest stiffness property. This finding is also in line with flexural stiffness portrayed by P. This means that P is most brittle compared to GPG and GGGG composites. This finding was further supported by the open loop P graph (refer to Figure 8), indicating that the composite did not fully take the rebound during impact, showing that the composite has less elasticity properties [26]. The P composite had the same force displacement graph pattern with kenaf/epoxy composite reported by Majid et al. (2018) where, at stage 1, the loading is proportional with displacement until a “sawtooth” curve formed at peak force before unloading takes place [27]. Such a curve characteristic was presented due to the vibrational motion between the impactor and the composite.

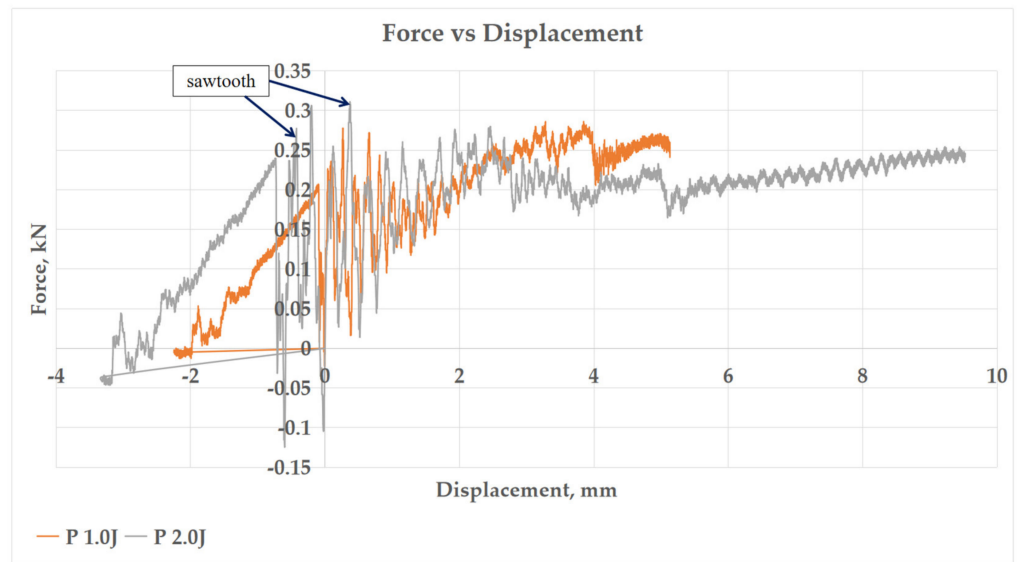
Figure 8. Force–Displacement curve of impact energy prior to P perforation.

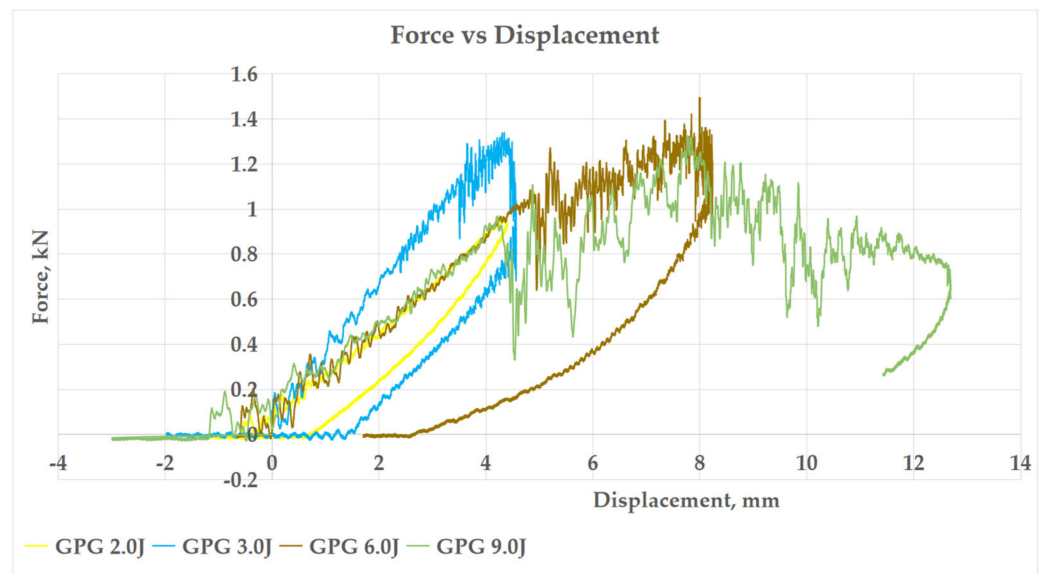
Figure 9. Force–Displacement curve of impact energy prior to GPG perforation.

In contrast, both the GPG and GGGG composites graphs shows a close loop started with the loading curve increasing proportionally until it reached a peak force then curve returned to its initial point as shown in graph, as in Figures 9 and 10. The curve shows that the composites fully took the rebound upon impact. This curve can be broken down into three stages, which are first stage linear force increment, second stage peak force, and third stage sudden force decrements. The GPG and GGGG graph shows that as the impact energy increases, the larger the area under the curve is covered. The area under the curve is the deformation energy that is initially transferred from the impactor to the composite and then returned (rebound) from the composite to the impactor [28]. This process is called the energy recovered process. At lower impact energy, 2.0–6.0 J, the GPG curve shows a sharp impact force drop after reaching the peak. This pattern was seen for GGGG at 9.0 J as well. However, at high-impact energy, 9.0 J GPG and 10.5–12.0 J GGGG as the

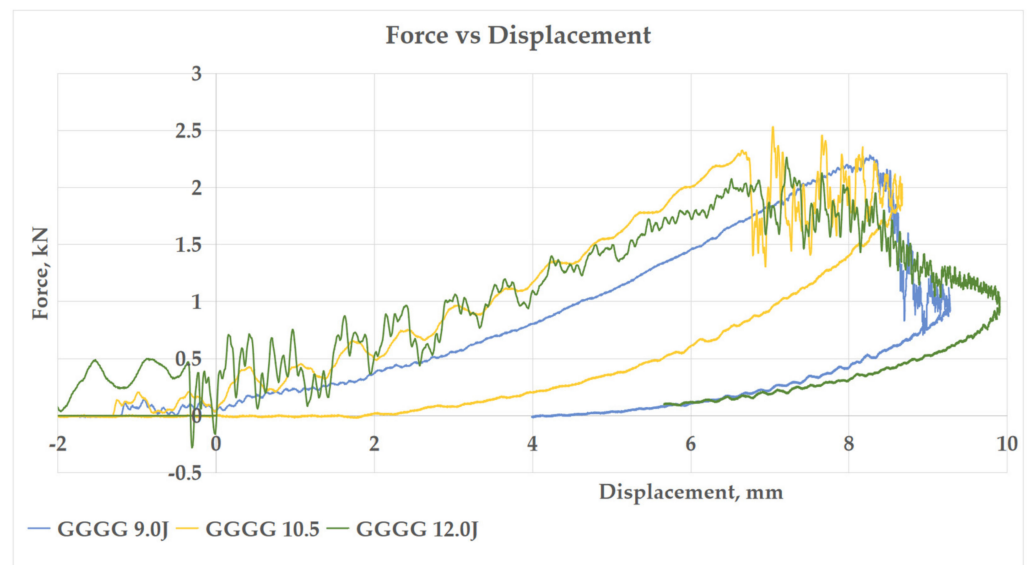
Figure 10. Force–Displacement curve of impact energy prior to GGGG perforation.

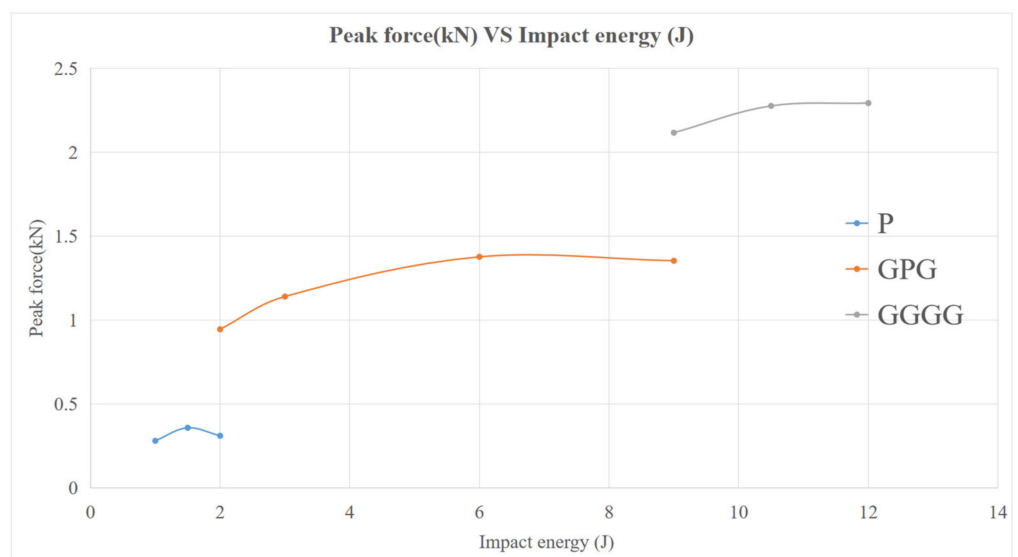
Figure 11. Peak force of composites.

Peak force, indicating the maximum load that a composite can withstand prior to experiencing failure during impact, is shown in Figure 11. The maximum peak force of P was recorded at 0.35 kN compared to GPG 1.37 kN, showcasing a 291.43% improvement in impact resistance. The same case was also observed in Majid et al. (2018). At maximum-impact energy kenaf hybrid with glass fiber shows an increment in peak force compared to kenaf composite from approximately 0.9 kN to 1.5 kN [27]. This is because the glass fiber helps to improve damage impact-resistance by reducing the damage propagation and localizing the damage at the point of impact [30]. The maximum peak force of GGGG was 2.29 kN, which is 67.15% higher than the GPG. Even though the GPG contains only two layers of glass fiber-woven mat, the added PALF fiber plays an important role in taking the impact and distributing it throughout the matrix. Furthermore, the presence of PALF had improved the composite impact-resistance capacity by increasing the impact time as shown in the impact vs. time curve. The shift of the curve peak point towards the right-hand side shows the longer period for achieving its maximum peak [27].

Moreover, the trend of the three composites shows decreased peak force at each respective maximum-impact peak force. This indicates that at the highest impact energy that each composite can bear, the composite experiences a drop in its flexibility (due to major damage) to absorb the impact force [31].

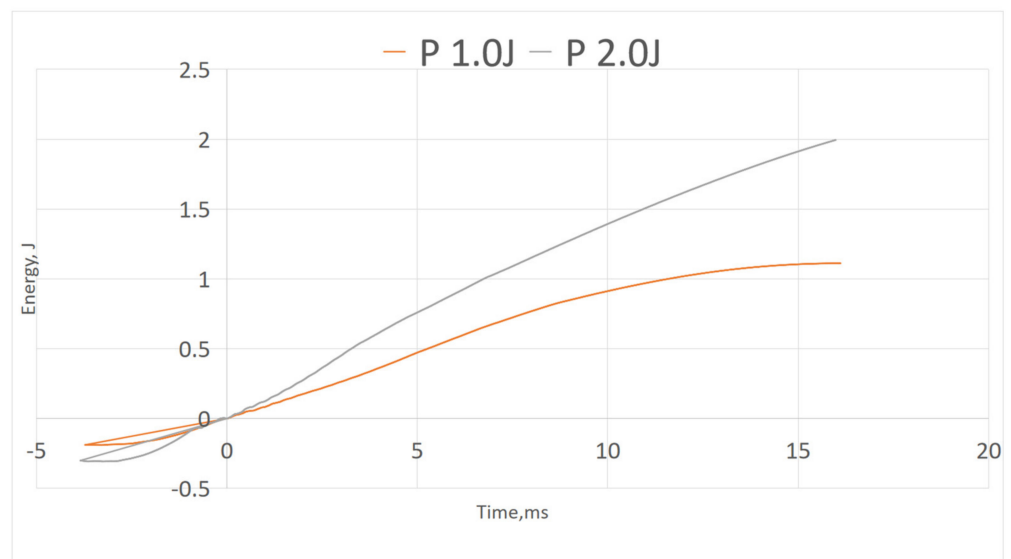
Figure 12. Energy-time of P.

Figures 12–14 show energy–time history of three composites under different impact energy, obtained by software. Figure 12 shows P did not display curve peak, indicating the composite did not experience rebound upon impact as shown in force–displacement curve where there was no close loop presented. Whereas in both Figures 13 and 14, GPG and GGGG composites displayed the maximum energy peak before dropping into constant energy; the maximum peak presenting the impact energy while the constant energy represents the energy dissipated by the samples [25]. GPG displayed longer time to reach peak compared to GGGG which is on average 9.4 ms and 8.6 ms, respectively. This shows that the GPG layering had slowed down the time taken for damage initiation and propagation through the whole sample [32].

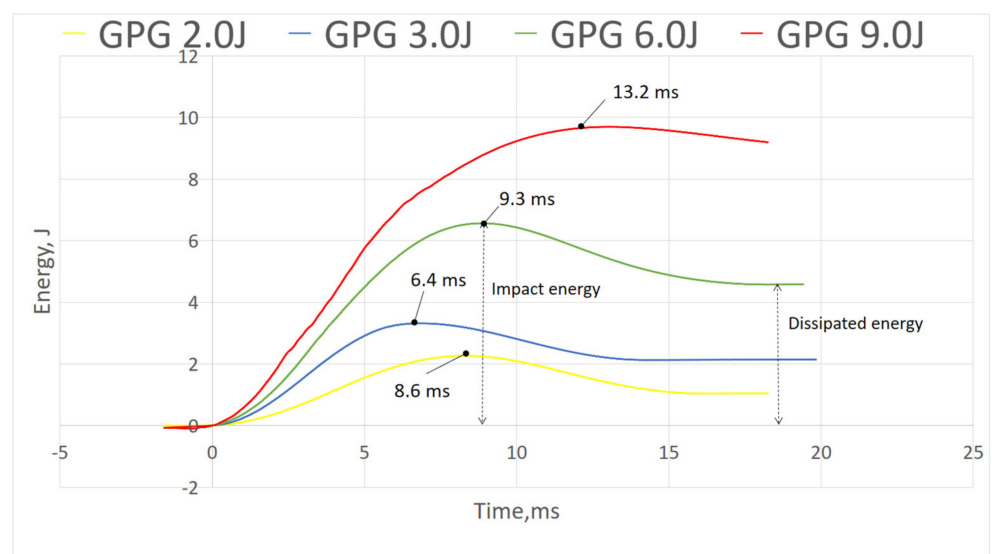
Figure 13. Energy-time of GPG.

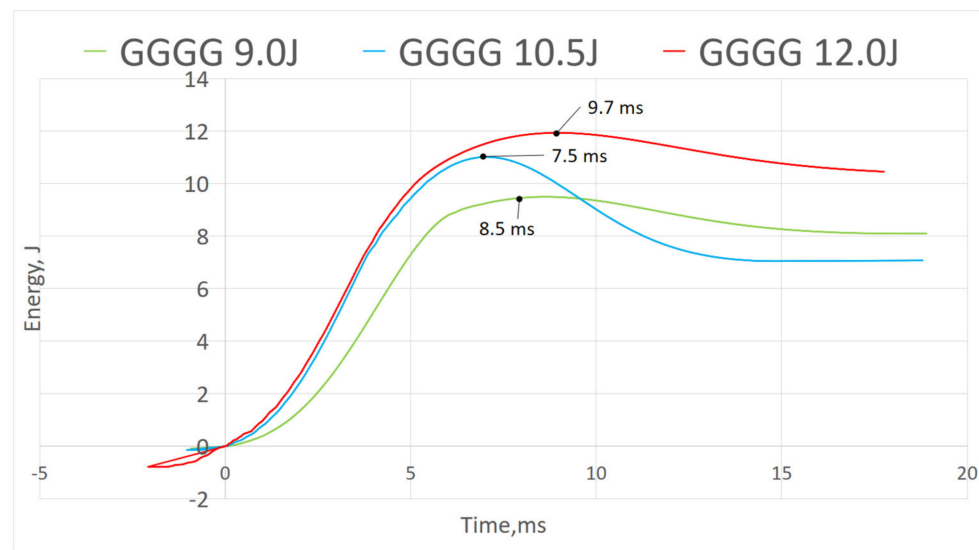
Figure 14. Energy-time of GGGG.

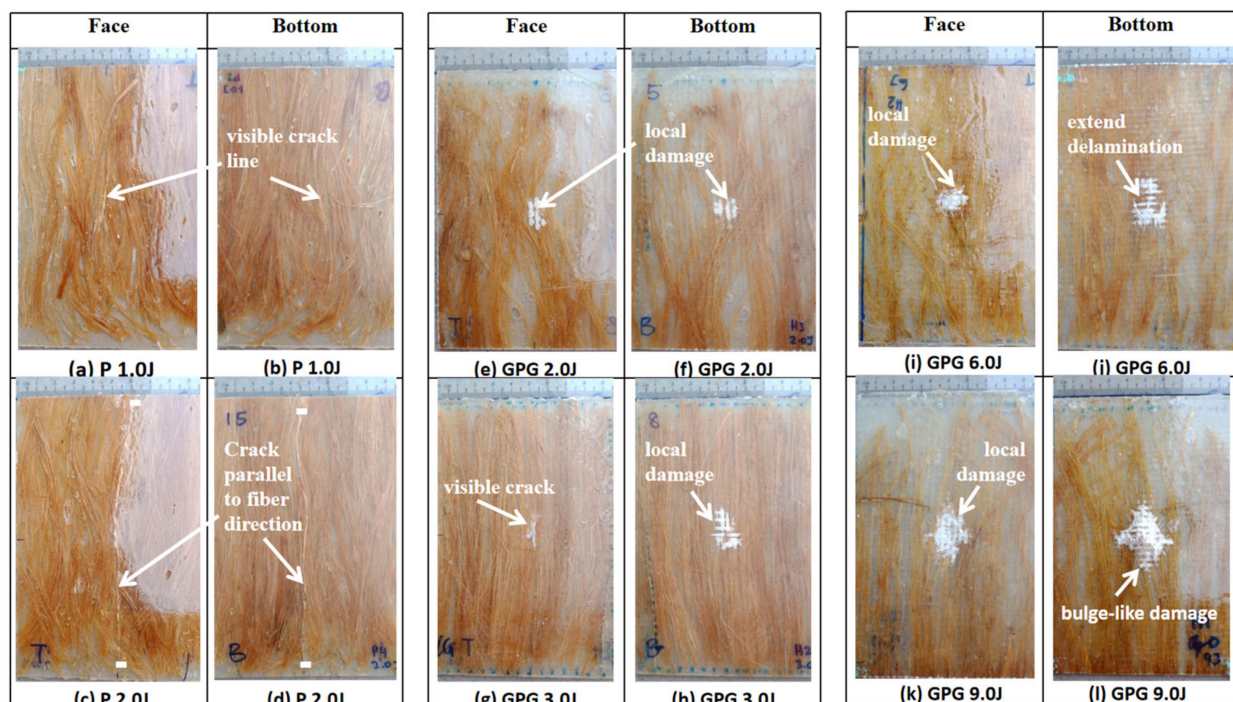
Figure 15. Visual damage of impacted P and GPG.

Figure 15 shows the front and back impact surface images after the impact test of the specimens. The P composite has been tested with two different measures of impact energy, 1.0 J and 2.0 J, where at 2.0 J impact energy is a prior perforation impact energy. Figure 15a–d observes that at both measures of impact energy, 1.0 J and 2.0 J, the composite was associated with a particular damage mechanism that does not give rise to the classical perforation but to a typical “transverse” failure with fracture surface parallel to the fiber direction. At 1.0 J impact energy, the crack was measured at 1.0 cm while at 2.0 J impact energy it was measured at 1.3 cm. Note the study conducted by Militello et al. (2020) which stated that the fracture mode was due to matrix crack and fiber breakage [33]. Based on the damage in Figure 15a–d show that the fiber unidirectional alignment cannot help much in resisting the load effectively through the matrix.

The impact test was carried out on the hybrid composite, GPG comprising two pieces of glass-woven mat sandwiched between 5% wt PALF placed in a unidirectional position. The impact energy subjected on the GPG composite began from 2.0 J, as it is the highest impact energy where the P composite can resist prior to perforation. The impact energy subjected on the GPG composite was set at 2.0 J, 3.0 J, 6.0 J, and 9.0 J. Unlike the P composite, the GPG composite displayed damage concentrated around the point of impact, as shown in Figure 15e–l. This is because the presence of fiber glass-woven mat can help localize the impact damage, preventing it from extensively spreading throughout the composite. A similar trend has been seen on a sandwich composite, whose top and bottom surfaces used woven glass fiber mat. Through visual inspection, it can be observed that the fibre pull-out localized at the impact contact area [34].

The results show the damaged area is increased when the composite is treated to higher impact energy. It was also observed that the size of the damage is similar at both the top and bottom surfaces when subjected to 2 J and 3 J impact energy. However, when subjected to impact energy of 6.0 J and 9.0 J, the size of the damaged portion at the bottom surface of the composite is doubled compared to the impacted surface at the front. This suggests that at a higher impact energy, the lowest part of the composite experienced greater tension thus creating a wider crack, compared to the upper surface which experienced compression upon impact. When subjected to 9.0 J impact energy, the bottom surface of the composite displayed greater damage due to further delamination of the glass-woven fiber mat and matrix crack as shown in Figure 16a. From the side view in Figure 16a, bulging damage can be observed after the composite is subjected to 9 J impact energy. This further supports earlier discussions pertaining to various modes of damage, including matrix crack, delamination, and fiber breakage. Beyond 9 J impact energy, the composite displayed perforation. Table 3 summarizes the typical damage mode associated with low-velocity impact for natural fiber and its hybrid composite.

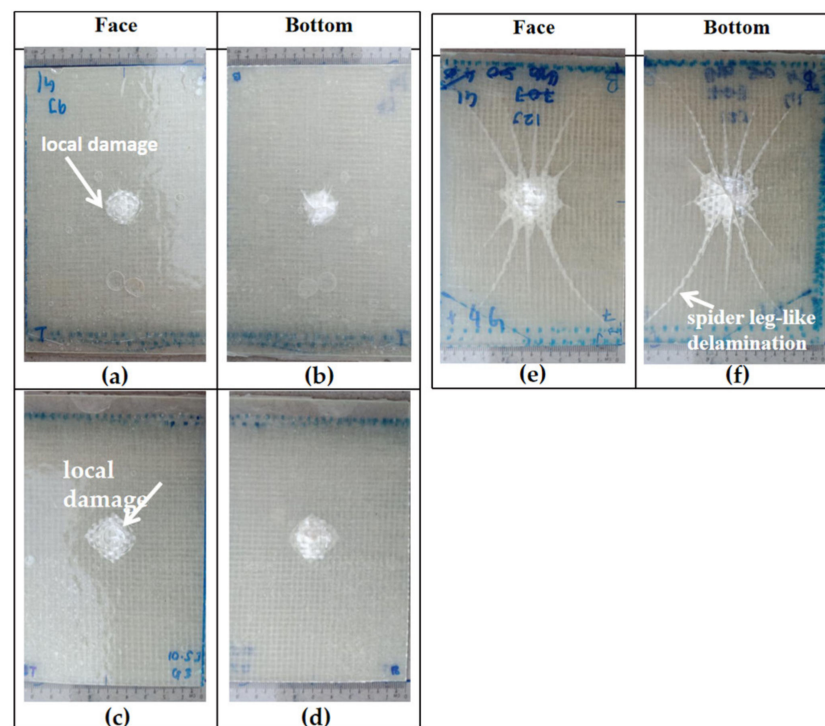
**Figure 17.** Visual damage of impacted GGGG: (a) GGGG 9.0 J, (b) GGGG 9.0 J, (c) GGGG 10.5 J, (d) GGGG 10.5 J, (e) GGGG 12.0 J and (f) GGGG 12.0 J.

The impact test was carried out on a composite made up of four layers of glass-woven mat, GGGG. As in all other composites tested in this experiment, the thickness of the GGGG was also fixed at 3 mm, in keeping with the desired application. The GGGG was subjected to impact energy of 9.0 J, 10.5 J, and 12 J. Beyond 12 J impact energy, the GGGG experienced perforation. A similar mode of damages were observed at the front and bottom of the composite upon being subjected to various impact energy up to 12 J. Damages in the form of bulge can be observed at the bottom surface of the GGGG. However, the degree of damage was relatively less severe compared to GPG. Localized circular damage can be observed on the top and bottom surfaces when the composite samples were subjected to 9 J and 10.5 J impact energy, as shown in Figure 17.

However, damages appearing like “spider legs” can be observed on both sides of the sample surface when subjected to 12 J impact energy. This shows that the composite experienced extensive delamination across the composite plate. Figure 16b shows a close-up view at the bottom surface showing that the glass-woven mat did not experience visible fiber breakage but the epoxy was severely damaged at the centre, with the appearance of broken pieces that were detached from the main structure.
