# The Behavior of Glass Fiber Composites under Low Velocity Impacts

**Abstract:** This paper presents experimental results on the behavior of a class of glass fiber composites under low velocity impacts, in order to analyze their usage in designing low velocity impact-resistant components in car and marine industries. Also, a finite element model at the meso level (considering yarn as a compact, homogenous and isotropic material) was run with the help of Ansys Explicit Dynamics in order to point out the stages of the failure and the equivalent stress distribution on the main yarns in different layers of the composite. The composites were manufactured at laboratory scale via the laying-up and pressing method, using a quadriaxial glass fiber fabric ( $0^\circ / +45^\circ / 90^\circ / -45^\circ$ ) supplied by Castro Composites (Pontevedra, Spain) and an epoxy resin. The resin was a two-component resin (Biresin<sup>®</sup> CR82 and hardener CH80-2) supplied by Sika Group (Bludenz, Austria). The mass ratio for the fabric and panel was kept in the range of 0.70–0.77. The variables for this research were as follows: the number of layers of glass fiber fabric, the impact velocity (2–4 m/s

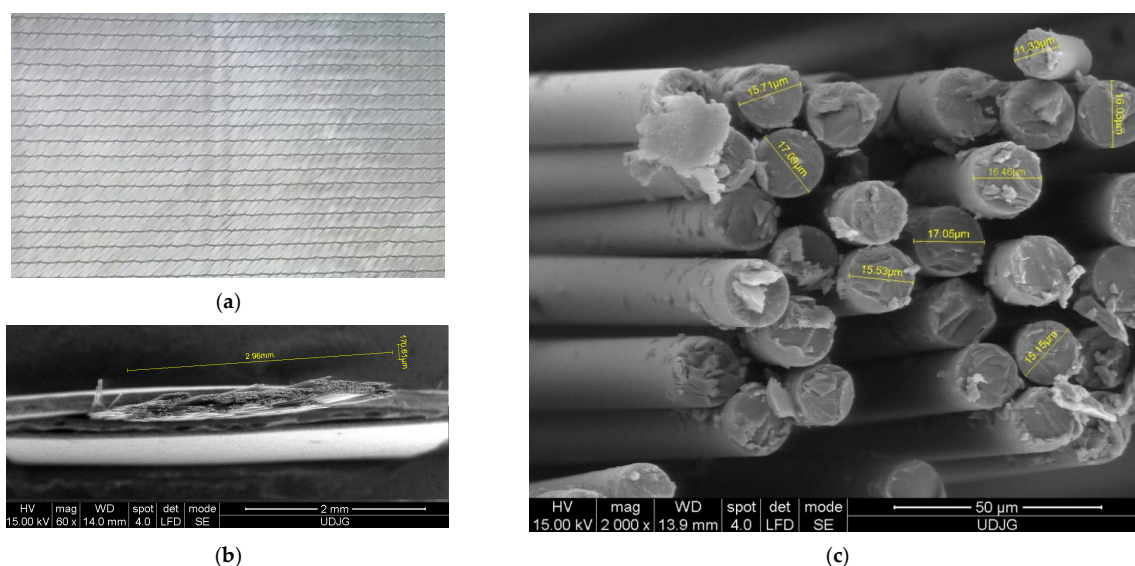
**Figure 1.** Aspects of the glass fiber fabric: (a) front view of the quadriaxial fabric, (b) dimensions of the yarn, (c) measurements of the glass fibre diameters (fibres in the same yarn, cut with scissors).

Based on research reported in [7,13–18], the authors selected a glass fiber fabric or a prepreg with four sublayers, with yarn orientation  $0^\circ / +45^\circ / 90^\circ / -45^\circ$ . This fabric has the trade name “1200 g/m<sup>2</sup> Quatriaxial Glass Cloth ( $0^\circ / +45^\circ / 90^\circ / -45^\circ$ ) 127” and is made of E-glass fibers. The product was purchased from Castro Composites (Pontevedra, Spain) [19]. Figure 1 presents aspects of the fabric: a) macro aspects of the fabrics, b) detail with the dimensions of the yarn and c) a micro-view of fibers in a yarn, with cross-section diameter measurements. Table 1 presents the average composition of glass fibers for the cross-section and for the fiber jacket, and it may be noticed that Boron (B), Carbon (C), Aluminum (Al), Silicon (Si) and Calcium (Ca) predominate, with traces of Iron (Fe), Zinc (Zn) and Titanium (Ti), a composition that could be positioned between E-glass and S-glass, its particularity being assigned to the extraction area of the raw material.

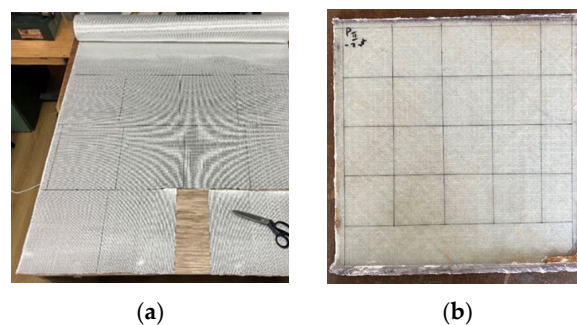
**Figure 2.** Images during the laboratory-scale production of the samples: (a) cutting the sheets of 300 mm × 300 mm, (b) a panel marked for cutting 60 mm × 60 mm samples.

The operations for producing the panels are as follows: cutting sheets of fabrics of 300 mm × 300 mm, weighing each package of sheets (2 sheets, 4 sheets and 6 sheets in a panel), waxing the active zone of the press for easier removal of the obtained panel, mixing the resin components in the recommended ratio, laying-up each sheet with the resin, pressing and maintaining this for at least 8 h, extracting the sheets from the press mold, verifying and polishing the edges, natural ageing for 7 days, a heat treatment for structure stabilization (6 h at 60 °C in an oven with controlled temperature), quality control and measurements (thickness in four points, mass of the panel and calculation of the mass ratio between the fabrics and the obtained panel), and tailoring and cutting with high-speed disks in the dry regime of samples of 60 mm × 60 mm from each larger panel (Figure 2) and their codification. For an easier extraction of the panel from the press, a wax type CIREX CP 10 was used (the supplier being RomPolimer Composites, Romania). The production time is not significantly influenced by the number of fabric layers in the composites.

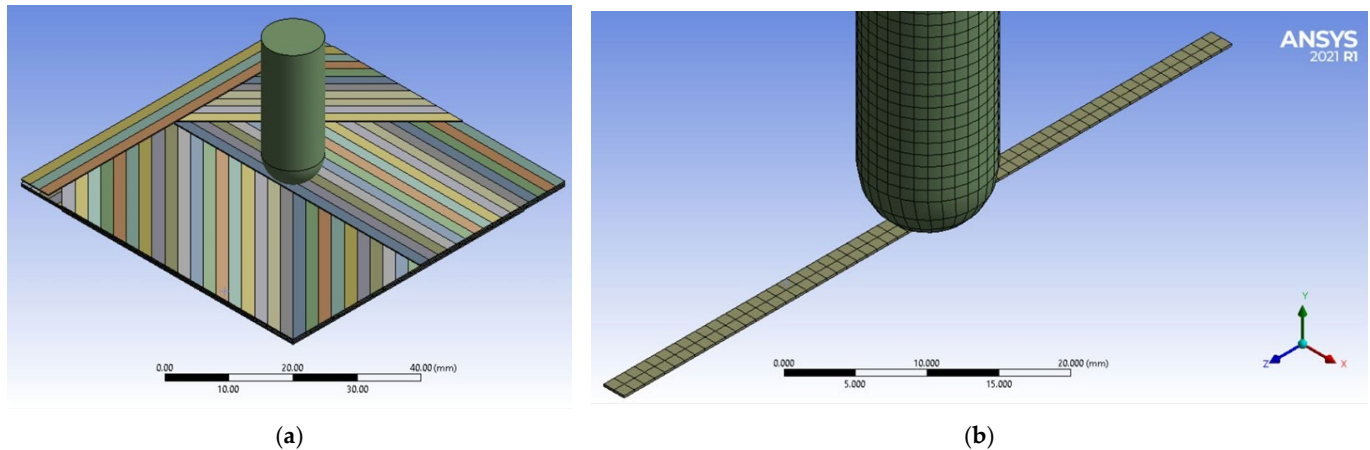
**Figure 5.** Details of the model: (a) yarn architecture (orientation of several yarns on each sublayer); (b) mesh network of the impactor and a yarn.

The simulation is performed for a panel having the same dimensions as the actually tested samples,  $60\text{ mm} \times 60\text{ mm}$ , with two layers of quadriaxial layers (meaning 8 sublayers of single yarn arrangement). The geometry of the model is given in Figure 5.

The glass fibers are known as having an anisotropic feature, but in this model, the yarn is considered a monobloc body, with isotropic and homogenous character. Actually, due to the architecture of the yarns, for the four sublayers in the fabric, at orientations of  $0^\circ$ ,  $+45^\circ$ ,  $90^\circ$  and  $-45^\circ$ , there exists a quasi-isotropic character of the panel, generated by the yarns' different orientations.

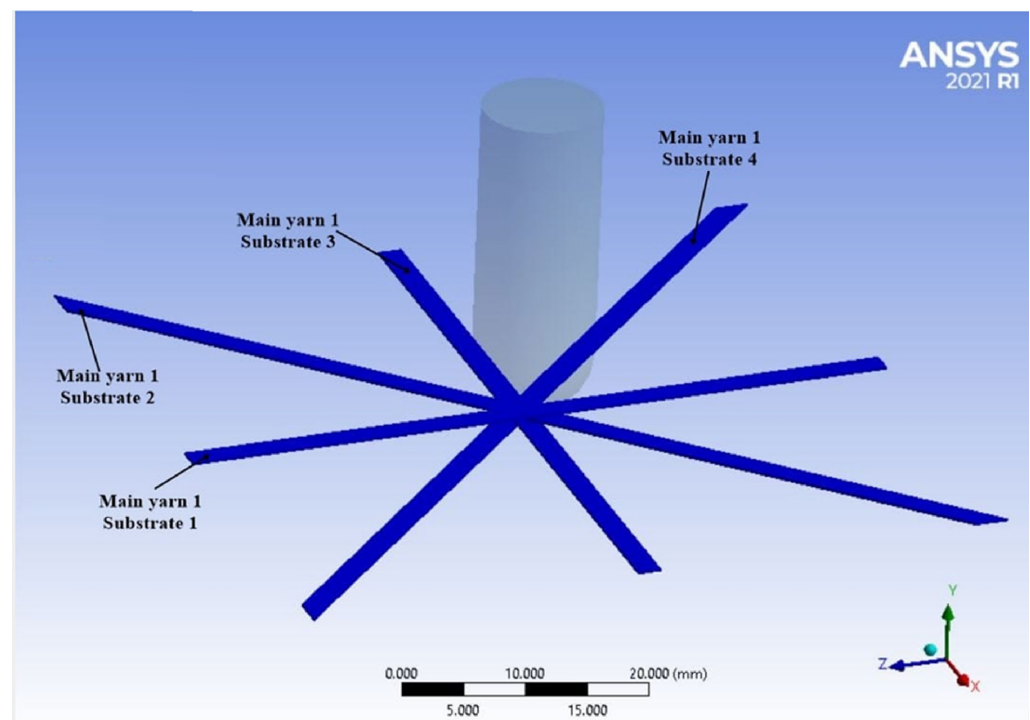
**Figure 6.** The codification of the yarns for a sequence of 4 sublayers (yarns are in their initial position, without being stressed).

The codes of the analyzed main yarns are preserved throughout this analysis, as in Figure 6. Main yarn is the first one near the plane of symmetry of the model (through the impactor axis and parallel to one panel side) and it will bear the direct contact of the impactor. In the following figures, the number of the substrate on which the yarn is located is added.

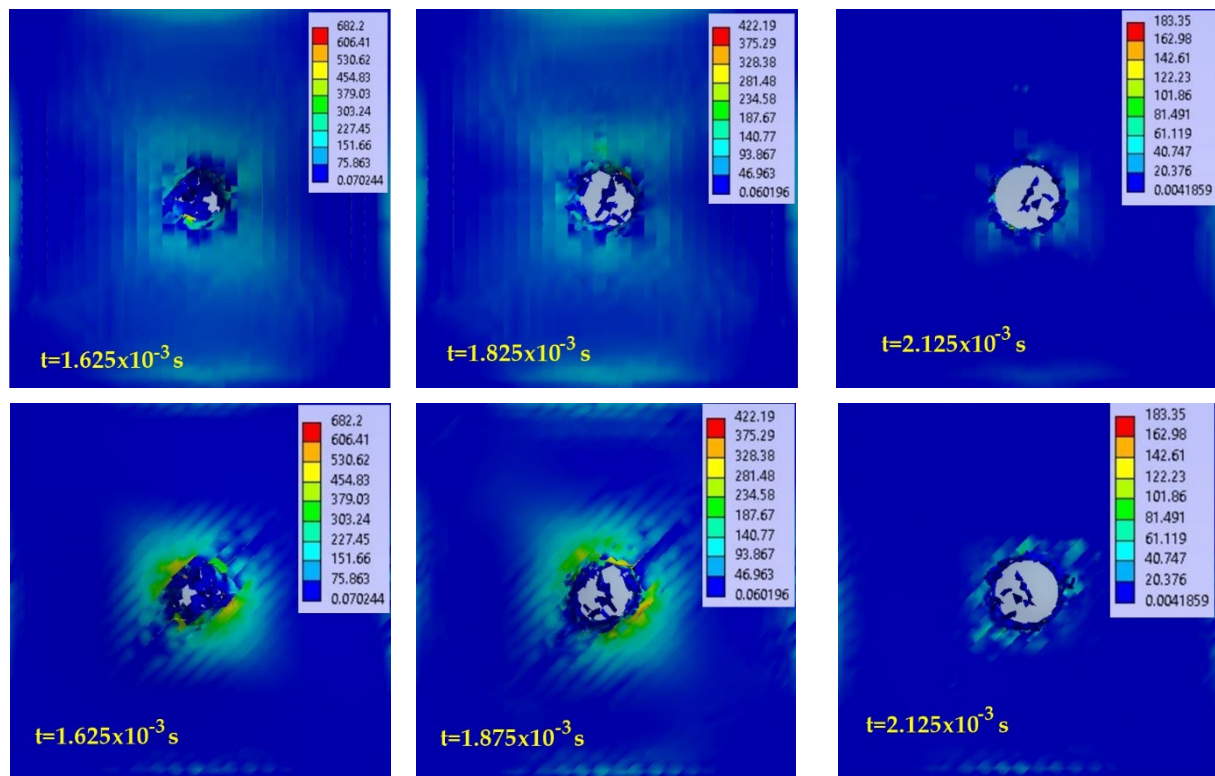
**Figure 7.** Virtual images from simulation with equivalent stress distribution (in MPa), at different moments, for the panel made of 2 layers of quadriaxial fabric (meaning 8 sublayers) hit by the impactor with  $\Phi 10$  mm at the impact velocity of  $v_3 = 4$  m/s (up—panel face, down—panel back).

Figure 7 presents virtual images from the simulation for different time moments, including the equivalent stress distributions for the 2-layer panel, impacted with the  $\Phi 10$  mm impactor: up—the panel face, down—the panel back. Figure 8 presents the same panel but hit with the  $\Phi 20$  mm impactor. Each image has its own color scale for the equivalent stress, given in MPa.

For the total penetration characterizing the 2-layer panel impacted with a hemispherical impactor, the impact stages noticed during simulation are as follows:

- the stressing of sublayers without breaking yarns is a very short stage, lasting  $10^{-4}$  to  $10^{-3}$  s, longer than in a ballistic impact, which is of the order of  $10^{-5}$ – $10^{-6}$  s [20], but the equivalent stress values reach high values, close to the breaking limit, and the fiber strain approaches the failure criterion value, which is, here, the equivalent plastic deformation at break;
- the initiation of yarn breakage and delamination between substrates from the moment when the value set for the yarn failure criterion is reached (here equivalent plastic

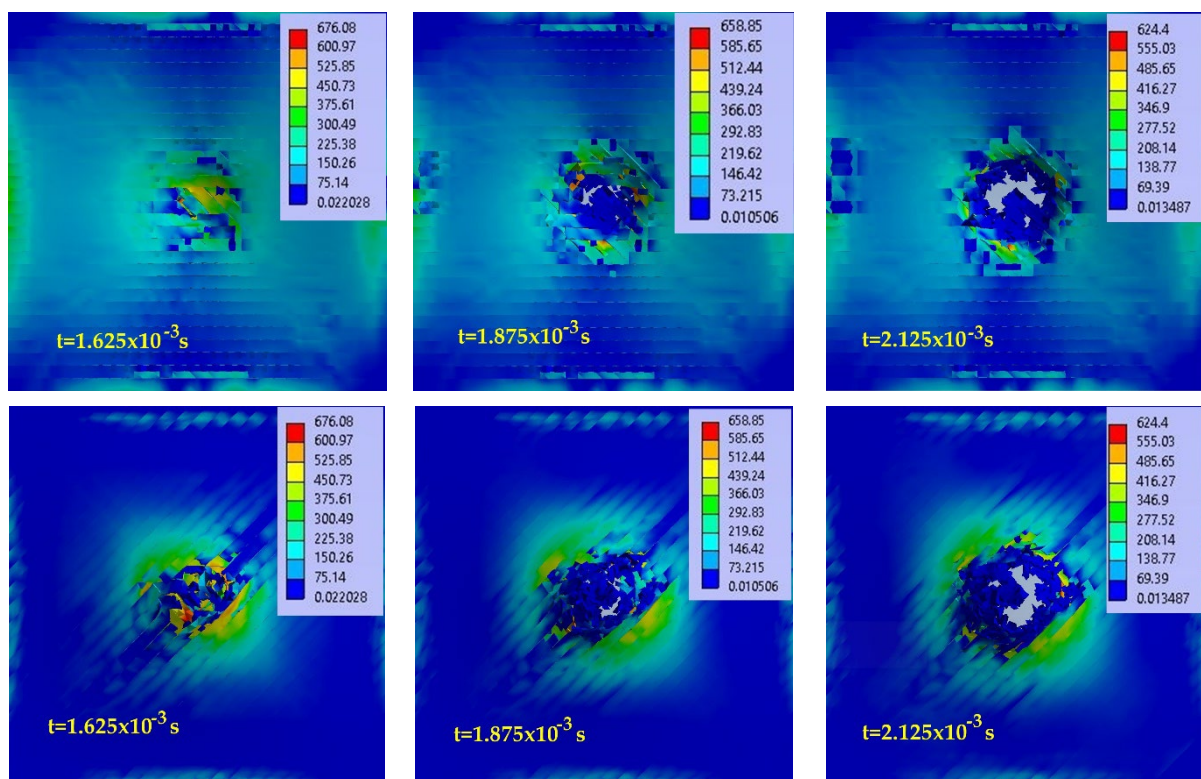
**Figure 8.** Images from simulation with equivalent stress distribution (in MPa), at different moments, for the panel with 2 layers (8 sublayers) with the impactor of  $\Phi 20$  mm at impact velocity  $v_3 = 4$  m/s (up—panel face, down—panel back).

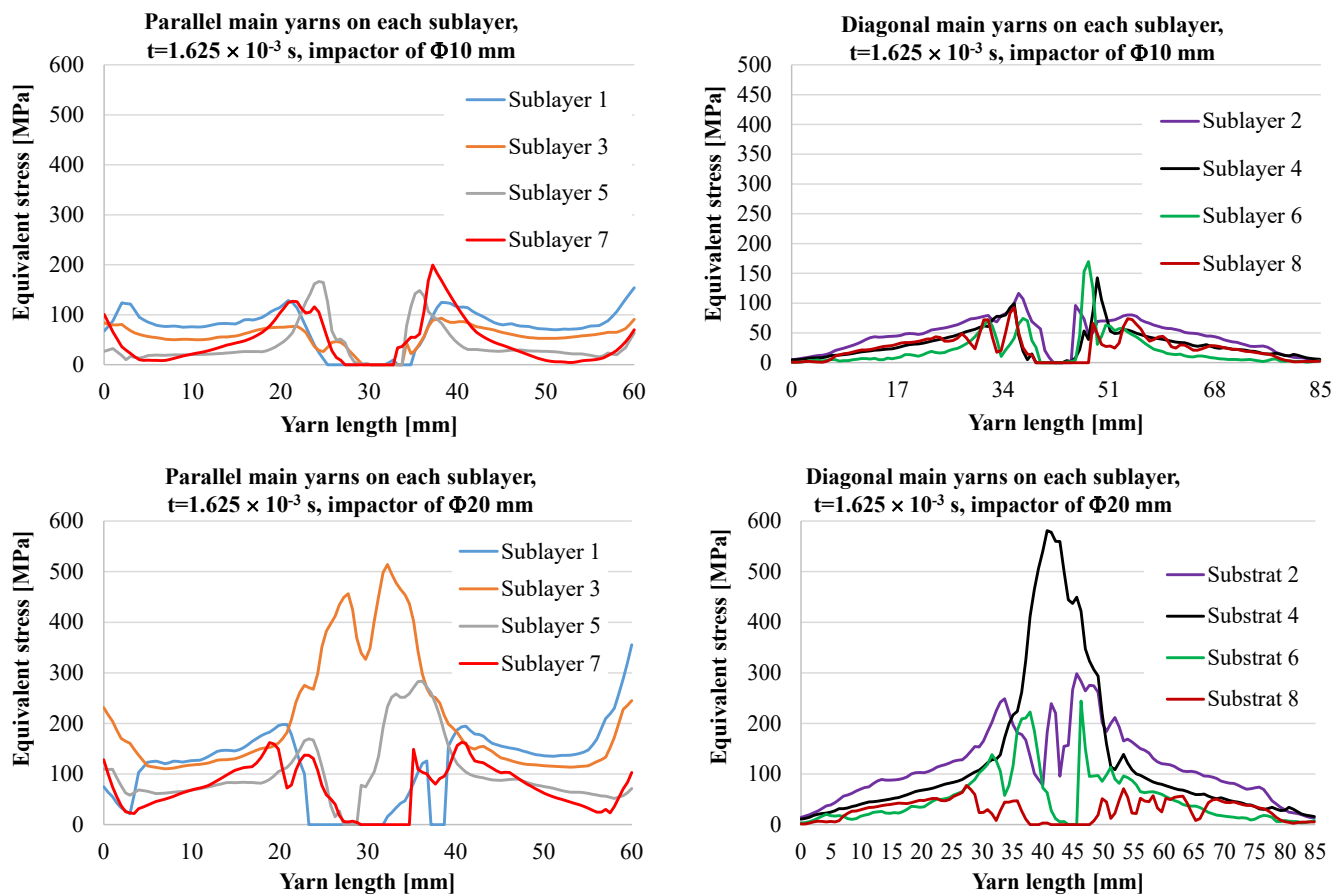
Figure 10. Equivalent stress distribution for moment  $t = 1.625 \times 10^{-3}$  s.

The same notations are preserved for Figure 10, which presents equivalent stress distributions at the moment  $t = 1.625 \times 10^{-3}$  s. For the impactor of 10 mm in diameter, all main yarns are broken and delamination is visible near the contact due to the bending of the yarns when the impactor pushes the panel and/or advances through the panel. The impactor of 20 mm in diameter does not break all of the yarns; those on sublayers 2, 3 and 4 are still intact but highly stressed. The yarns on the last layers are prone to be broken as they have no solid support on their back.

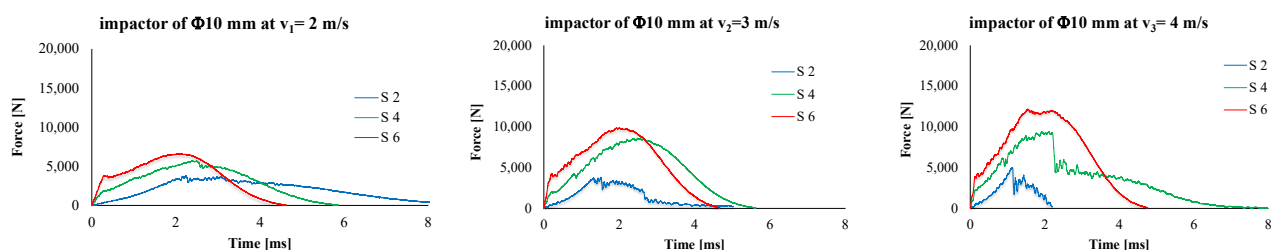
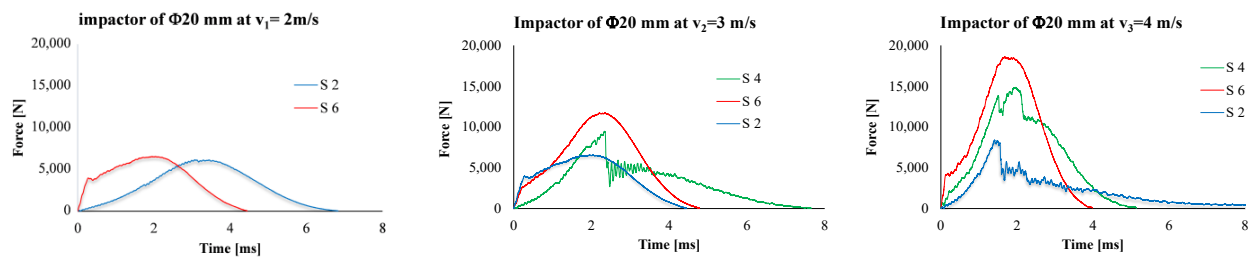
Figure 11. Cont.

**Figure 11.** Typical force–time curves for the test conditions (up—impactor of 10 mm in diameter, down—impactor of 20 mm in diameter; impact velocity increases from left to right).

Figure 11 presents typical force–time curves. Total penetrations are characterized by a saw-teeth aspect (see, in particular, the panels made of two layers of quadriaxial fabric, hit by the smaller diameter impactor). Partial penetrations are characterized by an asymmetrical bell shape. The maximum value of the force increases with the number of layers of the hit panels, and the same dependence on velocity is evident. For the same impactor, the maximum values for  $F_{\max}$  were obtained for the highest velocity (4 m/s): 12,000 N for the  $\Phi 10$  mm impactor and 18,000 N for the impactor of  $\Phi 20$  mm.

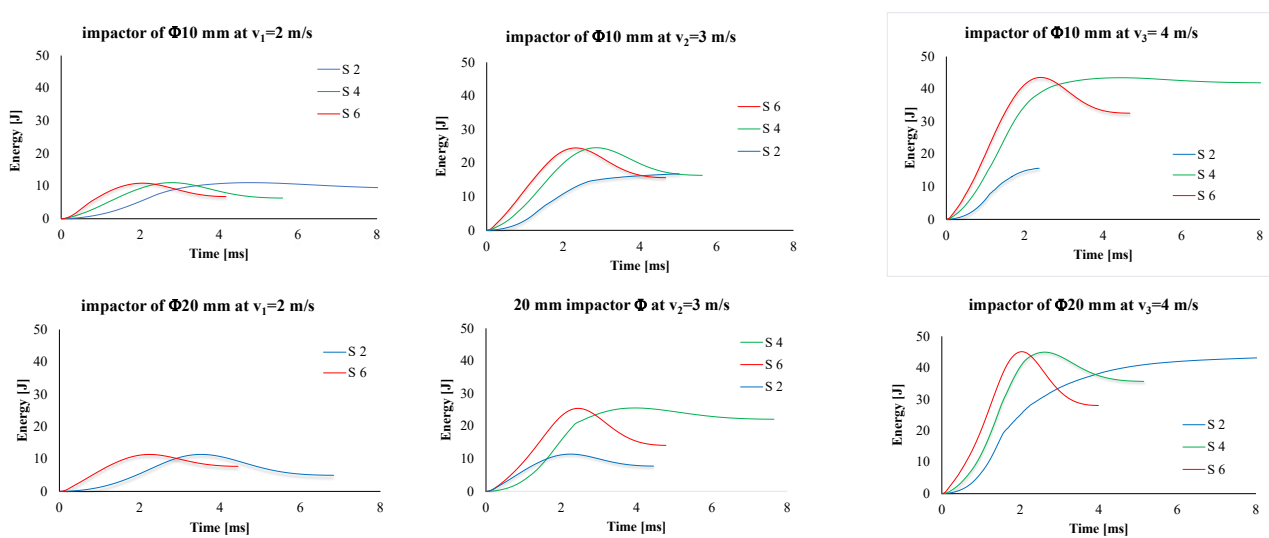
**Figure 12.** Influence of number of layers of quadriaxial fabrics and of impact velocity on the energy–time curve (up—impactor of  $\Phi 10$  mm, down—impactor of  $\Phi 20$  mm).

Typical absorbed energy–time curves are given in Figure 12. The slope of the energy is greater for thicker panels; thus, these are capable of absorbing the impact energy faster.

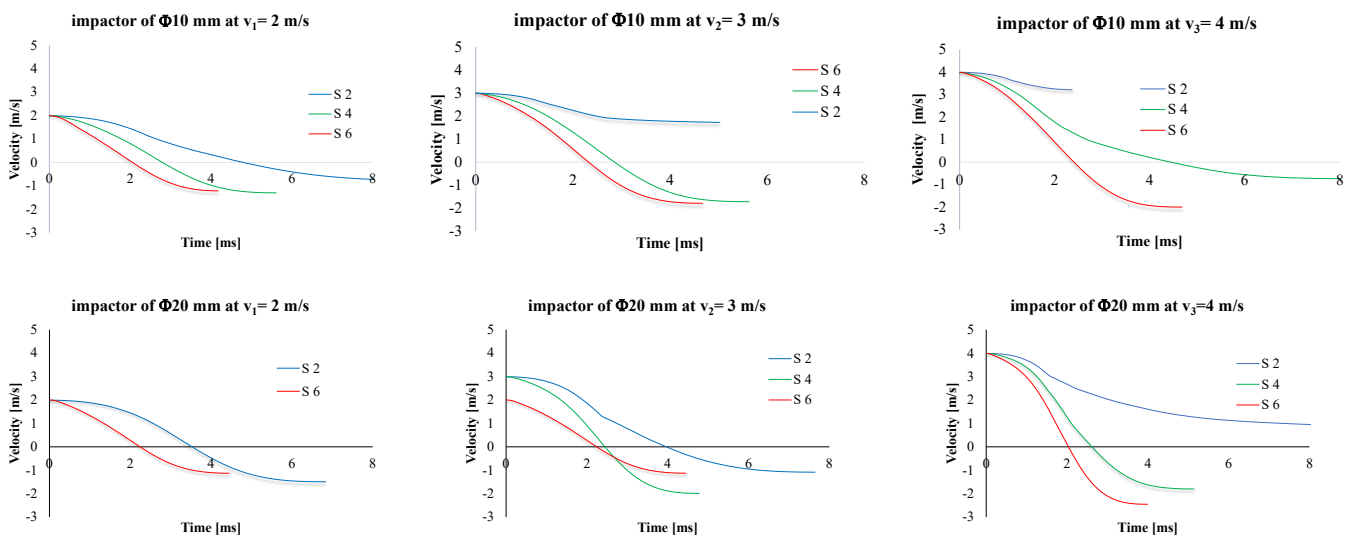
**Figure 13.** Influence of number of layers of quadriaxial fabric and impact velocity on the velocity–time curve (up—impactor of  $\Phi 10$  mm, down—impactor of  $\Phi 20$  mm).

Figure 13 presents the typical curves for the velocity of the impactor (up—for the impactor of  $\Phi 10$  mm, down—for the impactor of  $\Phi 20$  mm). The slopes of the plots are greater for thicker panels. A null value of the velocity means that the impactor is stopped and then it rebounds (the velocity becomes negative in the machine system of measurement). Total penetration is characterized by graphs that do not reach the null value during the impact, meaning the impactor is continuing its trajectory after the total penetration of the panel till the recovery (stopping) system of the machine is activated. The moment when the impactor velocity is null,  $t_{(v=0)}$ , indicates the moment when the entire kinetic energy of the impactor is transferred to the composite panel. The velocity decreases and reaches zero when the impactor is stopped; then, it is rebounded and the velocity is recorded as negative ( $v < 0$ , Figure 13). When the penetration is total (meaning all of the layers are damaged and the impactor continues its trajectory with a residual velocity), the velocity–time curve has no intersection with the time axis.

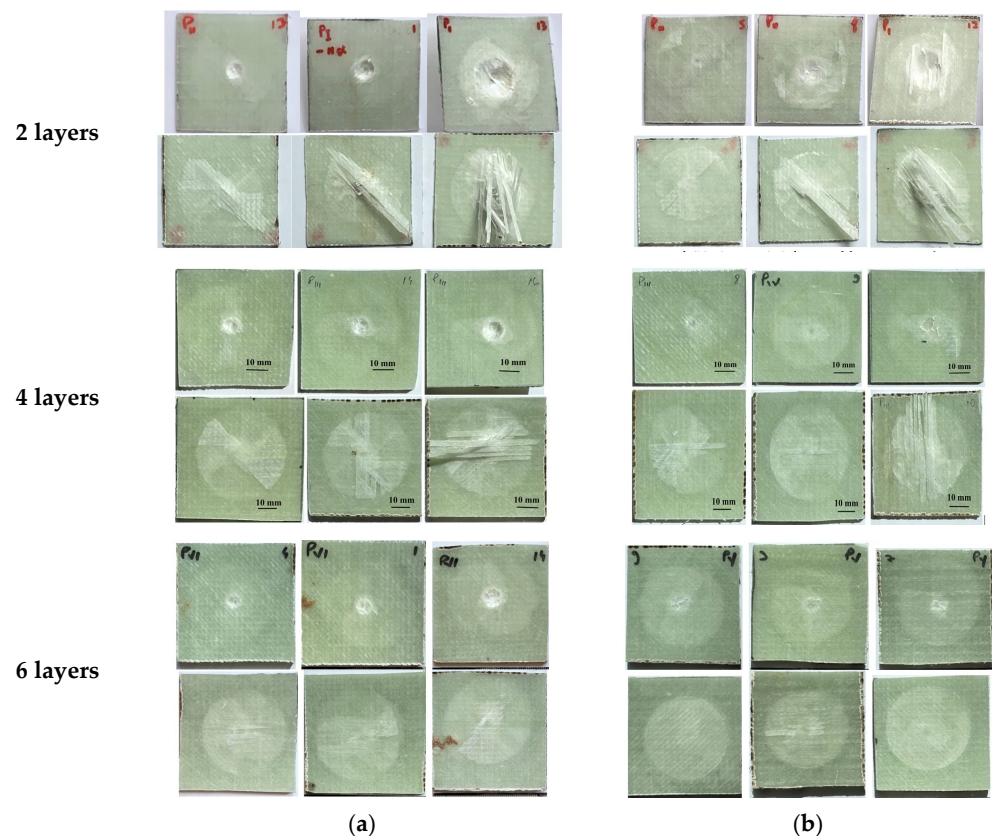
**Figure 16.** Macro views of composite panels after being tested—face (up) and back (down)—for impact velocities of  $v_1 = 2$  m/s,  $v_2 = 3$  m/s and  $v_3 = 4$  m/s (from left to right). (a) Impactor of  $\Phi 10$  mm, (b) impactor of  $\Phi 20$  mm.

Figure 16 presents in images, and very suggestively, the results of the test plan. It is obvious that panels with two layers of quadriaxial fabrics do not resist to impact caused by both impactors. For the panels made of four layers and six layers of quadriaxial fabric, the diameter of the imprint caused by the impactor of 10 mm is proportional to the impact velocity. But the impactor of 20 mm generates similar dimensions of the imprint and no dependence on impact velocity could be formulated. Considering the color change as the effect of delamination, this failure mechanism is less visible on the front of the two-layer

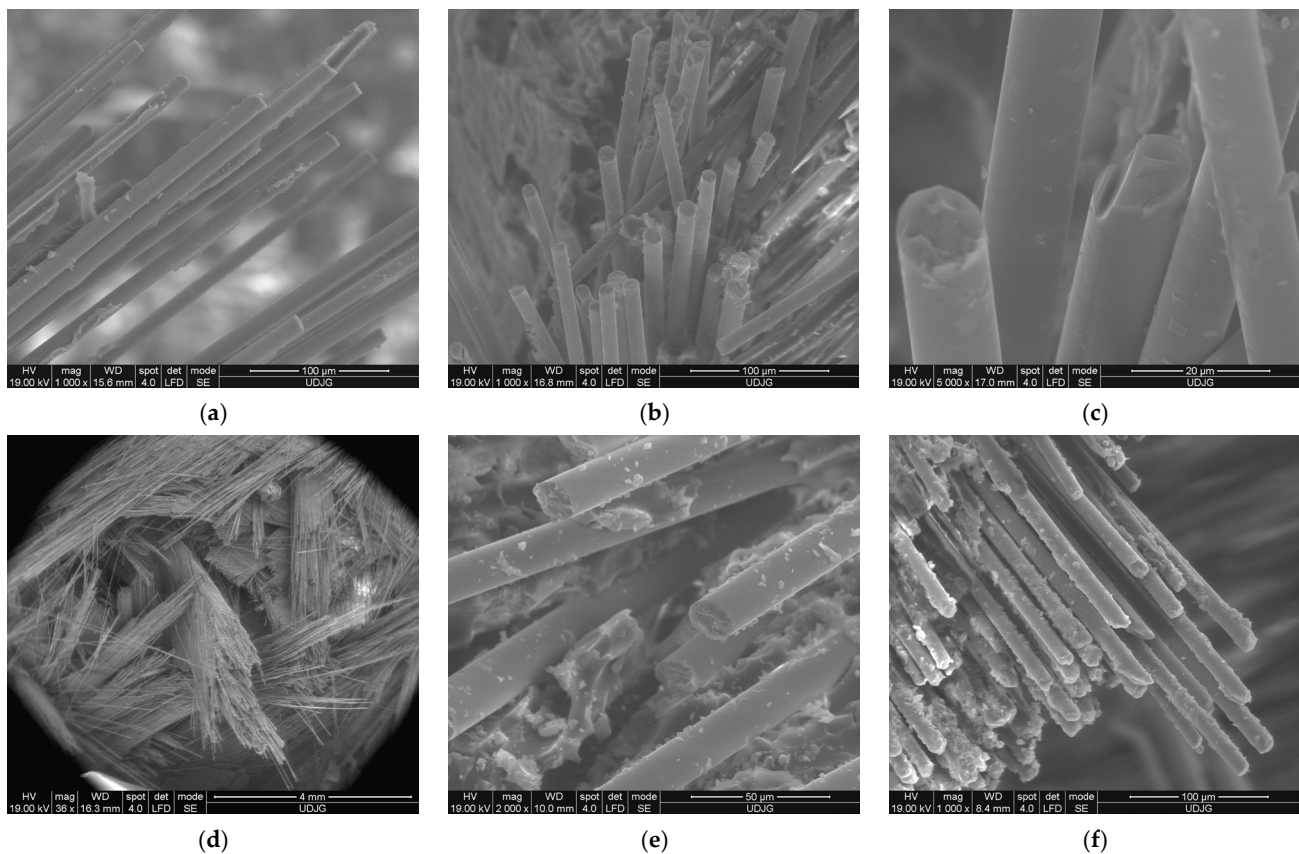
Figure 19 shows different failure mechanisms that can occur in these glass fiber composites noticed on the SEM images of the two-layer quadriaxial fabric panels subjected to an impact velocity of  $v_3 = 4$  m/s, with a  $\Phi 10$  mm impactor:

- fibres broken by shearing at different lengths: the matrix was already detached from the fibers as its mechanical characteristics are much lower; breakage occurred at different positions on the fibers (not like a straight cut resulting from a knife impact) by shear, which is more visible in image b); the fibers are stressed above the limit of the matrix, and thus, the matrix was already detached from the fibers, weakening the zone; the image is from the face of layer 1;

- an image of broken fibers near the edge of the imprint; two different orientations of fibers are visible, with sections of the shear breakage being almost perpendicular to the fiber length;

- detail with shear-cut fibers, one having a chippy edge;
- a low magnification ( $\times 30$ ) that points out the different orientations of the yarns in the quadriaxial architecture; the impactor has penetrated the entire panel and broken the yarns and fibers that subsequently are bent and forced by the impactor trajectory through the orifice;

- detail with shear-cut fibers, with small spots of the matrix still bonded to the fibers; below the “naked” fibers, the fragmented matrix is visible;
- the cut fibers in a yarn at different lengths suggest a statistical process of being broken; it is visible that the matrix was already detached on the end of cut fibers.

**Figure 19.** SEM images of the composite with 2 layers of quadriaxial fabric—panel face (**up**) and panel back (**down**)—after being hit with the impactor of  $\Phi 10$  mm at an impact velocity  $v_3 = 4$  m/s.

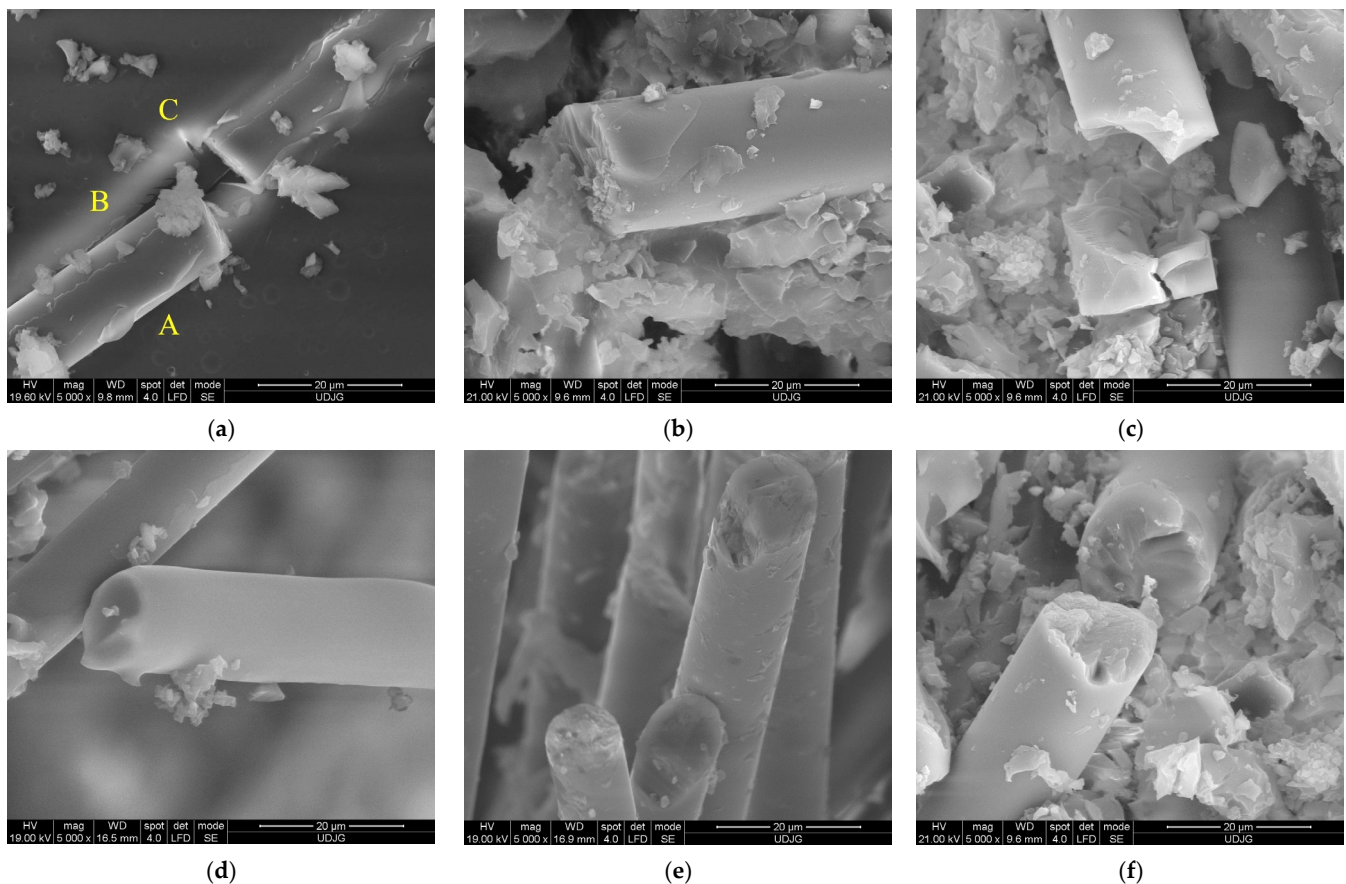
Figure 21 presents, at the same magnification ( $\times 5000$ ), the fiber breakage for different panels. Shear breakage seems to be similar for the fibers and does not give an indication of both test conditions and panel thickness. The failure mechanisms at the micro scale are as follows: (a) there is a broken fiber (A) still bonded in the matrix (B), but the fiber breakage also initiates cracks in the matrix (C); (b) there is a broken fiber with the cross-section almost perpendicular to the fiber length, meaning a dominant shear, as the fiber is still attached to the matrix on its end, but the matrix surrounding the fiber is cracked and fragmented, and on the fiber end, a superficial spalling is visible; (c) there is a fiber fragmented in more than one location, with the small fragment being cracked and the matrix being smashed and partially detached from this fiber: (d) and (e) there are fibers cut by shear, with cross-sections almost perpendicular to the fiber length, but one presents the trace of a detached chip; (f) there is a cut fiber, with one of the two fragments having changed its position, and the aspect of the breakage suggests a discontinuity in the fiber material (impurity or a high difference in composition).

**Figure 21.** SEM images of the broken glass fibers. (a) 6-layer panel, impactor of 20 mm,  $v_1 = 2$  m/s, (b) 6-layer panel, impactor of 10 mm,  $v_3 = 4$  m/s, (c) 6-layer panel, impactor of 10 mm,  $v_3 = 4$  m/s, (d) 2-layer panel, impactor of 20 mm,  $v_3 = 4$  m/s, (e) 2-layer panel, impactor of 10 mm,  $v_3 = 4$  m/s and (f) 6-layer panel, impactor of 10 mm,  $v_3 = 4$  m/s.
