Effect of Flame Treatment on Bonding Performance of GF/EP Pultrusion Sheets Used for VARI Process

Keywords: pultrusion process; glass fiber-reinforced epoxy composites; VARI; flame treatment; bonding property

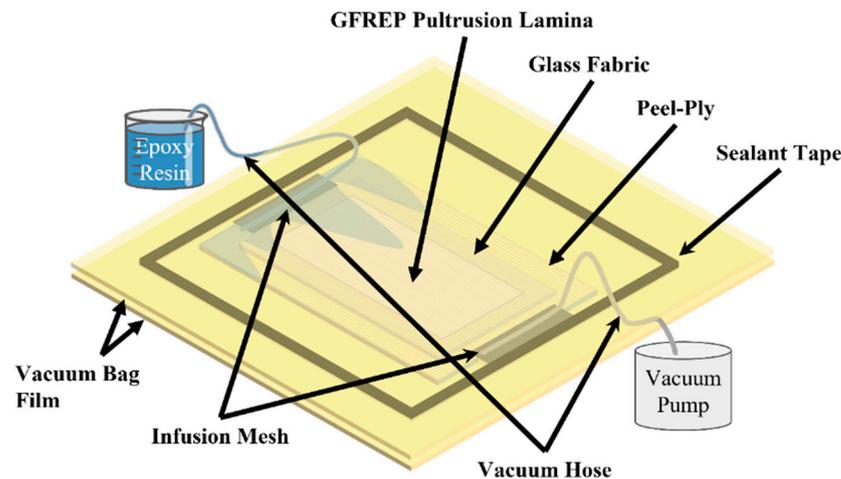
Figure 4. Vacuum-assisted resin infusion diagram.

surface, and introducing epoxy resin (SWANCOR 2511-1A/BS, Shangwei (Tianjin) Wind Power Materials Co., Ltd., Tianjin, China) through the VARI process (as shown in Figure 4), the ratio of the main agent to the curing agent is 100:30. After the vacuum introduction is completed, the entire VARI infusion plate is cured at room temperature for 6 h, which was then put into the oven to cure at 60 °C for 8 h.

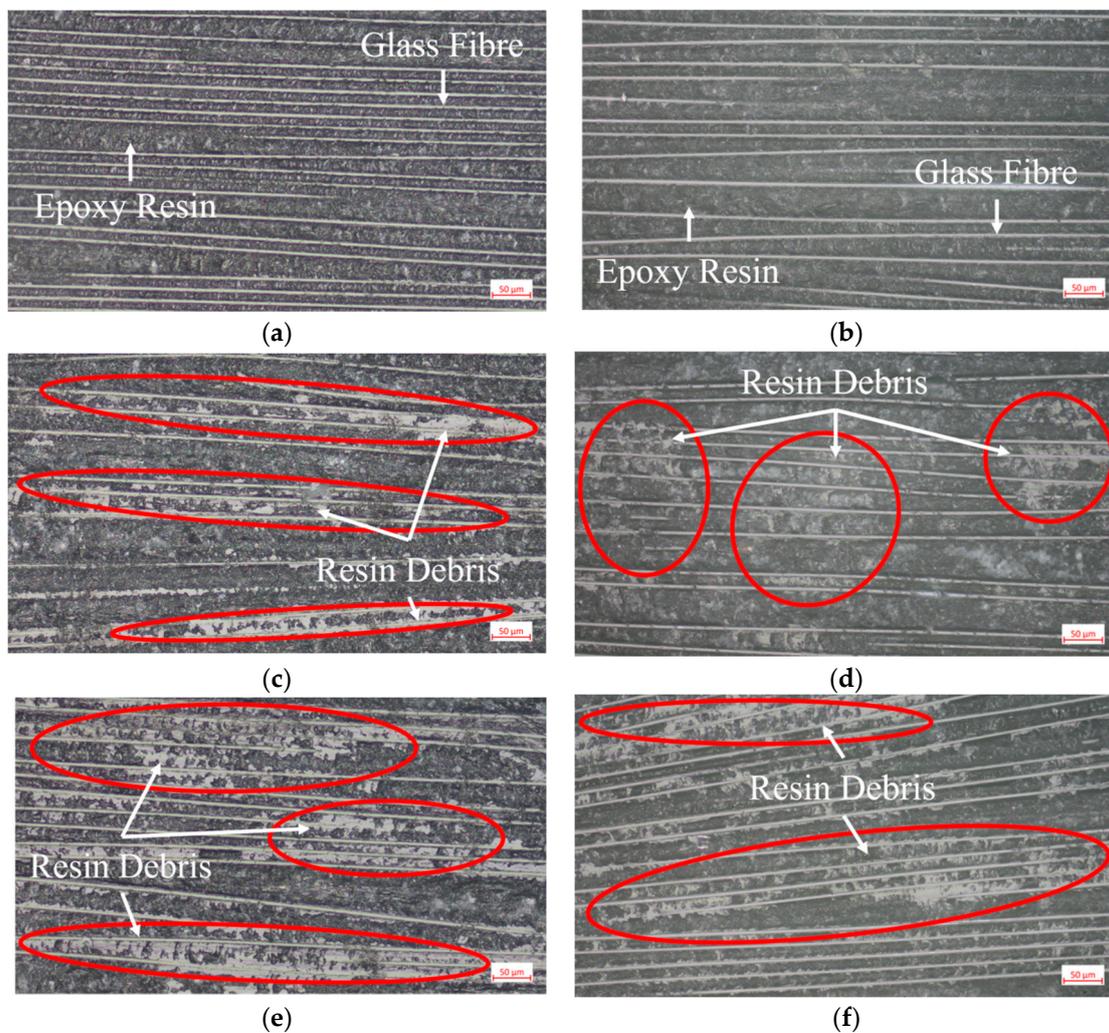
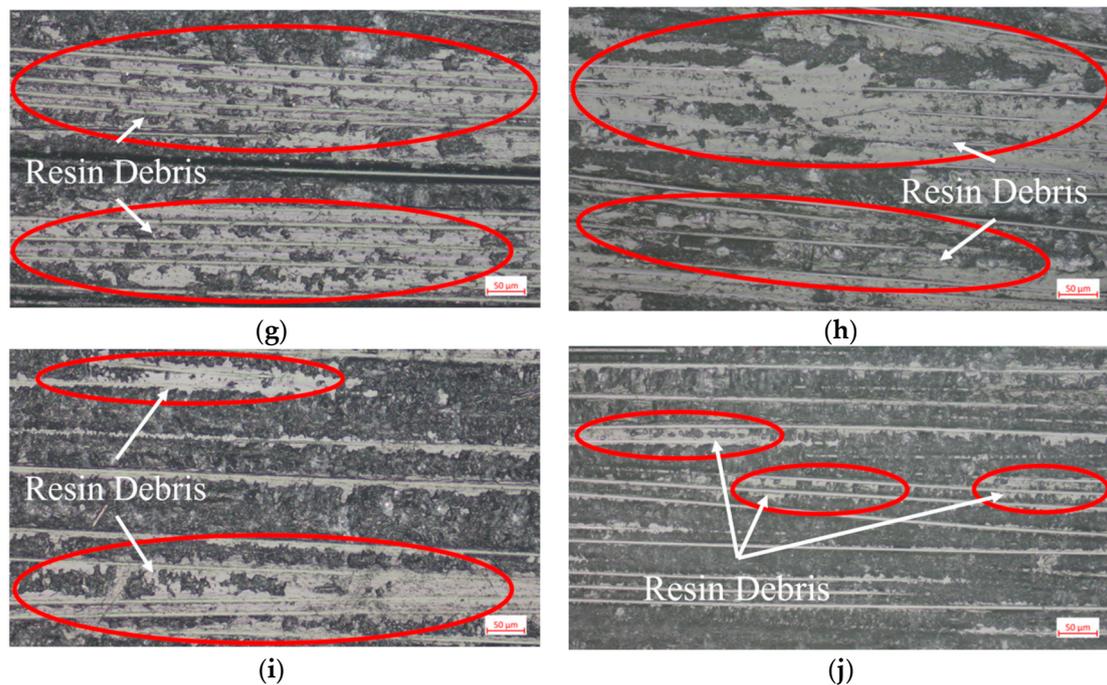
Figure 7. Micrographs of the failure surfaces of the tensile shear specimen with different times of flame treatment: (a) GF/EP infusion sheets that have not undergone flame treatment; (b) GF/EP pultruded sheet that has not undergone flame treatment; (c) GF/EP infusion sheet with one flame treatment; (d) GF/EP pultruded sheet after one flame treatment; (e) GF/EP infusion sheet after three flame treatments; (f) GF/EP pultruded sheet after three flame treatments; (g) GF/EP infusion sheet after five flame treatments; (h) GF/EP pultruded sheet after five flame treatments; (i) GF/EP infusion sheet after seven flame treatments; (j) GF/EP pultruded sheet after seven flame treatments.

An optical micrograph of the bonded surface after a gradient flame-treated bonded specimen fails to load is shown in Figure 7.

From Figure 7, it can be seen that the surface of the resin matrix between the glass fibers on the failure bonding surface of the sample without flame treatment is smooth (Figure 7a,b), and the failure form is pure interface failure. With the increase of the number of flame treatments, from 1–5 flame treatments (Figure 7c–h), more and more white resin chips attached to the bonding surface of the GF/EP pultruded plate and infusion plate due to the failure of resin between the fibers during the tensile loading process, the section is rougher, and the failure form changes from pure interface failure to mixed failure of interface failure and resin matrix failure. This phenomenon is significant with the increase of the number of flame treatment, which indicates to a certain extent that the bonding strength between the resin on the bonding surface also increases. After seven flame treatments, there are still some white fragments on the bonding surface of the GF/EP pultruded sheet and its bonded infusion plate (Figure 7i,j), and the failure form is still a mixed failure of interface failure and matrix failure, but compared with the bonding surface of seven flame-treated specimens (Figure 7g,h), the number of white fragments is significantly reduced, which indicates that the bonding strength of the two bonding surfaces after seven flame treatments may be less than the bonding strength of five flame treatments.

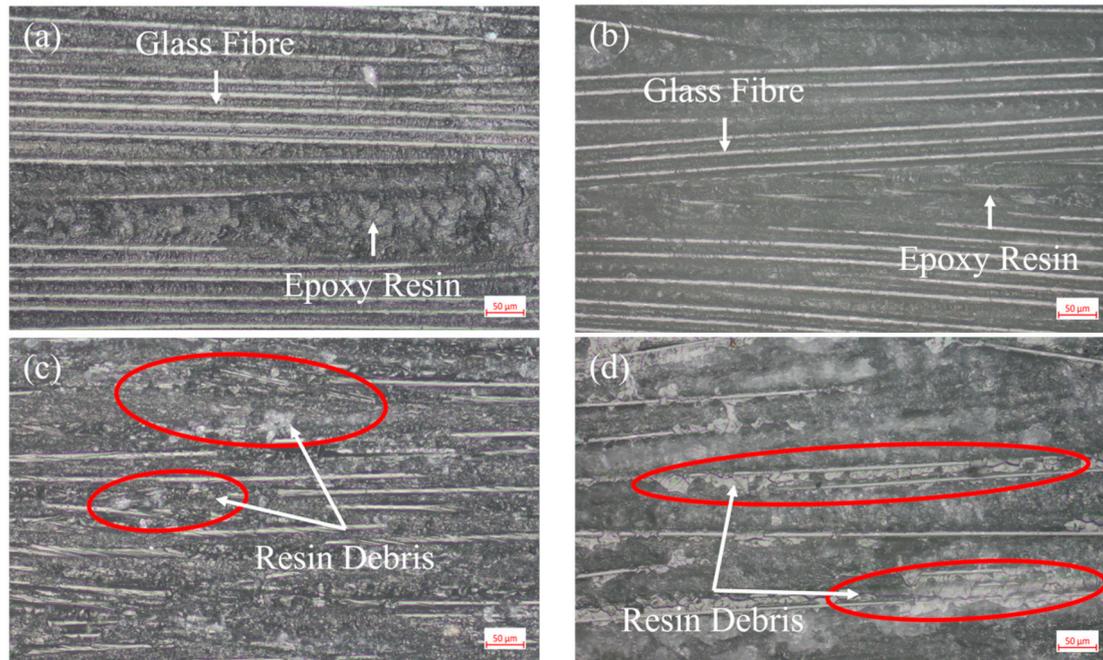
Figure 9. Photomicrograph of the failure surfaces of DCB sample: (a) GF/EP infusion sheets that have not undergone flame treatment; (b) GF/EP pultruded sheet that has not undergone flame treatment; (c) GF/EP infusion sheet after five flame treatments; (d) GF/EP pultruded sheet after five flame treatments.

In this part, the influence of the optimal flame treatment process on the failure of the bonding surface of the GF/EP pultruded sheet and infusion plate under the open working condition is explored by using the composites type I interlaminar fracture toughness G_{IC} obtained by DCB test. An optical microscopic picture of the specimen bonding surface after the DCB test is shown in Figure 9.

From Figure 9, it can be seen that the glass fiber, resin matrix, and interface of the bonding surface of the GF/EP pultrusion sheet without flame treatment are clearly visible, and the resin matrix between the glass fibers is smooth (Figure 9a,b); moreover, the section shows the failure characteristics of pure interface peeling under the DCB open loading condition. After five flame treatments, the GF/EP pultrusion plate bonding surface glass fiber and matrix interface is relatively blurred, the GF/EP plate glass fiber between the glass fiber has scaly resin fragments, the GF/EP bonding surface on the epoxy resin matrix uneven, and the bonding surface is rough (Figure 9c,d), and under DCB open load, the failure form between the two plates can be regarded as both interface failure and resin matrix failure. This difference in the failure morphology of the bonding surface caused by flame treatment can explain to a certain extent why the five flame treatments can improve the bonding between the GF/EP pultruded plate and infusion plate under the open working condition.

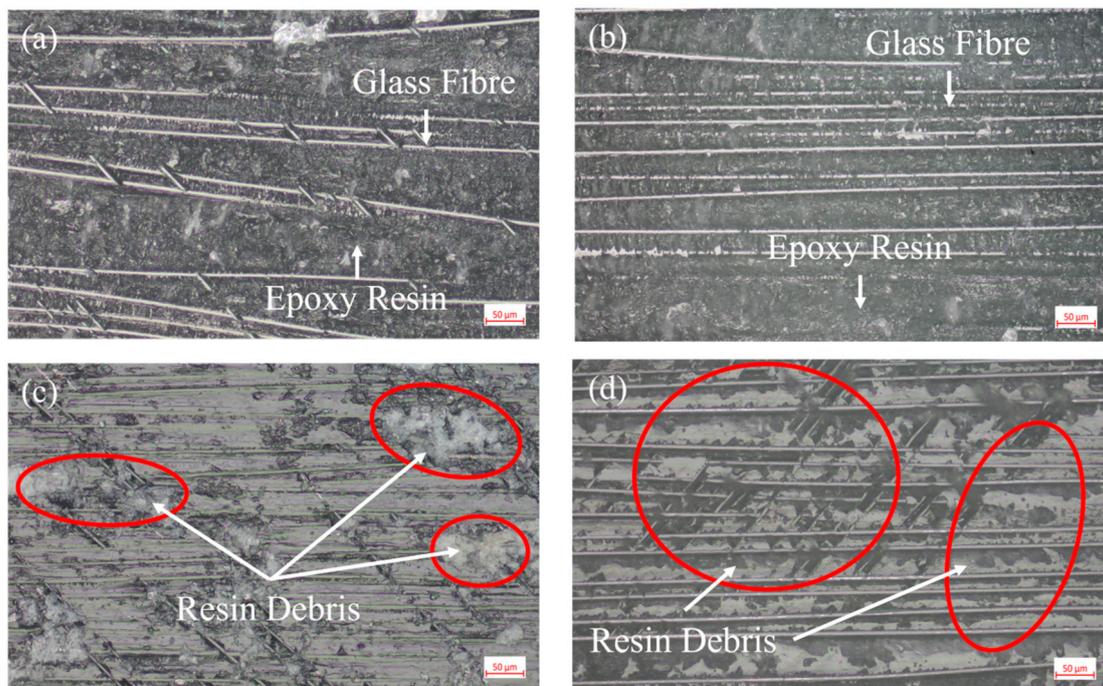
Figure 11. Photomicrographs of the failure surfaces of ENF sample: (a) GF/EP infusion sheets that have not undergone flame treatment; (b) GF/EP pultruded sheet that has not undergone flame treatment; (c) GF/EP infusion sheet after five flame treatments; (d) GF/EP pultruded sheet after five flame treatments.

Through the ENF test, the type II fracture toughness G_{IIC} of the composite was used to characterize the effect of the best flame treatment process on the bonding strength of the GF/EP pultruded sheet and infusion plate under slip condition. An optical micrograph of the specimen bonding surface after the ENF test is shown in Figure 11.

From the comparison of the micromorphology of ENF specimen after failure in Figure 11, it can be seen that compared with the bonding surface of the GF/EP pultruded plate without flame treatment (Figure 11a,b), the bonding surface of the GF/EP pultruded plate after five flame treatments is significantly rougher and the resin matrix fragments attached between the glass fibers are distributed in a large area of continuous blocks, while many resins are left on the bonding surface (Figure 11c,d) after loading and crushing. Similar to the open loading case in Figure 9, the failure of the adhesive layer under the slip condition also changed from pure interface shear failure to a mixed form of interface failure and resin matrix failure, which also indirectly indicates that the anti-slip failure ability of the interface between the GF/EP pultruded sheet and infusion plate was improved after five flame treatments.

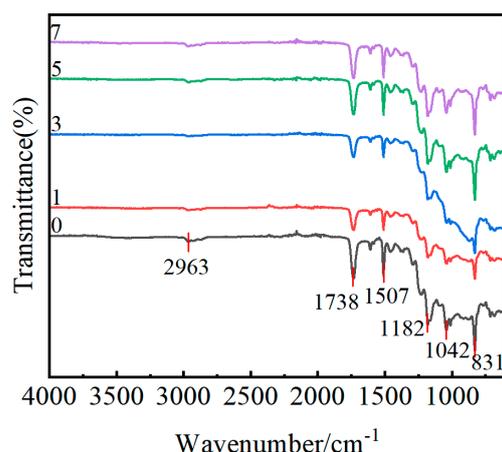
Figure 18. FTIR spectra of samples treated with a different number of flame treatments (0, 1, 3, 5 and 7).

In order to explore the effect of flame treatment on the chemical elements and groups on the surface of the GF/EP pultruded plate, FTIR tests were carried out on the surface of the release agent INT-1890M and the gradient flame-treated the GF/EP pultruded sheet, and the results are shown in Figures 17 and 18.

During the analysis, the spectrum can be divided into two parts: the functional groups region ($4000\text{--}1333\text{ cm}^{-1}$), which is used to identify the presence and absence of functional groups, and the complex fingerprint region ($1333\text{--}667\text{ cm}^{-1}$), in which the absorption is less conspicuous [62]. From the infrared spectrum of the release agent INT-1890M, the CH_2 telescopic vibration absorption peaks are 2922 cm^{-1} and 2853 cm^{-1} , the $\text{C}=\text{O}$ telescopic vibration absorption peak is 1736 cm^{-1} , the CH_2 bending vibration absorption peak is 1460 cm^{-1} , the $\text{C}-\text{O}$ telescopic vibration absorption peak is 1105 cm^{-1} , the $\text{C}-\text{OH}$ off-plane bending absorption peak is 949 cm^{-1} , and a CH_2 out-of-plane deformation absorption peak at 722 cm^{-1} can be clearly seen. This is consistent with the composition of INT-1890M organic fatty acids, esters, and humectants. The resin matrix used in the GF/EP pultrusion sheet is acid anhydride-cured DGEBA, and the vibration absorption peak of methylene ($\text{C}-\text{H}$) can be seen at 2962 cm^{-1} , the ester carbonyl ($\text{C}=\text{O}$) telescopic vibration absorption peak at 1737 cm^{-1} , the vibration absorption peak of benzene ring skeleton around 1506 cm^{-1} , and the expansion vibration absorption peak of aliphatic ether and aromatic ether bond ($\text{C}-\text{O}-\text{C}$) at around 1182 cm^{-1} and 1041 cm^{-1} . Around 830 cm^{-1} , the $\text{C}-\text{H}$ bending vibration absorption peak can be seen on the multi-substituted benzene ring [63–65]. The FTIR spectra of the GF/EP pultruded plates by the gradient flame treatment process show that the position and number of the absorption peaks of each bond have not changed, except for some changes in intensity, which indicates that the gradient flame treatment has changed the content of some substances but has not introduced new chemical bonds.

Compared with the sample without flame treatment, one flame treatment caused the FTIR spectrum of the GF/EP pultruded plate to move down as a whole, which may be because the high-energy flame broke the original equilibrium state of the molecules on the surface of the plate, so that its molecular conformation changed and entered another new equilibrium state. After three flame treatments, the characteristic peaks of the benzene ring at about 1506 cm^{-1} in the FTIR spectra of the plate did not change, and the peaks of 1182 cm^{-1} , 1200 cm^{-1} , and 830 cm^{-1} in the fingerprint region were enhanced, which may be due to the decomposition of the release agent in the plate and the removal of the benzene ring side group in DGEBA. The FTIR spectra of the plates after five flame treatments showed the enhancement of the 1506 cm^{-1} and 1737 cm^{-1} peaks caused by epoxy backbone rupture and end group oxidation. The FTIR spectral fingerprint area decreased after seven flame treatments, possibly due to the flame further damaging the DGEBA backbone and oxidation of part of the benzene ring opening.

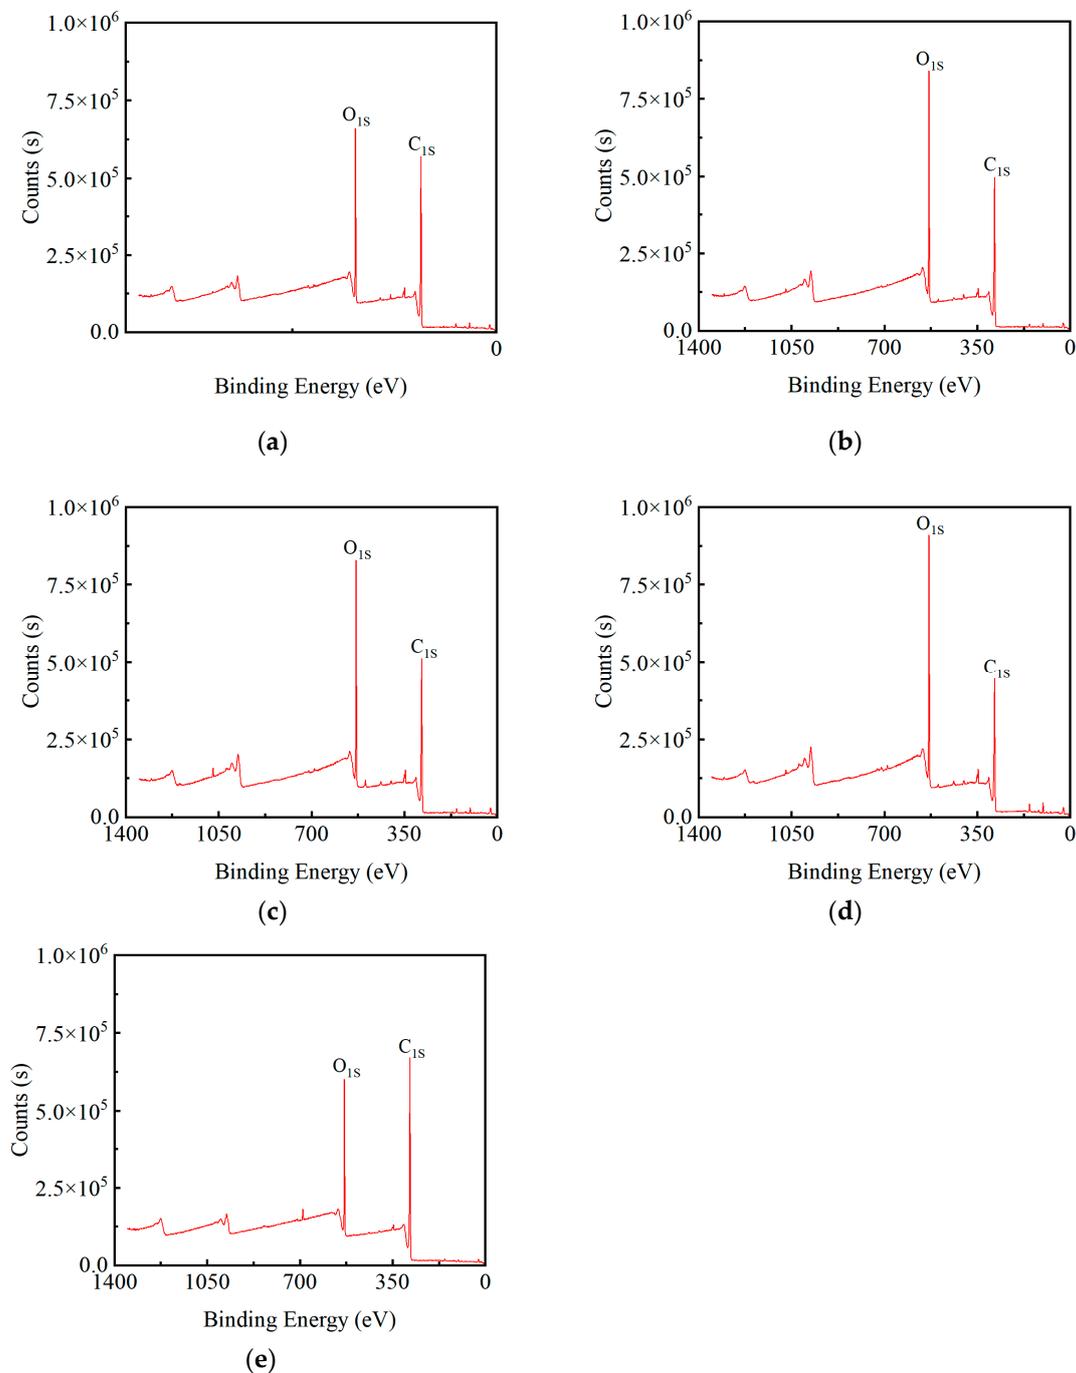
Figure 19. XPS spectra of samples treated with a different number of flame treatments: (a) no flame treatment; (b) one flame treatment; (c) three flame treatments; (d) five flame treatments; (e) seven flame treatments.

Because of the difference in detection depth, XPS is a more sensitive surface inspection technology than FTIR. The content of carbon, oxygen, and their groups on the surface of the GF/EP pultruded plate after gradient flame treatment was tested by XPS, and the full spectrum of XPS is shown in Figure 19.

The C_{1s} peak of 283.5 eV and the O_{1s} peak height of 530.5 eV in Figure 19 represent the carbon and oxygen content, respectively. It can be seen from the figure that the surface of the GF/EP pultruded plate without flame treatment itself contains a certain amount of

oxygen and carbon (Figure 19a). After one butane flame treatment, the surface oxygen content increased and the carbon content decreased, which may be due to the oxidation caused by the violent combustion of butane and oxygen and the removal of some carbon-containing small molecules in the weak boundary layer (Figure 19b). With the increase of the number of flame treatments, the oxygen content was further increased, and the carbon content was further decreased (Figure 19c,d). However, after seven flame treatments, the carbon content increases and is higher than the oxygen content, and the oxygen content is even lower than the sample without flame treatment (Figure 19e), which may be due to excessive flame treatment caused by the release agent in the GF/EP pultrusion plate and resin forming a carbonization layer covering the surface of the plate, which may also be one of the reasons why the contact angle increases after seven flame treatments. The oxygen content in the XPS test was consistent with the tensile shear strength and contact angle test with the change trend of the number of flame treatments.

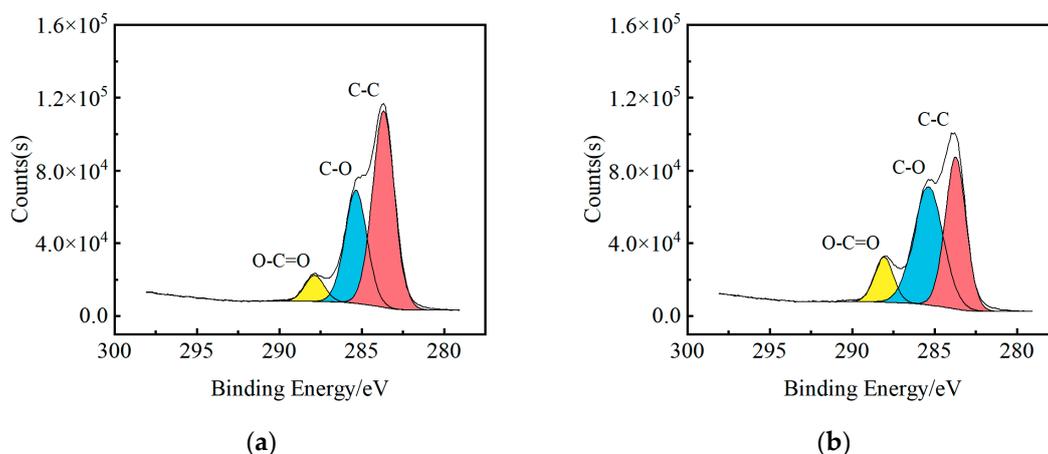
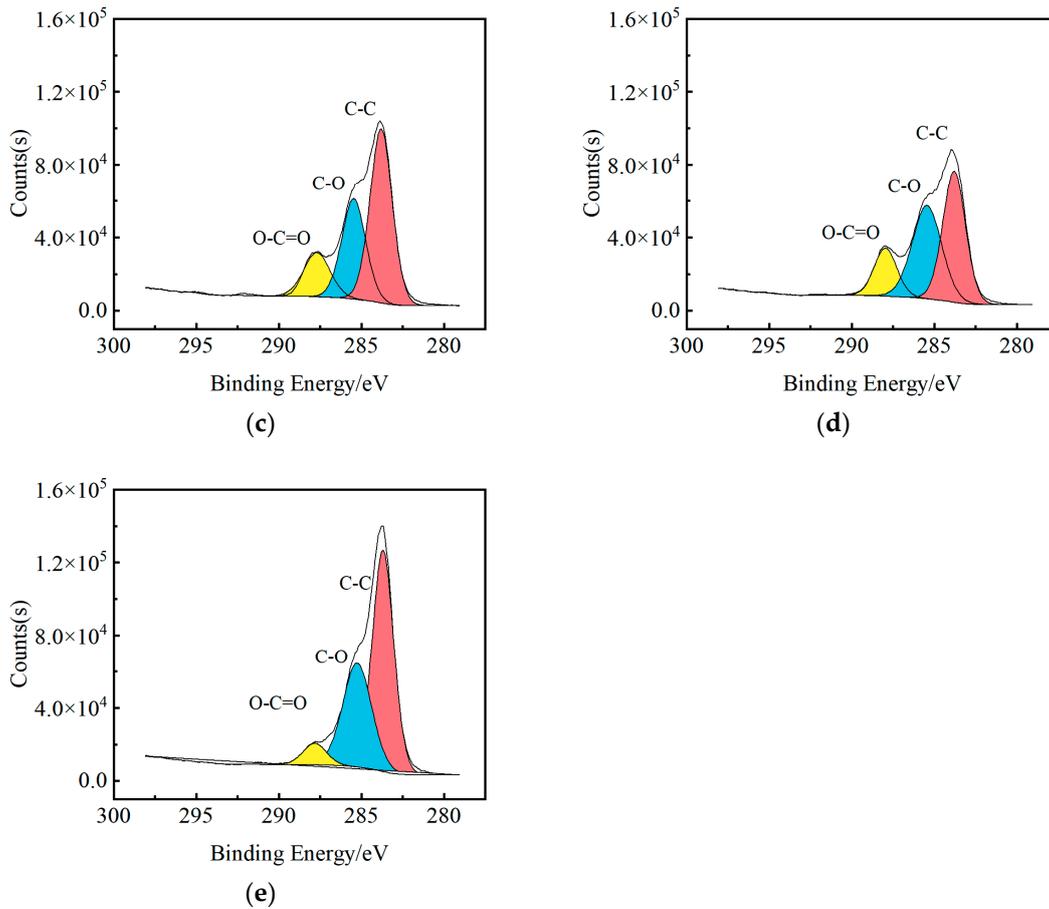
Figure 20. C_{1s} fitting spectra of XPS on the surface of samples treated with a different number of flame treatments: (a) no flame treatments; (b) one flame treatment; (c) three flame treatments; (d) five flame treatments; (e) seven flame treatments.

To further explore the type and content variation of active groups introduced into the specimen surface by butane flame treatment, a C_{1s} high-resolution scan of the flame-treated specimen surface was performed and the results were fitted, as shown in Figure 20.

The C_{1s} spectra of XPS test on the surface of the GF/EP pultruded plate specimens can be seen as fitting the C–C peak of 284.8 eV, the C–O peak of 286.5 eV, and the O–C=O peak of 288.5 eV, while the content of each group is positively correlated with the area between its peak and the background baseline. The change of the three groups with the increase of the number of flame treatment is obtained by Avantage software, as shown in Figure 21.

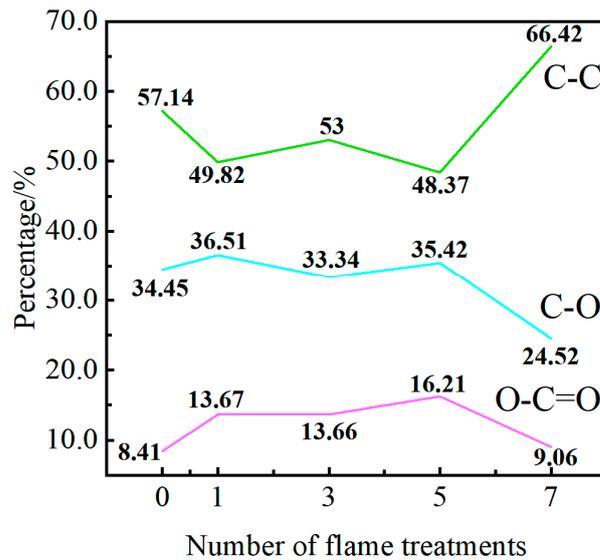
Figure 21. C_{1s} peak fitting results before and after surface treatment.

Combined with FTIR and XPS data analysis, compared with the untreated specimen, the weak boundary layer of the GF/EP pultruded sheet after one flame treatment was removed, and the surface was slightly oxidized, resulting in a decrease in C–C content and an increase in C–O and O–C=O oxygen-containing groups. The release agent in the GF/EP pultruded sheet after three flame treatments was removed, which slightly reduced the content of oxygen-containing groups such as C–O and O–C=O. After further oxidation by five flame treatments, the content of C–O and O–C=O oxygen-containing groups increased and the content of C–C decreased due to the fracture of the epoxy backbone and the oxidation of the end groups of the chain segments, which was conducive to the formation of a strong chemical bond between the GF/EP pultruded plate and infusion plate. The carbon content of the sample after seven flame treatments increased rapidly due to the carbonization of the mold release agent and epoxy resin, resulting in a rapid decrease in the content of C–O and O–C=O oxygen-containing groups.
