1 **Characterizing supply variability and operational**  
2 **challenges in an intermittent water distribution network**

3 *Supporting Information*  
4

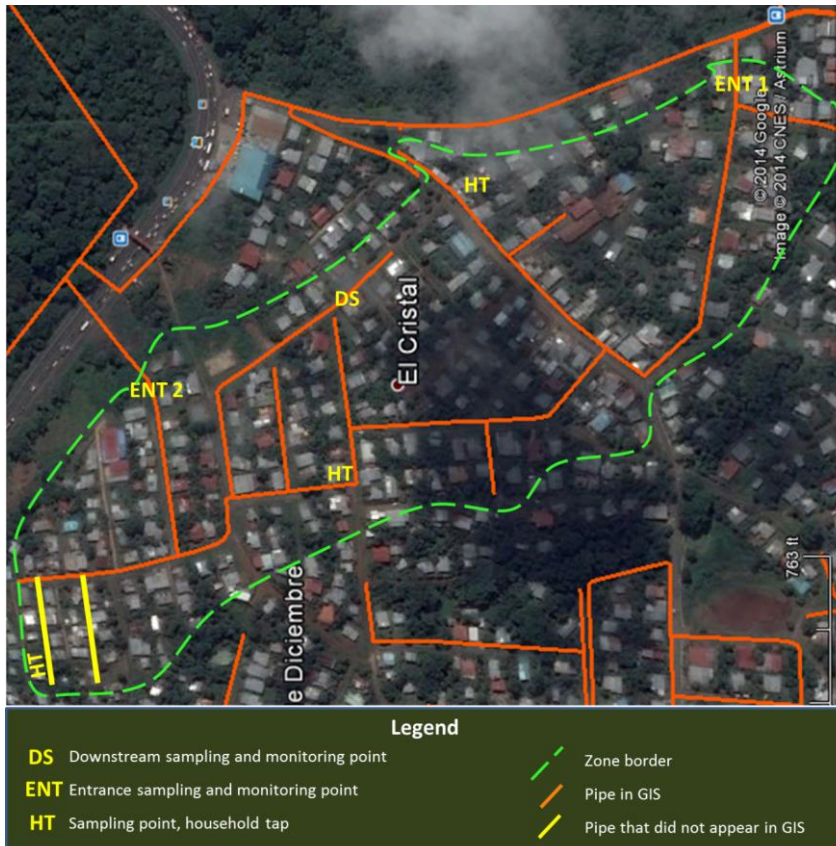
**Figure S2:** Schematic of Study Zone 1. (Source of satellite images and study zone schematic: Google Earth and IDAAN's GIS database)

15 **Figure S2:** Schematic of Study Zone 1

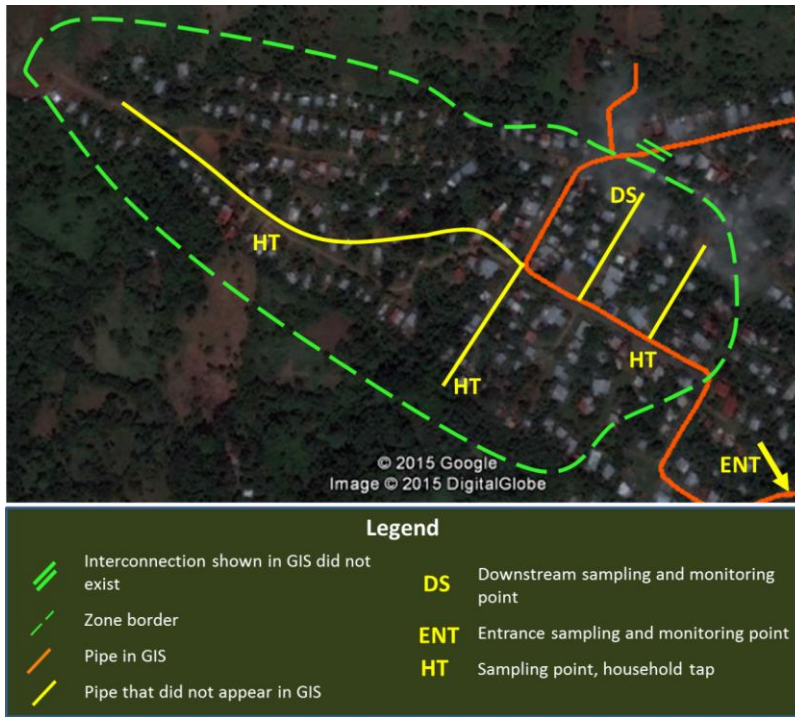
**Figure S3:** Schematic of Study Zone 3. Pressure and entrance flow were measured at the ENT location, approximately 1 km to the southeast of the bottom right corner of the diagram. Water quality grab samples were collected and chlorine, turbidity and pressure were monitored continuously at the pump station discharge, located approximately 400 m to the south (upstream) of ENT. (Source of satellite images and study zone schematic: Google Earth and IDAAN’s GIS database)

16 **Figure S3:** Schematic of Study Zone 3

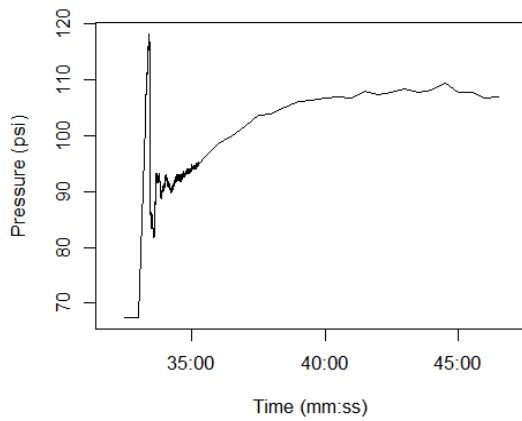
41 **Figure S5:** Pressure transient at 3:30 am 11-18-2014 at the discharge of the Zone 4 pump station caused  
 42 by the startup of the second of two pumps.

18 **Figure S5:** Pressure transient at 3:30 am 11-18-2014 at the discharge of the Zone 4 pump station caused  
19 by the startup of the second of two pumps.
