Article

Study on the Evolution Characteristics of Dam Failure Due to Flood Overtopping of Tailings Ponds

Keywords: tailings pond; overtopping; model test; dam failure; liquefaction flow

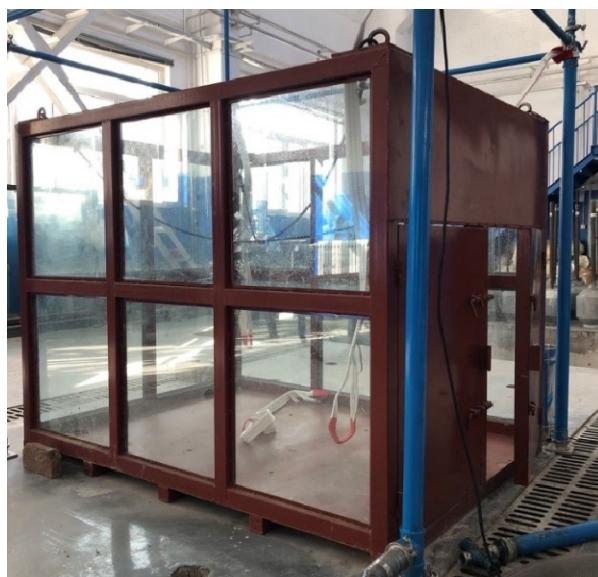
The model tailings dam was arranged in a flume, as shown in Figure 3. The length, width, and height of the flume were 2.0 m, 1.5 m, and 1.5 m, respectively. Three sides of the flume were Plexiglas, which could facilitate the observation of rainwater infiltration and slope failure.

Figure 3. Photo of the model flume.

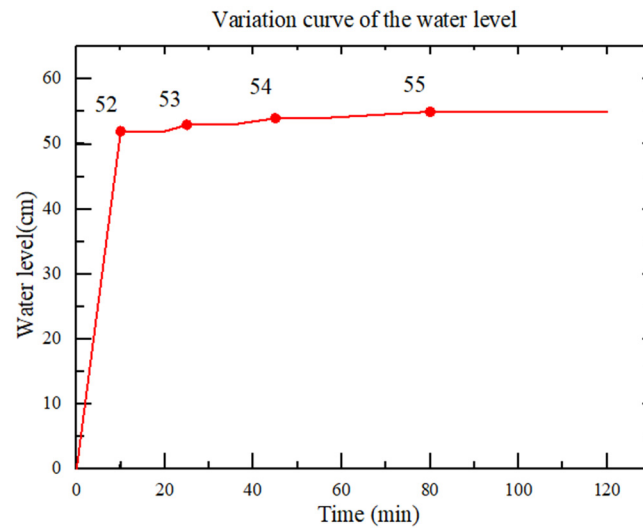
(5) The dam break test started when the water level reached a measurement of 54 cm. Continued rainfall with a flow rate of $0.02 \text{ m}^3/\text{h}$ persisted until the floodwater overtopped the top of the dam and caused it to breach. The variation curve of the water level is shown in Figure 7.

Figure 7. Variation curve of the water level.

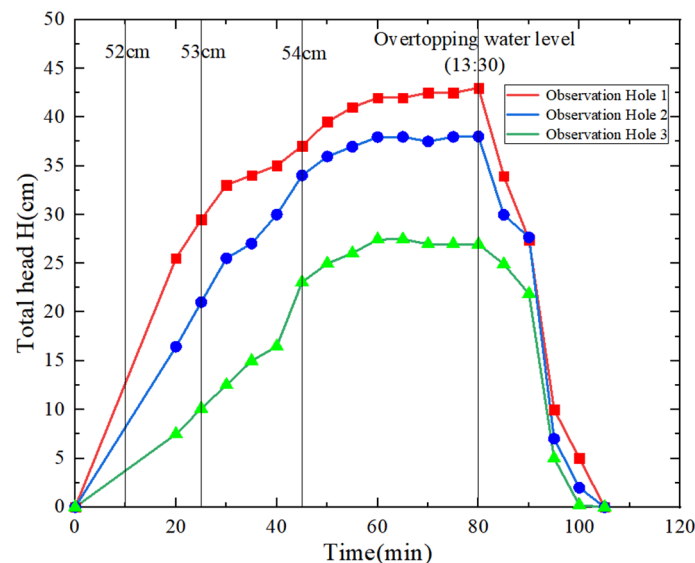
During the rise in water level, variation in the water level in each observation tube with time was recorded, and the variation curve is shown in Figure 8. As can be seen from Figure 8, as the water level in the pond rises, the water level in each observation tube basically rises at different speeds. During rainfall, the water level at observation tube 1 was measured 10 min after the test began, and it was found to be 12 cm. In comparison, the water level in the pond was 52 cm. The water level in observation tube 2 was 8 cm, while in tube 3 it was 3 cm. The water level in various observation tubes was still rising, indicating that seepage in the model dam had not yet reached a steady state at this point.

Figure 8. Change curve of water level in the three observation tubes.

After the water level in the pond reached 54 cm, the seepage line measured by the three observation tubes remained rather constant. The measurements were 42 cm, 38 cm, and 27 cm. This indicates that a steady seepage rate was achieved in the model dam. After eighty minutes from the beginning of the experiment, the model experienced a breach in which water overflowed, and subsequently, there was a swift decrease in the water level at each observation tube during the next twenty minutes until the experiment concluded.

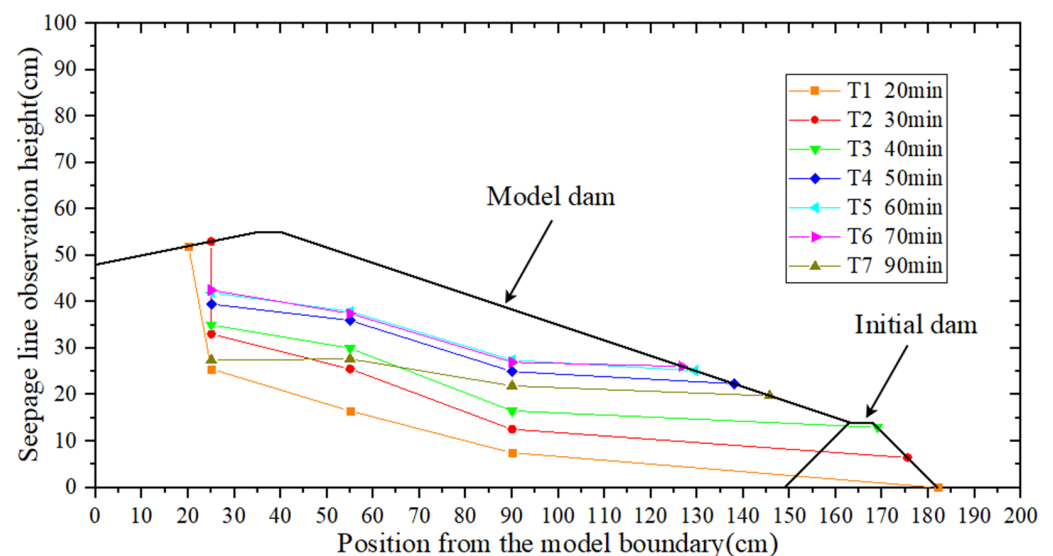
The seepage lines of the model dam were drawn at different periods using the water level data from the three observation tubes and the model boundary, all represented in the same coordinates. Figure 9 shows the variation diagram of the seepage lines in the model dam at various time intervals. Figure 9 clearly demonstrates that, during the initial phase of the test, the seepage line exhibited a fast increase as the upstream water level rose. The alteration in the upstream water level induced a modification in the seepage field of the dam, resulting in a transition from one stable state to another. This transition between stable states took place over a specific time span, characterized as the lag effect [28]. After the water level stopped rising, due to the lag effect, the upward lifting speed of the seepage line slowed down significantly (from 50 min to 70 min, as seen in Figure 9), and then maintained a certain burial depth. After 50 min of the test, most of the dam tended to be saturated and the matrix suction decreased. Approximately 80 min after the test, a breach in the model dam occurred in an overflow, causing a sudden and significant dip in the seepage line.

Figure 9. Curve of seepage line with time.

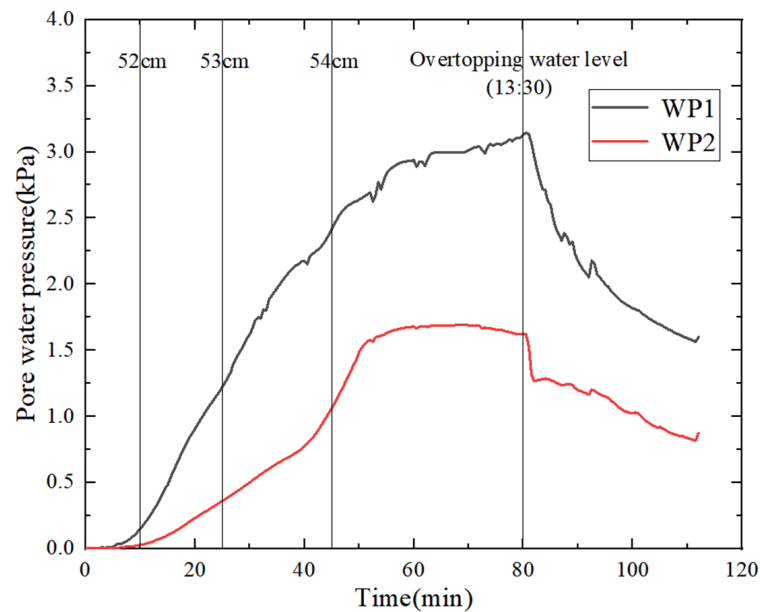
It can be seen from Figure 10 that the pore water pressure showed the characteristics of slowly rising, tending to be stable, and then rapidly decreasing after dam break. The pore water pressure at WP2 exhibited a substantial delay compared to WP1. This can be attributed to the shallow burial depth and distance of the WP2 sensor from the pond region. Additionally, the model dam had unstable seepage due to rainfall. When the overtopping water level was reached, the pore water pressure at the measuring point WP1 was about 3.1 kPa, which was consistent with the static pore pressure at the location.

Figure 10. Change curve of pore water pressure.

The measuring point WP1 first reached about 2.9 kPa at a rate of about 48 Pa/min at 60 min after the test, and then the pore water pressure no longer increased significantly. When rainfall began at 75 min, the pore water pressure gradually increased until it reached its maximum value. After 80 min, the dam began to break, and the water pressure at the measuring point WP1 dropped to 1.6 kPa at a rate of 43 Pa/min.

in the dam was slightly delayed compared to the uplift of the water level in the pond. With gradual infiltration, the matrix suction of tailings decreased, but the pore water pressure increased at a faster rate. Subsequently, the model dam reached a state of near saturation, causing the pore water pressure to stabilize and no longer fluctuate with the increase in water level. The rainfall started at 75 min and peaked at 80 min. Then, the pore water pressure also reached the highest value of about 1.6 kPa at the same time. After a duration of 80 min, the dam began to break, causing a gradual decline in water pressure at the measuring location at a rate of around 120 Pa/min. Approximately three minutes after the dam burst, the water pressure at monitoring site WP2 experienced a decline at the rate of 15 Pa/min, eventually reaching a stable value of 0.81 kPa.

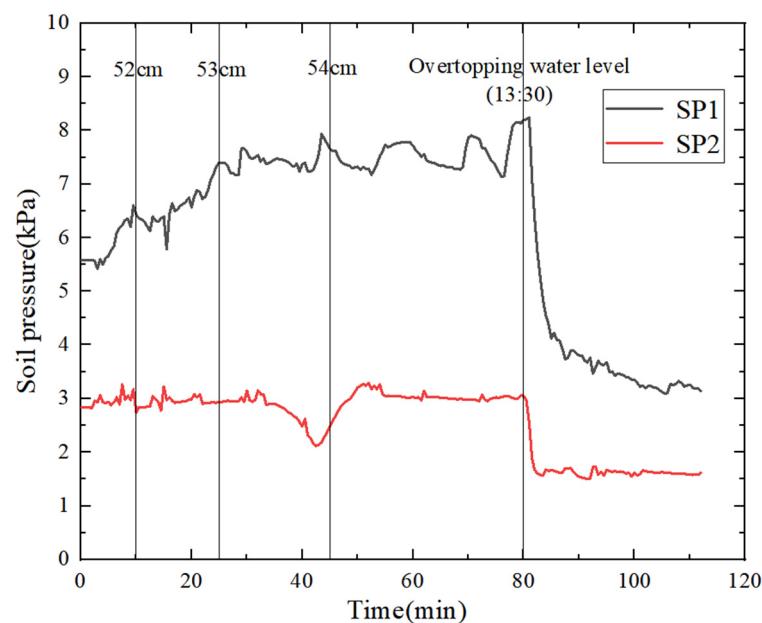
Figure 11. Change curve of soil pressure.

Figure 11 shows the variation curve of soil pressure at each measuring point. The variation trend of soil pressure at measuring points SP1 and SP2 was basically the same as the tendency of pore water pressure. The soil pressure fluctuated slightly before the dam break and plummeted sharply after the dam break.

The initial value of soil pressure at the SP1 was 5.5 kPa. The soil pressure progressively escalated over time, reaching a peak value of 8.2 kPa before the occurrence of a dam break. With the seepage of rainwater into the dam, the moisture content of the tailings gradually increased, and the tailings sand gradually transitioned from natural weight to saturated weight, reaching the highest value of soil pressure when the water level reached its highest point. After dam break, the measuring point of SP1 first dropped to 4 kPa at a rate of 420 Pa/min and then dropped to 3.1 kPa at a rate of 36 Pa/min.

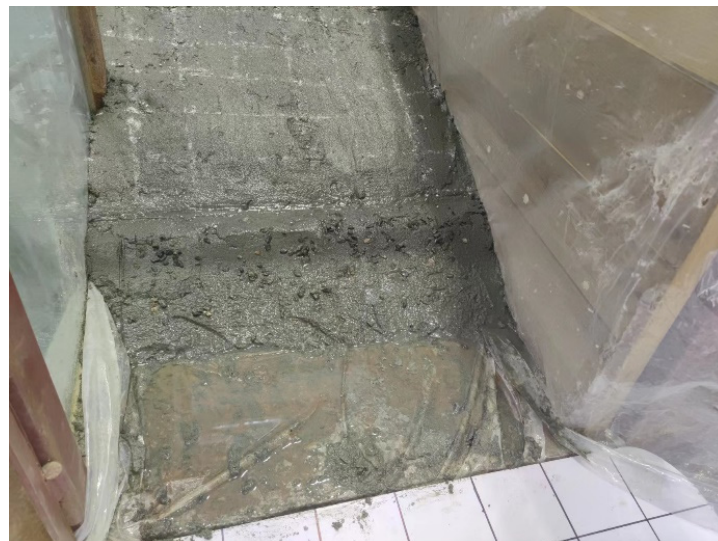
The overtopping test lasted for a total duration of 120 min. At 55 min after the start of the test, the water level in the pond was 54 cm. At this point, the seepage in the model dam had reached a state of stability, and water started to gently seep out of the initial dam, as shown in Figure 12.

Figure 12. Water seeped out of the initial dam.

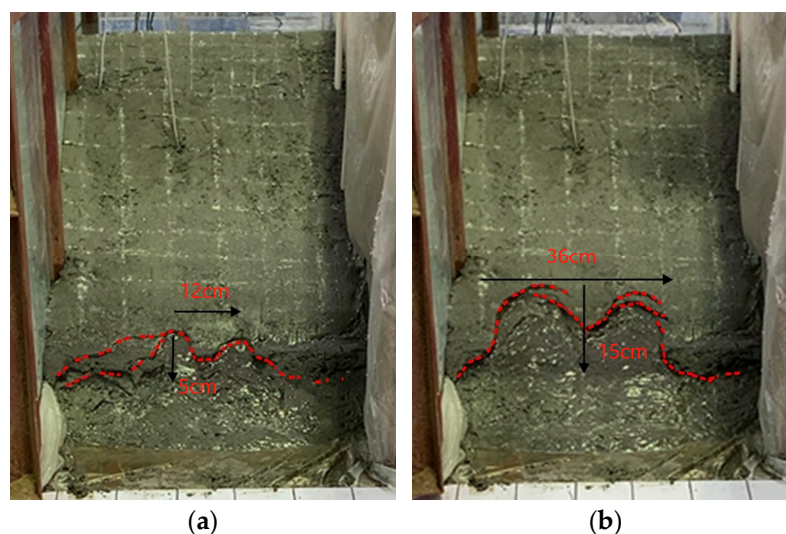
the seepage line. Swamping began to occur at a distance of 5 cm from the dam foundation, and the swamp area was 12 cm wide. The swamping of the dam foundation is shown in Figure 13a.

Figure 13. Deformation of slope surface: (a) Dam foundation swamping; (b) Sliding of dam foundation.

At 75 min after the start of the test, the water level in the pond was gradually approaching the dam crest as the rainfall continued. At this time, more water seeped out from the vicinity of the initial dam. The saturation degree of tailing near the initial dam was further increased, and the swamping area was further expanded to 36 cm wide. Local slippage and instability occurred in the swamping area of the dam foundation, and the slippage occurred 15 cm away from the dam foundation, as shown in Figure 13b.

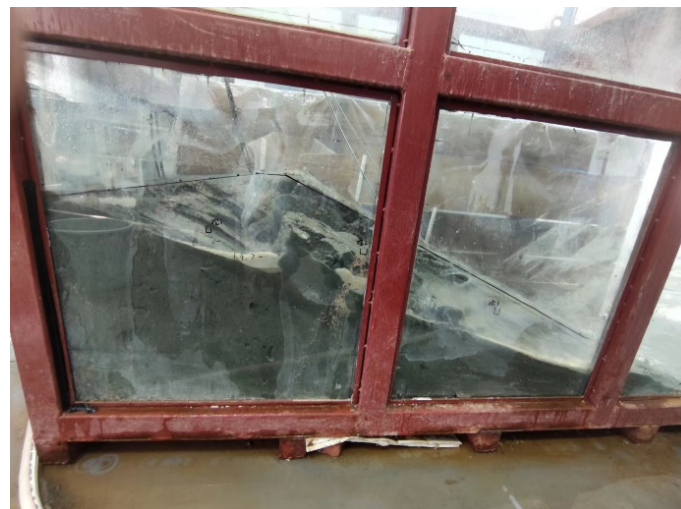
Figure 15. Side view after dam break.

Due to the ongoing increase in water level, the water flow surpassed the lowest point of the dam crest and spilled over at the left shoulder of the dam. At this time, the breach and the flow rate from the breach were both small. The water flowed through the slope surface to form a trench with the same width as the breach, about 1.5 cm. About 387 s later, the gully laterally widened to 4 cm, and there was a breach of about 5 cm wide at the dam foundation. The velocity of the flow through the breach increased rapidly, resulting in a continuous and forceful stream that carried away loose tailings from the dam and flowed toward the dam foundation. As the discharge from the breach increased, the erosion effect on the slope surface became more pronounced, causing the breach to widen laterally and deepen longitudinally. Then, 411 s later, the fracture at the dam foundation widened to 6 cm, and a longitudinal crack with a length of about 20 cm appeared in the middle of the slope face. After 422 s, the crack in the dam collapsed, and a crack 25 cm long and 14 cm wide appeared at the top of the dam. Then, the water level in the pond dropped rapidly, cracks penetrated the upstream crest, and the dam failed in its entirety. After the collapse, a large amount of tailings flow was fan-shaped downstream of the model, and the dam break process ended. The overtopping dam breach process is shown in Figure 14, and the side view of the model after the dam break is shown in Figure 15.

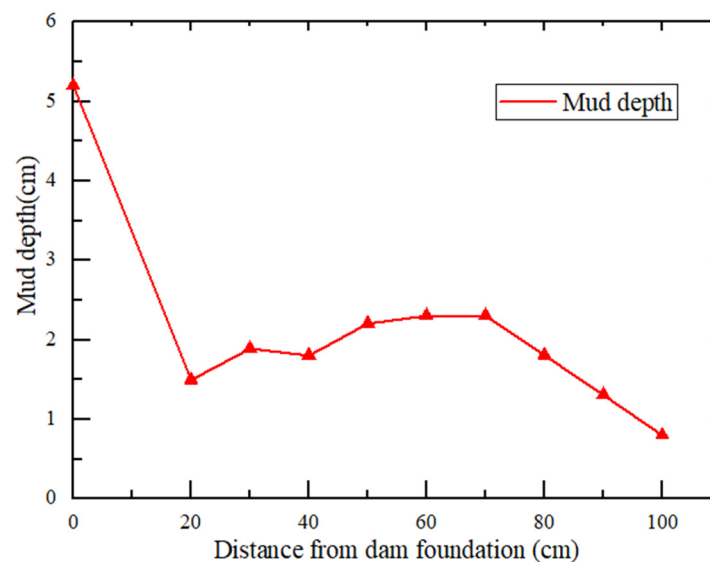
After the break of the dam, the extent of the flooded area where the tailings were discharged was measured. The deposited tailings discharged from the breach were about 156 cm in length and 140 cm in width. The depth of the mud at a distance of 156 cm was 0.2 cm. The depth of deposited mud was measured by ten monitoring points, as shown in Figure 16. The figure illustrates the substantial accumulation of tailings at the foundation of the dam, with a mud depth of 5.2 cm in front of the dam foundation. The mud depth increased first with the distance from the breach, reaching the maximum of 2.2 cm at the distance of 71 cm. Since then, the depth of mud decreased as the distance of transportation increased. The reason for this was that there was an ample supply of water and tailings at the beginning of the dam break, allowing the tailing sand to flow over a distance of 156 cm. As the dam broke, the ability of the water flow to carry sand decreased. The majority of the sand that was being carried lost its energy when it reached a depth of 60 cm–70 cm and settled at the bottom. After that, there was a reduction in the rate at which tailings were discharged, resulting in a decrease in the overall quantity of tailings. Tailings could not be transported farther and had to be silted up near the initial dam.

Figure 16. Change curve of mud depth.

Typically, when there is flat terrain downstream, the tailings released from the breach disperse downstream in a radial pattern, forming an alluvial fan and covering a wide expanse of area. The furthest transportation distance of the outflow tailings was 156 cm, which was equivalent to an actual 234 m according to the similarity scale. The diffusion width was 140 cm, which was equivalent to an actual 210 m. At a distance of 150 m from the initial dam, the depth of deposited mud was 1.2 m, and at the farthest distance of 234 m, the depth of deposited mud was 0.3 m.

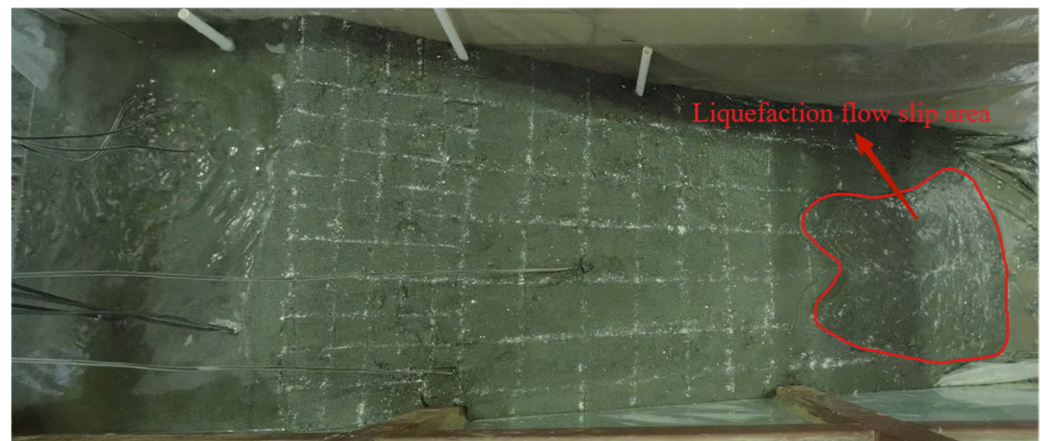
During the test, the foundation of the dam remained saturated for an extended period, resulting in a decrease in the cohesiveness of the saturated tailings and eventual liquefaction of the dam foot. As the liquefaction zone expanded, the tailings at the foot of the slope induced local landslide, which then spread toward the upstream slope, as shown in Figure 22.

Figure 22. Liquefaction of dam foundation from the top view.
