# Characterization and Analysis of the Mortars in the Church of the Company of Jesus—Quito (Ecuador)

**Abstract:** The Church of the Company of Jesus in Quito (1605–1765) is one of the most remarkable examples of colonial religious architecture on the World Heritage List. This church has multiple constructive phases and several interventions with no clear record of the entire architectural site, including the historical mortars. A total of 14 samples of coating mortars inside the central nave were taken, with the protocols suggested by the research team and a comparative sample of the architectural group that does not have intervention. The analysis presented in this paper focuses on mineralogical characterization, semi-quantitative analysis by X-ray diffraction and scanning electron microscopy with microanalysis of the samples. The results showed the presence of volcanic aggregate lime and gypsum, used in lining mortars and joint mortars. Mineralogical and textural composition data have allowed the mortar samples to be relatively dated.

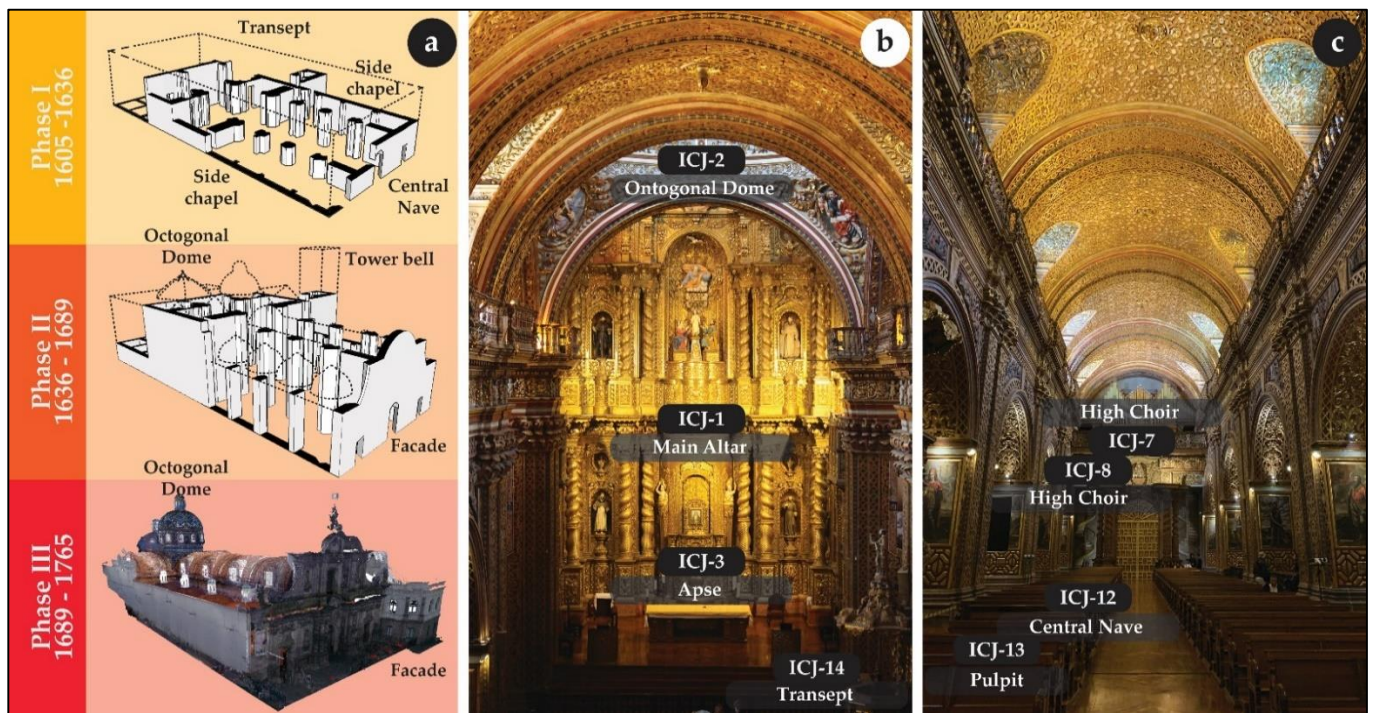
**Figure 2.** (a) Illustration of the three phases (during a period of 160 years) of the construction process of the Church of the Company of Jesus in Quito: Phase I (1605–1636), construction of the central nave and side chapels; Phase II (1636–1689), construction of the sacristy, the high choir, and the tower; Phase III (1689–1765), the works of the stone façade are finished. (b) Photograph from the central nave to the Main Altar, including the locations where the mortar samples were taken: ICJ-1 sample was taken behind the Main Altar of the central nave; ICJ-2 sample was taken in the octagonal dome; ICJ-3 sample was taken in the lower wall of the apse; ICJ-13 sample was taken in the column start of the pulpit, and ICJ-14 sample in the lower wall of the transept. (c) Photograph from the central nave to the side chapel and choir with the locations where the mortar samples were taken: ICJ-4 sample was taken behind the Calvary Altarpiece; ICJ-5 sample was taken in the lower part of the Calvary Altarpiece; ICJ-6 sample was taken behind the San Jose Altarpiece; ICJ-7 sample was taken in the back of the high choir; ICJ-8 sample was taken in the balustrade of the high choir; and ICJ-12 sample was taken in the column start, ground floor below the choir at the central nave.

The construction of the Jesuitic temple began at the beginning of the 17th century and lasted 160 years. There were three constructive phases. The first phase took place between 1606 and 1636 (Figure 2) and was led by the full order under Father Martin de Azpitarte and Jesuit Gil de Madrigal with an official standard Jesuitic style. The second phase, between 1636 and 1689, was led by Marcos Guerra S.J., a Neapolitan architect who provided visual and spatial unity, proportion and baroque details in the temple [15]. In the third phase, between 1689 and 1765, with the participation of Leonardo Deubler and Venancio Gandolfi, the stone façade of the church was finished (1723–1765). The reading of the church and its adjoining buildings, such as college and university cloisters, was finally consolidated [16].

the pulpit area (as in ICJ-13) and the apse (ICJ-1); these two samples belonged to the oldest phase of the church. Thanks to these data, the construction phases of the church was better understood, and the information provided by Figure 2 was corroborated.

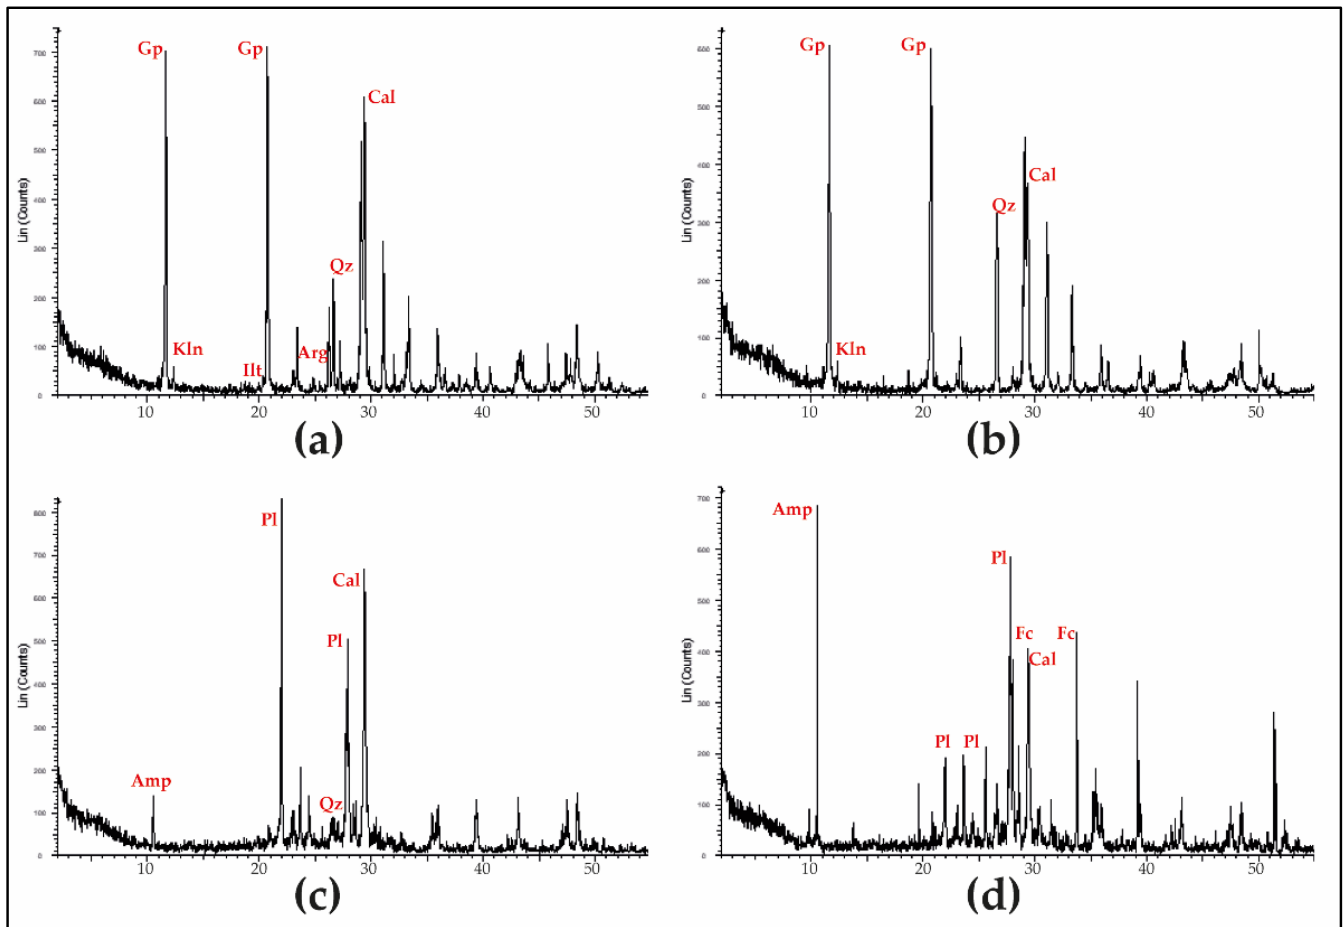
**Figure 4.** X-ray diffraction patterns of the mortar types: (a) lime and gypsum plaster (ICJ-1); (b) lime and gypsum plaster with carbonate aggregates (ICJ-5); (c) lime joint mortar with volcanic aggregates (ICJ-7); and (d) lime joint mortar with volcanic aggregates and fire evidence minerals (ICJ-4). The main reflection of the mineral identification is printed. Quartz = Qz, Plagioclase group = Pl, Illite group (Clay Minerals) = Ill, Kaolinite = Kln, Amphibole group = Amp, Calcite = Cal, Aragonite = Arg, Fairchildite = Fc, and Gypsum = G.

Figure 4 shows only the most representative X-ray diffraction patterns of each mortar type found in the Church of the Company of Jesus.

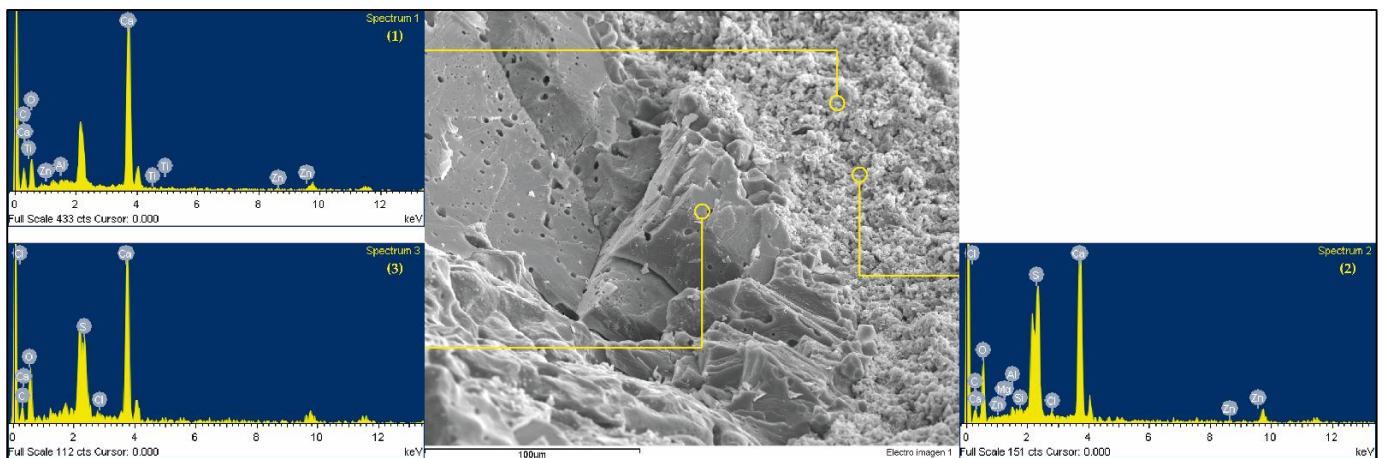
**Figure 5.** Electron secondary image of lime and gypsum plaster (ICJ-1) with 500 magnifications. EDX analysis at three different points with the main chemical elements: Spectrum 1 with Ca, C, O; Spectrum 2 with Ca, S, O; and Spectrum 3 with Ca, S, O, C.

Scanning electron microscopy (SEM) was used to know the morphology and the textural relations of the different mineral phases identified by XRD. Two samples, ICJ-1 (Figures 5 and 6) and ICJ-7 (Figure 7), were chosen as representative samples of the two mortar types existing in the Church of the Company of Jesus: a finishing mortar as base for later ornamentation (lime and plaster mortar) and a joint mortar (lime mortar and volcanic aggregates), respectively [37].

The SEM analysis allowed the origin of the materials used in the church construction to be determined, thus giving value to the hypothesis of the origin of the limestone mines that supplied Quito in the colonial period. Moreover, the effort of the technicians of the Church of the Company of Jesus Foundation was also understood to be faithful to the interventions in this living museum. It is understandable that some materials were replaced to be used, fragmentated or implemented in a vulnerable and seismic area. To use wisely the principles of restoration so as not to alter the building, it should also be noted that the mining catalogue of the Metropolitan District of Quito does not recognize the presence of gypsum mines. Calacali, Pomasqui and San Jose de Minas areas have the extraction of Calcite and Pozzolana as products (Figures 5 and 6).

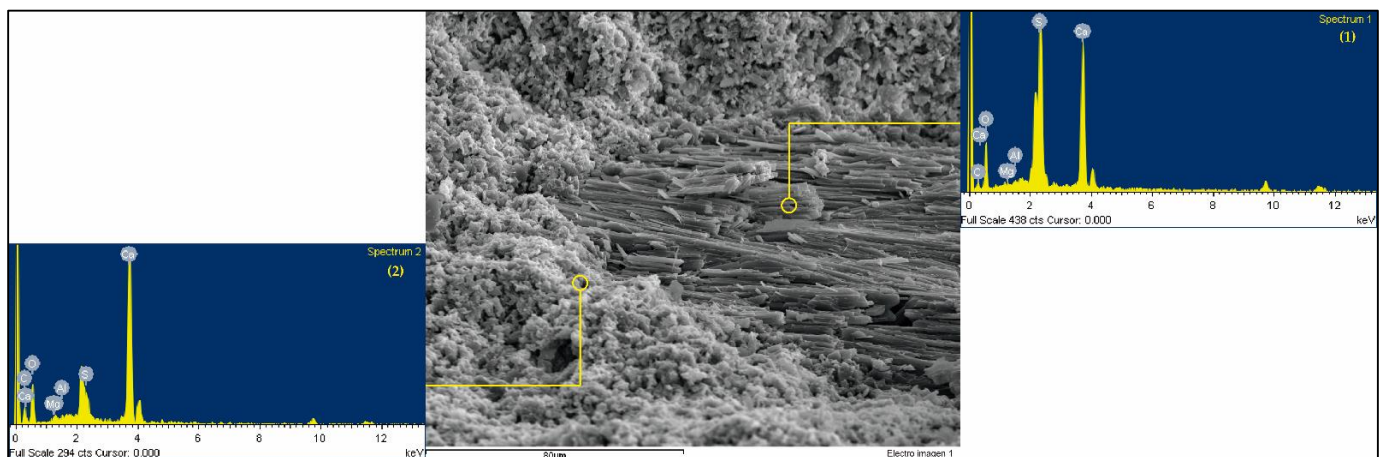
**Figure 6.** Electron secondary image of lime and gypsum plaster (ICJ-1) with 750 magnifications. EDX analysis at two different points with the main chemical elements: Spectrum 1 with S, Ca, O corresponding to thermoanhydrite no rehydrated to gypsum, and Spectrum 2 with Ca, C, S, O.

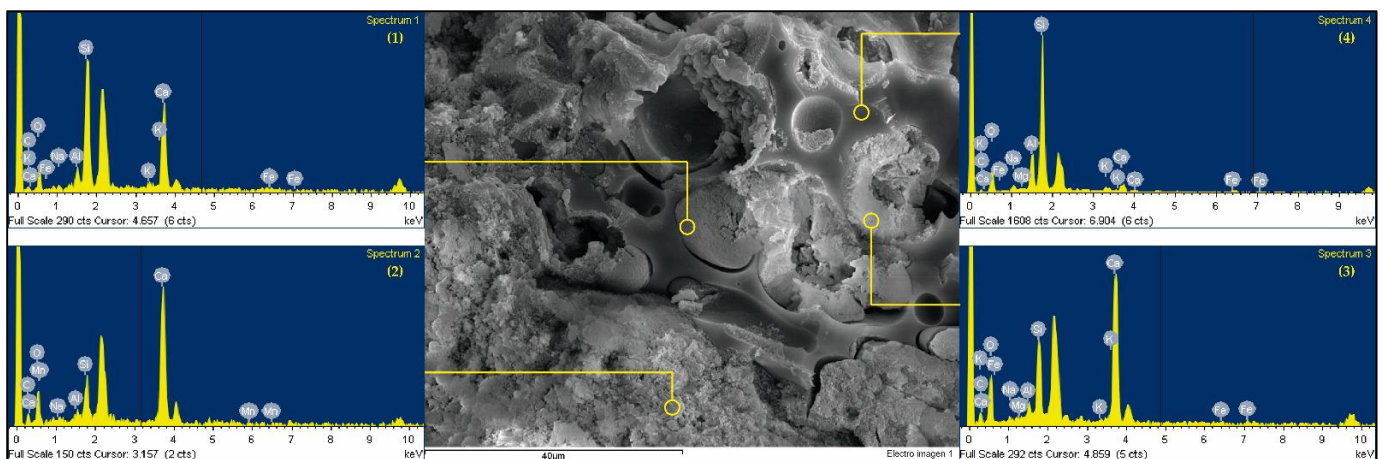
**Figure 7.** Electron secondary image of lime joint mortar with volcanic aggregates (ICJ-7) with 1500 magnifications. EDX analysis at four different points with the main chemical elements: Spectrum 1 with Si, C, K, O; Spectrum 2 with Ca, Si, K; Spectrum 3 with Ca, Si, K; and Spectrum 4 with Si, Al, C, O.

The main mortar in the church was a lime mortar with volcanic aggregate of glassy texture (Figure 7), which is typical of the basaltic andesite described as the stone used in the construction of the historical centre of Quito [13,14,41]. It seems logical that this stone was the origin of the aggregate crushing of the joint mortars in the Church of the Company of Jesus.
