Failure Mechanisms of Mechanically and Thermally Produced Holes in High-Strength Low-Alloy Steel Plates Subjected to Fatigue Loading

Abstract: High-strength low-alloy steels (HSLA) are gaining popularity in structural applications in which weight reduction is of interest, such as heavy duty machinery, bridges, and offshore structures. Since the fatigue behavior of welds appears to be almost independent of the base material and displays little improvement when more resistant steel grades are employed, the use of bolted joints is an alternative joining technique which can lead to an increased fatigue performance of HSLA connections. Manufacturing a hole to allocate the fastener elements is an unavoidable step in bolted elements and it might induce defects and tensile residual stresses that could affect its fatigue behavior. This paper studies and compares several mechanical (punching, drilling, and waterjet-cut) and thermal (plasma and laser-cut) hole-making procedures in HSLA structural plates. A series of 63 uniaxial fatigue tests was completed, covering three HSLA grades produced by thermomechanically controlled process (TMCP) with yield strength ranging from 500 to 960 MPa. Samp

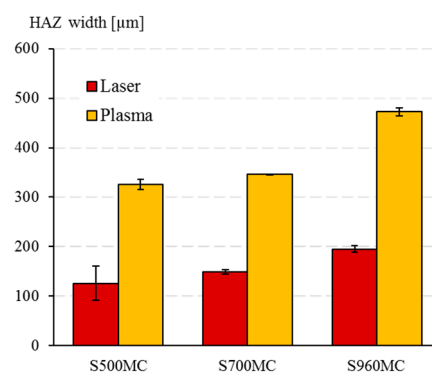
Figure 7. Average HAZ width in laser- and plasma-cut holes for S500MC, S700MC, and S960MC.

The average width of the HAZ was measured and it is displayed for all three HSLA grades in Figure 7. It can be noted that the difference between plasma- and laser-cut HAZ widths was bigger for S700MC and the S960MC and that the HAZ in both thermal processes tended to be wider with increasing material strength.

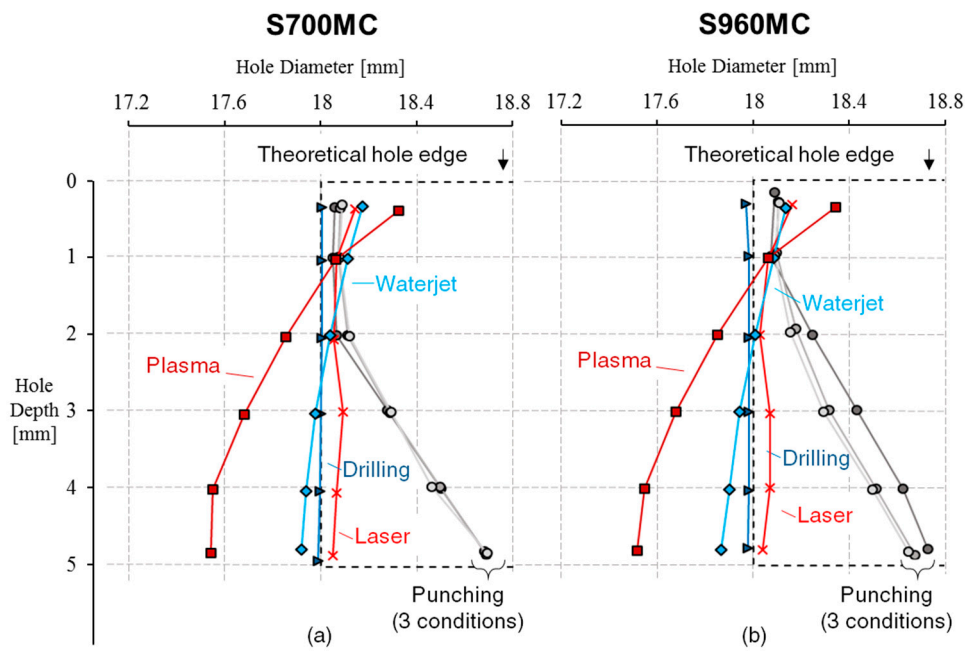
Figure 9. Hole diameter along sample thickness for waterjet cutting, laser cutting, drilling, and punching in (a) S700MC and (b) S960MC.

The averaged hole diameter for the S700MC and the S960MC steel grades is displayed in Figure 9. It is noted that the hole geometry was rather independent of the steel grade since both materials exhibited similar hole geometries for the same hole-making procedures. Drilling produced the most accurate hole geometry, with a constant hole diameter along the hole depth. Following, laser-cut resulted in a more deviated and undulating hole, with a less constant hole diameter. Waterjet-cutting displayed a tendency to produce an oversize hole diameter at the entry, which gradually shifted to a smaller hole diameter at the exit side of the hole. The waterjet-cut hole deviation did not exceed 0.2 mm in any case. Plasma-cut and punching resulted both in large deviations from the hole diameter. In the case of punched samples, an accurate hole diameter was produced at the hole start. However, at a depth of approximately 2 mm, the hole started to widen due to the shear cutting of the material. The hole produced by plasma-cutting had the most distortions, with a large oversize at the entry and an undersized hole at the exit.

The variation of the obtained results between repetitions was generally low (below 0.1 mm for most cutting procedures) and it has not been included in the graph to improve its clarity. Punched S960MC samples, however, displayed a substantial maximum scatter (0.203 mm) which was approximately eight times larger than punched S700MC and S500MC [13] samples. The higher hardness of this steel might make the forming process more difficult and, hence, produce less constant results when using a punching process. The rest of cutting techniques produced geometrically similar holes in all grades.

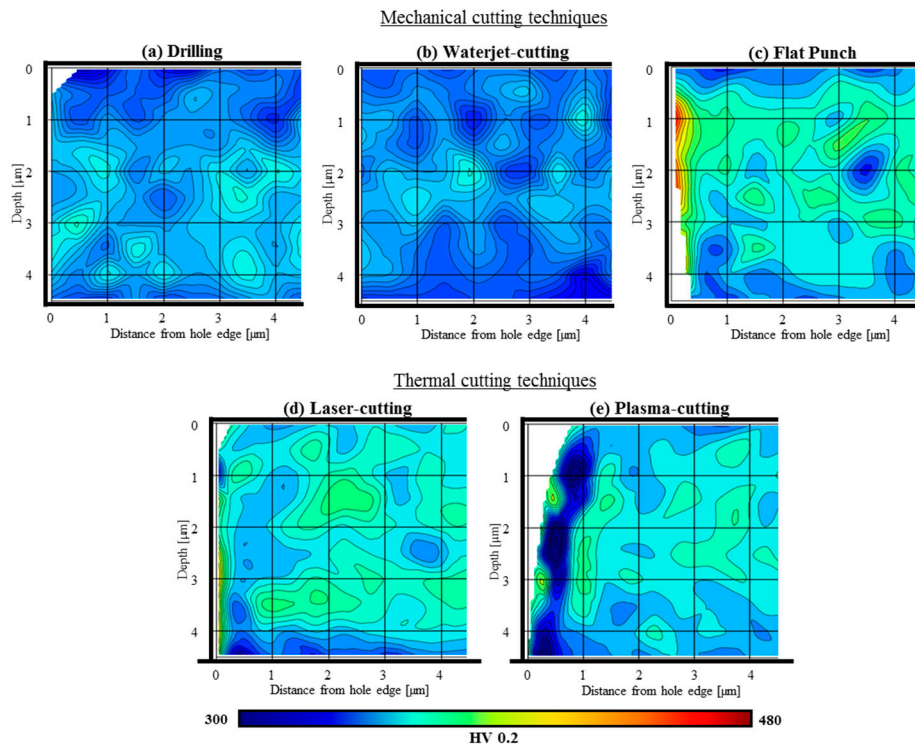
Figure 11. Hardness distribution near the hole edge in HSLA grade S960MC for various hole-making procedures: (a) drilling, (b) waterjet-cutting, (c) flat punching, (d) laser-cutting and (e) plasma-cutting. The hole edge is located on the left side of the images.

The produced hardening maps for the S700MC (Figure 10) and S960MC (Figure 11) show a clear increase in the material hardness near the edge for punching and the thermal cutting processes, similarly to the S500MC in [13].

region was 300 HV 0.2, which represented an approximate decrease in hardness of 15% with respect to the base material hardness. The lower hardness of the layer adjacent to the plasma accounted for the softer regions observed in Figure 11.

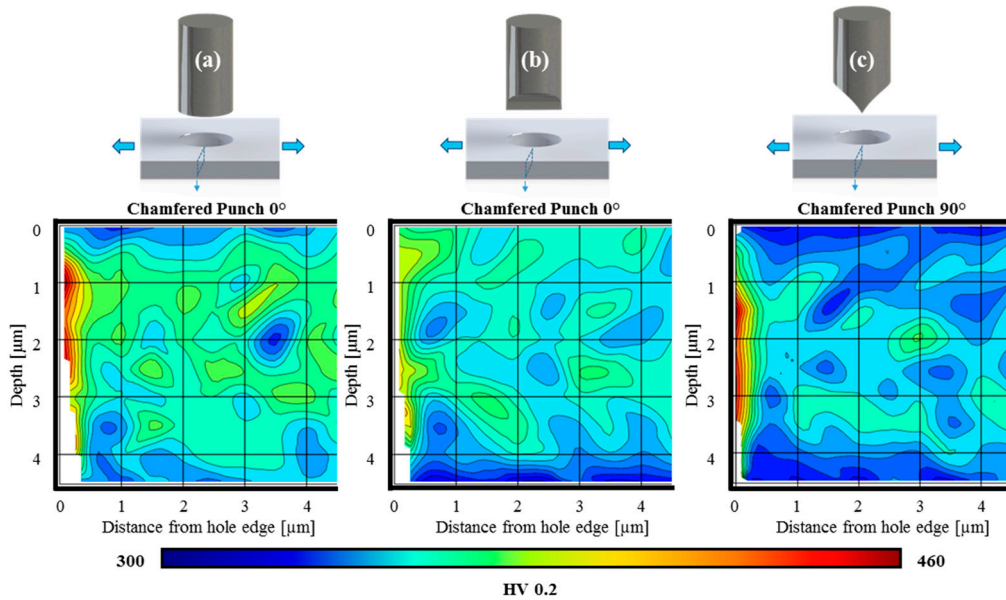
Figure 12. Hardness distribution produced in the S960MC by (a) flat punch, (b) chamfered punch at 0°, and (c) chamfered punch at 90°.

In the case of the punched samples, there was a clear hardness increase towards the hole edge. This phenomena has been already observed in punched specimens by Valtinat et al. [14] and can be attributed to the effect of cold-work hardening. The increase of hardness in punched samples (flat punch) with respect to the base material hardness was found to be 62%, 50%, and 28% for the S500MC, S700MC, and S960MC HSLA grades, respectively. The hardness increase was in accordance with the differences in ductility of the HSLA grades. The punch shape and orientation also played a role in the final hardening distribution near the hole. As displayed in Figure 12, when the chamfered punch was employed and its sharp edges were not facing the measured surface (0°), the resulting hardening values were lower than when the other punching conditions were adopted. The chamfered punch at 90° and the flat punch yielded, however, similar hardening distributions. This effect was mostly appreciable in the HSLA S960MC, while in the other two HSLA grades the punching conditions yielded similar results. This was related to the lower ductility and formability of the HSLA 960MC, which resulted in a less uniform strain accommodation along the entire hole.
