# Improving the Corrosion Resistance of Micro-Arc Oxidization Film on AZ91D Mg Alloy through Silanization

**Abstract:** The presence of inherent micro-pores and micro-cracks in the micro-arc oxidation (MAO) film of Mg alloys is a key factor contributing to substrate corrosion. A composite film layer with high corrosion resistance was achieved through silanizing the micro-arc oxidation film. The corrosion performance of the MAO films treated with various silane coupling agents was assessed through morphological characterization and electrochemical tests. SEM graphs depicted that the silane film can effectively seal the defects existing in micro-arc oxidation film, and electrochemical tests indicated the significant corrosion resistance improvement of MAO film after silanization treatment.

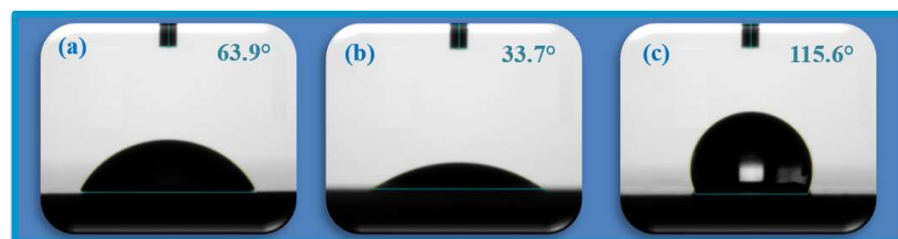
**Figure 1.** Contact angle of MAO film treated with (a) KH560, (b) BTSE, and (c) DTMS.

The surface hydrophobicity results of the MAO film on AZ91D magnesium alloy after silanization treatment with KH560, BTSE, and DTMS are depicted in Figure 1. The contact angles ( $\theta$ ) of the MAO film treated with KH560, BTSE, and DTMS were  $63.9^\circ$ ,  $33.7^\circ$ , and  $115.6^\circ$ , respectively. The high surface energy of the MAO film leads to rapid spreading of water droplets on its surface, rendering it challenging to measure the contact angle of the untreated film. Silanization of the MAO film can significantly lower its surface energy, enhance its hydrophobicity, and decrease the chances of contact between the corrosive medium and the film, thereby enhancing its corrosion resistance.

The choice of silane coupling agent significantly impacts the surface hydrophobicity of MAO-silane composite films. One end of the three silanes is Si-O-H, which binds to the hydroxyl group on the surface of the MAO film or other oligomers, forming a relatively dense silane film. The other end of the hydrolyzed product of BTSE is Si-O-H, while KH560 features an epoxide functional group that shares a similar polar bond with the O-H bond in a water molecule [8,24]. Consequently, the surface contact angle of BTSE and KH560 silane films is less than  $90^\circ$ . The hydrolyzed product of DTMS contains a hydrophobic long chain (dodecyl), leading to the formation of a predominantly hydrophobic silane film. As depicted in Figure 1, the surface hydrophobicity of the MAO film treated with the three silanes ranks in the order of  $\text{DTMS} > \text{KH560} > \text{BTSE}$ .

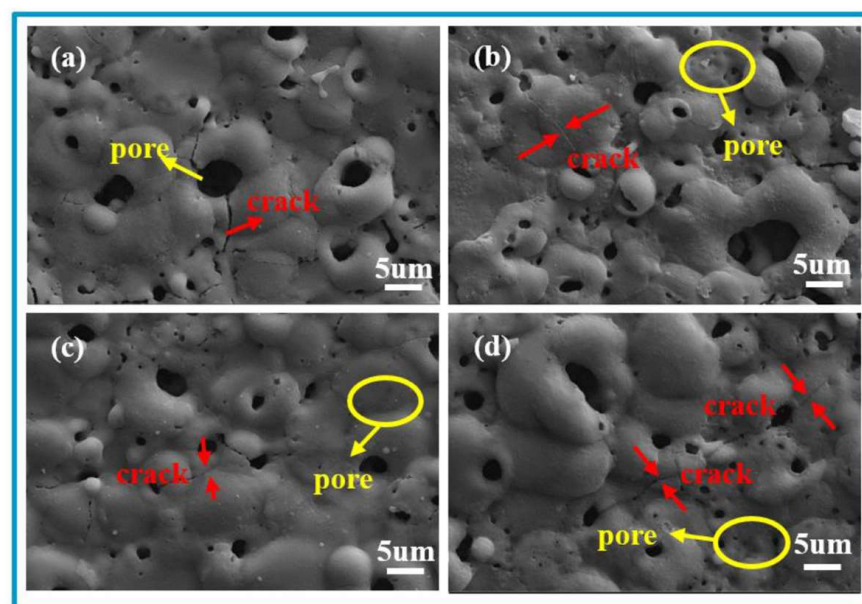
**Figure 2.** Surface morphology of MAO film modified by different silane coupling agents: (a) MAO; (b) MAO-KH560; (c) MAO-BTSE; (d) MAO-DTMS.

Figure 2 illustrates the surface morphology of the MAO film post-silanization with KH560, BTSE, and DTMS. Noticeable micro-pores and cracks were visible on the surface of the MAO film. Following silanization, some micro-cracks and small micro-pores on the MAO film surface were sealed, although the treatment had minimal impact on larger micro-pores. This could be attributed to the inability of the silane solution to penetrate the interior of the micro-pores, thus preventing the formation of a silane film within them. Consequently, the incomplete coverage of the silane film on the MAO film surface hinders the fundamental enhancement of the corrosion resistance of the MAO-silane composite film. Moreover, the acidic silane pre-hydrolysatate may react with the exposed magnesium alloy through the defects in the MAO film, leading to the generation of corrosion products that impede the formation of a silane film within the micro-pores, compromising the membrane's integrity [25]. Nonetheless, the corrosion resistance of the silane film is not clearly discernible from Figure 2.

Figure 2 displays the surface of the AZ91D magnesium alloy MAO film, revealing distinct structural defects such as micro-holes and micro-cracks. In the micro-arc oxidation process, the application of high voltage causes breakdown in the thinnest region of the oxide film, leading to the ejection of high-temperature molten oxide along the discharge channel under the influence of the electric and pressure fields. Quenching occurs when the molten oxide encounters the electrolyte, resulting in the formation of a “crater”-like microscopic morphology and generating stresses that lead to the formation of micro-cracks.

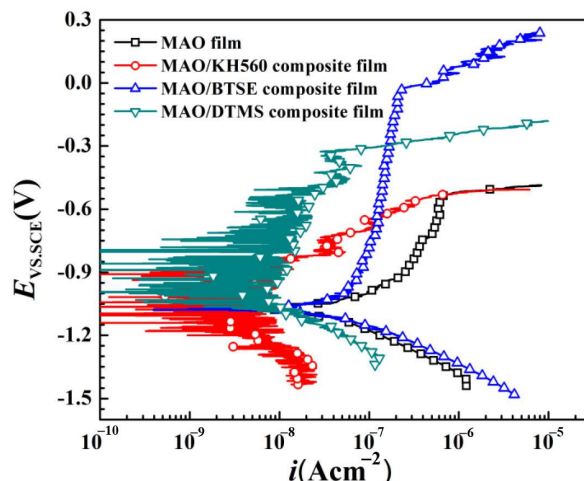
**Figure 3.** Potentiodynamic polarization curves of MAO film before and after treatment with different silane coupling agents.

Figure 3 depicts the potentiodynamic polarization curves of the MAO film both before and after silanization treatment with KH560, BTSE, and DTMS. Following the sealing treatment, a remarkable decrease in the corrosion current density of the MAO film and a positive shift in the corrosion potential were observed, indicating that all the silane coupling agents significantly contributed to the closure of structural defects in the MAO film, thereby enhancing its corrosion resistance. Furthermore, the MAO film treated with BTSE and DTMS exhibited a partial increase in the pitting potential of the film layer, which may be attributed to variations in the densification of the silane film. Additionally, the corrosion current density of MAO, MAO-KH560, MAO-BTSE, and MAO-DTMS film were  $1.38 \times 10^{-7}$ ,  $7.68 \times 10^{-9}$ ,  $7.86 \times 10^{-8}$ , and  $1.05 \times 10^{-8}$  A/cm<sup>2</sup>, respectively, which demonstrated lower corrosion current density of the MAO-KH560 and MAO-DTMS composite films.

The hydrolysis products of BTSE contain six Si-O-Hs, resulting in a relatively denser silane film compared to KH560 and DTMS. However, the highly hydrophilic surface of the BTSE silane film makes it more vulnerable to infiltration by corrosive media, which can penetrate the micro-defects of the MAO-silane composite film and reduce its long-term corrosion resistance. The slight repulsive effect of the hydrophobic long chains in DTMS on the hydroxyl groups results in the outer layer of the silane film being hydrophobic, leading to a more effective barrier against corrosive media.

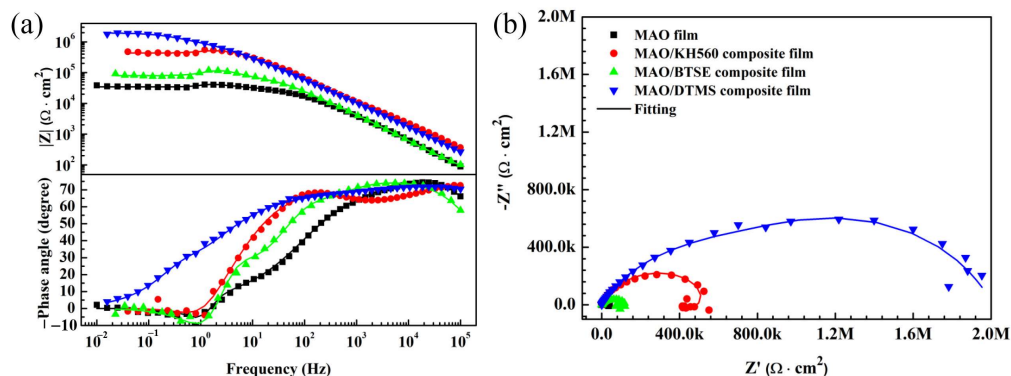
**Figure 4.** (a) Bode and (b) Nyquist diagrams of MAO film before and after silanization with different silane coupling agents.

Figure 4 illustrates the electrochemical impedance spectra of the AZ91D magnesium alloy MAO film before and after silanization with different silane coupling agents. The figure shows that the impedance modulus value, phase angle, and capacitance arc radius all increased after silanization, indicating that the silanization treatment can effectively enhance the integrity of the MAO film and improve its corrosion resistance. Therefore, the corrosion resistance of the MAO film is improved as a result. The results of the EIS test also laterally confirmed the results of the potentiodynamic polarization curves.

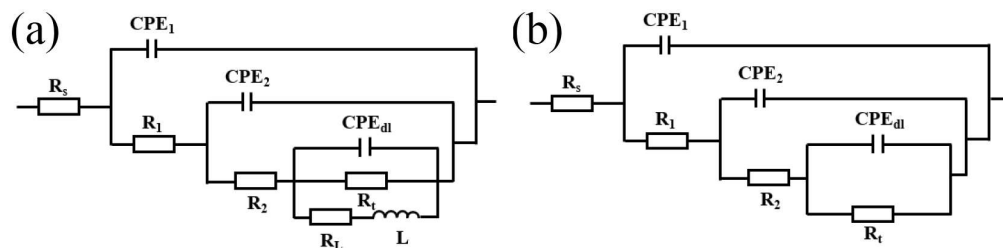
Figure 6. Two types of electrical equivalent circuit used for fitting the EIS spectra. (a) corrosion stage, (b) initial stage.

continues to decrease. The process can be analyzed by data fitting using the equivalent circuit shown in Figure 6a, in which  $R_s$  represents solution resistance, and  $R_1$  and  $R_2$  represent the resistance of the loose and dense layers of the MAO film, respectively. CPE1 indicates the interaction between the outermost MAO film and the corrosive medium. The decrease in the peak phase angle predicts that the loose layer in the MAO film is infiltrated by the corrosive medium, leading to an increase in the conductivity of the MAO layer and a decrease in the resistance of the film layer. As the immersion time extended, the loose layer gradually failed. Similarly, CPE2 provides information on the dense MAO layer, and with increasing immersion time, this layer also gradually failed. CPE<sub>dl</sub> indicates the corrosion occurring at the oxide film/substrate interface. The micro-defects on the surface of the MAO film provide channels for corrosive media to reach the MAO film/substrate interface. The low-frequency inductive reactance arc ( $L$ ) indicates the occurrence of localized pitting corrosion on the AZ91D magnesium alloy substrate [27], and  $R_t$  means the charge transfer resistance.

Figure 7 shows the EIS of MAO film treated with silane KH560, BTSE, and DTMS, respectively. In Figure 7a–c, an inductive reactance arc was not observed in the Nyquist spectra at an immersion time of 0.5 h, indicating that the corrosive medium did not reach the MAO/matrix interface. This proves that the silane treatment acts as a physical shielding effect on the corrosive medium, significantly improving the corrosion resistance of the MAO film. As the immersion process proceeded, a similar inductive reactance arc to that in Figure 5 appeared. When the immersion time reached 198 h, the loose layer of the MAO-silane film composite had been dissolved by the corrosive medium. Therefore, Figure 6b is used for fitting before 0.5 h, and Figure 6a is utilized when an inductive reactance arc appears [28].

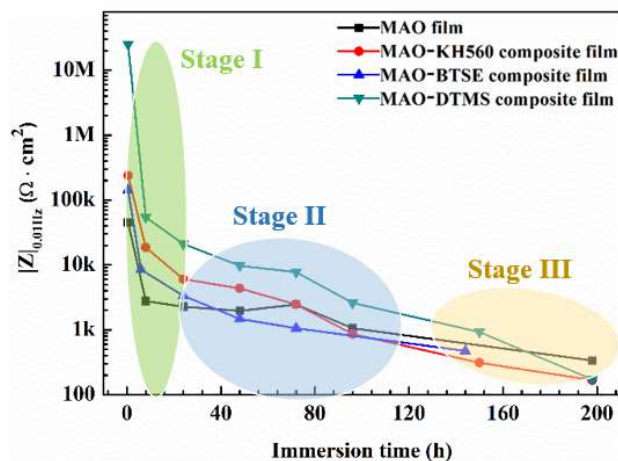
Figure 8. Time dependence of impedance modulus at 0.01 Hz.

The low-frequency impedance modulus values ( $|Z|_{0.01\text{Hz}}$ ) can be used to evaluate the protective coating failure process [28]. Figure 8 shows  $|Z|_{0.01\text{Hz}}$  before and after the silanization treatment of the MAO film. The modulus satisfies MAO-DTMS > MAO-BTSE > MAO-KH560 > MAO film, which is consistent with the results of polarization tests. During the immersion process, the corrosive medium passes through the silane film and reacts with the magnesium alloy substrate, resulting in a gradual decrease in  $|Z|_{0.01\text{Hz}}$  of the composite layer. Additionally, during the early stage (stage I) of immersion (0.5–8 h), the  $|Z|_{0.01\text{Hz}}$  of the MAO-silane composite layer decreased rapidly from  $10^6$ – $10^7 \Omega \cdot \text{cm}^2$  to  $10^4$ – $10^5 \Omega \cdot \text{cm}^2$ . From 8–96 h of immersion (stage II), the decrease in the  $|Z|_{0.01\text{Hz}}$  slowed

down with prolonged immersion time due to the gradual accumulation of corrosion products in the micro-pores. This accumulation hindered the mass transfer process of the corrosive medium, thus delaying the corrosion reaction. The  $|Z|_{0.01\text{Hz}}$  was further reduced in stage III, which may be the reason for the gradual complete failure of the silane film.

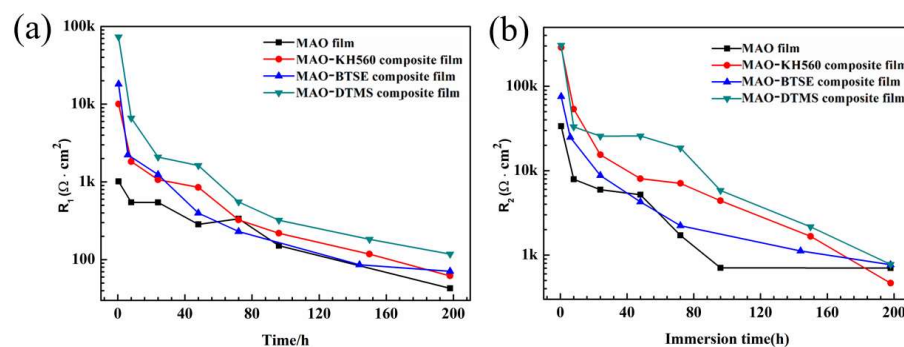
Figure 9. Time dependence of (a)  $R_1$  and (b)  $R_2$  of MAO film before and after silanization.

The fitting results of  $R_1$  and  $R_2$  with immersion time are shown in Figure 9. The trend of  $R_1$  and  $R_2$  with immersion time is similar. During the initial stage of immersion (0.5 h), the  $R_1$  and  $R_2$  values for the MAO-silane film are 1–2 orders of magnitude higher than those for the MAO film, indicating a significant enhancement in the physical shielding capability of the MAO film due to silanization treatment. In the middle phase of immersion (8–48 h),  $R_1$  and  $R_2$  gradually decrease with immersion time, as the silane film hinders the mass transfer process of the corrosive medium. As the immersion time reaches 48–72 h, the resistance values of  $R_1$  and  $R_2$  decrease significantly once more, likely because the silane film is hydrolyzed by the corrosive medium, leading to a reduction in the density of the silane film.

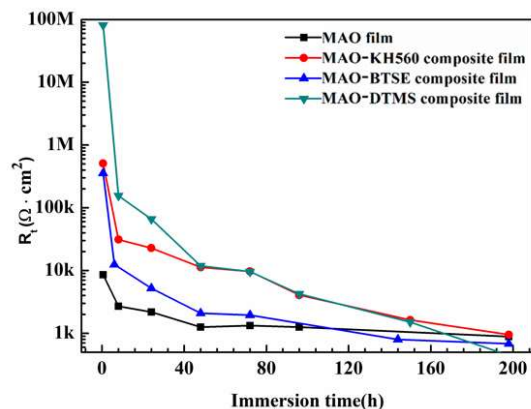
Figure 10. Time dependence of  $R_t$  of MAO film before and after silanization.

A higher resistance value of the charge transfer resistance ( $R_t$ ) indicates greater difficulty in charge transfer at the interface between the magnesium alloy substrate and the corrosive medium [29]. In Figure 10, during the initial stage of immersion (0.5 h), the  $R_t$  value for MAO-DTMS was  $10^8 \Omega \cdot \text{cm}^2$ , while the  $R_t$  values for MAO-KH560 and MAO-BTSE composite layers ranged from  $10^5$  to  $10^6 \Omega \cdot \text{cm}^2$ , significantly higher than that of the MAO film. From 0.5 to 8 h,  $R_t$  decreased rapidly, indicating the initial degradation of the silane film layer. As the immersion time progresses, the decrease in  $R_t$  may be attributed to the accumulation of corrosion products at the interface, leading to the hindrance of charge transfer. However, as the immersion time further extends, the corrosion channel widens, facilitating charge transfer.

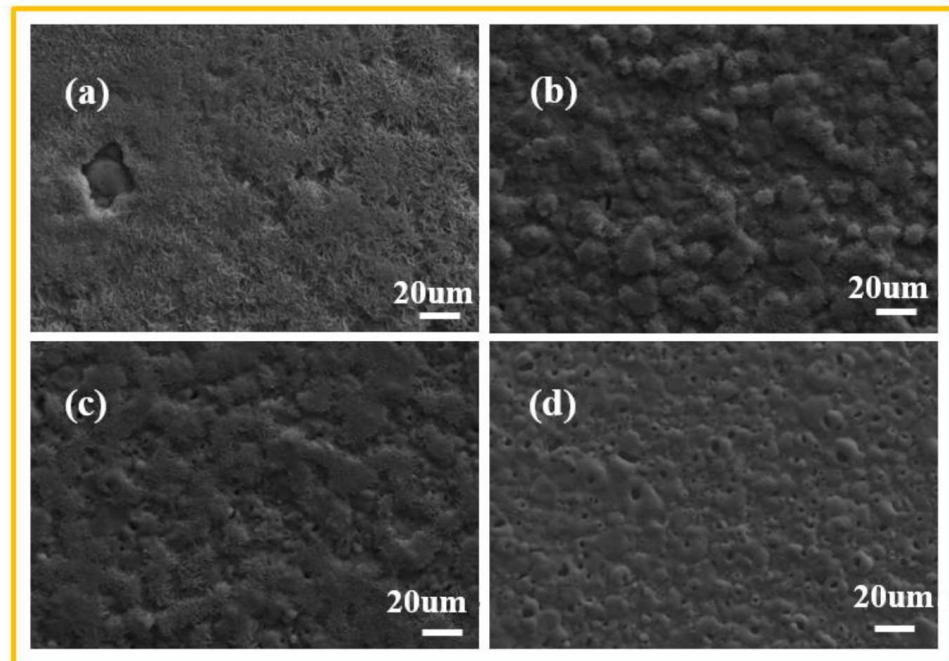
**Figure 12.** The microscopic surface morphology of MAO film after salt spray test before and after treatment with different silane coupling agents: (a) MAO coating; (b) KH560; (c) BTSE; (d) DTMS.

Figure 12 illustrates the micro-surface morphology of the MAO-silane composite film after the neutral salt spray test. Following the salt spray test, the micro-arc oxidation film underwent significant changes in surface morphology, resulting in the formation of a layer of loose and porous flaky corrosion products on the original surface. The surface of the MAO-DTMS composite film layer did not exhibit noticeable changes, possibly due to the effective surface hydrophobicity of the DTMS silane film, which inhibited the occurrence of corrosion reaction. Volcano-like protrusions of corrosion products were observed on the surface of the MAO-KH560 and MAO-BTSE composite film layers, indicating that the surface of the KH560 or BTSE silane membranes was incomplete, leading to the occurrence of corrosion.

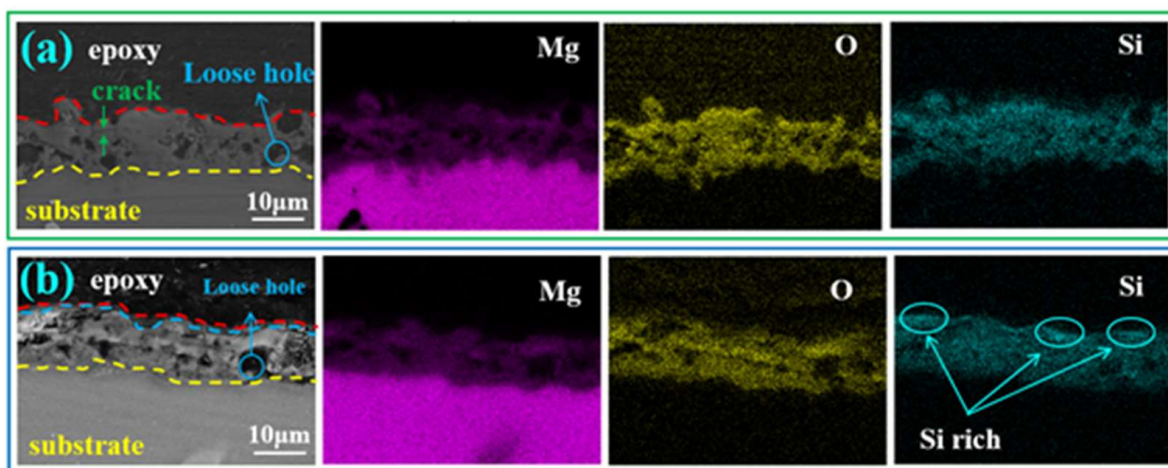
**Figure 13.** Micromorphology of the cross-section of MAO film (a) before and (b) after DTMS silanization.

Figure 13 depicts the cross-sectional morphology and elemental surface distribution of the MAO film before and after the silanization treatment. In Figure 13a, the MAO film is divided into an outer porous layer and an inner dense layer. The outer layer is thicker and more porous, whereas the inner layer is thinner but denser, exhibiting fewer defects. Furthermore, the elemental distribution diagram of the MAO film cross-section indicates that the film is predominantly composed of Mg, O, and Si. In Figure 13b, a “Si”-rich film layer is observed on the surface of the MAO film, indicating that the silanization treatment can effectively create a protective silane film on the MAO film. Moreover, significant enrichment at the micro-cracks was observed, indicating that silane can be deposited within the micro-cracks of the MAO film, enhancing the integrity of the MAO membrane [30].

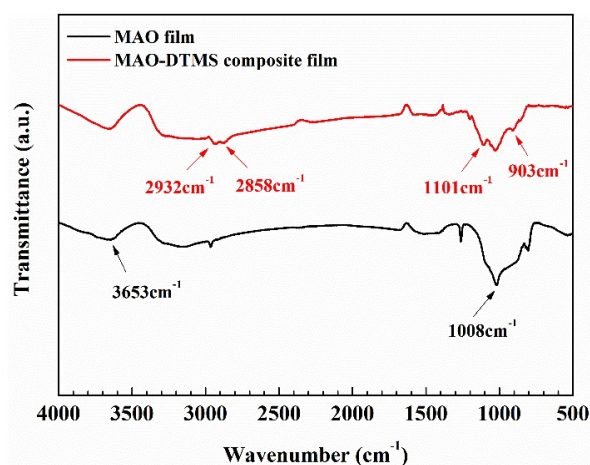
**Figure 14.** FTIR spectra of MAO film before and after DTMS silanization.

Figure 14 displays the FT-IR spectra of the magnesium alloy MAO film before and after the silanization treatment with DTMS. The peak at  $3653\text{ cm}^{-1}$  in the MAO film corresponds to the metal hydroxide O-H stretching vibration peak [31], while the peak at  $1008\text{ cm}^{-1}$  indicates the presence of  $\text{Mg}_2\text{SiO}_4$  in the MAO film [32]. Following silanization, peaks were observed at  $2932\text{ cm}^{-1}$ ,  $2858\text{ cm}^{-1}$ ,  $1101\text{ cm}^{-1}$ , and  $903\text{ cm}^{-1}$ , corresponding to the antisymmetric  $\text{CH}_2$ , symmetric  $\text{CH}_2$ , Si-O-S, and Si-OH stretching vibrations in the silane film [33], respectively. Notably, the peaks at  $3653\text{ cm}^{-1}$  and  $1008\text{ cm}^{-1}$  persist after the silanization of the MAO film, possibly indicating the destruction of the MAO film during sample preparation or the incomplete sealing of the MAO film by the silanization process.

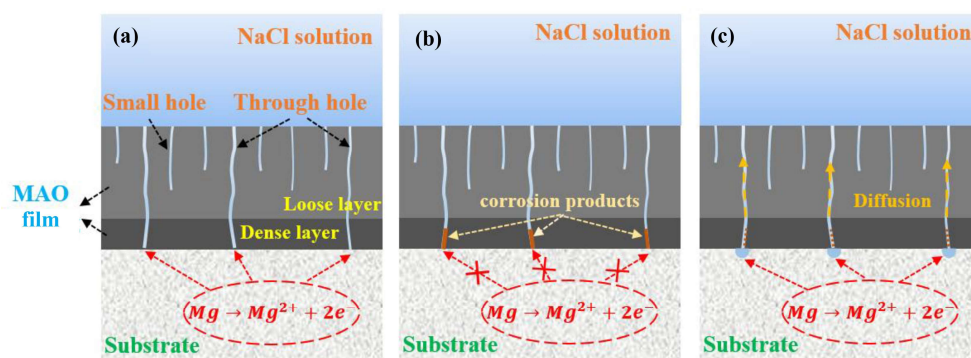
**Figure 15.** Schematic diagram of corrosion process of MAO-silane composite film. (a) initial stage, (b) corrosion product accumulation, (c) diffusion stage.

The corrosion mechanism of the MAO-silane composite film in a 3.5 wt.% NaCl solution is illustrated in Figure 15 based on the preceding analysis. This mechanism can be categorized into three stages based on Figure 7. In Stage I, the corrosive medium is obstructed by the silane film covering the MAO surface, providing effective corrosion resistance. Despite some corrosive medium penetrating the film through defects, the corrosion rate remains relatively low, as depicted in Figure 15a. As the immersion time increases, corrosion at the interface between the magnesium alloy substrate and the MAO intensifies, preventing timely outward diffusion of corrosion products. This results in the gradual accumulation of corrosion products in the pores, consequently decelerating the corrosion rate, as shown in Figure 15b. In Stage III, the surface silane film undergoes

gradual hydrolysis and dissolution, allowing corrosion products to diffuse outward through the exposed defects. This re-exposes the magnesium alloy substrate at the defects to the corrosive medium, accelerating the corrosion process, as illustrated in Figure 15c.
