Comparison of Rating Systems for Alberta Rock Slopes, and Assessment of Applicability for Geotechnical Asset Management

Abstract: In 1999, Alberta Transportation and Economic Corridors (TEC) implemented the Geohazard Risk Management Program (GRMP) to identify, assess, monitor, and prioritize the mitigation of risk resulting from geohazard events at specific sites along the provincial highway network. The GRMP was developed to address a variety of geohazard types including rockfall hazards that occur at natural and constructed (cut) highway backslopes. An evaluation of various methods for the condition assessment of rockfall geohazards, including TEC's current GRMP risk rating system, has been completed with the intent of better understanding the suitability of each method as TEC transitions to a formalized GAM program. The GRMP risk rating values for selected rockfall geohazard sites along highway corridors in Alberta were compared to values developed from the results of five established rock mass and rock slope rating systems. The results of this study demonstrate that TEC's current GRMP risk rating system is a viable tool for the condition assessment and performance monitoring o

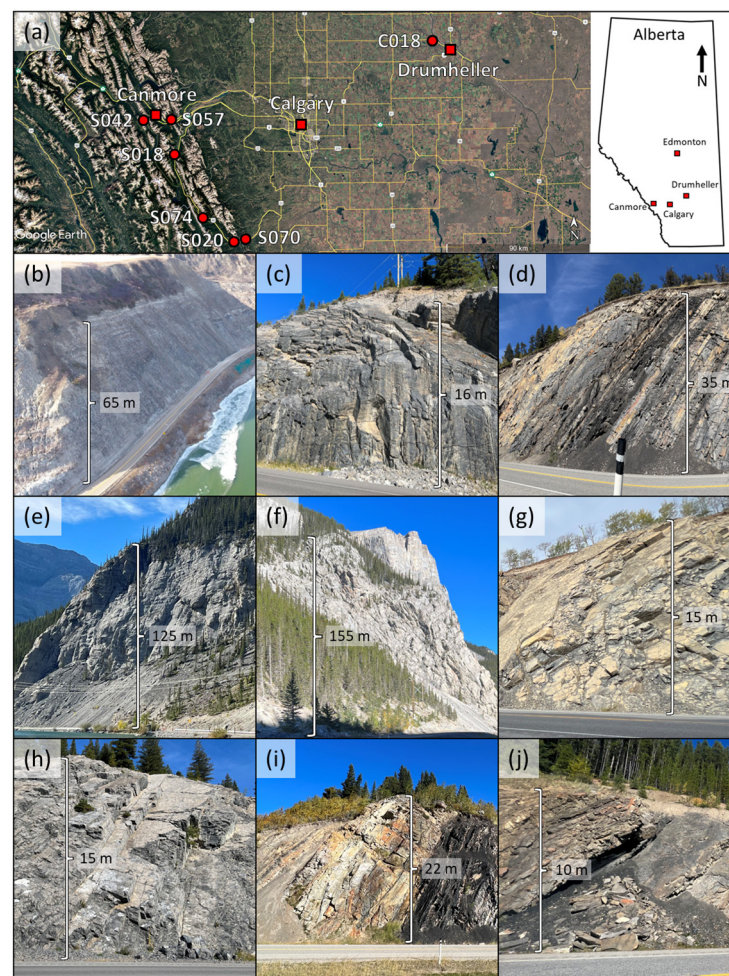
Figure 1. (a) Location of rock slope study areas (red circles) with map of Alberta and populated centres (red squares) as reference [48]. Site photos and approximate slope heights of (b) C018, (c) S018, (d) S020, (e) S042-North, (f) S042-South, (g) S057-A, (h) S057-B, (i) S070, and (j) S074.

The slope inspections and application of rating systems were completed on 12 November 2021 for site C018 in Central Alberta and between 24 and 25 September 2022 for sites S018, S020, S042, S057, S070, and S074 in Southern Alberta. Limited tools were required for the application of the selected rating systems, which included the following: a range finder with a built-in clinometer, a 2 m long measuring stick, and two measuring tapes with lengths of 6 m and 30 m. Preliminary ratings developed for C018 were published by Wollenberg-Barron et al. [47] and have been updated for inclusion in this study. The locations of the study sites and representative photographs are shown in Figure 1.

distinguished the relative difference in RL for small (S042-North-S and S042-South-S), or frequent, and large (S042-North-L and S042-South-L), or infrequent, rockfall block volumes corresponding to isolated rockfalls from block detachment and larger wedge failures, respectively. Large rockfall blocks volumes were defined as greater than 15 m³ by KCB [63]. The small rockfall block volume was selected as less than 0.3 m³ following the observations and analysis presented in Macciotta et al. [13] and Macciotta et al. [55] for S042. Subsequently, for the changes in rockfall event volumes, the Rockfall History and Rockfall Frequency categories pertaining to the RHRS and CRHRS, respectively, were adjusted to reflect the likelihood of the varying volumes. Note that small and large rockfall block volumes were applied to both the north and south slope portions of S042. The varying RLs associated with different failure mechanisms were incorporated into this study as additional data points to analyze the effectiveness of each rating system at capturing the change. The inclusion of the additional RL data increased the total number of slopes to 12 for each of the following comparative analyses. The GRMP ratings, estimated slope angles, and results of each rock slope and rock mass rating system for each study area are presented in Table 3 and may be inspected together with the slope photos presented in Figure 1.

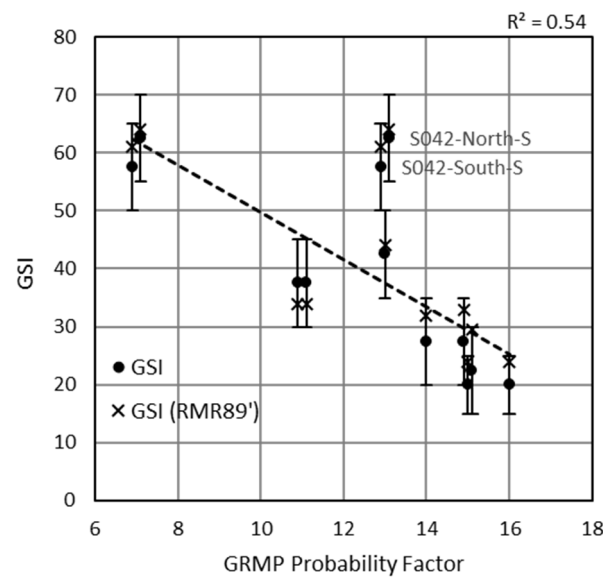
Figure 4. Correlation between and observed GSI, GSI from RMR89', and the prescribed GRMP probability factor for each slope.

An appropriate RMR score was determined for each slope and adjusted to fit the RMR89' requirements for direct comparison to GSI using Equation (5). Figure 4 presents the correlation between GSI, RMR89', and GRMP PF for each of the slopes included in this study. Vertical error bars correspond to the representative bounds of the GSI range selected for each of the slopes. The computed GSI value using RMR89' and Equation (5) proved very effective and fell within the representative GSI range for each of the slopes included in this study. The average percent difference of RMR89' to the median GSI value was 9% which is not significant from a practical geotechnical engineering perspective.

Q-Slope, GSI, and RMR are not formally considered preliminary assessment tools for the application of GAM but still resulted in moderately acceptable correlations to the GRMP probability factor (PF), as shown in Figure 3 for Q-Slope, with an R^2 of 0.40 to 0.48, and in Figure 4 for GSI and RMR, with an R^2 of 0.54. Outliers for each methodology could be explained with reasoning pertaining to site-specific characteristics, e.g., varying failure mechanisms and rockfall event volumes (S042 and C018), the presence of rockfall mitigation measures (S018), or slope heights extending beyond the rating system's input ranges (C018 and S042 for Q-Slope). The limitations of Q-Slope, GSI, and RMR pertaining to their applicability to GAM are evident since they do not carry the capacity to measure consequence and, subsequently, risk. However, when considering the likelihood of failure alone, Q-Slope could be employed as a tool to determine PF if varying rockfall event volumes are considered through their failure mechanism and not strictly volume. The selection of an appropriate Discontinuity Orientation Factor (O-factor) proved to be the most challenging aspect when implementing Q-Slope due to the ambiguity of discontinuity orientation descriptions. Careful consideration must be made by the scorer to maintain consistency throughout an asset inventory when applying Q-Slope. GSI should be considered as a solid baseline methodology to determine the likelihood of a rockfall occurring. Its correlation with the GRMP PF gives credit to TEC's PF at capturing the reality of low-quality rock masses bearing a greater likelihood of rock block detachment.
