# Fine Characterization Method of Concrete Internal Cracks Based on Borehole Optical Imaging

**Abstract:** The internal cracks of concrete are very important in the safety evaluation of structures, but there is a lack of fine characterization methods at present. Borehole cameras are a piece of in situ borehole detection technology which can measure the structural elements of a borehole wall with high precision. In this paper, borehole camera technology is used to measure the concrete cracks of a tunnel floor, and the morphological characteristics (depth, width, and orientation) of the cracks are analyzed. The results show that the average extension depth of the crack extending from the orifice exceeds 1.195 m, and the width decreases with the increase in depth. The crack orientation is basically stable, with the maximum deviation of 19° at the orifice of different boreholes and 30° at different depths of the same borehole. The crack inside the concrete (not extending to the orifice) usually has a small extension depth and a relatively stable width, but the crack orientation changes greatly. The coarse aggregate and concrete interface have different effects on the extension directi

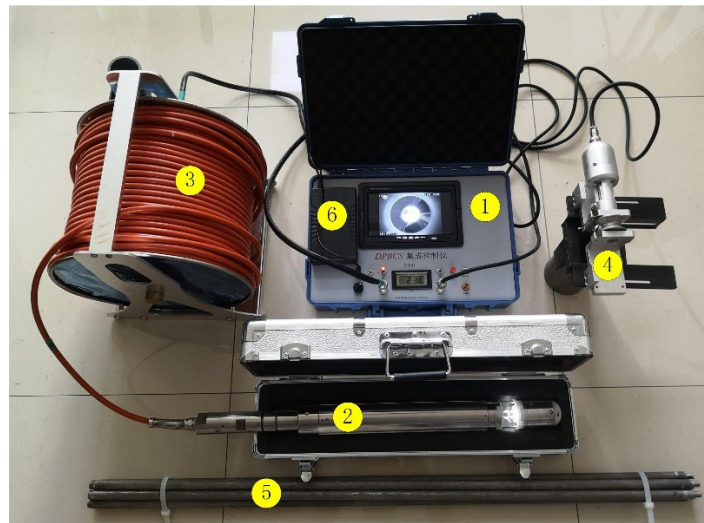
**Figure 1.** Digital panoramic borehole camera system (1—Control box; 2—Optical probe; 3—Flexible cable; 4—Depth encoder; 5—Rigid push rod; 6—Power supply).

A borehole camera system is a kind of in situ optical measurement technology. This technology records the structural information of the borehole wall by continuous photography or video recording, and the measurement results are intuitive and low-cost. The equipment used in this paper is the digital panoramic borehole camera system (DPBCS) developed by the Institute of Rock and Soil Mechanics, Chinese Academy of Sciences. The system mainly includes a control box, optical probe, flexible cable, depth recorder, rigid push rod (used in nonvertical downward boreholes), and power supply components. The structural diagram of the DPBCS is shown in Figure 1.

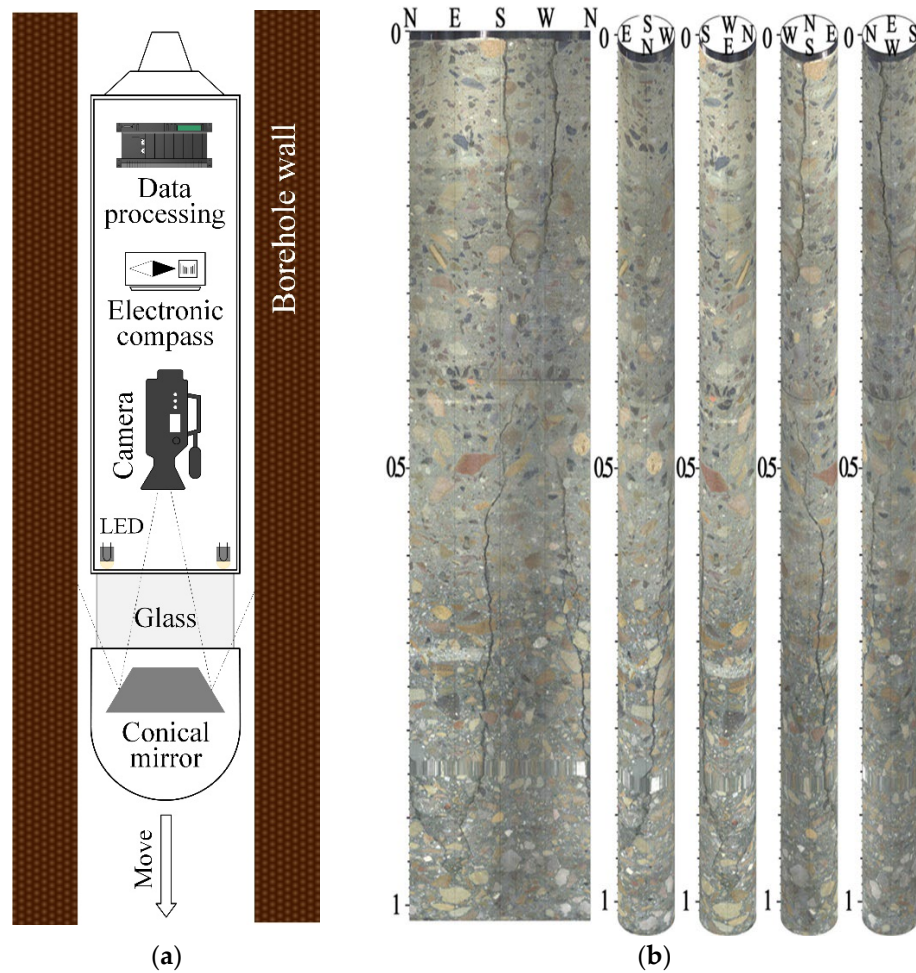
**Figure 2.** Principle of borehole camera system. (a) Measurement process. (b) Borehole wall image.

The optical probe is the most critical component of the system, mainly including a data-processing module, electronic compass, LED light source, glass window, camera, and conical mirror, as shown in Figure 2a. The optical probe has three sizes, with diameters of 31 mm, 51 mm, and 73 mm, respectively, and corresponding lengths of 471 mm, 462 mm, and 587 mm, respectively. The functions of the three types of probes are the same, and the probe closest to the borehole diameter is usually selected for use. The use of conical mirror technology is creative, so that the 360° borehole wall reflects into a planar panoramic image. The advantage of this technology is that the camera can capture a video image of the 360° borehole wall at the same time without rotating the probe. The LED light source illuminates the borehole wall through the glass window, and the light is reflected into the camera by the conical mirror. The conical mirror is located in the focal length range of

Figure 2a shows the measurement process. As the optical probe moves in the borehole, the video image, orientation information, and depth information of the borehole wall structure are collected and saved. Because the conical mirror technology reflects the panoramic strip image, the image must be restored to a form convenient for viewing through a certain algorithm. As shown in Figure 2b, the borehole wall image collected by the borehole camera system is shown. The first picture is the plan expansion of the borehole wall along the due north direction, and the other four are borehole histograms from different perspectives. In the image, the aggregate and cracks on the borehole wall can be clearly seen. The top of the image is the orientation data, and the left is the depth data; that is, the coordinates of each pixel on the borehole wall are determined.

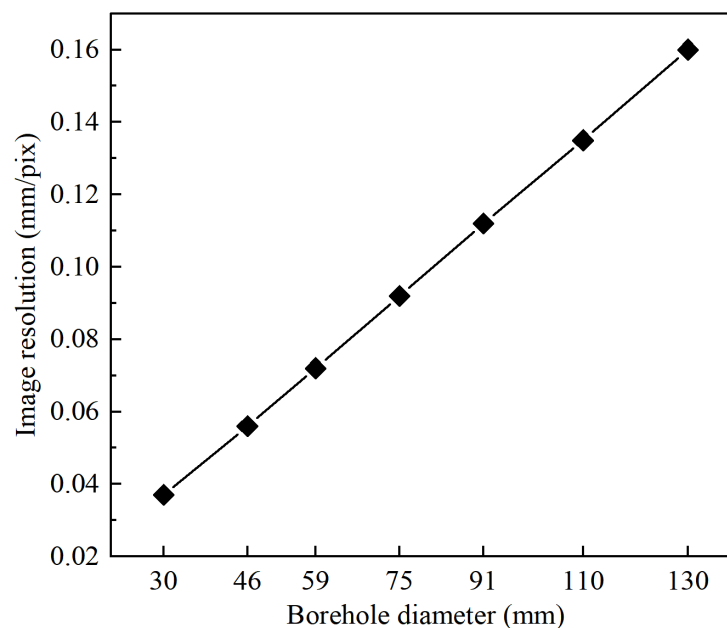
**Figure 3.** Relationship between borehole diameter and image accuracy.

The measurement accuracy of the concrete crack is also the resolution of the borehole wall image. The hole wall image is a dot matrix composed of pixels, so it is necessary to analyze the corresponding relationship between the image pixels and the real size of the observed points. The axial resolution of the borehole wall image obtained by the digital borehole camera system can reach 0.1 mm/pix. The circumferential resolution of the image is related to the borehole diameter. The borehole wall images obtained from exploration boreholes with different diameters correspond to different circumferential resolutions. The maximum number of pixels in the circumferential direction of the borehole wall image obtained by the digital borehole camera system is 2560, and the circumferential resolution of the image in the conventional exploration boreholes with different diameters is shown in Figure 3.

It can be seen from Figure 3 that the circumferential resolution of the hole wall image decreases with the increase in the hole diameter. The resolution is 0.037 mm/pix in 30 mm

diameter holes and 0.16 mm/pix in 130 mm diameter holes. The measurement accuracy is fully sufficient in concrete crack detection.

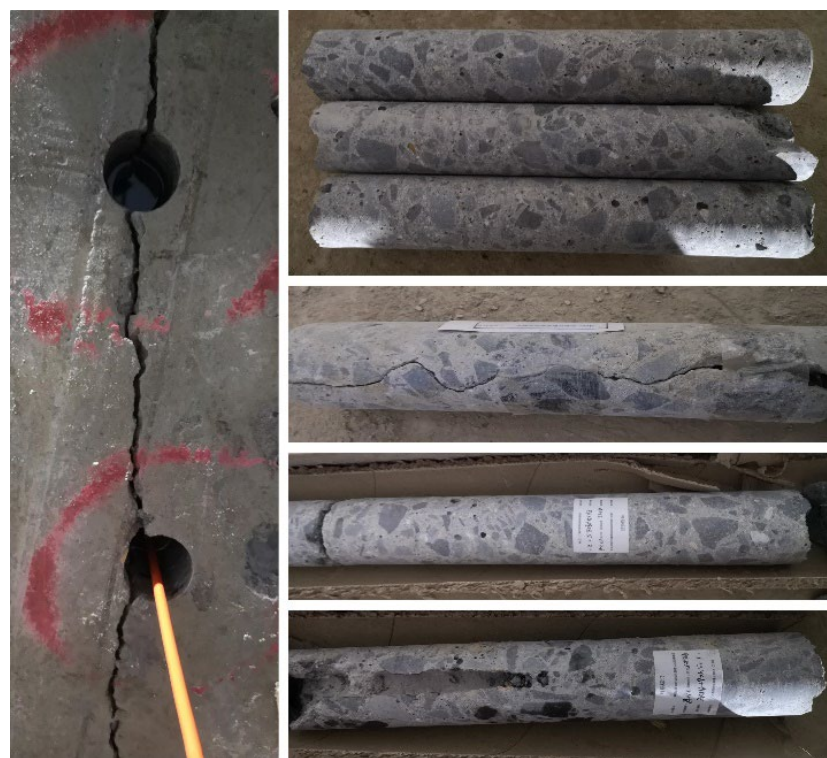
**Figure 4.** Concrete crack and concrete cores.

The measurement project is a highway tunnel with open excavation and concealed burial construction. After backfilling with soil and stone, a long and deep crack appeared on the bottom plate along the axis of the tunnel, as shown in Figure 4. In order to quantitatively evaluate the cracks, several drilling and coring operations were carried out at the crack location. However, the drilled concrete core cannot accurately describe the characteristics of cracks. Because some concrete cores are broken and damaged, it is impossible to determine whether the damage is caused by drilling factors or crack expansion. More importantly, it is difficult to determine the width of cracks and the extension direction inside the concrete, and it is impossible to evaluate the development of cracks with time through the concrete core.

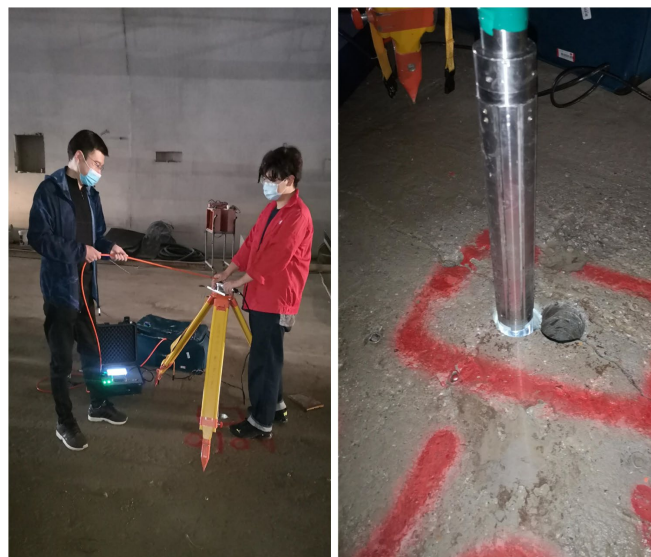
**Figure 5.** Measurement site and measurement equipment.

Therefore, in order to quantitatively characterize the morphological characteristics of internal cracks in concrete, the cracks on the borehole wall were quantitatively measured using borehole camera technology in the borehole after coring. Due to the large number of on-site boreholes, we selected nine representative boreholes for measurement. The borehole number and measurement depth are shown in Table 1. The diameter of all boreholes was 57 mm, and the diameter of the optical probe used in this paper was 51 mm. Figure 5 shows the measurement site and measurement equipment.

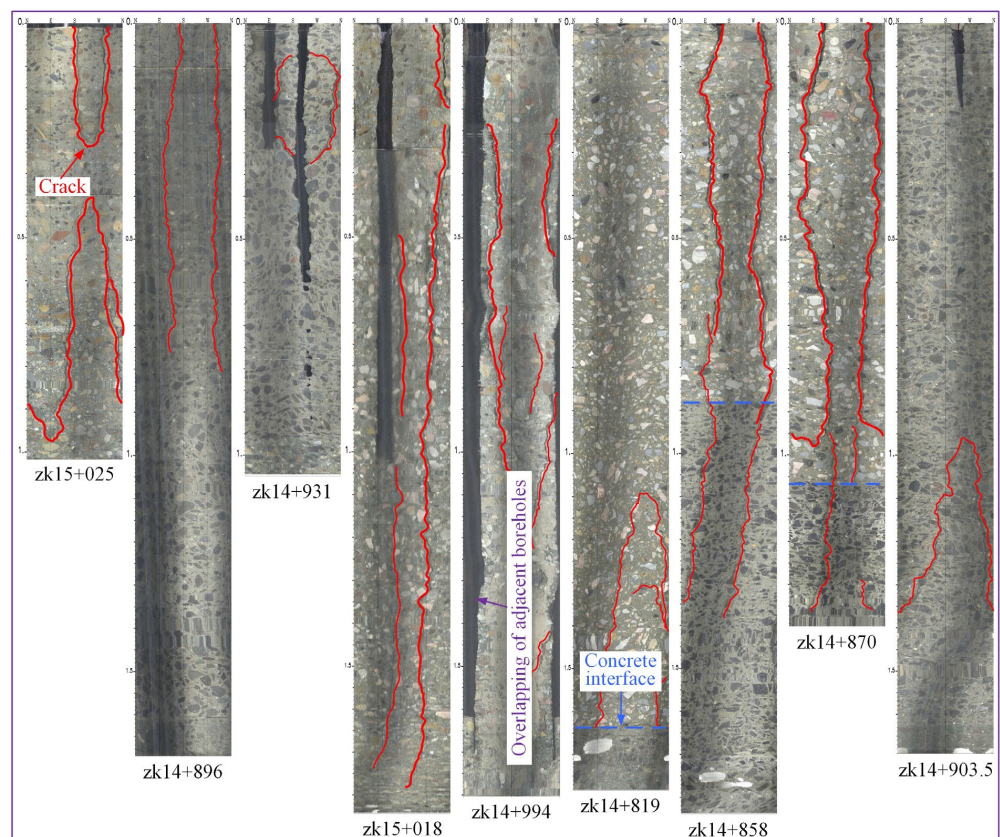
**Figure 6.** Borehole wall images of 9 measuring boreholes.

After measurement, high-resolution borehole wall images of nine measurement holes were obtained, as shown in Figure 6. In the borehole wall image, structural information, such as aggregate, damage, and cracks, can be clearly observed. For the convenience of viewing, the shape of the crack is depicted with red lines in Figure 6. It should be reminded that the wide black vertical defects in the figure are not cracks, but borehole wall defects caused by the overlapping of adjacent boreholes. There are two types of cracks in the nine boreholes, the cracks that expand from the orifice (zk15 + 025, zk14 + 896, zk15 + 018, zk14 + 994, zk14 + 858, and zk14 + 870) and the cracks inside the concrete (not extending to the orifice; zk15 + 025, zk14 + 931, zk14 + 819, and zk14 + 903.5).

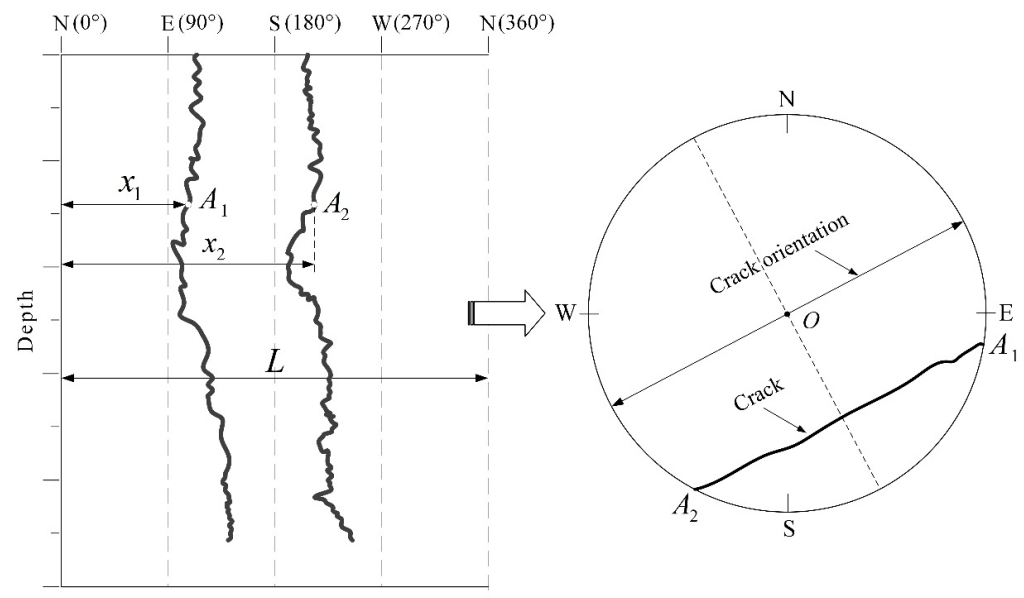
**Figure 8.** Calculation principle of crack orientation in borehole wall image.  $A_1$  and  $A_2$  are two points on the crack at the same depth in the borehole wall image, respectively.  $x_1$  and  $x_2$  are the distances from  $A_1$  and  $A_2$  to the leftmost side ( $0^\circ$ ) of the borehole wall image, respectively.  $L$  is the perimeter of the borehole.

The extension orientation of the crack is very important for describing the morphological characteristics. An accurate understanding of the crack orientation is very important for analyzing the cause of crack initiation and subsequent repair. When the crack intersects with the borehole, two cracks will appear on the expanded image of the borehole wall, as shown in Figure 8. The crack may intersect with the borehole at any angle, and when the crack does not pass through the borehole center, the orientation of the crack cannot be directly seen on the borehole wall image. Figure 8 shows the calculation principle of the crack orientation at any position on the borehole wall. Suppose that at a certain depth in the borehole wall image, the two points on the crack are  $A_1$  and  $A_2$ , respectively, then the orientation of the crack at this depth can be expressed as Equation (1):

$$\gamma = \frac{1}{2L}(x_1 + x_2) \times 360^\circ \pm 90^\circ \quad (1)$$

where  $\gamma$  is the orientation of the crack.  $x_1$  and  $x_2$  are the distances from  $A_1$  and  $A_2$  to the leftmost side ( $0^\circ$ ) of the borehole wall image, respectively.  $L$  is the perimeter of the borehole.

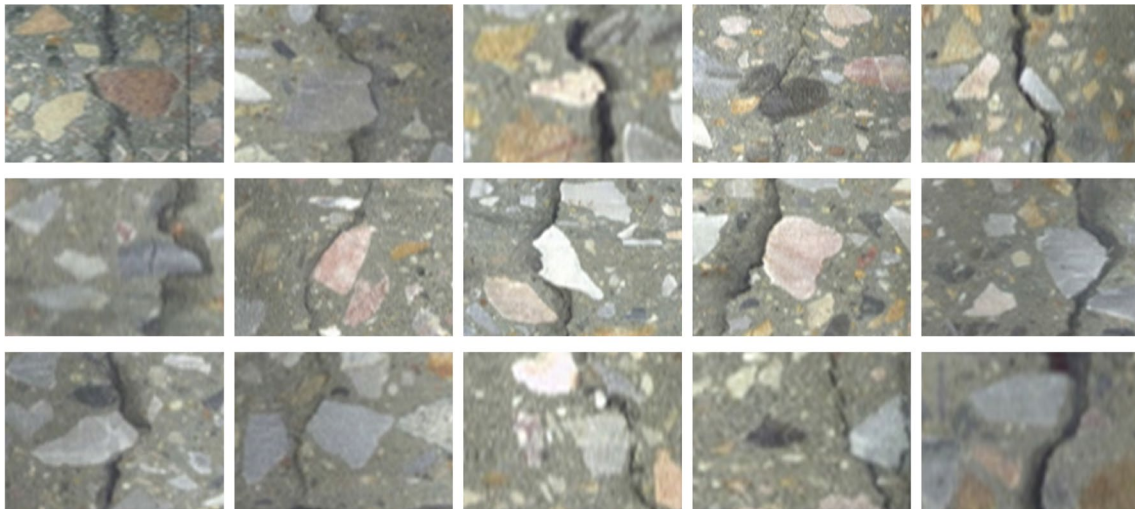
**Figure 10.** Crack extension characteristics at the edge of coarse aggregate.

There was little difference in the orientation of cracks at the orifice. The orientation of cracks at the orifice was measured in boreholes zk15 + 025, zk14 + 896, zk14 + 858, and zk14 + 903.5, which were 151°, 143°, 132°, and 132°, respectively, and the maximum difference was only 19°. The orientation change of cracks at different depths in the same borehole was relatively small, and, basically, the deviation did not exceed 30°. However, after passing through the concrete interface and entering another different type of concrete, the orientation of cracks changed significantly. The change in crack orientation inside the concrete was relatively large. For example, in boreholes zk14 + 819 and zk14 + 903.5, the change in crack direction reached 59° and 43°, respectively, in a short extension depth. The crack extension in the concrete is affected by the coarse aggregate structure. The crack extends along the interface between coarse aggregate and mortar, and rarely directly penetrates the coarse aggregate, which affects the orientation of the crack to a certain extent, as shown in Figure 10. However, in this paper, the influence of coarse aggregate on the orientation of cracks that extended from the orifice was limited. After bypassing the coarse aggregate, the crack soon continues to extend along the previous orientation.
