Article

Experimental Study on Failure Mechanism and Mode of Fly-Ash Dam Slope Triggered by Rainfall Infiltration

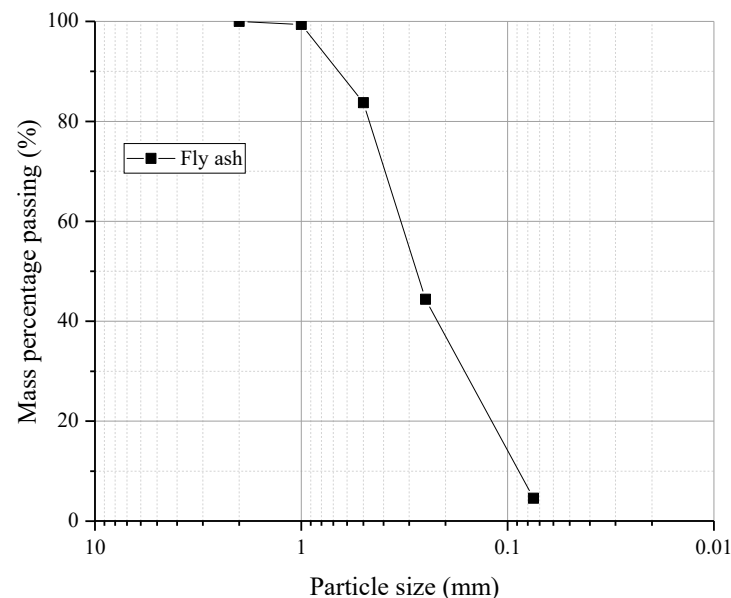
Figure 1. Particles grading curve of fly ash.

In this test fly ash was selected from the Xiangyanggou fly-ash dam in Shijiazhuang City, China, and gravel was used in the initial dam. Its physical and mechanical parameters are shown in Table 1, and the particles grading curve of fly ash is shown in Figure 1.

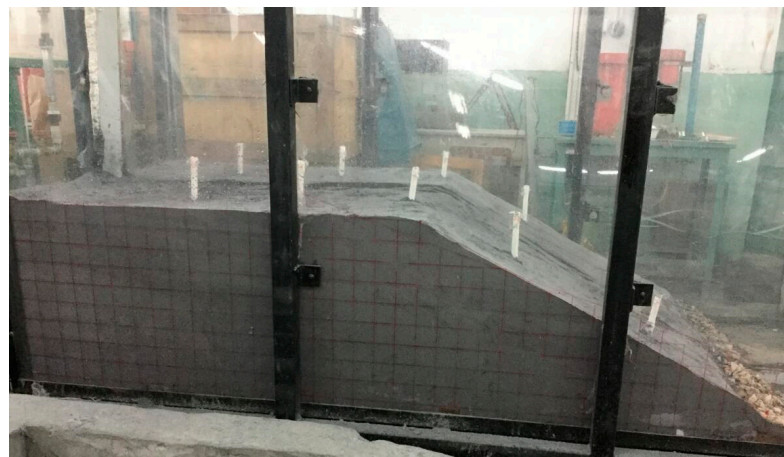
Figure 3. Pressure measuring pipes buried in the dam.

Firstly, the dam slopes of S1 and S2 were subjected to the seepage tests under the constant total head of 0.48 m. Both dam slopes had the same infiltration position. Five pressure measuring pipes were arranged in the dam body (as shown in Figures 3 and 4), and two settlement observation positions were set at the top and the middle of the dam-slope surface. In the seepage tests, the water level of the pressure measuring pipe would change with time. When the water level was stable in the pipes, it showed that the stable seepage fields were formed in the dams, and then the seepage tests were over.
