Failure Process of High-Loess-Filled-Slopes (HLFSs) during Precipitation under Different Mitigation Measures

Abstract: The problems of gully and soil erosion caused by large-scale urban construction and agricultural development in China have become more and more serious in recent years. In an effort to solve this problem, a series of gully stabilization and highland protection projects have been carried out on the Loess Plateau, and this has resulted in a large number of high-loess-filled-slopes (HLFSs). Although these filled slopes use several different mitigation measures, the HLFSs have been eroded and destroyed under the action of water. In order to study the influence of different mitigation measures on the stability of HLFSs and their failure process, this paper uses a flume test of the effects of various mitigation measures on this failure process. The results show that: (1) the failure processes of slopes with different mitigation measures are obviously different. Slope deformation u with a declining gradient mitigation mainly occurs on the surface of the slope body, and although slope erosion is quite serious, the slope does not fail as a whole. Slopes with a stepwise dra

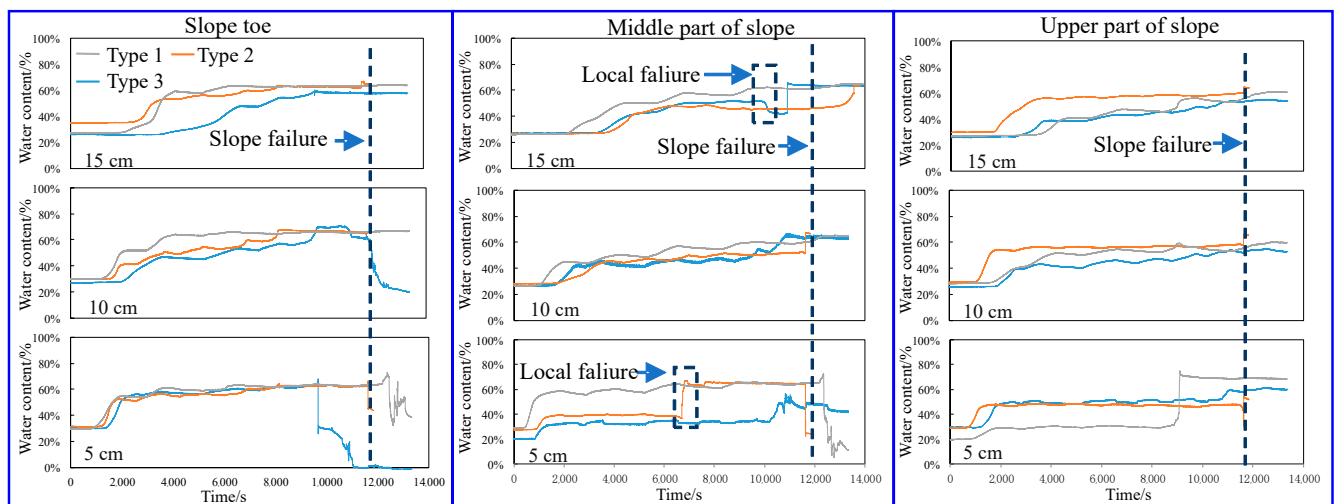
Figure 3. Water content changes for different slopes at different sites.

The changes in the water content of different parts of the slopes with different types of mitigation measures are shown in Figure 3, and from the figure we can see that the changes were all quite similar. First, the water content gradually decreased before finally leveling off in all cases. In the early stage of testing, the infiltration rate of rainwater was relatively fast, and the soil water content curves increased rapidly within 15 min after the initial change in water content before stabilizing. In the later stage of the experiment, the slope surfaces reached saturation, and the water content of the soil at different positions and depths stayed at around 60%. In addition, the rainwater infiltration rates of all types of slopes showed were fastest at the upper part of the slope and became slower toward the toe.

As far as what differences there were in the water content changes with different types of mitigation measures, due to the converging effect of the slope drainage channels, which effectively prevent rainwater from accumulating on the slope surface, the time until rainwater infiltration to deep soil (15 cm) was relatively slow (Figure 3). Additionally, the infiltration rate of slopes with a stepwise drainage channel mitigation measure was slower than with the other two types of slopes, and the time required for the soil to reach saturation was longer as well.

Regarding local changes, the water content changes in slopes without any mitigation measures were linked to both local and overall failure. When a large-scale block failure occurred at the slope middle, the moisture sensors (5 cm) had obvious fluctuations. The same phenomenon also occurred when the overall slope failed. From Figure 3 we can see that this change was synchronous with the instability of the slope and was a nearly instantaneous change. The response of shallow soil (5 cm) was the most obvious. Shallow

When the slope without any mitigation measures failed, the water content of the shallow soil (5 cm) at the upper, middle, and toe of the slope all showed almost instantaneous drops, with the most obvious changes at the upper and middle parts and only a slight change at the toes. The water content of the deeper soil (10 cm, 15 cm) also changed but varied within wide limits. These changes in water content did not appear in the other two types of slopes. The slope with the step-by-step mitigation measure had failures mainly concentrated on the slope surface, and a landslide even occurred in the later stage that had a relatively shallow depth little impact on the deeper soil's water content. Therefore, in the later stage of the experiment, the soil water content of the slope with a declining gradient mitigation did not undergo any sudden changes. The water content of the slope with a stepwise drainage channel mitigation measure also did not undergo any sudden changes, and the water content of the soil at each position increase gradually without sudden uplifts or drops.

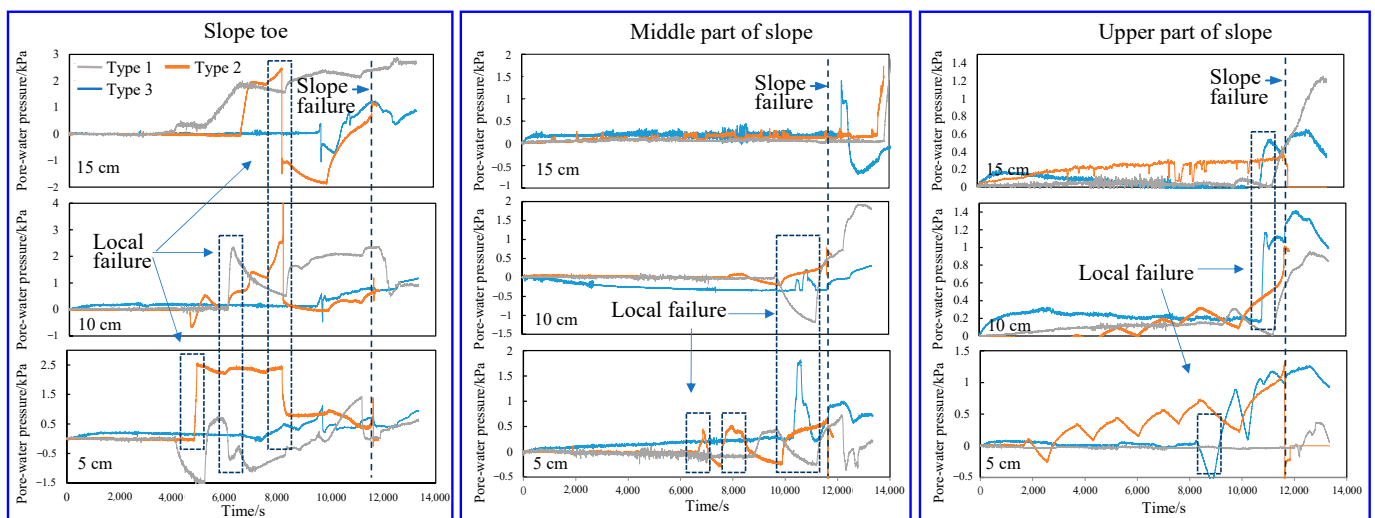
Figure 4. Pore-water pressure changes for different slopes at different sites.

Variations in pore-water pressure show a periodicity and strong correlation with the slope deformation [42,43]. In our experiments, fluctuations in pore-water pressure mainly occurred during various stages of slope failure. In the initial stage of the testing, the deformation of the slope occurred due to creep caused by an increase in the slope's water content and erosion on the slope surface. During this stage, the pore-water pressure at the toe and middle part of the slope changes only slightly, with a small upward trend (Figure 4).

In the second stage of the testing, continuous rainfall caused surface instability and a shallow slide in the slopes, and the pore-water pressure changed with these events (Figure 4). The pore-water pressure in given area had significant fluctuations during local failures in that area. When the sliding depth was shallow, only the surface pore-water pressure had significant changes, and when the sliding depth was high, the pore-water pressure at different depths had a significant response. The responses of pore-water pressure during local failure of slopes with different mitigation measures were slightly different, however (Figure 4). Specifically, the fluctuation of pore-water pressure on the slope without any mitigation measure mainly occurred in the shallow soil (5 cm), and the pore-water pressure variation in the deep soil did not change significantly. Combined with the deformation data, this indicates that when a local failure occurred, the pore-water

pressure was mainly concentrated in the soil 5–15 cm deep from the slope surface, which means that the failure depth was concentrated at 5–15 cm as well. In the slope with step-by-step mitigation, the change in pore-water pressure was not significant, which indicates that at this stage, the response of the slope to rainfall was mainly concentrated on the surface. Although the water content in the deep soil increased, the pore-water pressure did not increase significantly, and the failure was mainly in the shallow soil. In the slope with a stepwise drainage channel mitigation, the pore-water pressure changed more rapidly, and the pore-water pressure in the deep soil (15 cm) was larger than in the other two types of slopes, indicating that the sliding surface of the slope was deeper than the other two types of slopes as well.

In the last stage of the testing, the slope without any mitigation measures experienced overall failure along a sliding surface under continuous rainfall. Pore-water pressure at different depths and locations underwent rapid changes all at the same time as well. The most significant change in pore-water pressure occurred in the shallow soil, and the change in the deep soil was relatively small. Unlike the changes in the second stage, the change in pore-water pressure was nearly instantaneous. The trend in pore-water pressure changed at different positions and was a sudden increase within 1–2 s, followed by a rapid decrease prior to stabilization. This phenomenon is due to the rapid failure of the entire slope causing almost instant displacement of various parts of the slope and subsequent poor drainage that led to excess pore water pressure. This in turn caused a sudden increase in pore-water pressure in various parts of the slope [44–46]. The slope with a declining gradient mitigation also experienced shallow sliding, with a synchronous increase in pore-water pressure at all parts of the slope before eventually stabilizing.

Compared to the slope without any mitigation measures, the changes in pore-water pressure in the slope with a declining gradient mitigation were more gradual, with a clear process of continuous growth and no pore-water pressure surges. The amplitude of the pore-water pressure response for the slope with a stepwise drainage channel mitigation was the highest during the local failure stage, and the subsequent pore-water pressure fluctuations were relatively weaker than with the other two types of slopes. During both local and overall failures, pore-water pressure both increased and decreased. Pore-water pressure decreased and became negative at the upper and middle part of the slope but increased at the toe of the slope. This indicates that the toe of the slope exhibited shear contraction characteristics that led to a sharp increase in pore-water pressure and that the upper part of the slope exhibited a tension stress state that led to a sharp drop in pore-water pressure [45,46].
