# Condition Monitoring of Wind Turbine Blades Using Active and Passive Thermography

**Abstract:** The failure of wind turbine blades is a major concern in the wind power industry due to the resulting high cost. It is, therefore, crucial to develop methods to monitor the integrity of wind turbine blades. Different methods are available to detect subsurface damage but most require close proximity between the sensor and the blade. Thermography, as a non-contact method, may avoid this problem. Both passive and active pulsed and step heating and cooling thermography techniques were investigated for different purposes. A section of a severely damaged blade and a small “plate” cut from the undamaged laminate section of the blade with holes of varying diameter and depth drilled from the rear to provide “known” defects were monitored. The raw thermal images captured by both active and passive thermography demonstrated that image processing was required to improve the quality of the thermal data. Different image processing algorithms were used to increase the thermal contrasts of subsurface defects in thermal images obtained by active thermography. A method called “Step Phase and Amplitude

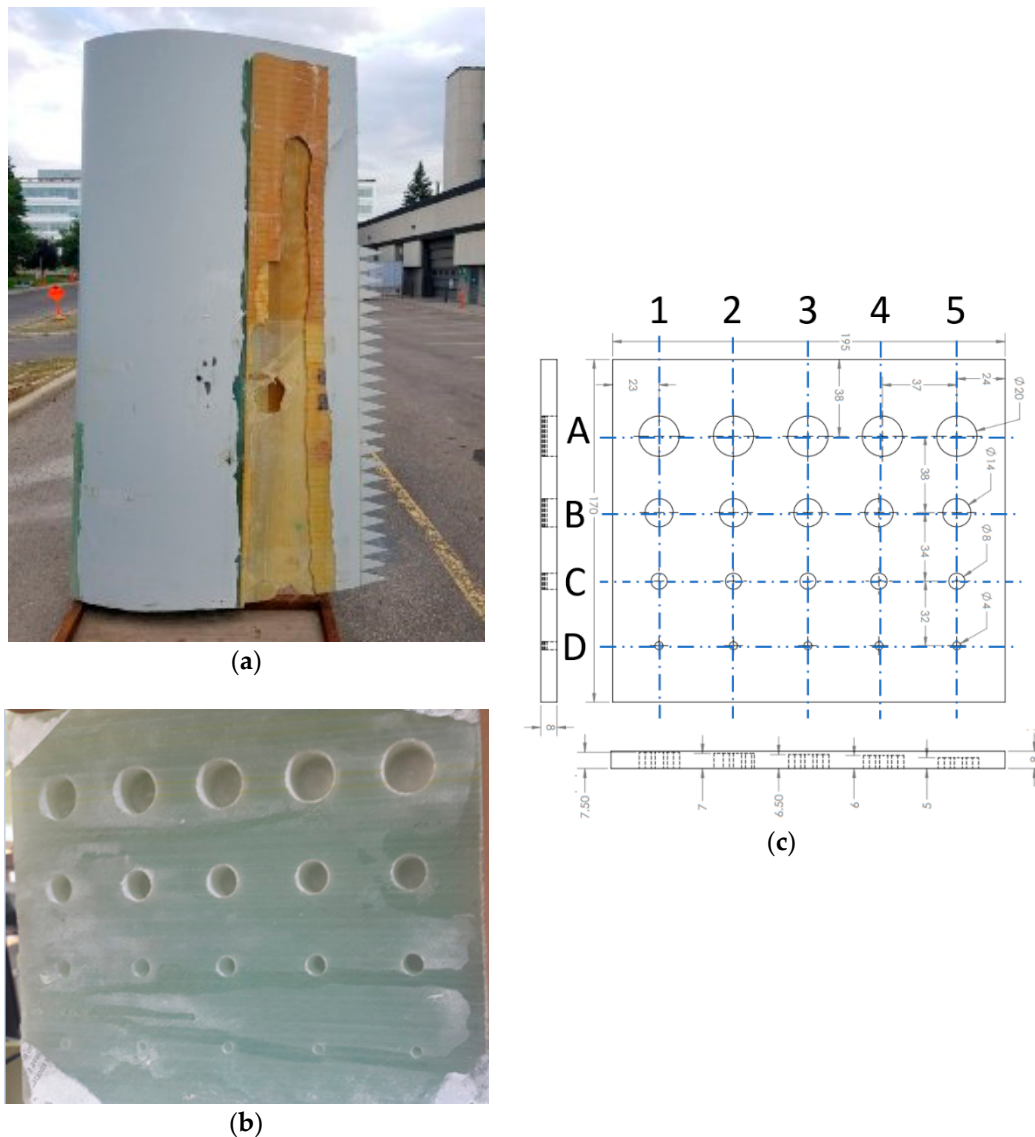
**Figure 1.** (a) The damaged wind turbine blade. (b,c) The defect plate with flat-bottomed holes. All holes were drilled from the rear and did not penetrate the outer surface.

All samples used in this experiment came from a 50 m long wind turbine blade made of fiberglass composite obtained after it had been damaged in transit to a wind farm. The blade was never installed or operated. Figure 1a shows the 3 m long blade section with significant surface damage that was used for the passive thermography experiments. The laminate thickness in the damaged section was 14 mm. The chord length was approximately 1 m. The yellow/orange regions in Figure 1a are the exposed sandwich core on the rear section of the suction surface where there is very little laminate. Some patches of glue on the suction side resulted in different emissivity than the background and therefore generated spots with different brightnesses on the thermograms. The upper side of the blade section contained a crack which was visible to the naked eye.

A “defect plate” with dimensions of 170 mm × 195 mm × 8 mm was cut from the laminate skin of another section of the blade closer to the tip where the laminate skin was thinner. Flat-bottomed holes with different diameters and depths were drilled from the rear to produce a range of known “defects”. The holes had diameters ranging from 4 mm to 20 mm with depths between 0.5 mm and 3 mm. Figure 1c is a schematic of the plate that illustrates the geometry and pattern of the defects. No holes penetrated the outer surface of the plate which corresponded to the outer surface of a blade and all thermograms were of the outer surface. The defect plate was attached to the surface of the damaged blade section during passive thermography experimentation. It was also the only blade

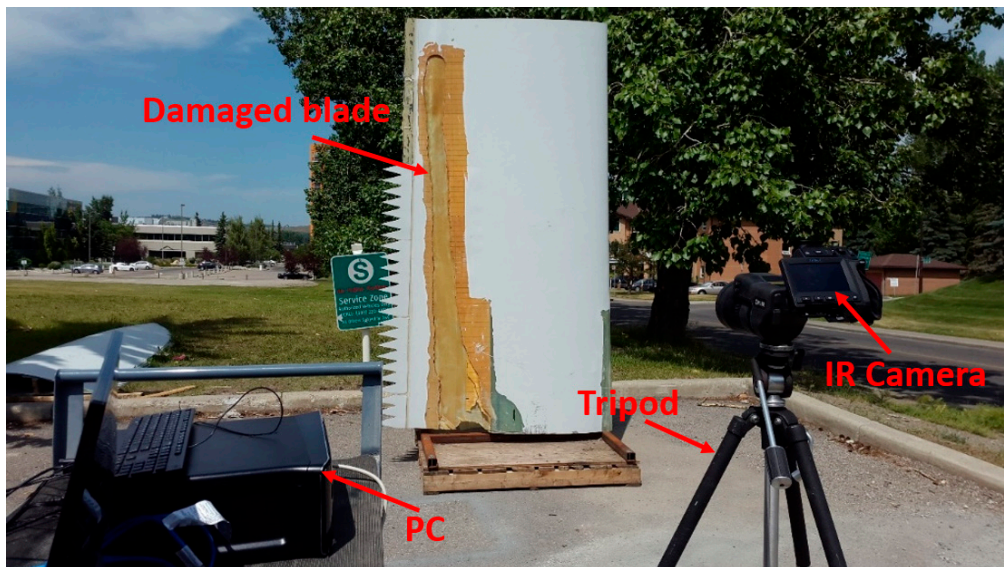
Figure 2. Passive thermography experiment.

In the passive thermography experiment, the suction side of the blade was monitored outdoors during a sunny day from morning until the afternoon. The blade’s position was not changed relative to the IR camera during this time. This experiment, whose setup is depicted in Figure 2, sought to determine the most favorable conditions to reveal the most defects and to evaluate the fault detection capability of thermography when the blade is heated by the sun.

The experiment was conducted on a sunny day in July 2017 from 9:00 a.m. to 7:30 p.m. Sunrise and sunset on this day were 5:53 a.m. and 9:30 p.m., respectively. During the experiment, the sky was clear, the humidity was almost 36%, and the temperature varied between 16 °C and 26 °C. A T1030Sc IR camera made by FLIR Systems was located 4 m from the blade section and equipped with a 21.2 mm lens, resulting in a spatial resolution of 4 mm per pixel. ResearchIR, a software package developed

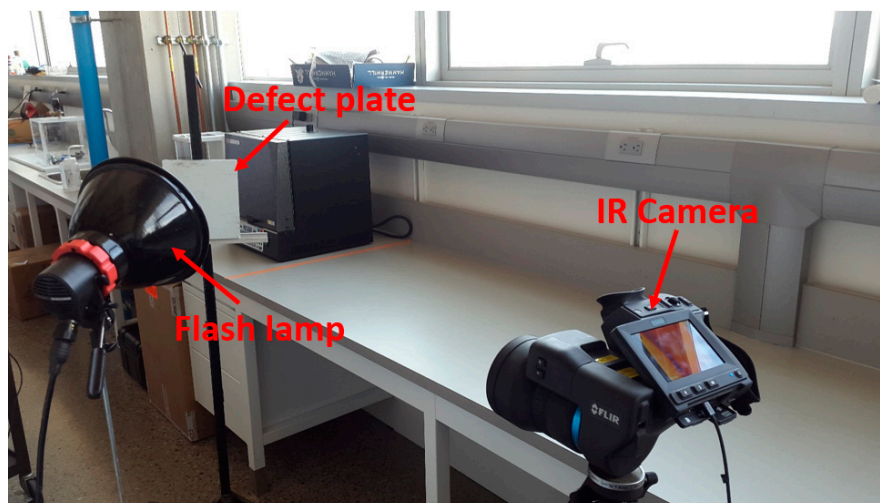
Figure 3. Pulsed thermography experiment.

These techniques were used only on the defect plate mounted 1.5 m from the IR camera. Despite being mounted near windows, the defect plate was always in a shadow during the experiments. During pulsed thermography, the defect plate was heated by a 2400 W flash lamp and thermal images were recorded at a frequency of 15 Hz immediately after flashing the sample. To heat the surface uniformly, the flash lamp was around 0.3 m from the object with the angle of around  $15^\circ$  with respect to the normal of the defect plate. The pulsed thermography experiment is depicted in Figure 3. The spatial resolution of thermal images obtained by active thermography was almost 0.5 mm per pixel.

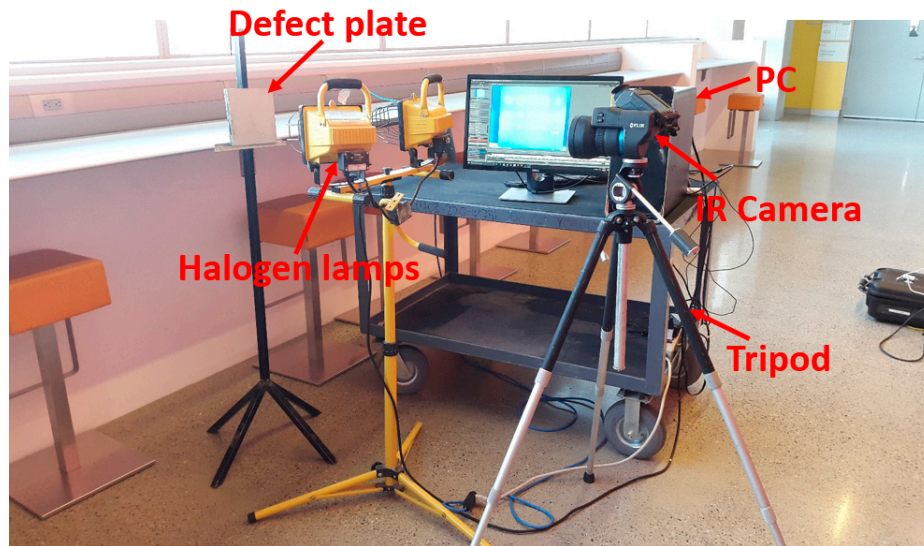
Figure 4. Step heating thermography experiment.

The step heating thermography experiment, shown in Figure 4, used two 500 W halogen lamps to continuously heat the surface. The sample was heated between 10 and 75 s and the thermal evolution on the surface of the specimen was recorded at a frequency of 15 Hz. Once heating was finished,

thermal decay was recorded with the same frequency. The room temperature was  $23 \pm 2 \text{ }^\circ\text{C}$  during the experiment. The thermal contrast associated with the defects could be observed after a few seconds of heating.

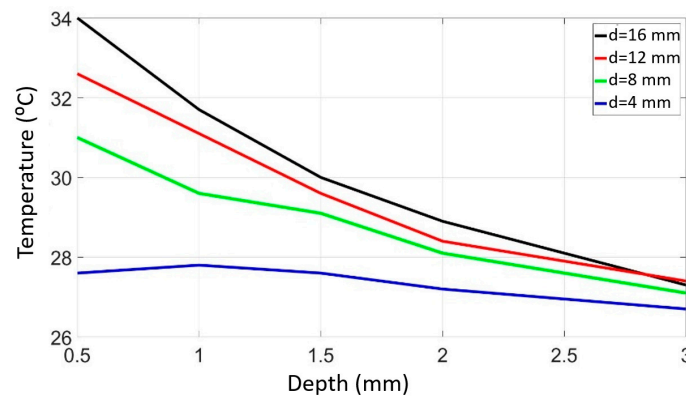
**Figure 6.** Effect of depth and size of the defect on the temperature distribution in a sample heated up by a halogen lamp for 75 s.

Temperatures near the defects were measured and analyzed to better evaluate the effects of the defect’s depth and size on the temperature variation. The temperatures measured at the locations of the flat-bottomed holes with various depths are illustrated in Figure 6. The sample was heated by two halogen lamps for 75 s, during which time data were recorded. It can be concluded from this figure that an increase in a defect’s depth reduces its temperature variation, which makes detection more difficult because there is not a significant change in the surrounding temperature.

By increasing the size of the defect, the slope of the temperature variation also increased, which implied that the effect of the depth variation on the temperature was more significant for larger defects.

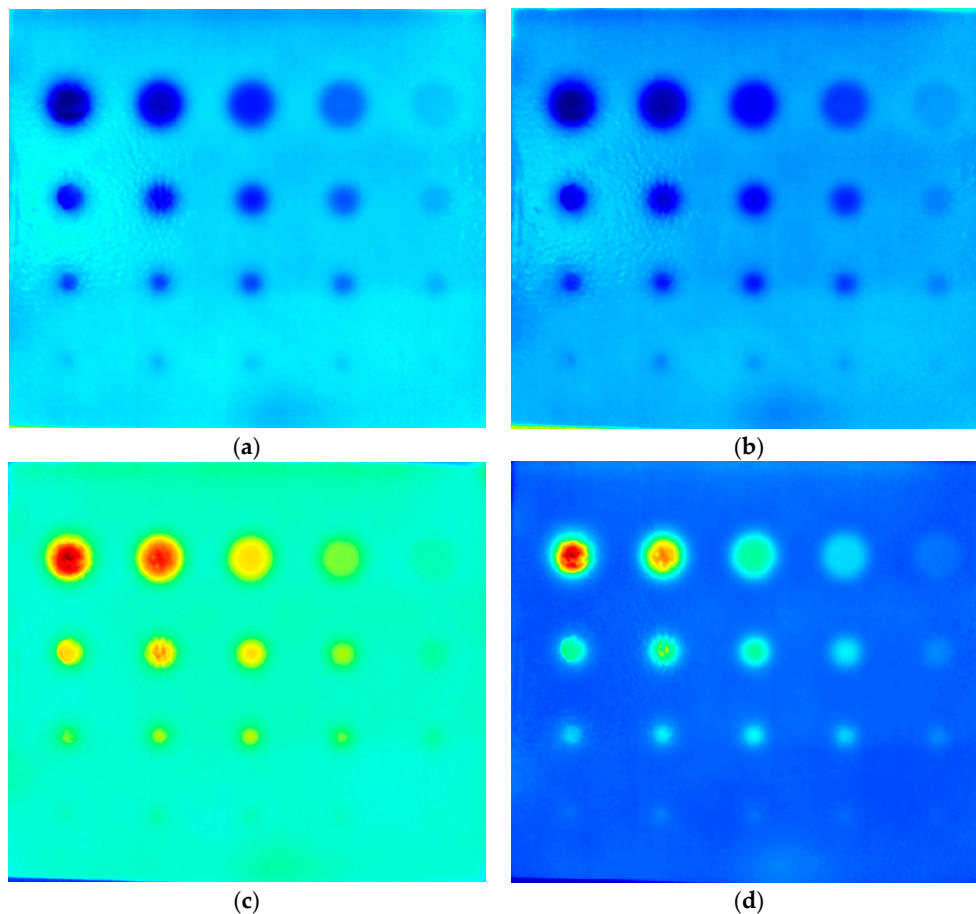
**Figure 7.** Four matched filters including (a) Spectral Angle Map (SAM), (b) Adaptive Coherence Estimator (ACE), (c)  $t$ -statistic and (d)  $F$ -statistic when the specimen was being heated.

Applying MF to the step heating thermograms improved the quality of the results, as shown in Figure 7. All four versions of MF increased the visibility and contrast of the defects. Three of these filters, including the SAM, the ACE, and the  $F$ -statistic, showed very promising results where all defects could be detected. However, the  $t$ -statistic highly improved the quality of the raw thermal data and compared to other MF methods provided less details regarding subsurface defects.

By using the above results, it can be seen that the diameter-to-depth ratio of the minimum detectable defect for each of SAM, ACE and *F*-statistic was 1.33, while this value for *t*-statistic was 2. To quantitatively evaluate the MF results, the SNRs for defective areas were determined. Figure 8a illustrates the signals of the *F*-statistic results obtained from the step heating data. The background noise around A2 is also shown in Figure 8b. These results were averaged to get the representative noise. It should be noted that all of the processed images have been normalized by dividing the intensity of each pixel over the difference between the maximum and minimum intensity available on the image.

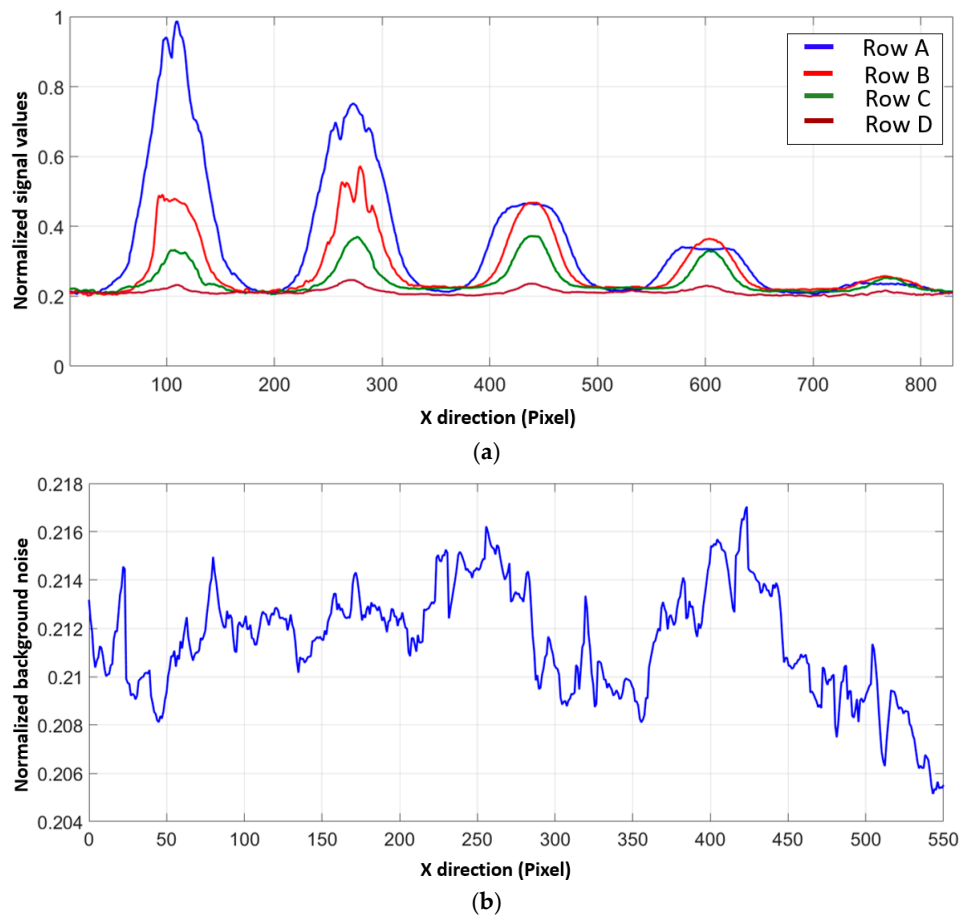
Figure 8. (a) Normalized signal values along the defect rows and (b) background noise around A2.

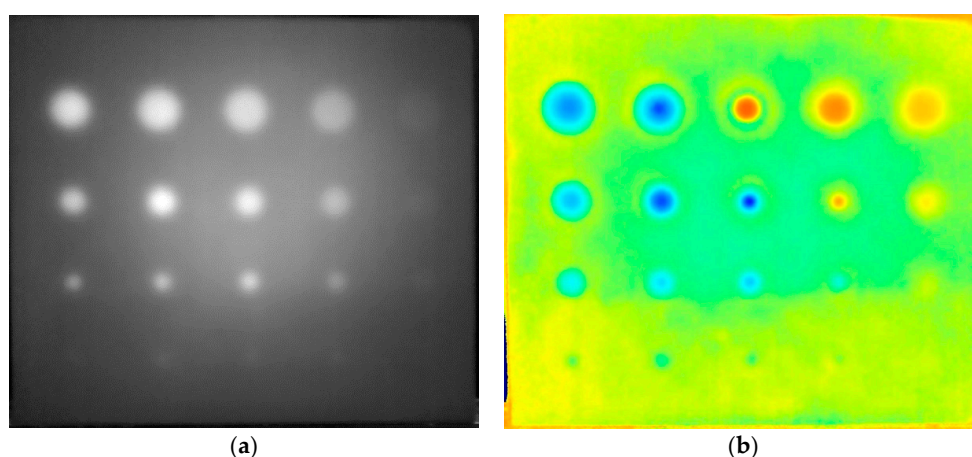
**Figure 9.** (a) Raw thermogram and (b) phase image (acquisition time = 53.2 s) obtained from the thermal image sequence recorded during cooling after flashing the surface.

Pulsed thermograms were converted to a frequency domain using the FFT and the phase images were analyzed. Since the surface was excited uniformly during step heating, both phase and amplitude images of the transformed step heating thermograms were evaluated. Figure 9a,b shows a comparison of the raw pulsed thermograms and the normalized phase contrast obtained using the FFT. PPT significantly increased the contrast so that all defects, except D5, were detected. The same normalization method as the one used for the MF method was applied to the results obtained using the transformed-based techniques.

The SNR values for the phase images depicted in Figure 9 are presented in Table 8, which shows that larger defects that were closer to the surface had higher SNRs. The first column of defects is an exception to this observation, mainly due to non-uniform heating of the surface.

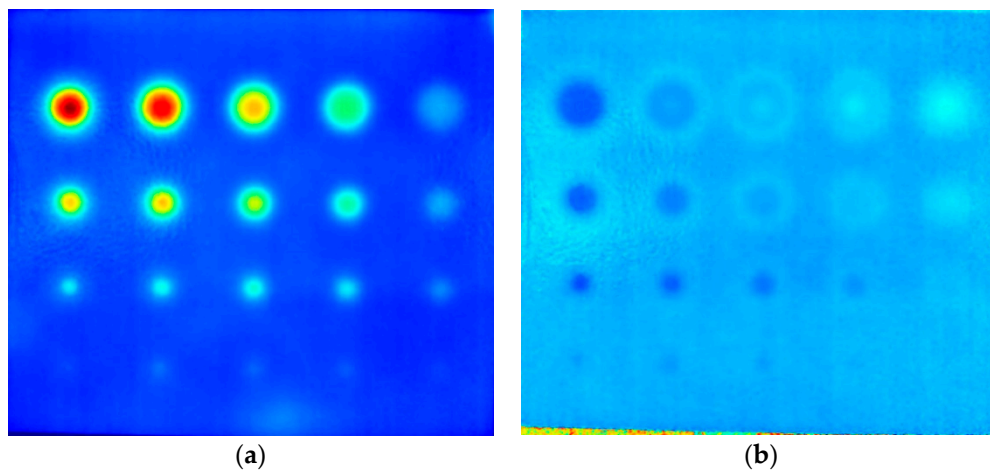
**Figure 10.** (a) Amplitude image and (b) phase image of the thermograms captured during cooling after 75 s of heating.

Figure 10a,b shows the phase and amplitude images at the minimum frequency where the FFT was applied to the step heating thermograms captured during cooling after heating for 75 s.

The diameter-to-depth ratio of the minimum detectable defect in each of phase images of PPT and SPAT was 2, while the amplitude of SPAT provided a better value of 1.33. It can be concluded from these results that the application of the FFT transform to step heating thermography was more effective than it was for flash thermography. This was especially true for the amplitude data, where clearer results with higher contrasts were achieved. Phase images revealed that defects with a better contrast compared to the amplitude images, in some cases. This demonstrated that a reliable inspection could be achieved by evaluating both results. Figure 11 shows the results of an FFT transform applied to thermograms captured during heating for 75 s. The phase image captured all defects—assumed to be indicated by the signals that were more than three times the background level—demonstrating that phase images extracted from the heating data provided more visibility compared to the data obtained from cooling. The amplitude images obtained during cooling were less noisy and contained more detail, which allowed the shape of defects to be determined.

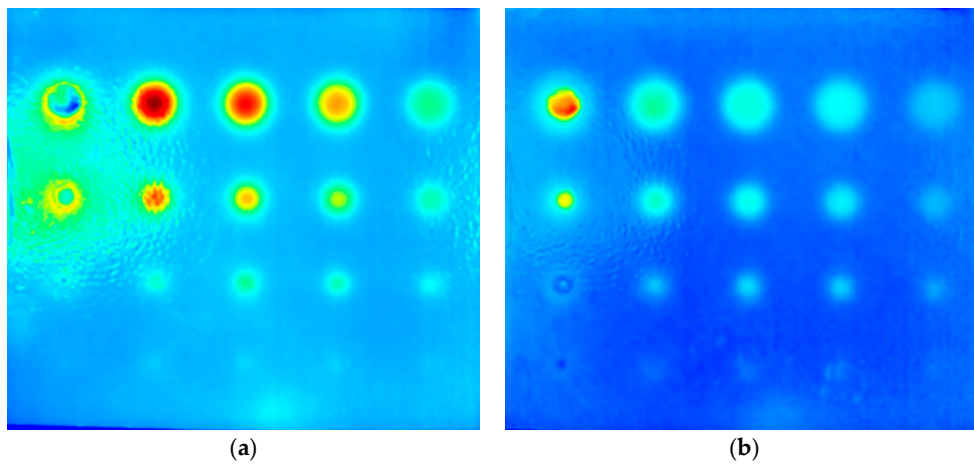
Figure 11. (a) Amplitude image and (b) phase image of thermograms captured during heating for 75 s.

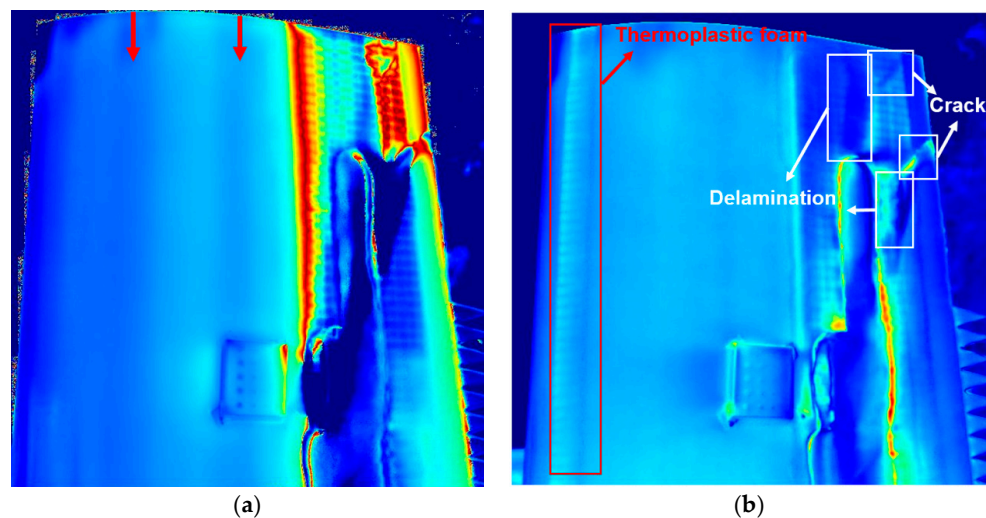
**Figure 14.** (a) Phase images of the passive thermograms captured during the morning at a frequency of 0.00184 Hz and (b) amplitude image of the passive thermograms recorded during the morning at a frequency of 0.0165 Hz.

The transform-based technique, discussed in Section 5.2.2, SPAT, was employed for the first time to increase the quality of the passive thermography results. The phase images captured using this method were not sensitive to non-uniform heating. The FFT was applied to passive thermograms obtained at morning. The results are shown in Figure 14. Part (b) illustrates that the amplitude images considerably increased the quality and visibility of the visualized subsurface defects, as the visibility of cracks, delamination, and a large portion of the flat-bottomed hole defects was improved. Phase images have noticeably increased the contrast of shear webs signatures, marked by red arrows in Figure 14a.

Cracks and delamination are marked by white boxes in Figure 14b. The thermoplastic foam near the leading edge was detected in the amplitude results and is highlighted by the red box in Figure 14b. This method not only increased the quality of the thermal images and improved the detectability of

thermography but also eliminated the false indications associated with environmental reflections, dirt, and dust on the surface.
