Detection of Impact Damage on PVA-ECC Beam Using Infrared Thermography

Abstract: The main purpose of the current research is to pilot study the impact damage detection in a beam structure using infrared thermography. In this study, a beam structure, made of polyvinyl alcohol fiber reinforced engineering cementitious composite (PVA-ECC) was subjected to multiple low-velocity impacts at a constant energy level. After each impact, the structure was heated by means of halogen lamp, and acquisition of thermal images was conducted simultaneously. Sequences of thermal images were acquired with starting and ending time sets so as to include the entire evolution of thermal phenomenon, during both heating to cooling processes. Based on the relationship between the damage and the temperature variation under the thermal excitation, different damages in the impacted structures were analyzed in the thermographs. Through experimental investigation, the results demonstrated that different degrees of damage correspond to different infrared thermal characteristics. The generation and evolution of thermal signatures revealed the initiation and propagation of impact damages. It further illustrated th

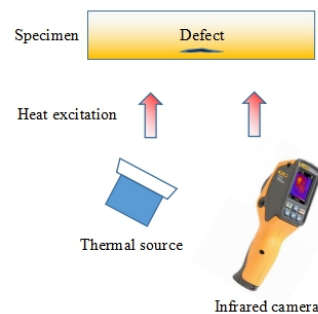
Figure 1. Schematic diagram of infrared thermography detection.

In active infrared thermography, a thermal source is applied to provide external heat stimulus. The applied thermal stimulation generates heat which propagates as thermal waves from the surface into the inside of the tested structure. When the thermal waves reach a defect or crack, they will change their propagation rate and produce thermal contrast on the surface above the anomaly immediately [50,51]. Figure 1 demonstrates the infrared thermography method for impact damage detection.

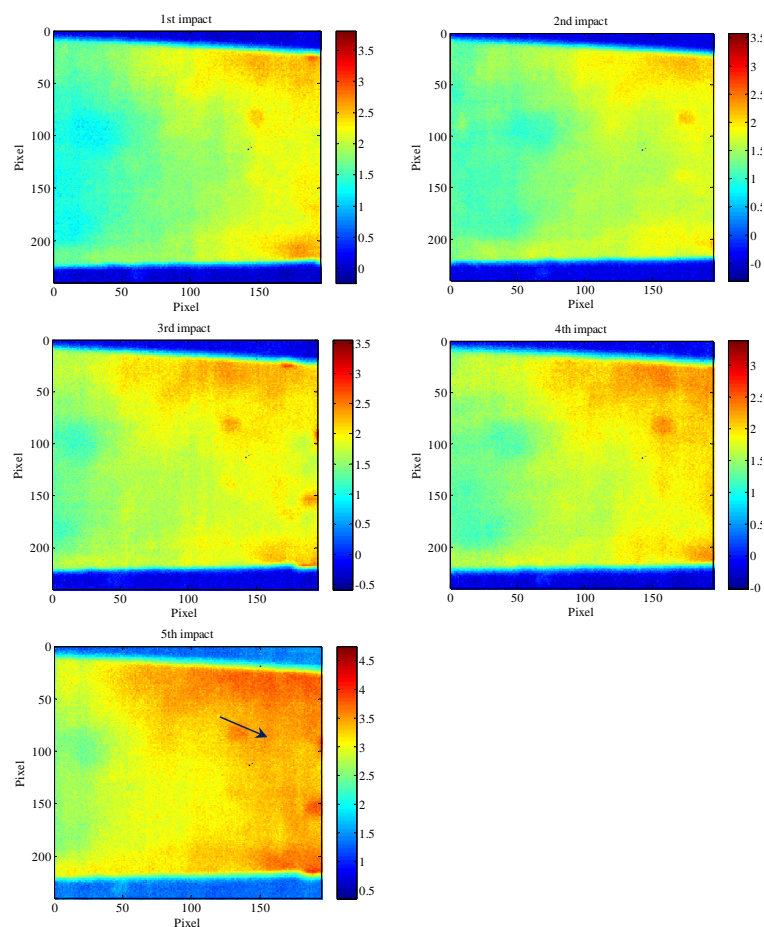
Figure 3. Thermal contrast of first five impacts in the warm-up period (The arrow indicates the high temperature abnormal zone).

The proposed procedure to detect impact damage has been applied to a PVA-ECC beam specimen. It should be noted that a micro-crack began to occur on the specimen's front side surface after the 6th impact. Then, as the impact tests continued, the micro-crack expanded and grew upwards. The thermal contrast images from the 1st to the 5th were shown in Figure 3. These figures represent the thermal signatures before the micro-crack appeared. As shown in Figure 3, the temperature differences of these first five impacts were similar. This is consistent with the result that no crack appears on the front side surface of the specimen. In the details, the temperature differences increased and concentrated gradually near the impact point of the specimen, especially after the 5th impact. It can be observed that there is a high temperature abnormal zone on the right side area of the image after the 5th impact, as the arrow indicates in Figure 3. After the 5th impact, the temperature contrast increased and the maximum value of the legend reached to 4.5 °C. A large area of high thermal contrast occurred on the right side area of the images. The thermal contrast in right side area was higher than that in the left side area. It means that the thermal energy was concentrated continuously on the right side area of the specimen after the 5th impact. Although we cannot find any micro-cracks on the surface until the 6th impact, we could speculate that there may be buried or subsurface cracks inside the specimen.

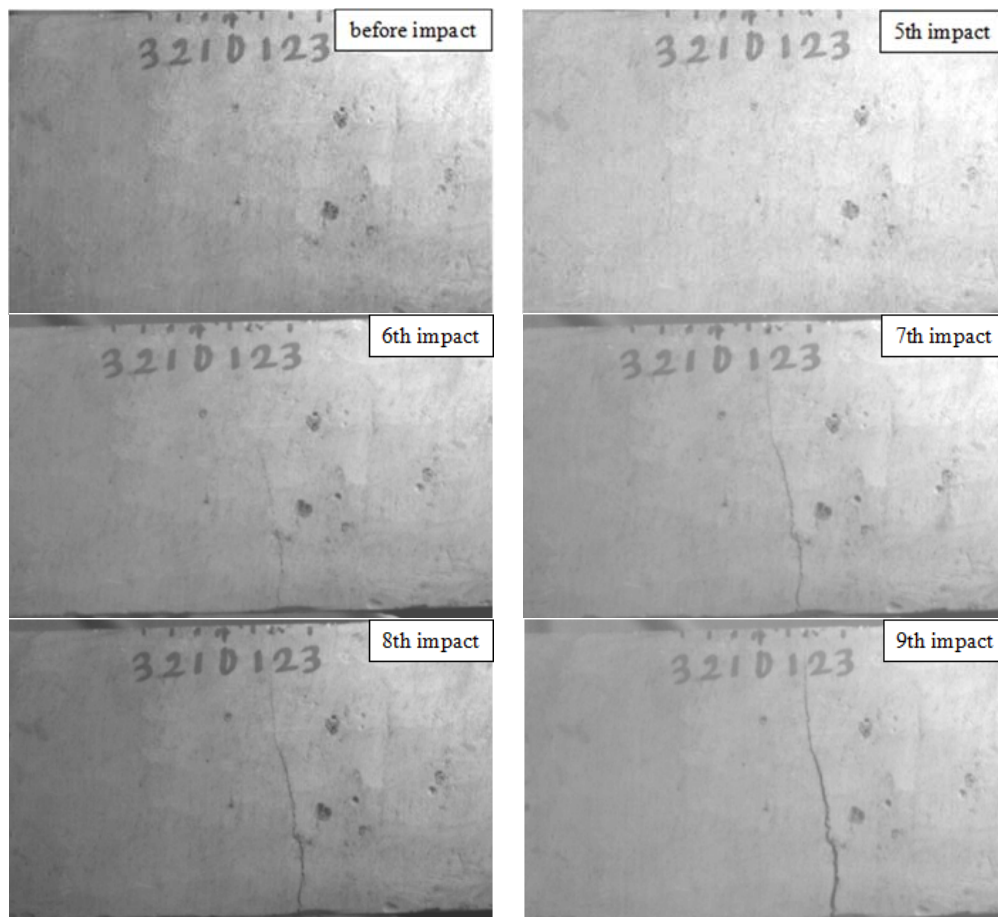
Figure 4. Photograph of the specimen's surface before and after impacts.

After the 6th impact, a vertical and narrow micro-crack appeared on the surface (Figure 4). From this point, the thermal contrast images were totally different from the first five, as shown in Figure 5. All the four thermal contrasts reached 4.5 °C and the temperature distribution was completely different, compared with the ones in Figure 3. It seems that the original high temperature zone on the right side area of the specimen suddenly cooled. The high thermal contrast zone was replaced by low thermal contrast zone. That may be interpreted by the explanation that there was a sudden energy release when the crack appeared on the surface. As a composite material, the PVA-ECC beam is comprised of materials with disparate thermal expansion coefficients. It will develop residual thermal stresses when subjected to a uniform thermal excitation [58]. If the beam develops cracks, the residual and mechanical stresses will change to accommodate the fracture surfaces. The redistribution of residual and mechanical stresses releases strain energy that can drive crack propagation—the energy release for crack growth [59,60]. As the rectangular box indicates in Figure 5, an elongated abnormal zone corresponding to the cracks occurred. As the impact continued, the crack expanded upwards and the abnormal temperature zone became longer and wider, which is easier to observe. In general, the wider the crack width, the quicker the maximum temperature difference is reached. The temperature difference increases when the area of crack increases.

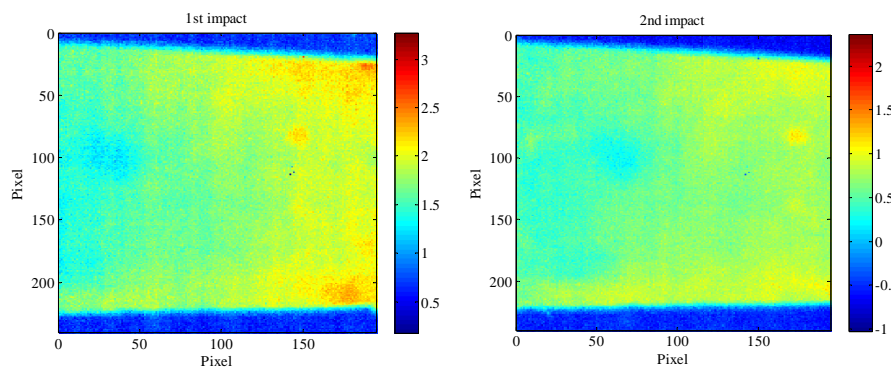
Figure 6. Cont.

Figure 6. Thermal contrast of first five impacts in the cool-down period.

Compared with the warm-up period, the cool-down period has roughly the same thermal contrast in general, as shown in Figure 6. However, there are two obvious differences. On the one hand, the values of the thermal contrast images were less than that in the warm-up period. The largest value occurred after the 1st impact and it was 3 °C. From the 1st to the 5th impact, the thermal contrast changed slightly by 2 °C. On the other hand, we can hardly find a concentrated thermal area in the middle of the images. As can be seen in Figure 7, after the 6th impact, thermal contrast for the last four impacts was totally different from the one after the first five impacts. The difference is that the thermal contrast is lower than that in the warm-up period. There is less interference of thermal contrast in the cool-down period. The elongated abnormal zone corresponding to the cracks can be observed more clearly. In summary, both the thermal contrast in warm-up and cool-down periods effectively detected the impact-induced crack. The signals in the warm-up period are much more sensitive than those in the cool-down period.

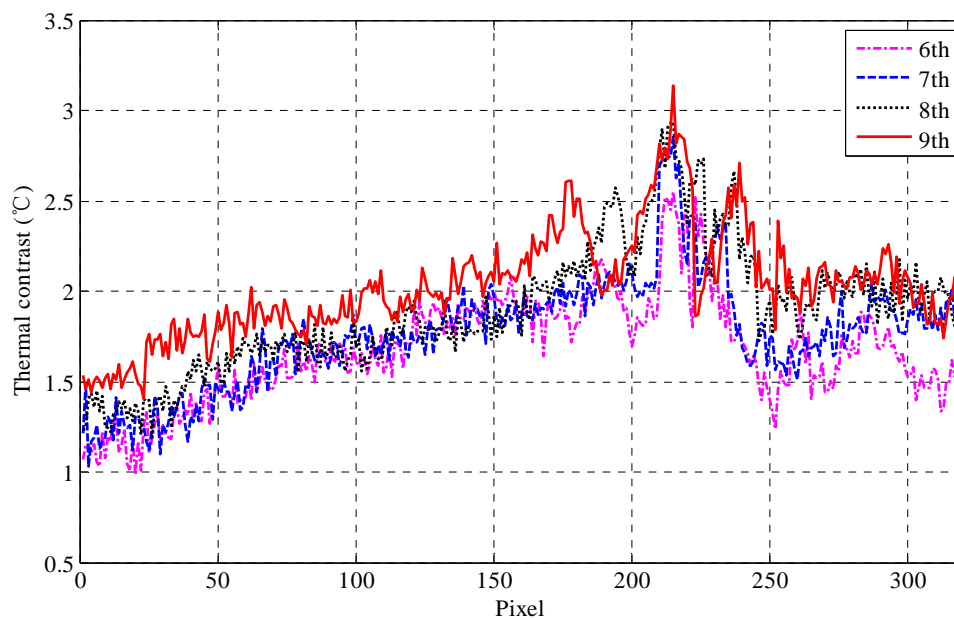
Figure 8. Thermal contrast profile perpendicular to the extension of the crack.

To provide quantitative analysis of the results, the thermal contrast variation profile was analyzed. The computed profile perpendicular to the extension direction of the crack along the x axis was shown in Figure 8, which revealed that the temperature variation gradually increased in the same profile line from the 6th to the 9th impact. It can be interpreted as the impact-induced cracks stretching and broadening as the impact continues. The thermal contrast was always the highest when it comes to the cracks. In this figure, we can easily find that the crack is near the 210 pixel on the x axis, where the temperature was higher than that of the nearby areas. We can also locate the position and even quantify the width of the crack from this figure. The width of the crack after the 9th impact was the most obvious. In Figure 8, the length of the highest temperature section was also the widest. These results agreed well with the actual crack width.

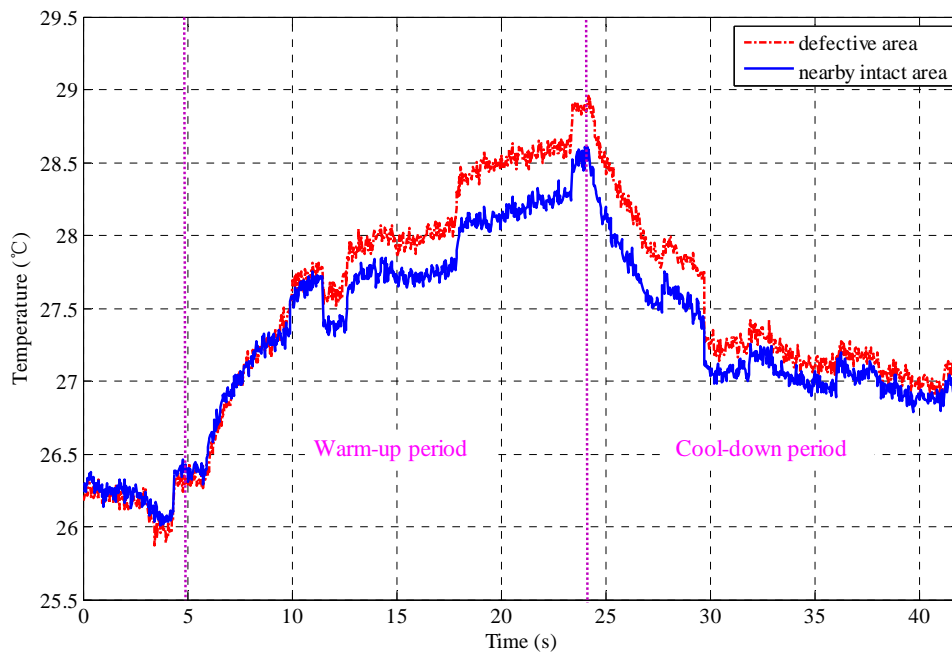
Figure 9. Temperature versus time in the defective area and nearby intact area.

To compare the temperature variations for different locations in the warm-up and cool-down periods, the temperatures over time in the defective area and nearby intact area after the 9th impact were computed, as shown in Figure 9. The temperatures show an overall increasing trend, and a sharp increase was observed near the 24th min. The possible explanation is that the defective area is filled with air and slag, which have different density, heat capacity and heat conductivity. Therefore, it shows the higher temperature curve in the warm-up and cool-down periods. In summary, the temperature on the defective area was higher than that on the intact area.
