# Additive Friction Stir-Enabled Solid-State Additive Manufacturing for the Repair of 7075 Aluminum Alloy

R. Joey Griffiths, Dylan T. Petersen, David Garcia and Hang Z. Yu \*

**Featured Application:** A novel metal additive manufacturing process, additive friction stir deposition, is investigated for use in the repair of 7075 aluminum alloy parts. Repairs include the demonstration of filling through-holes and long, wide grooves. This work is of interest to the aerospace and defense industries, in which 7075 aluminum alloy is widely used in critical components for its high strength and low density. Given its good scalability, additive friction stir deposition also has a great impact on large-scale repair applications, especially in infrastructure steel repair.

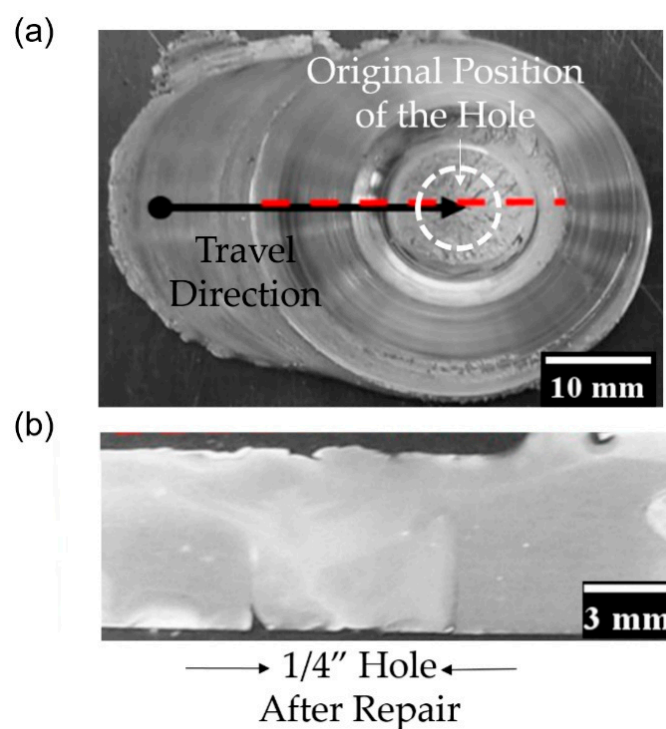
**Figure 5.** (a) Top-down view of the completed deposition for the hole fill sample with the tool traverse marked; (b) cross-sectional view of hole fill sample taken at the red dotted-line.

For single hole filling, the deposition starts close to the edge of the hole. This is followed by the print head traveling along the centerline of the hole until it reaches the center of the hole. After that, the print head stays over the hole for a pre-determined amount of time: the dwell time of 3 min, which controls the amount of filling material. Once the dwell phase finishes, no further traveling is applied. Instead, the print head is lifted while still rotating, so that the feed rod breaks off from the deposited material. Similarly to Experiment 1, the tool rotation rate is held constant at a rate of 400 RPM, the material feed rate is 0.1 mm/s, and the in-plane velocity is 0.32 mm/s. Figure 5 shows the top and cross-sectional views of the as-repaired sample with the 3 min dwell time. As can be seen from the images, additive friction stir deposition does not result in keyholes that are observed in friction stir welding; the breakage of the feed rod merely results in a rough surface at the end of deposition. In practical repair applications, the tool head could be retracted more slowly to allow this area to be flatter.

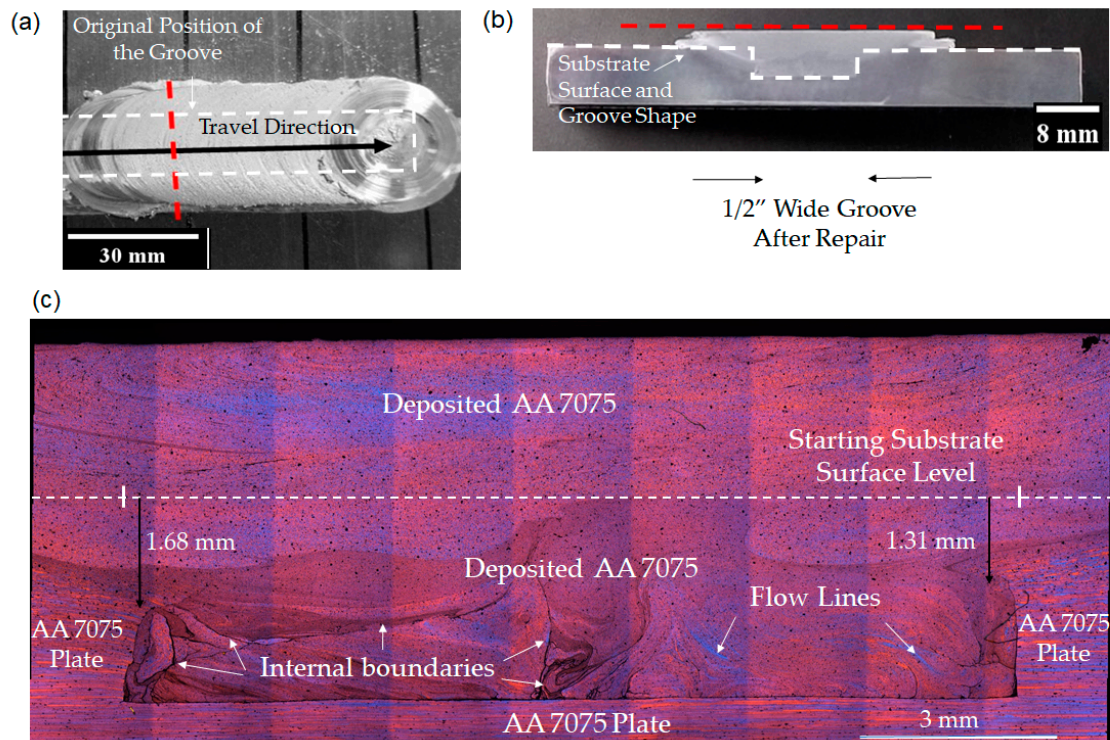
**Figure 7.** (a) Top-down view of completed deposition for the groove fill sample with the tool traverse marked; (b) cross-sectional view of the groove fill sample taken at the red dotted-line; (c) full cross-section of the groove filling sample, created by stitching together several optical micrographs.

contact between the feed material and the bottom of the groove leads to frictional heating so that the feed material is plasticized. Once the feed material begins spreading out under the print head to reach the side walls of the groove, slow traveling at a rate of 0.42 mm/s starts along the longitudinal direction of the groove with a material feed rate of 0.06 mm/s. Upon the completion of the first layer, the print head reverses direction to deposit another layer on top of the already deposited track. Finally, to ensure good filling, a third traverse is conducted over the two previous deposition layers, with the intention of pushing more material into the groove. Each layer after the first is approximately 0.76 mm in height. Figure 7a,b show the top view and cross-sectional view of the as-repaired groove, respectively.

A stitched optical image for the entire cross-section of the repaired groove is shown in Figure 7c, which confirms complete volumetric filling, notwithstanding the increased volume to fill and the increased distance from the print head to the side wall of the 1/2" wide groove. Unlike in single hole filling, no voids are observed after the groove filling. Moreover, the upper portions of the repair show sufficient mixing between the deposited material and the side wall of the groove, which is indicated by the lack of a distinct interface. Nevertheless, the depth of sufficient mixing (below the starting substrate surface level) is generally in the range of 1.31–1.68 mm, as highlighted by the two black arrows. This range is only about half of the groove depth. Addressing the inadequate mixing in the lower half of the repair is a critical necessity.

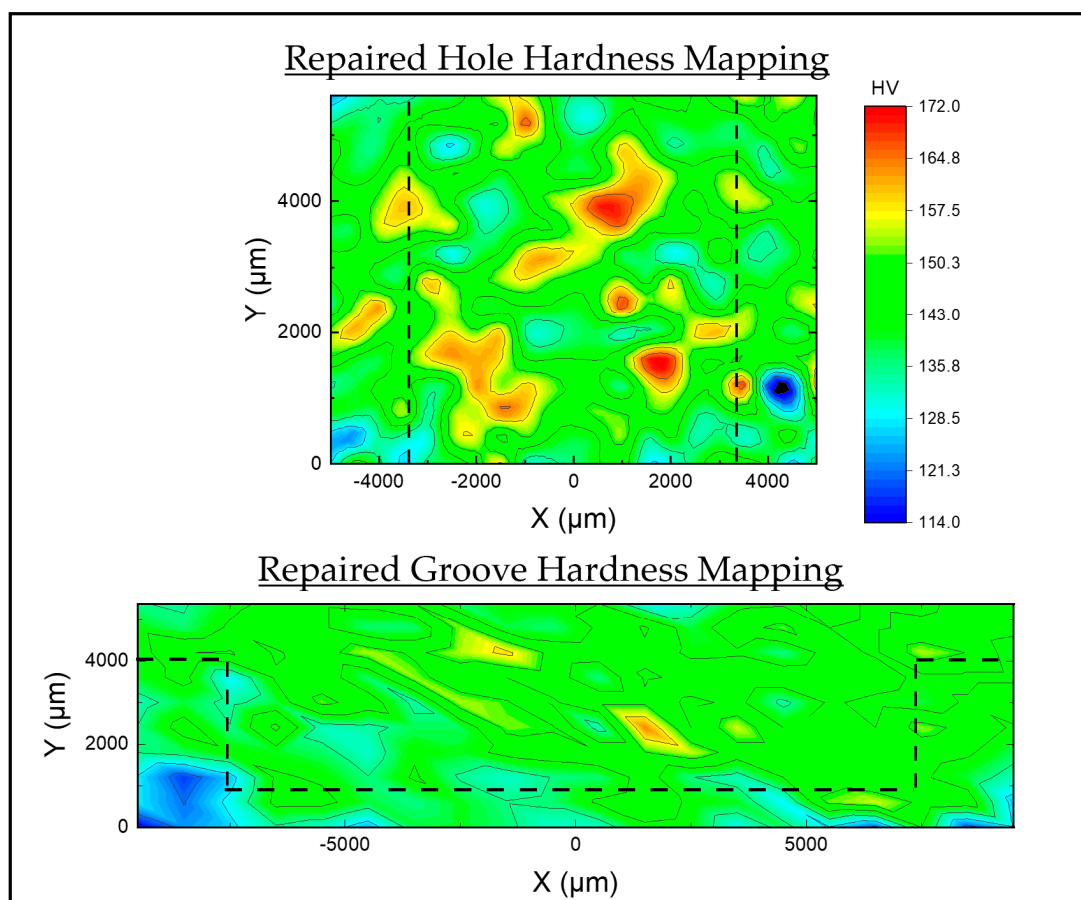
**Figure 8.** Hardness mapping of the (top) repaired hole and (bottom) repaired groove samples. The dashed lines represent the original perimeters of the hole and groove, respectively.

Figure 8 shows representative hardness maps measured from the cross-sections of the repaired hole (Experiment 2) and the groove (Experiment 3), respectively. The dashed lines represent the original dimensions of the defects to be repaired. The measured peak hardness is 172 HV in the repaired hole, and 168 HV in the repaired groove. In the deposited material, the hardness shows higher values inside the repaired volume than at the interface of mixing, a trend observed in both hole and groove repair. The average hardness of the feed rods is measured to be 164 HV. Although the deposited material is generally softened when compared to the original feedstock, most of the repaired volume exhibits a hardness value above 140 HV, which is 85% of the feed material value. There are even localized areas in the repaired volume showing comparable hardness to the stock AA7075-TT651.
